**PRE-RENOVATION ASBESTOS SURVEYREPORT**

**NIKE MISSILE SITE  
ADMINISTRATION AND CONTROL AREA  
AND  
LAUNCH AREA  
EVERGLADES NATIONAL PARK  
HOMESTEAD, FLORIDA**

March 4, 2010  
Revised August 18, 2010  
EE&G Project No. 2009-2333

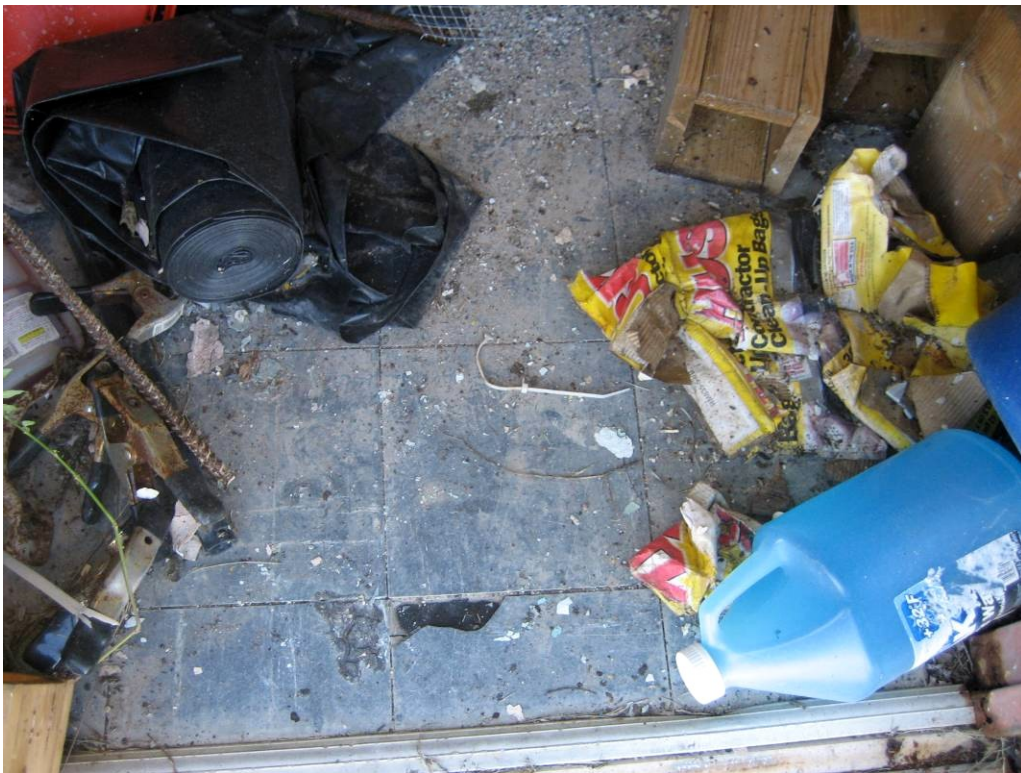
Asbestos was identified in amounts greater than 1 percent in the 9" black vinyl floor tile and associated mastic located in the Sign building (Generator Building 190A) and the Interconnecting Building 190B.

These materials were in good condition, but were exposed to substantial weathering to cause them to loosen. Any renovation of these buildings would probably require a cleanup of the floor tiles. A Florida-licensed asbestos contractor should be used for any disturbance of ACM.

190A Building : ACM 9" black vinyl floor tile and mastic.

These materials must be removed prior to any activities that would release asbestos fibers. Specifically, any renovation activity that will crush, abrade, or dissolve the matrix of these materials must be performed by a Florida-licensed Asbestos Contractor. If they will not be impacted during renovation, then no other special handling is required.

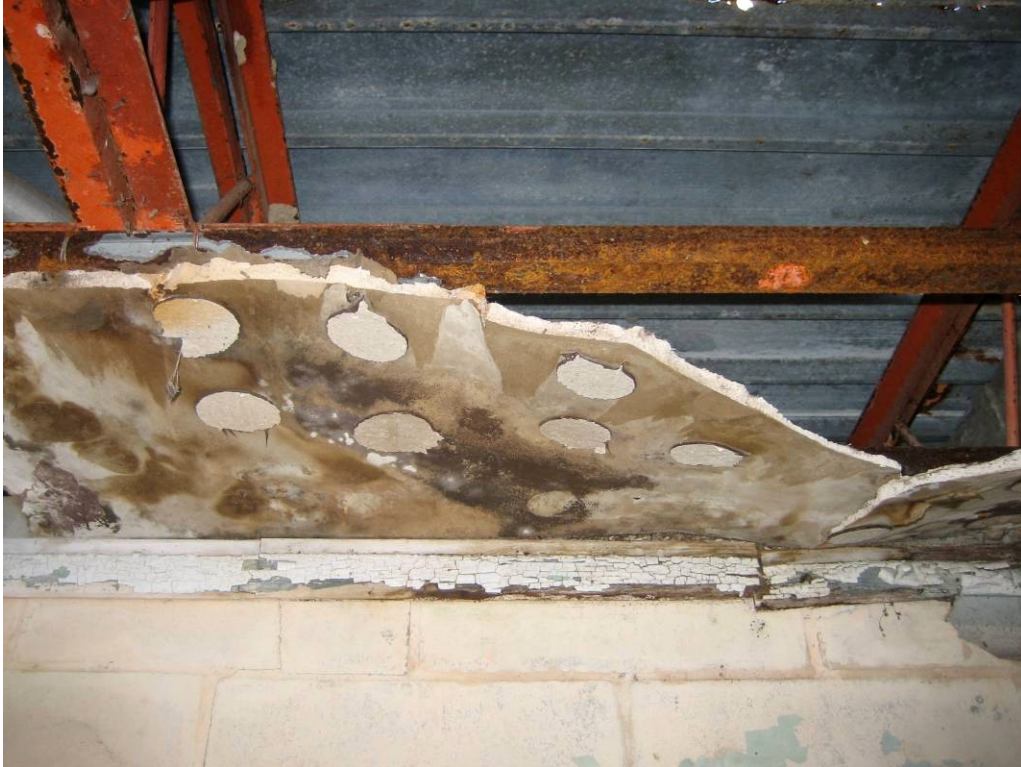
190A Building: NonACM drywall, ceiling tile glue, and ceiling tile.

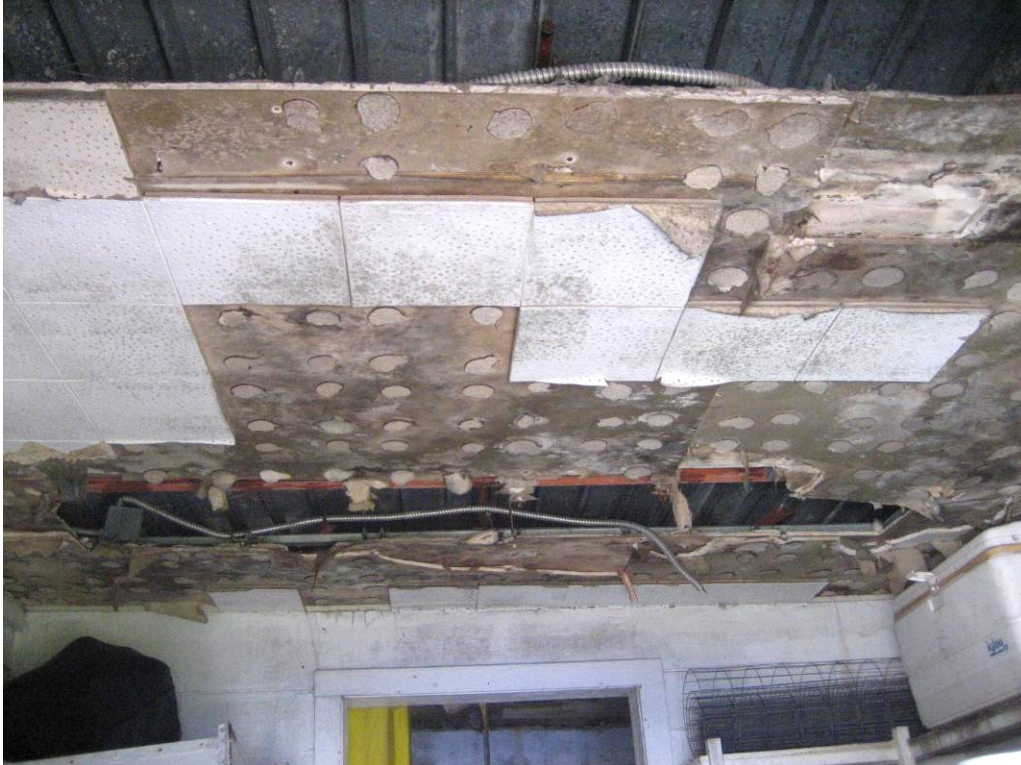
190 B Building: West side nonACM drywall, plaster, ceiling tile glue, and ceiling tile.

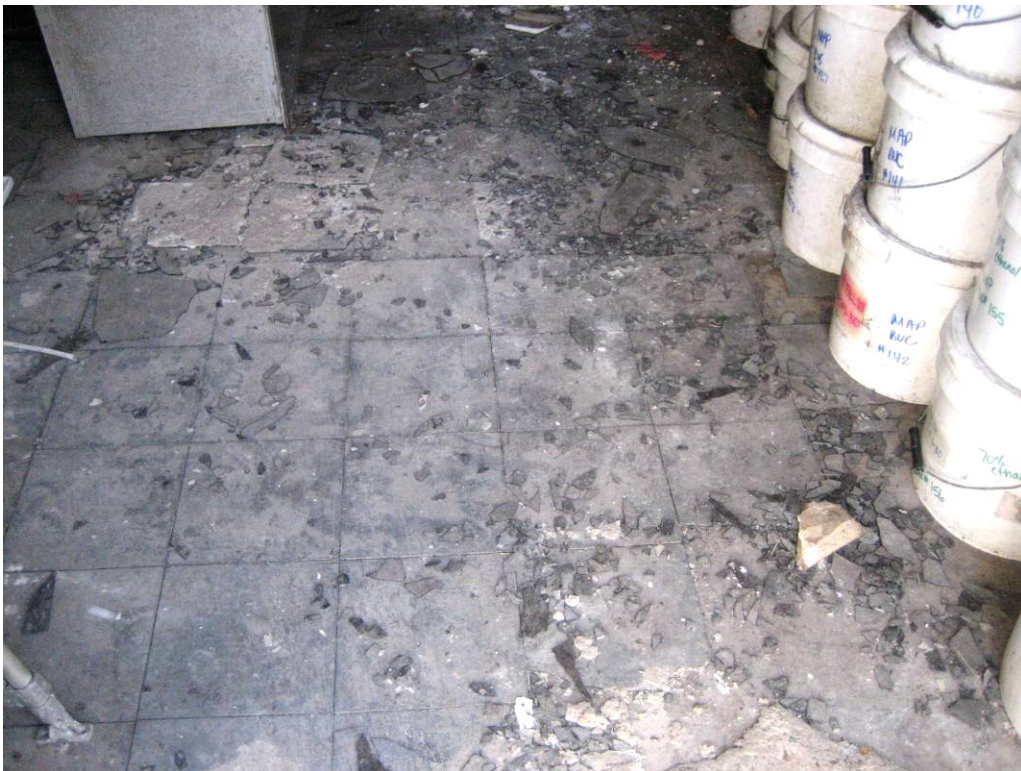
190 B Building: West side ACM 9" black vinyl floor tile and mastic.

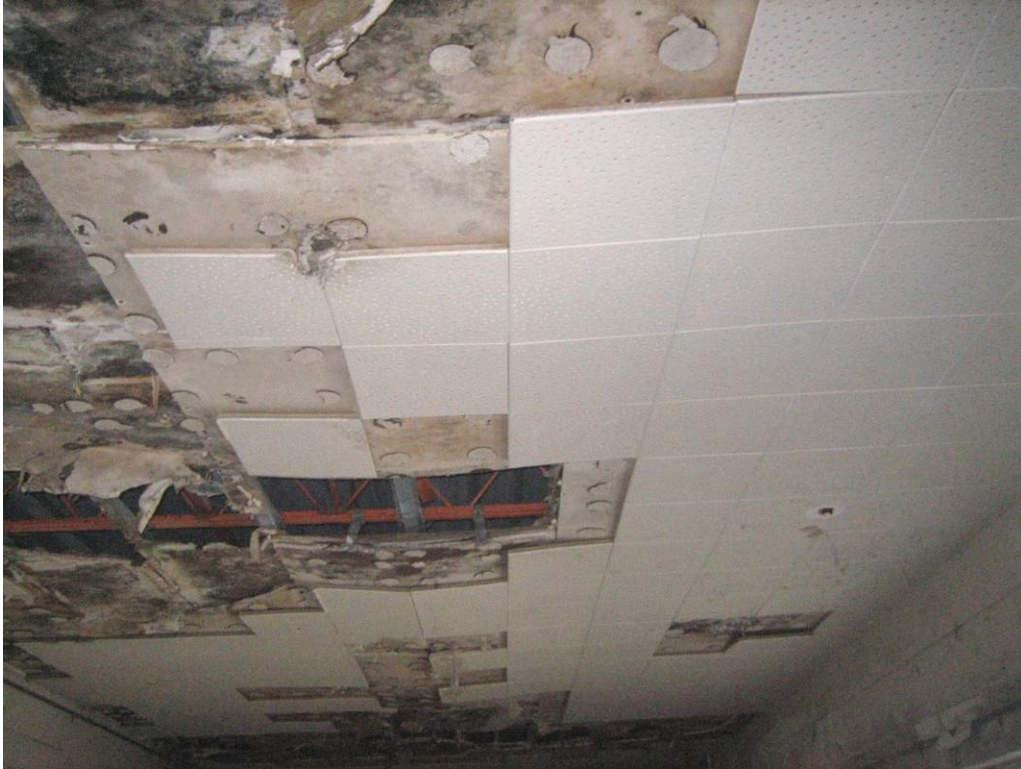
190 B Building: East side nonACM drywall, plaster, ceiling tile glue, and ceiling tile.

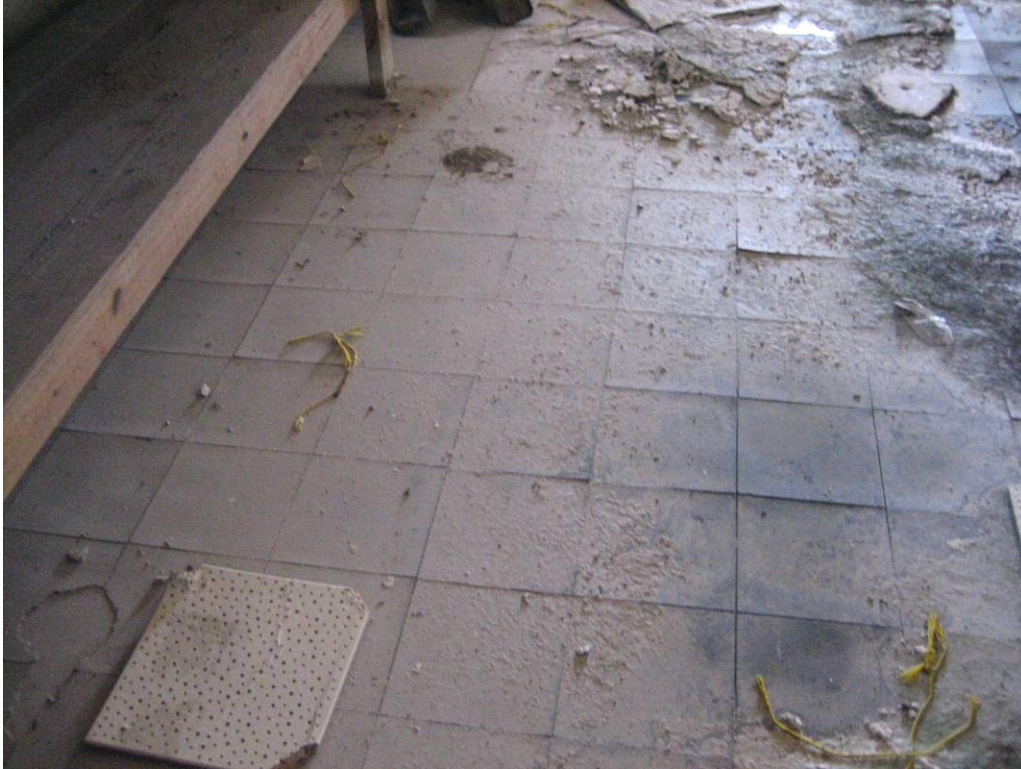
190 B Building: East side ACM 9" black vinyl floor tile and mastic.

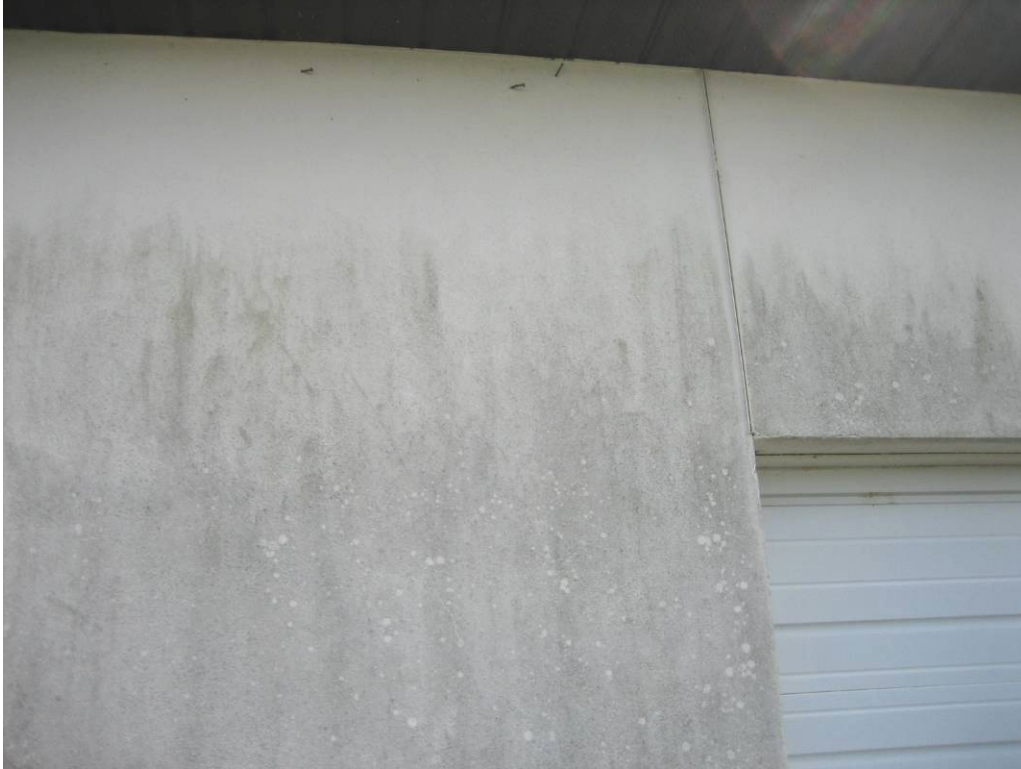
Workshop Building: NonACM exterior stucco.

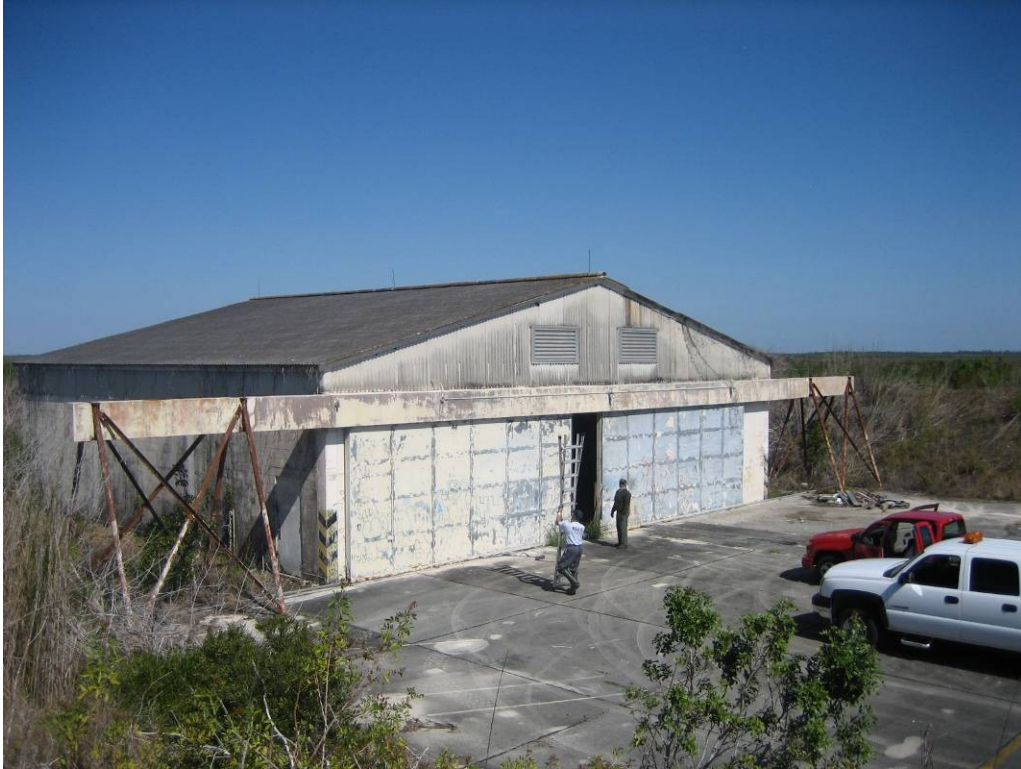
Asbestos was identified in amounts greater than 1 percent in the cementitious roof panels (exterior and interior) and cementitious siding of all three missile barns. The panels are in good condition.

Missile Barn A: ACM exterior cementitious siding and roofing panels.

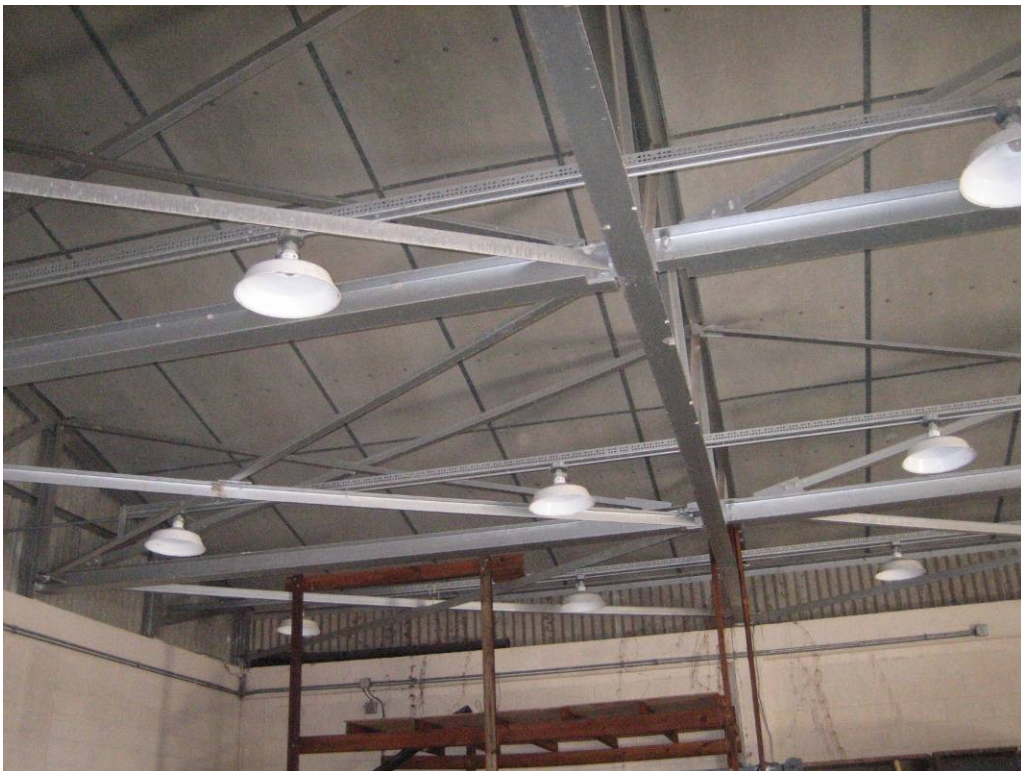
Missile Barn A: ACM interior cementitious ceiling panels.

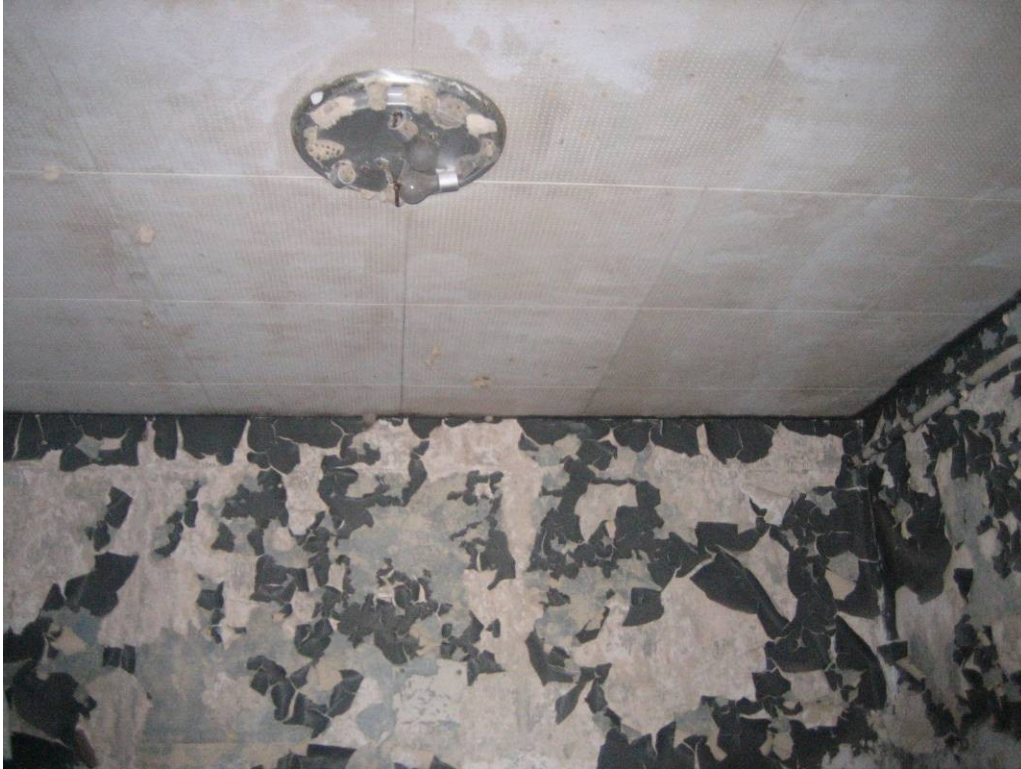
The fire-control bunkers were found to have 12" cementitious ceiling tiles that were identified as ACM. Most of these are still intact and in good condition.

Fire-control Bunker A: ACM interior cementitious ceiling tiles.

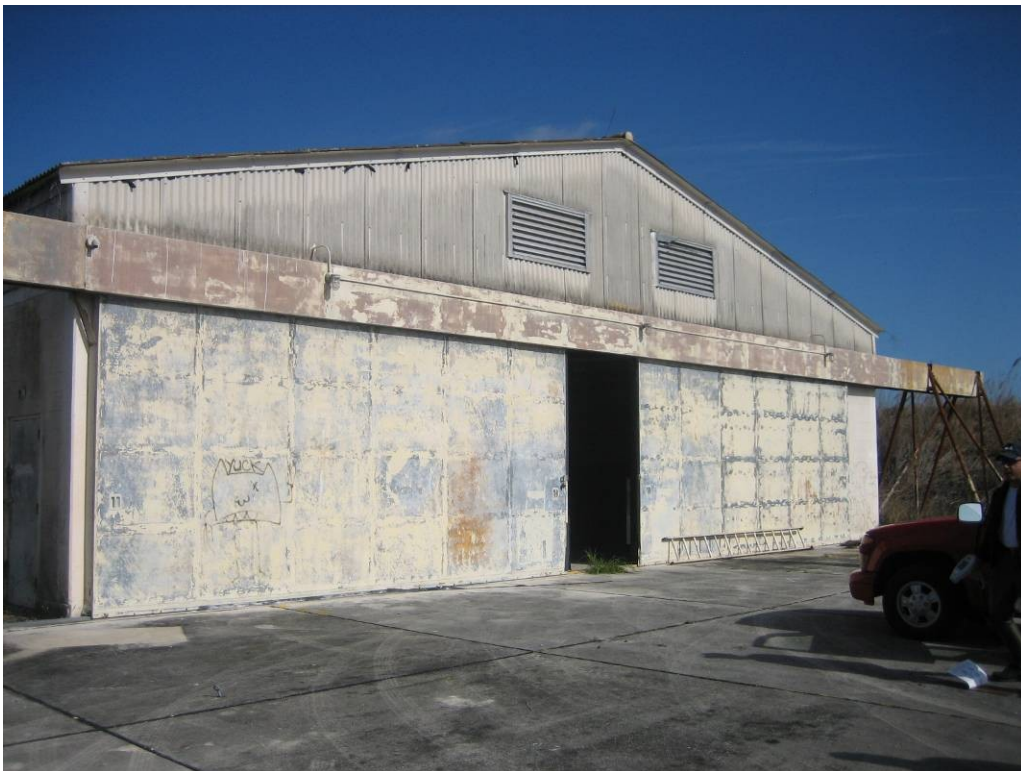
Missile Barn B: ACM exterior cementitious siding and roofing panels.

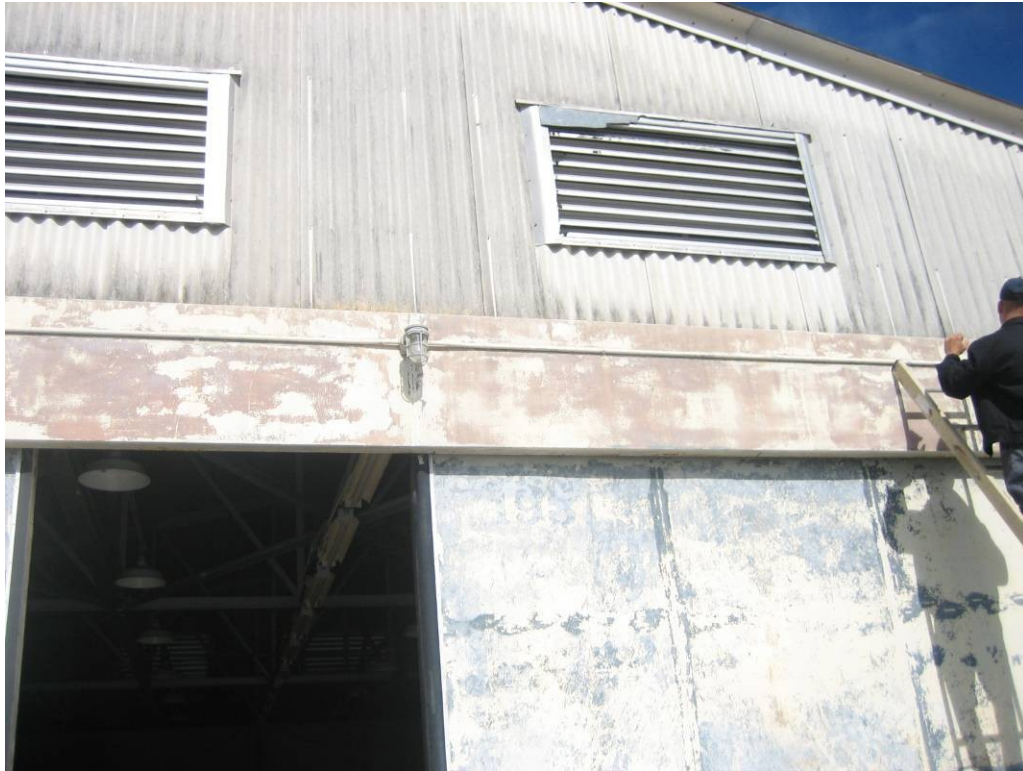
Missile Barn B: ACM exterior cementitious siding panels.

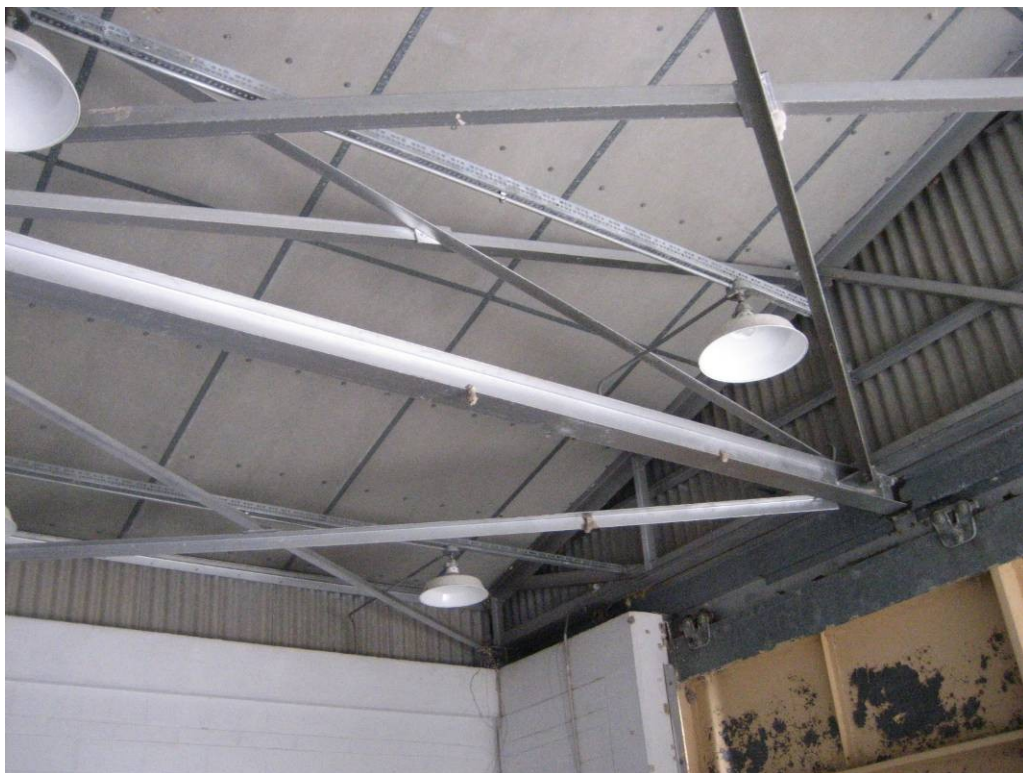
Missile Barn B: ACM interior cementitious ceiling panels.

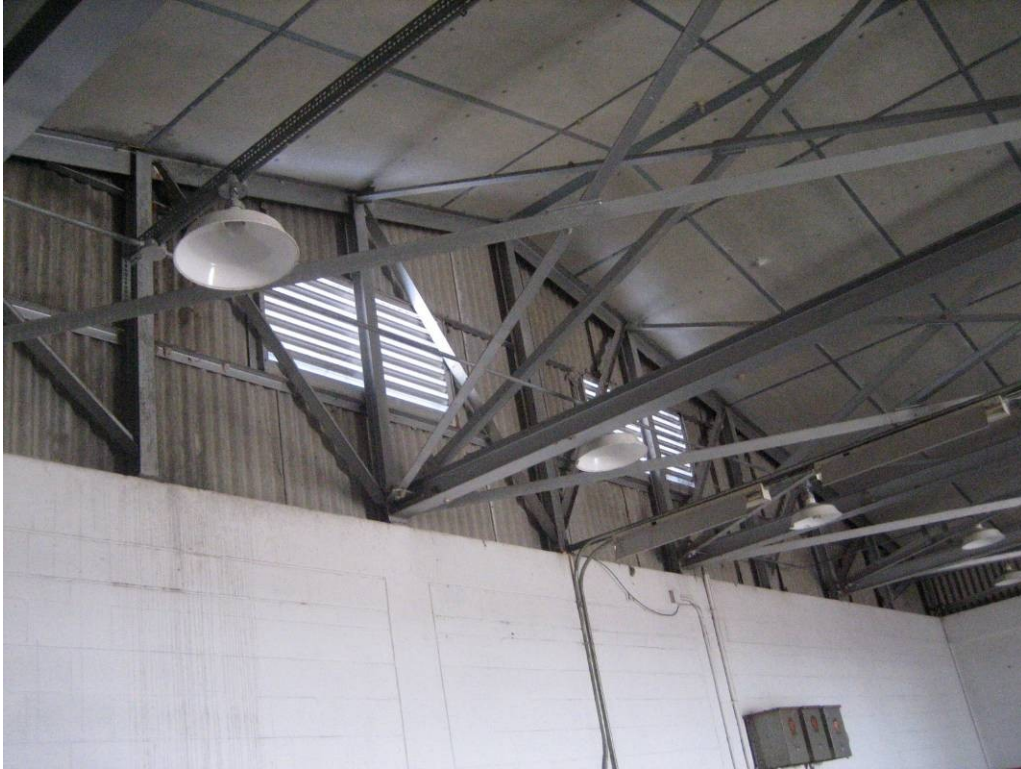
Missile Barn B: ACM interior cementitious siding and ceiling panels.

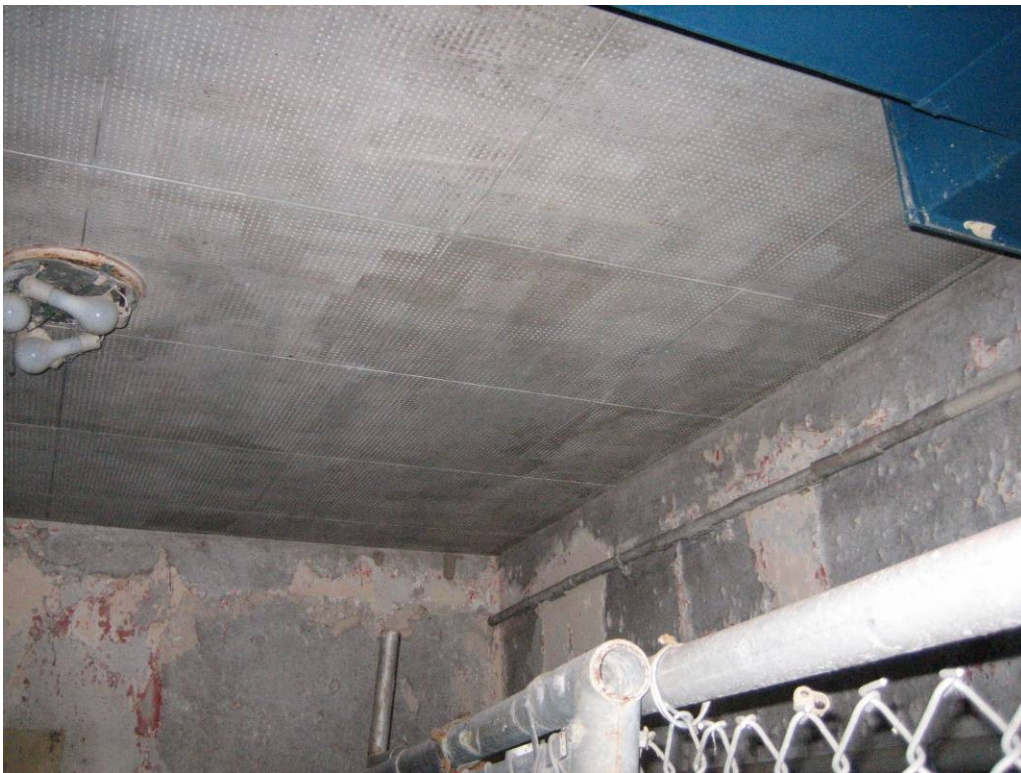
Fire-control Bunker B: ACM interior cementitious ceiling tiles.

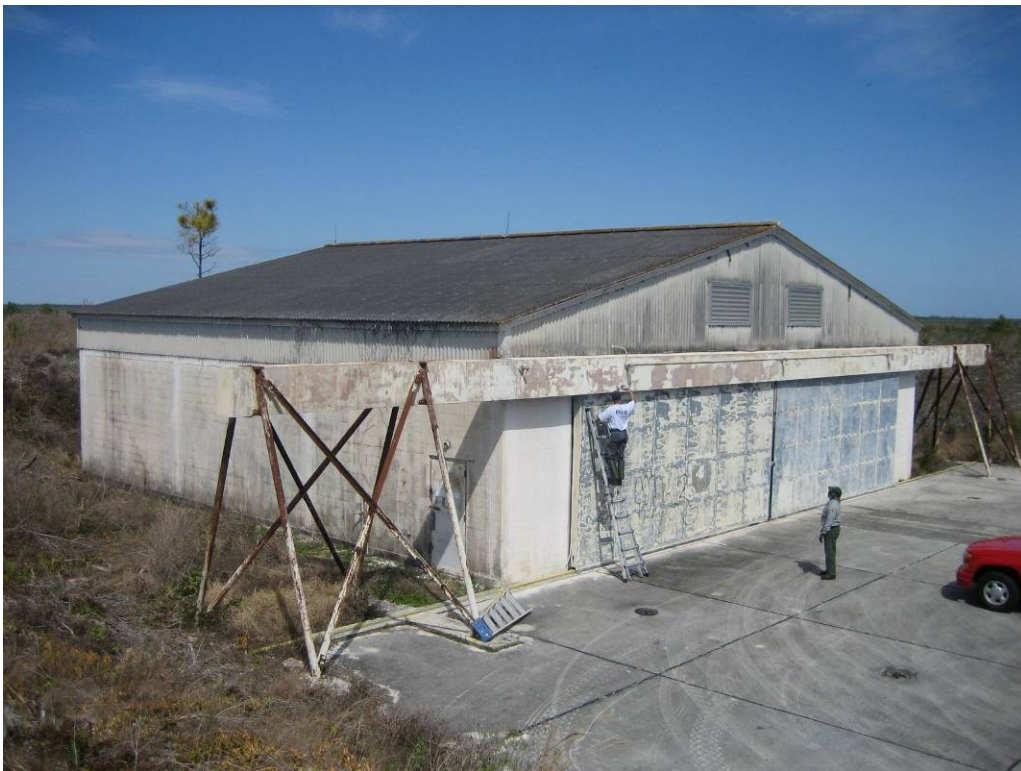
Missile Barn C: ACM exterior cementitious siding and roofing panels.

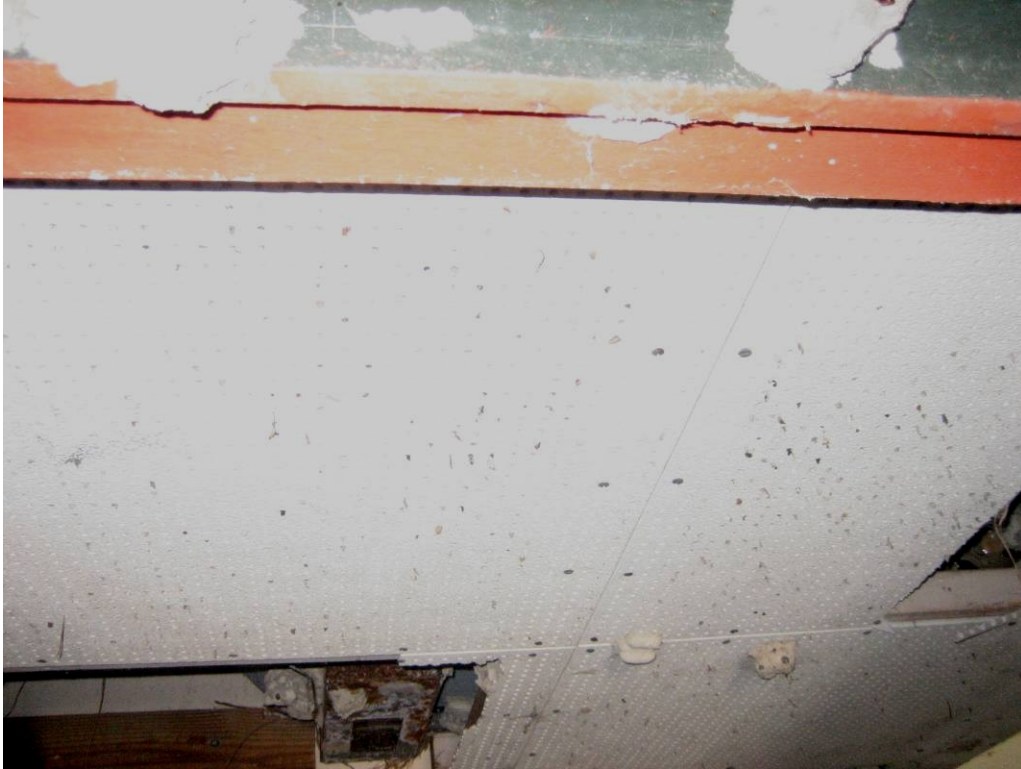
Fire-control Bunker C: ACM interior cementitious ceiling tiles.

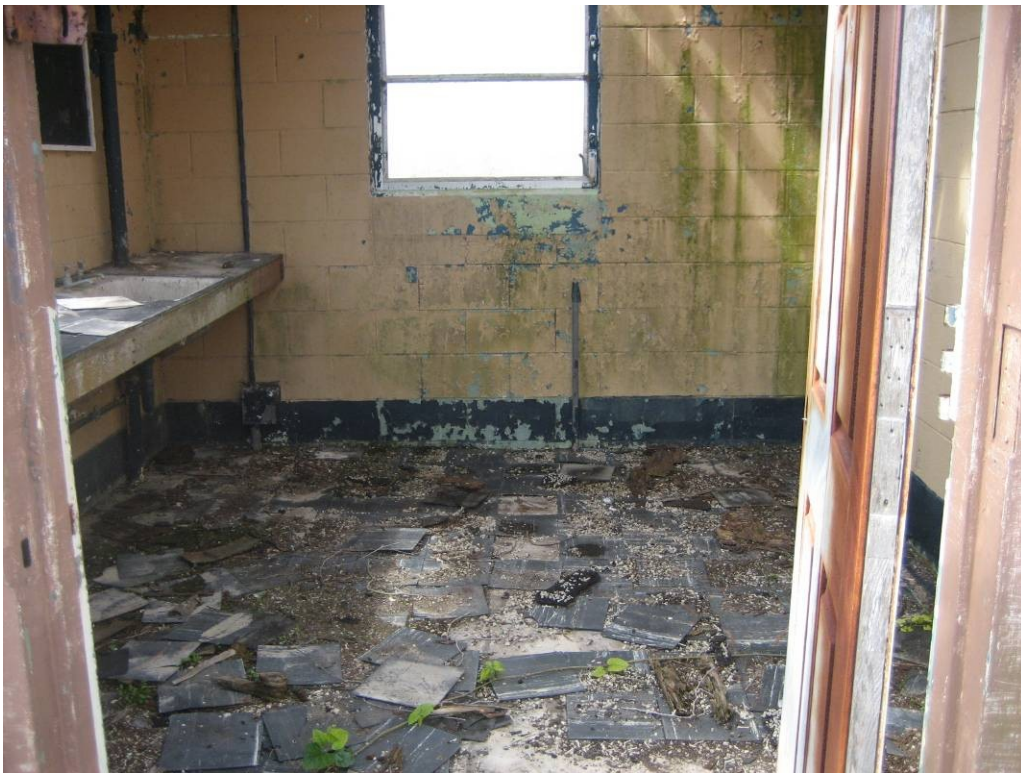
Kennel Building: ACM 9" black vinyl floor tile and mastic.

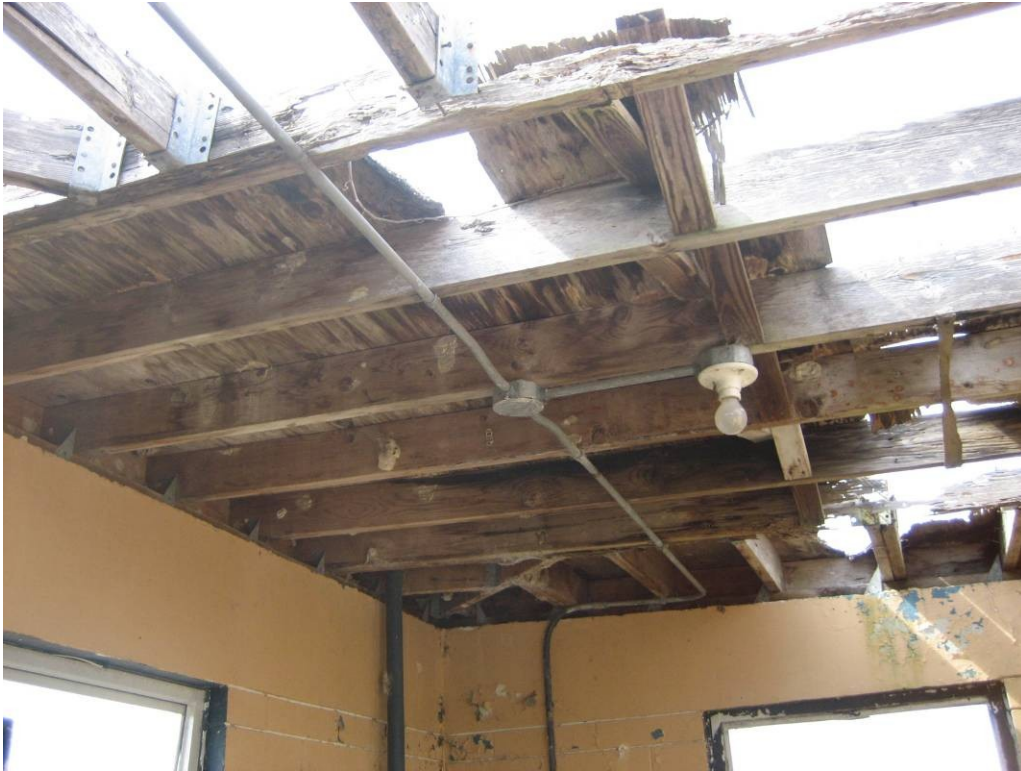
Kennel Building: NonACM roofing material.

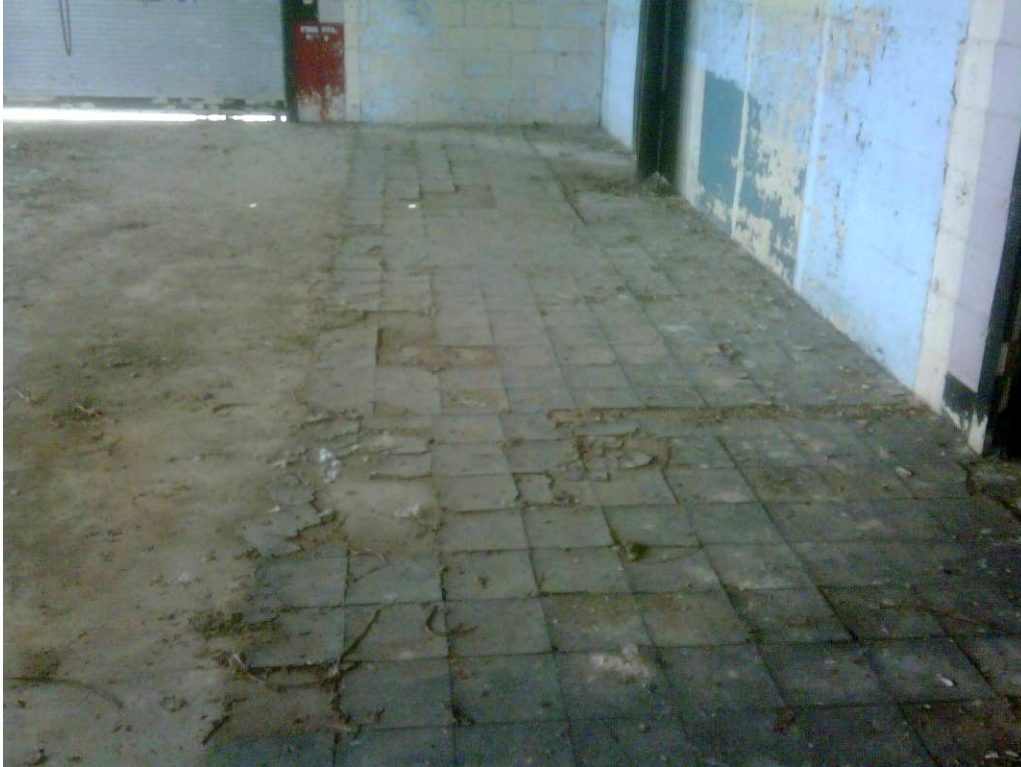
Missile Assembly Building: ACM 9" black vinyl floor tile and mastic.

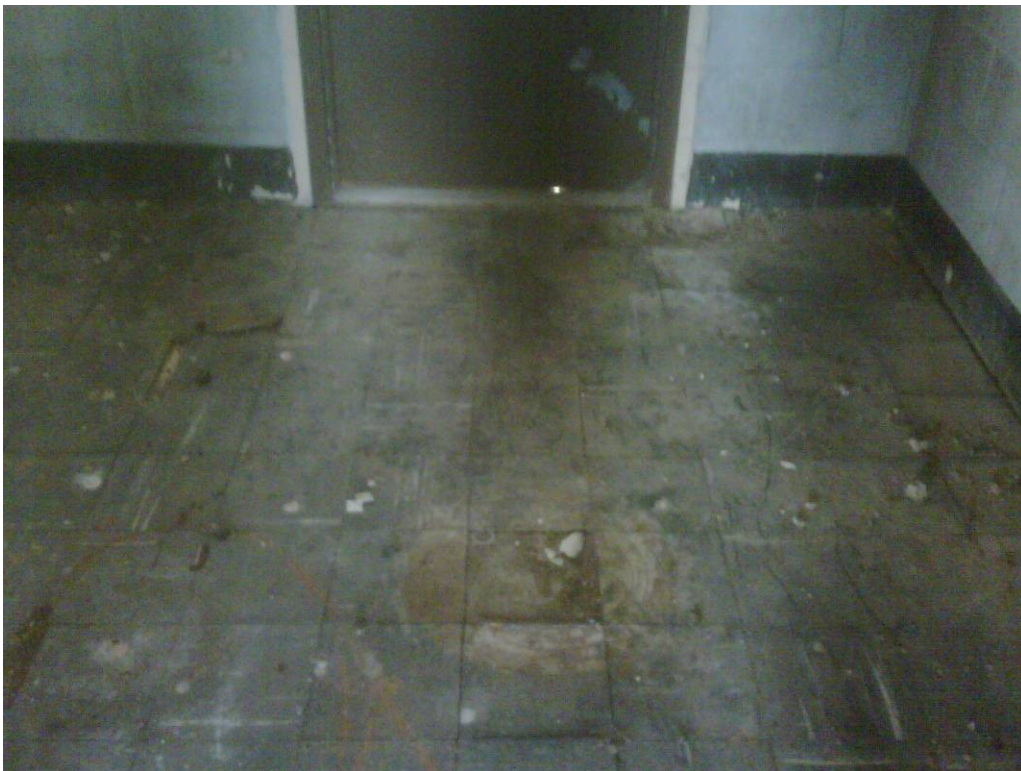
Missile Assembly Building: ACM 9" white (and black) vinyl floor tile and mastic.
