# **Condition Assessment Report**

491 Auburn Ave. NE,  
Fulton County, Atlanta, GA 30312

Jennifer Dixon  
HIST 8620  
September 29<sup>th</sup>, 2010

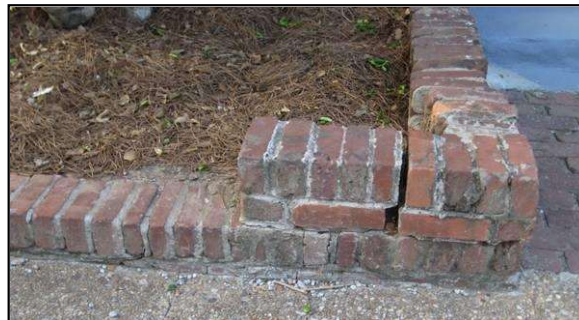
- Loose bricks around exterior pine islands (Fig. 14)

Figure 14 - Detail of loose brick, north

It is recommended that loose bricks be repointed, the driveway be repaired or repaved, and loose materials be cleared in order to remove safety hazards, especially if the building will be for public use.

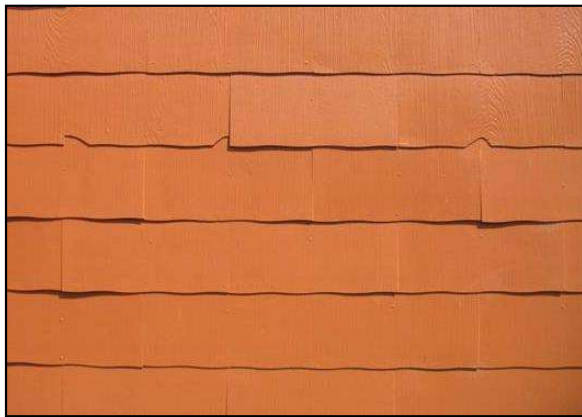
- Brick piers lacking mortar
- Moss growing on brick skirt around porch
- Crumbling concrete foundation on southern addition
- Spider webs and wasp nests evident
- Chipped asbestos siding throughout (Fig. 15)
- Nail holes and nails throughout (Fig. 16)

Figure 15 – Detail of exterior siding (courtesy of Angelica Dion)

It is recommended that brick piers and pilasters lacking mortar be repointed, moss be removed by the gentlest means possible, the concrete foundation be reinforced, and the insect issues be cleaned. The chipped asbestos siding, nail holes and unprepared surfaces do not pose an immediate threat, but should be assessed regularly (Appendix D). A balustrade and means of egress need to be installed on the back porch before the building can serve any purpose. Debris in the crawlspace should be photographed, tagged, and stored in order to decrease hazards. If

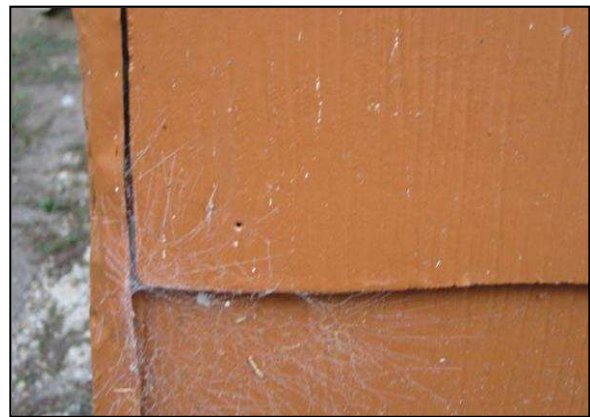
Figure 16 – Detail of nail holes, southeast corner

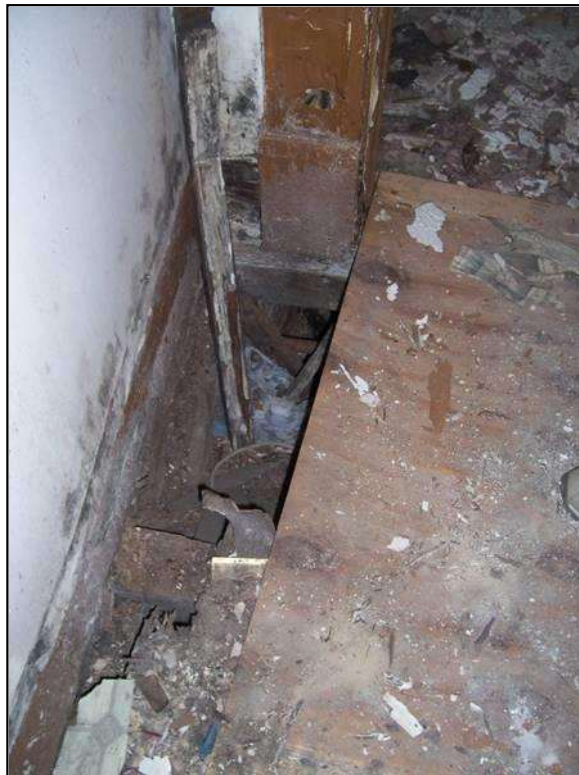
- Debris throughout entire first floor and rooms of second floor, such as room 202
- Casement openings
  - Mismatched casement openings and hardware in rooms 109, 201 and others
  - Decayed casement openings throughout
  - Insufficient hardware
- Flooring
  - Hole in southeast corner of room 103 (Fig. 17)

Figure 17 – Room 103 hole to crawlspace, southeast (courtesy of Mera Cardenas)

Recommendations also include repairing the hole in the floor in room 103. All plywood sheeting and the second type of hardwood flooring in room 108 should be replaced with in-kind hardwood flooring. All hardwood should be cleaned, repaired, and refinished where needed, removing furring strips. Areas intended to be used as wet spaces, such as room 112 or 206, should have impervious flooring installed, such as tile or laminate. Damaged walls and ceilings, whether minimal or expansive, need metal lath and plaster or plastered drywall installed. Rooms in which the walls and ceiling are sound need to be replastered, such as in room 201. Corrective plastering should take place under the window in room 108 (Fig. 23) and other areas that may

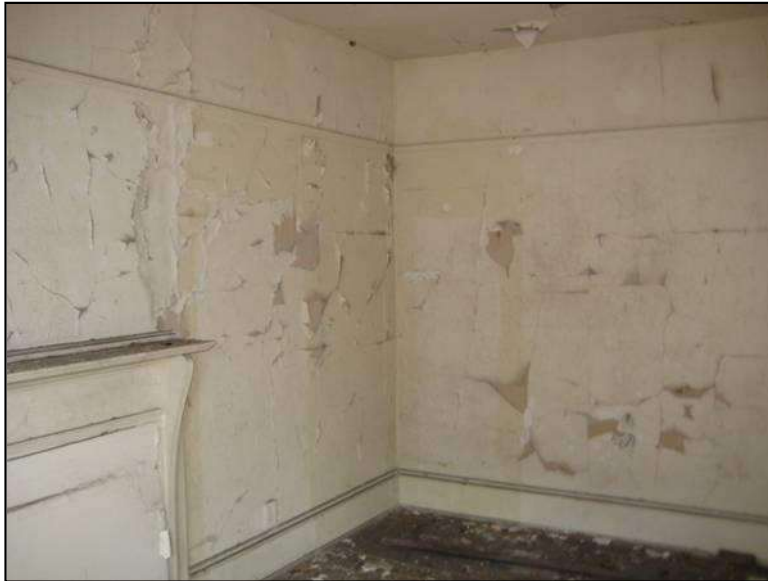
- Walls and Ceilings
  - Peeling plaster, such as in rooms 201 and 207 (Fig. 18)

Figure 18 – Peeling plaster in room 203, southwest

It is recommended that debris be disposed of while the architectural salvage material be photographed, tagged, and stored in a secure location for re-use in the building or elsewhere. All non-historic or non-existing doors should be replaced to match the six-panel, craftsman-style door. The three-light over three-panel door should remain in room 211 to the exterior and a similar door should be installed in room 204 to the exterior. Existing historic hardware should be cleaned and repaired, while the newly installed doors should have in-kind hardware installed. The 6/2 windows in 109 and 110 should be replaced to match the existing 2/2 windows, with a similar design replacing the 4/4 window in room 205. All casement opening hardware should be checked for security and all openings should be cleaned, repaired or replaced, and repainted.

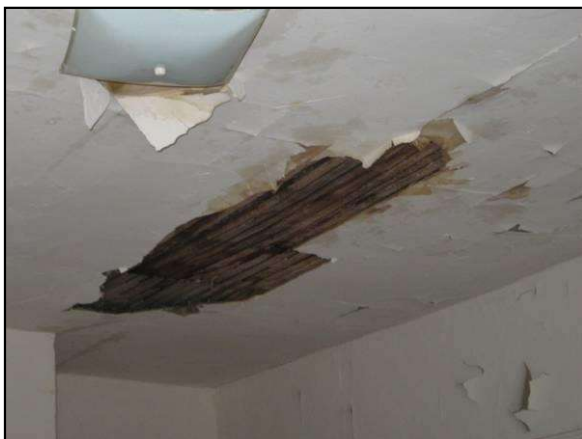
- Damage particularly around perimeter walls and ceilings (Figs. 19 and 20)

Figure 19 – Detail of minimal ceiling damage, room 201, southwest

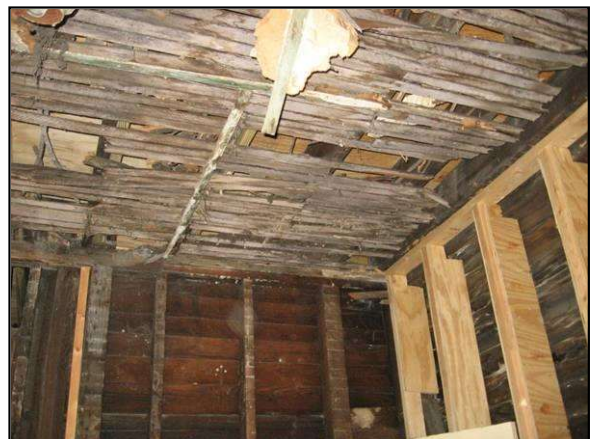
Figure 20 – Detail of extensive damage, room 110, southwest  
(courtesy of Justin Hutchcraft)

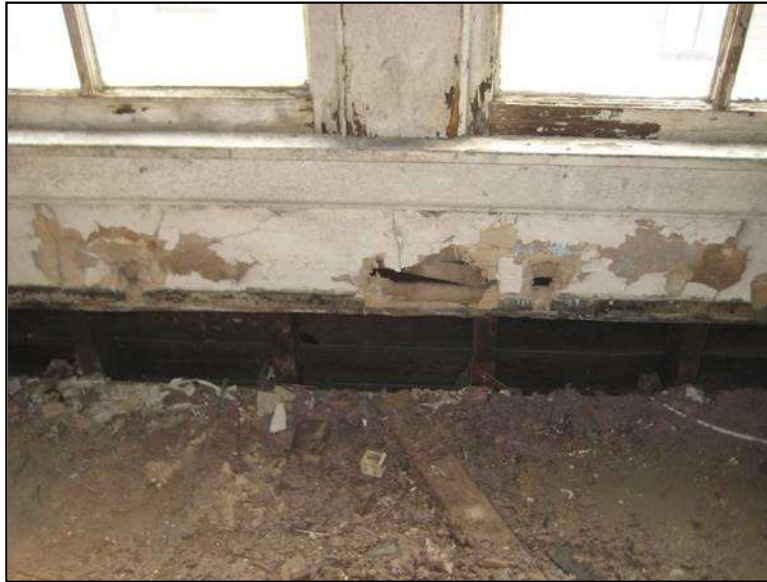
- Damaged surrounds and hearths in room 207 and others
- Decayed or missing trim throughout, such as in room 203 (Fig. 21)

Figure 21 – Non-existent baseboard in room 203, east wall

It is recommended that missing trim be replaced in-kind, including baseboard and mantels. All decayed trim should be cleaned, repaired or replaced, and repainted. Blocking that replaced trim (Fig. 24) should be replaced with in-kind trim as shown in other areas of the building. Other mismatched trim, such as in rooms 202 and 203, should be replaced to match historic trim. Fireplace surrounds and hearths should be replaced with materials significant to

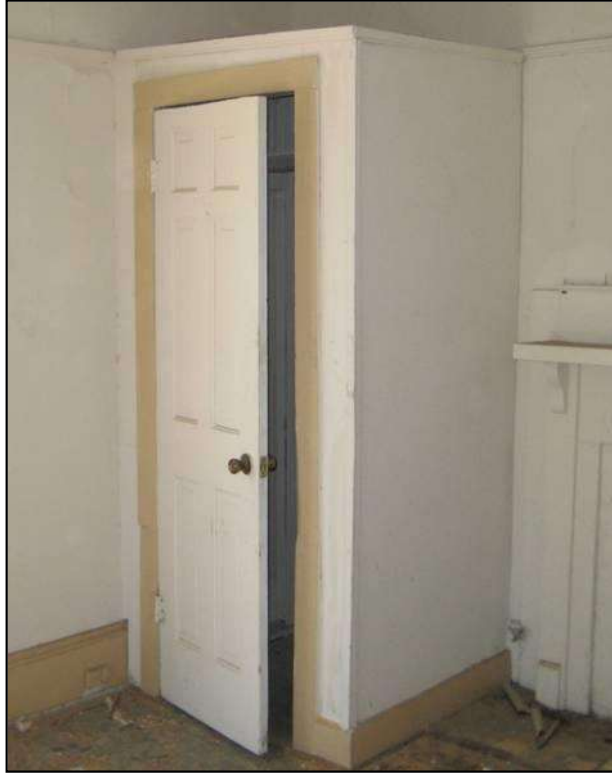
- Peeling paint throughout
- Mismatched trim, such as in room 202
- Lighting
  - Loose and exposed wiring
  - Non-historic or non-existent decorative lighting
- Specialty Areas
  - Exposed pipes, exhaust, and gas in rooms 112, 104, 206, 210 and others
  - Missing porcelain pieces in bathroom areas, such as room 212
  - Non-historic closet in room 201 (Fig. 22)

Figure 22 – Non-historic closet in room 201, southeast

Specialty areas, such as those previously used as kitchens and baths, need to be treated dependent on their proposed use. To minimize costs, it is recommended that these rooms be used for a similar purpose. According to NPS, the bathtub in room 212 was in good condition when removed and others were in states of disrepair. If they have been stored properly, these pieces should be retained and reinstalled. The non-historic closet in room 201 should be removed.

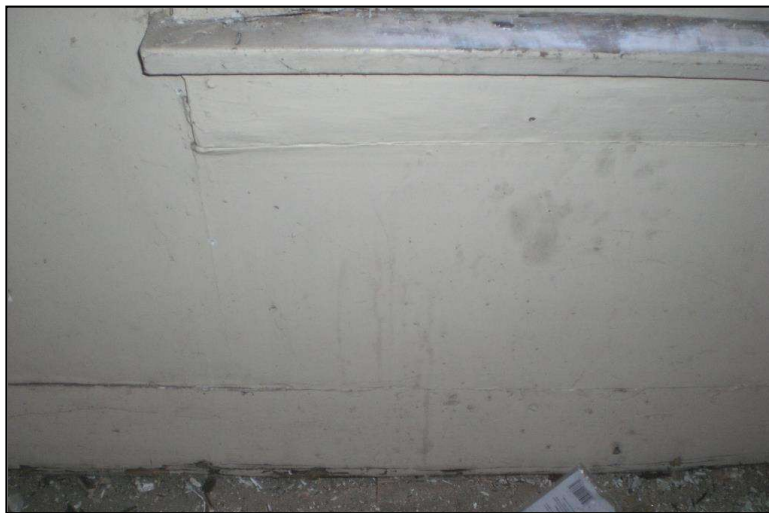
Figure 23 – Improper plaster repair, room 108, west wall (courtesy Rosemary Davis)

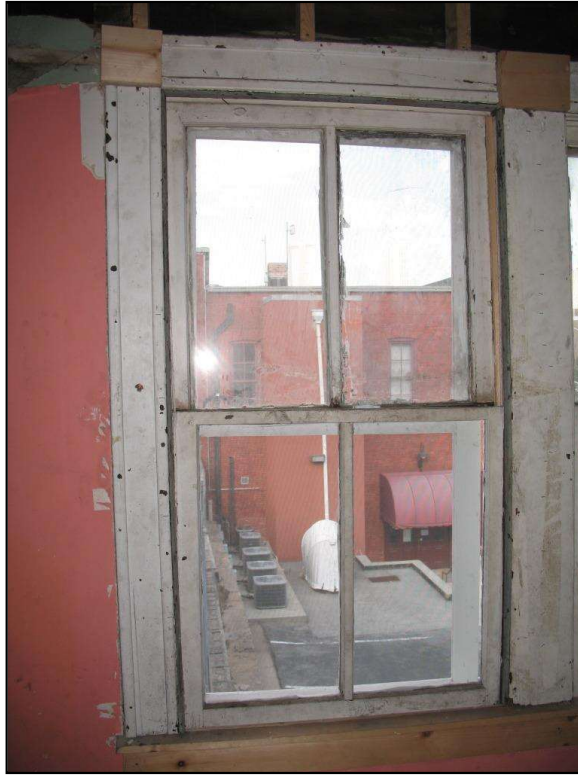
Figure 24 – Inappropriate corner blocking, room 208, west wall (courtesy Angelica Dion)

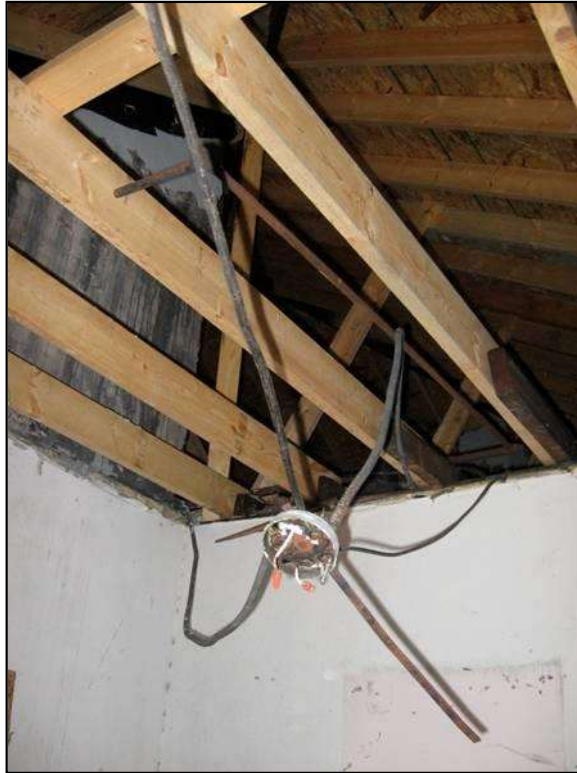
- Non-code compliant electrical wiring (Fig. 25)

Figure 25 – Electrical wiring in room 210 (courtesy of Justin Hutchcraft)

It is recommended that the electrical system be brought up to code with a three-wire, grounded system. Deteriorated piping should be repaired according to the building's proposed use. Gas heaters should be installed, if consistent with the new use of the building. Fire protection systems should be added to bring the resource up to code and weatherproofing should be updated to optimize energy performance.
