# HISTORIC STRUCTURE REPORT

1029 GURNEE AVENUE "THE MURAL BUILDING"

Anniston, AL

November 16, 2020

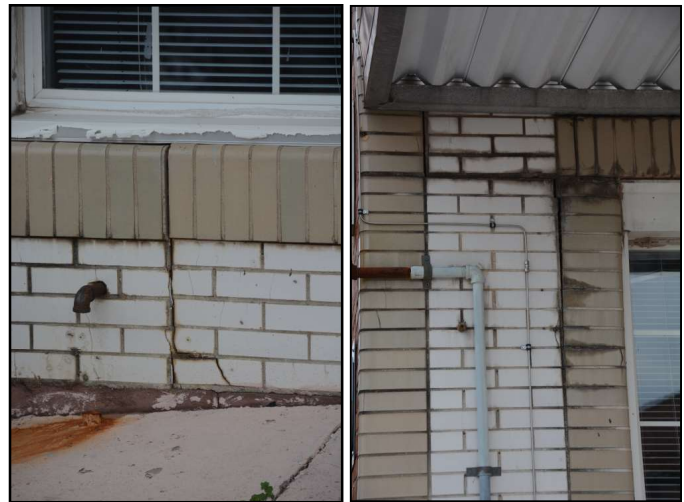
There are several vertical cracks near the north corner of the white glazed brick façade [Fig. 12]. These are likely due to cyclical thermal movement and a lack of expansion joints. There is also some damage to the tan bricks at the corner, likely due to vehicle impact, and iron oxide staining from old plumbing.

Figure 14: Cracking and water staining in the white and tan brick veneer on the east elevation. Left is below the Gurnee Avenue-facing window and right is left of the same window's header. Photo by author, 2020.

- The glazed brick facade has several deficiencies, including sustained moisture in the walls, cracks in mortar joints and unit masonry, and damage to the glazed face of several brick units.

- Thermal expansion is the natural movement of a material due to changes in temperature. Without an expansion joint (an architectural feature that had not completely caught on in 1947), the brick facade will relieve stress caused by the expansion of the assembly by cracking. There is one prominent vertical crack in the facade above the door and two more below the window. Because installation of an expansion joint may cause harm to the glazed brick, the existing cracks will continue to cyclically move. A flexible masonry sealant topped with an appropriately formulated mortar will protect the joint from water infiltration and maintain a consistent appearance of mortar joints.

- Cracked and spalled brick should be similarly treated with an appropriately formulated flowable repair mortar designed to blend in with the color of the glazed brick. Adequately visually-matched replacement bricks are likely difficult to source and so caution should be taken to do no additional harm during the facade repair or the work of other trades. This includes damage to the facade from plumbing and gas lines attached to and penetrating the wall at the north corner.

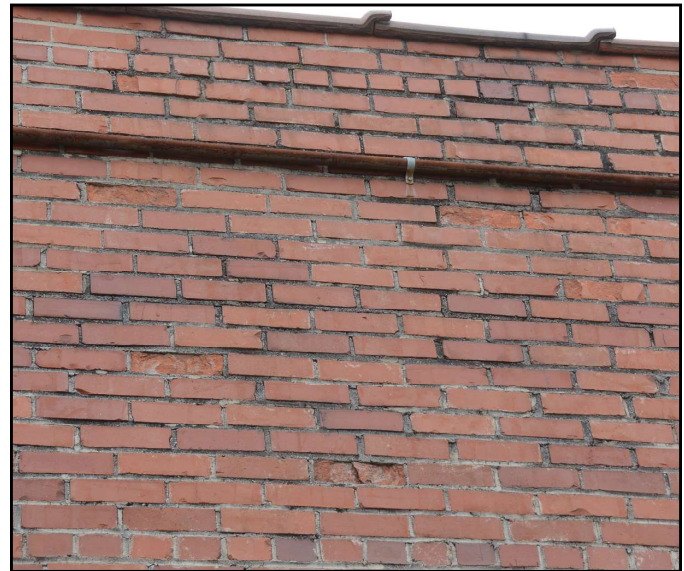
On the alley-facing elevation (north) on the upper half of the wall, about two-bricks per 10 square feet exhibit a spalled face [Fig. 13]. This is likely due to excessively hard mortar and water infiltration from the parapet and mortar joints. When rainwater or water vapor enters the wall, the mortar acts like a dam and forces water and water vapor to transmit through the face of the brick, often carrying salts. As the salts dehydrate, they expand and fracture the brick.

Figure 15: Some brick face spalling and wetness is evident on the upper portion of the north elevation. Photo by author, 2020.

- Spalling brick units and wetness in the upper half of the red brick walls indicate problems with water infiltration at the parapet and roof line. See below recommendations for the roof for waterproofing treatments to the parapets. The spalling may also be caused by mortar that is too hard for the brick unit. Arresting the water infiltration will stop the mechanisms that contribute to brick face spalling from mortar that is too hard, but analysis of the mortar and the brick is recommended. The exposed mortar appears to be a second application and may continue to cause harm to the brick units. However, removal of a hard Portland cement-based mortar from relatively soft brick often causes more damage to the brick than the benefit of mortar replacement.

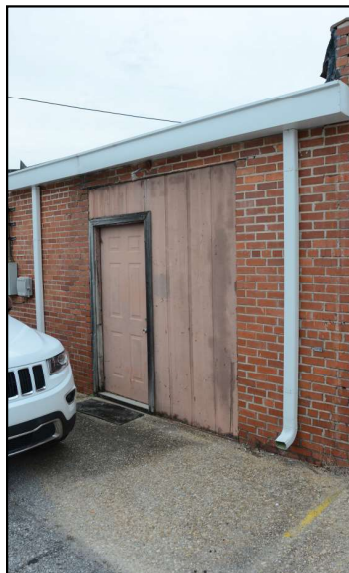
The threshold of the boarded-up overhead door was at the same elevation as the alley, but over time, the asphalt surface has been built up to slope up to the rear of the building, roughly six inches higher than the threshold of the overhead door. Water infiltration through the infill and at the old sill was observed. See detail in drawings.

Figure 18: Rear of 1029 Gurnee Avenue showing infilled overhead door. Note wetness at base of wall. Photo by author, 2020.

Water infiltration at the base of the boarded-up rolling door opening indicates that water is not adequately draining away from the building. As well, the downspout termination does not extend adequately away from the base of the wall. There is also a failed sealant joint at the boundary of the asphalt paving and the east masonry wall [Figure 18] that is allowing water entry.

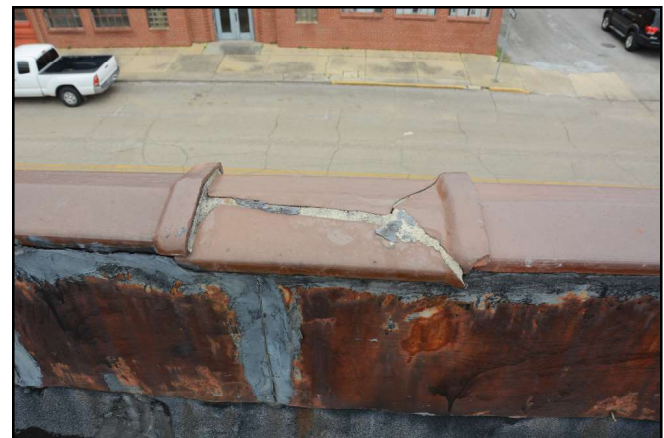
There are many areas of the roof that have been patched. The roof was in the process of being patched again during the condition assessment for this report. No active leaks were observed though. Several of the terra cotta coping units are cracked and/or broken, creating an increased potential for water to enter the wall.

Figure 22: Terra cotta coping tiles. The center tile in this image is cracked and has been repaired with mortar. Photo by author, 2020.

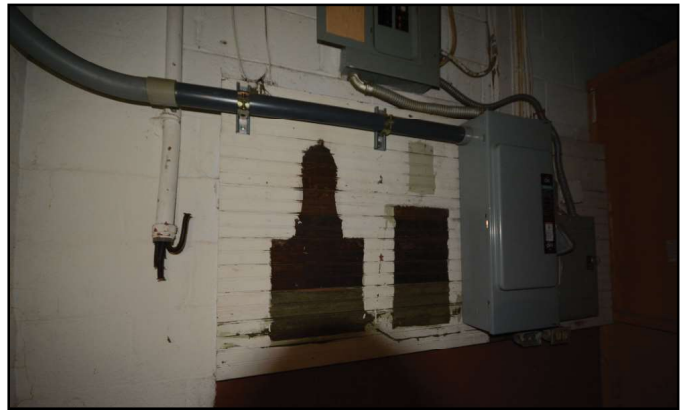
Electrical service comes into the building from the rear. There is an electrical panel room with both modern panels and older panels. Another electrical panel is mounted on the wall near the restrooms. Older, out-of-date electrical panels should be consolidated into newer panels. The panels are mounted on stained and painted tongue and groove beaded boards [Fig. 28]. The boards may or may not relate to historic finishes associated with this building and should be retained if evidence of material association is discovered.

Figure 30: Electrical panels in rear of 1029 Gurnee Avenue. Photo by author, 2020.

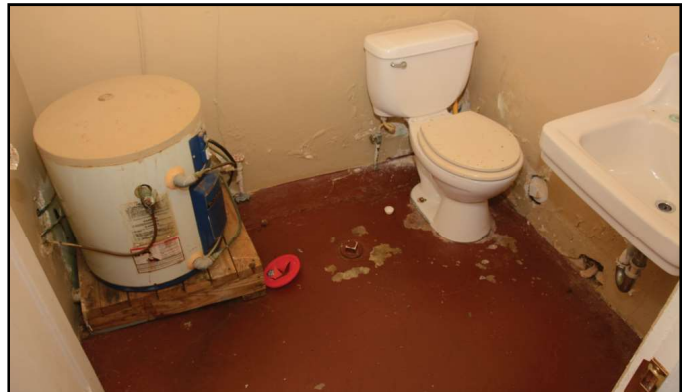
The original walls could not be fully observed to assess their condition, but judging from the areas where the walls could be observed, the plaster is in stable condition and needs minimal repairs. There is some water damage to plaster in the bathrooms, near plumbing.

Figure 31: East restroom showing typical condition of fixtures and finishes. Photo by author, 2020.
