# National Park Service Cultural Landscapes Inventory 2022

**HM-69 Nike Missile Site Landscape**  
**Everglades National Park**  
**[2022 Condition Reassessment]**

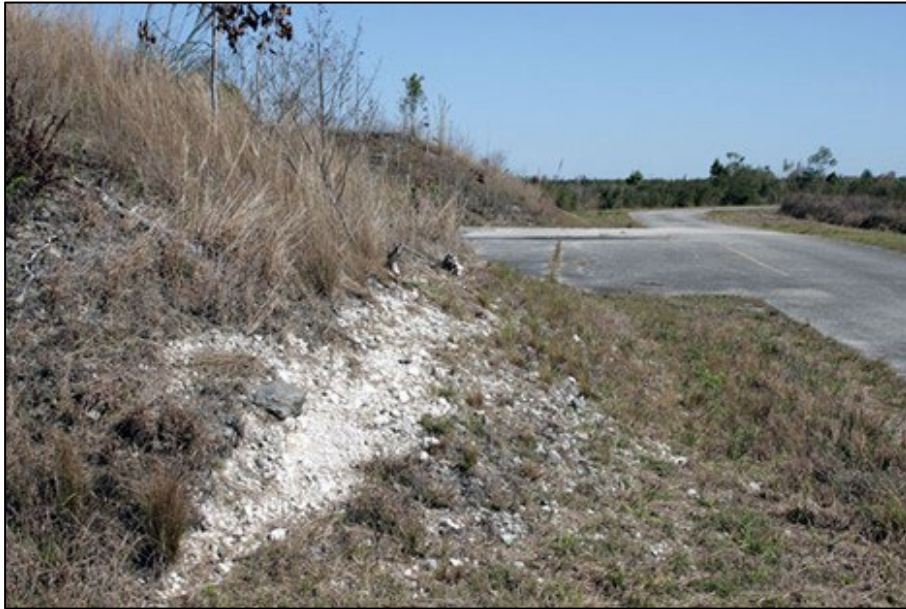
*Fig 20. Mower wheels have damaged the berms. Source: JMA, 2010*

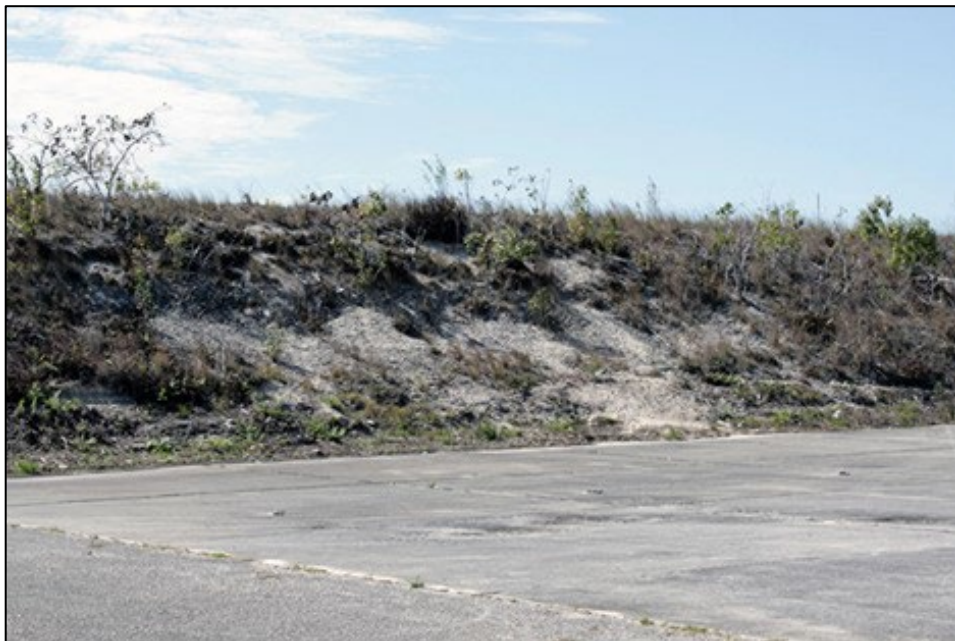
*Fig 21. Launcher section B was used as a shooting range, damaging the berm. Source: JMA, 2010.*

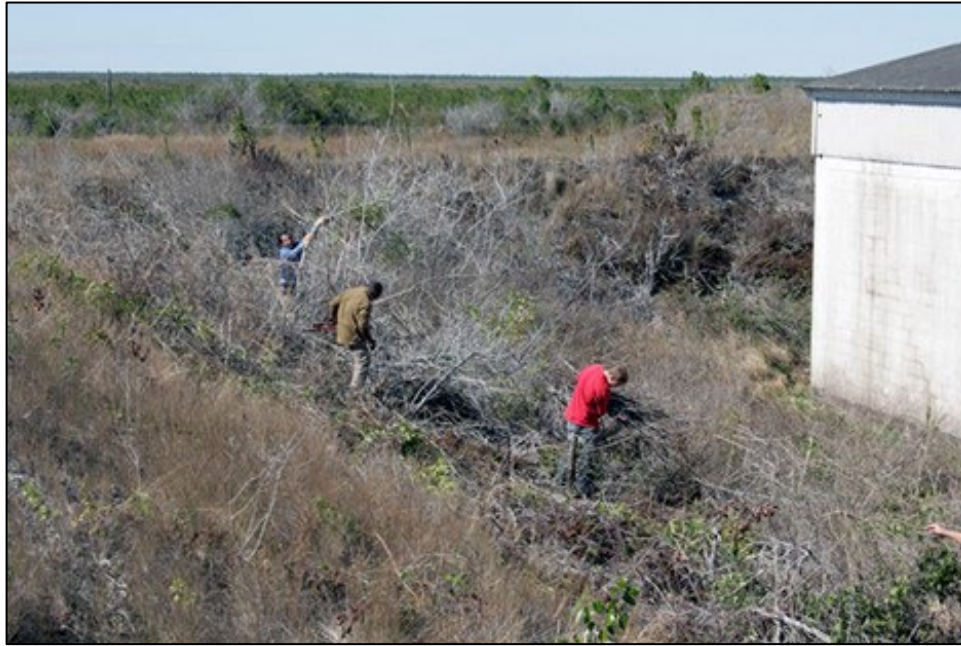
*Fig 35. A volunteer program exists to clear the berms of damaging vegetation. Source: JMA, 2010.*

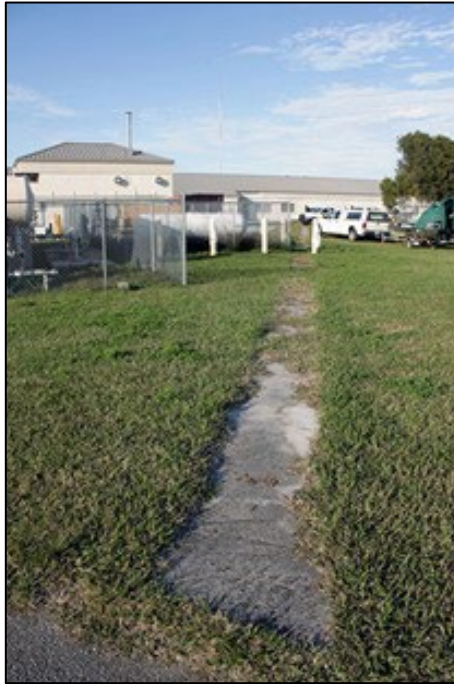
*Fig 40. The concrete sidewalk along the pumphouse complex is in poor condition. Source: JMA, 2010.*

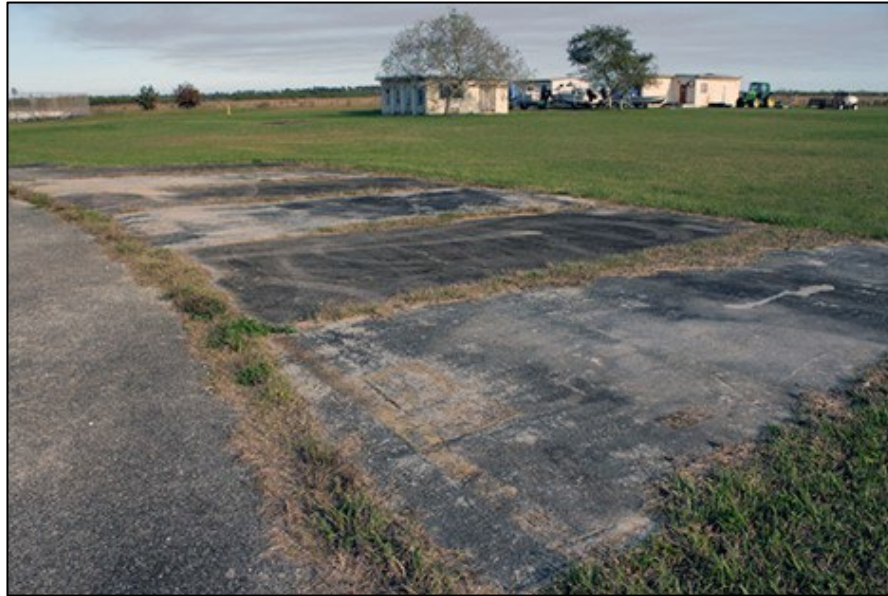
the access road leading to the drainfield (Fig. 43). The parking area near the drainfield was added following the period of significance; it is cracked and has grass growing along pavement seams.

*Fig 43. Cracked asphalt parking spaces near the Control Area drainfield. Source: JMA, 2010.*
