**HIGH DEFINITION STREAM SURVEY OF THE  
CHATTAHOOCHEE RIVER NATIONAL RECREATION  
AREA, GEORGIA, USA**

The U.S. National Park Service  
November 29, 2020

## **TRUTTA ENVIRONMENTAL SOLUTIONS, LLC**

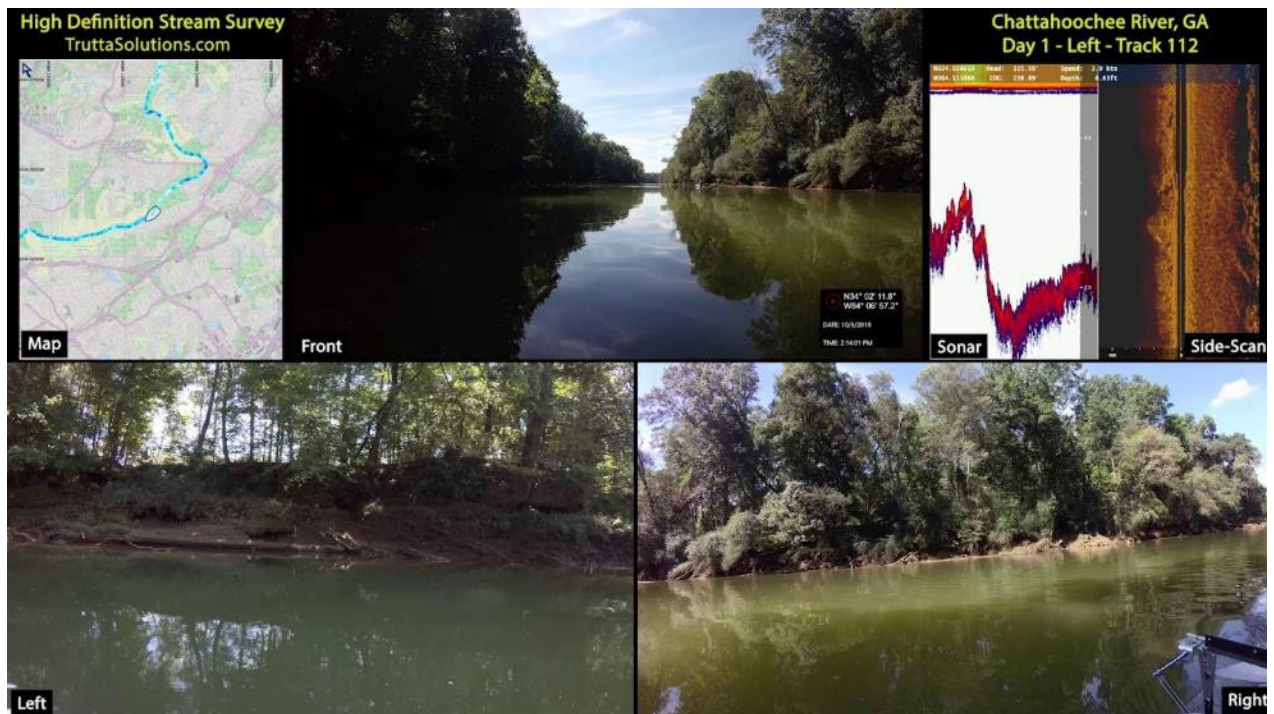
Figure 52: Image of number 1 worst area on left bank of the Chattahoochee River near river kilometer 17.2.

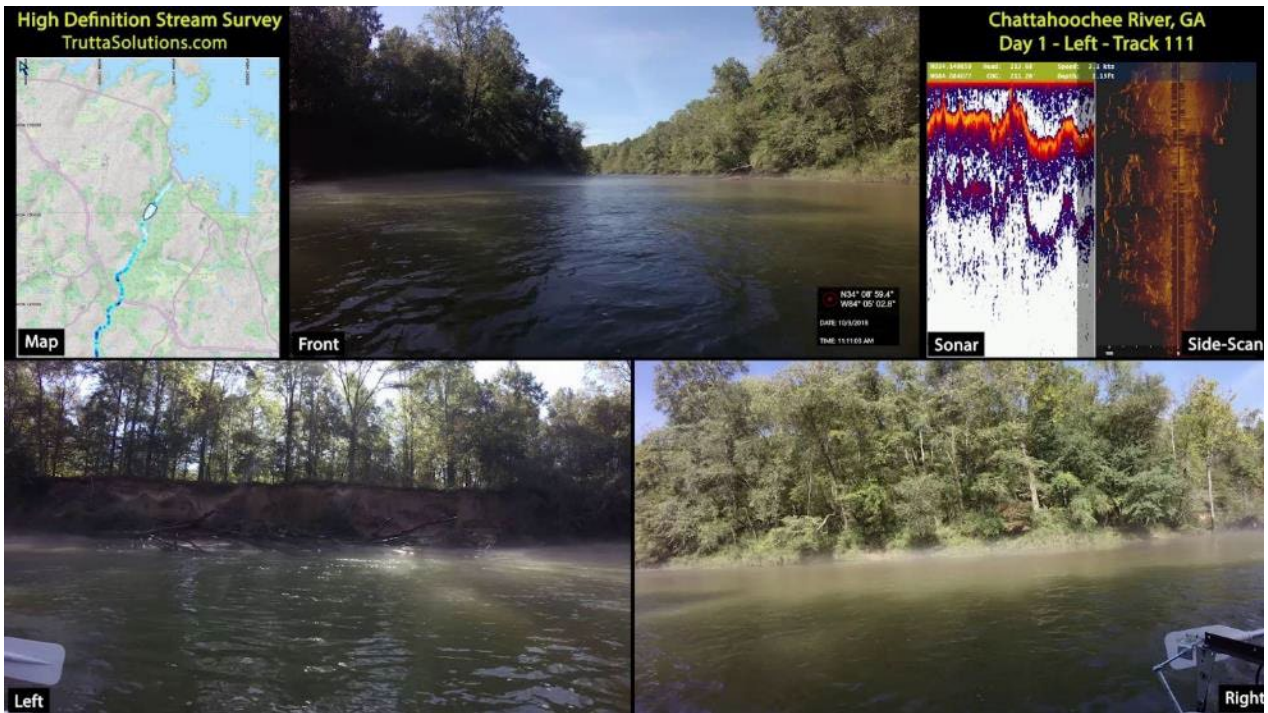
Figure 53: Example of image of second and third worst areas (a continuous segment of 400m) on left bank of the Chattahoochee River near river kilometer 1.0 and 1.2.

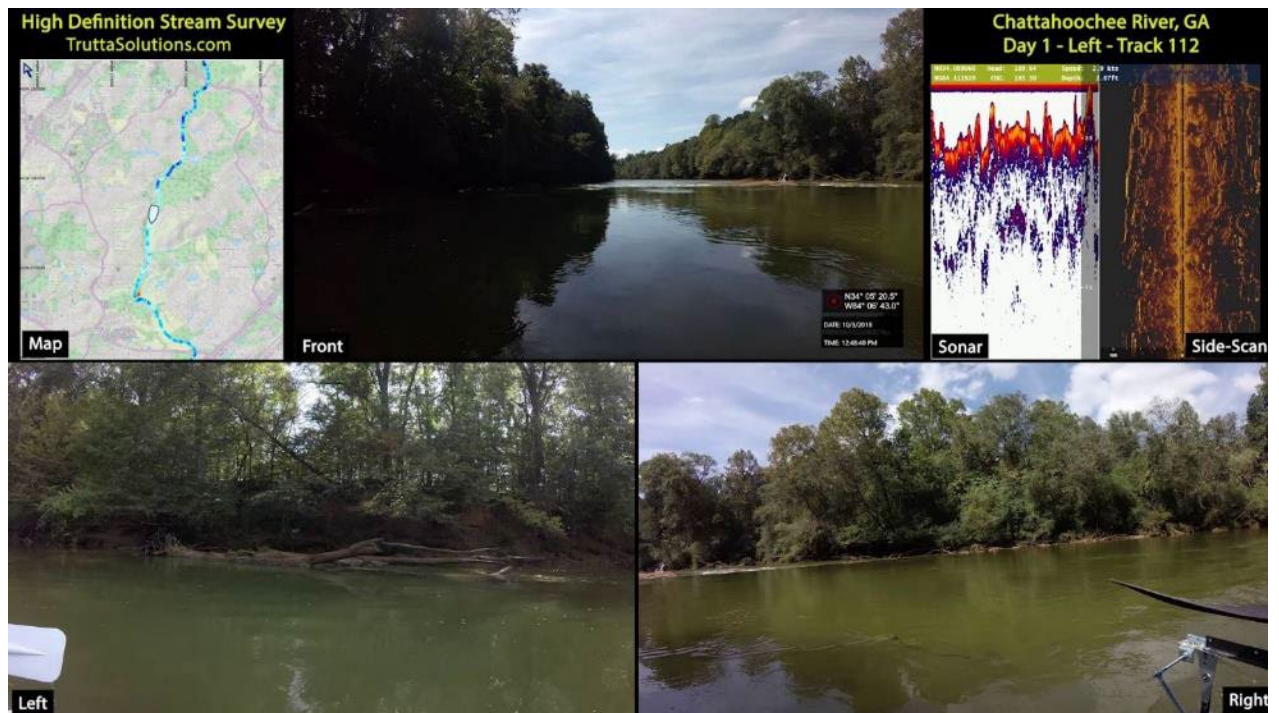
Figure 54 : Image of forth worst area on left bank of the Chattahoochee River near river kilometer 9.2.

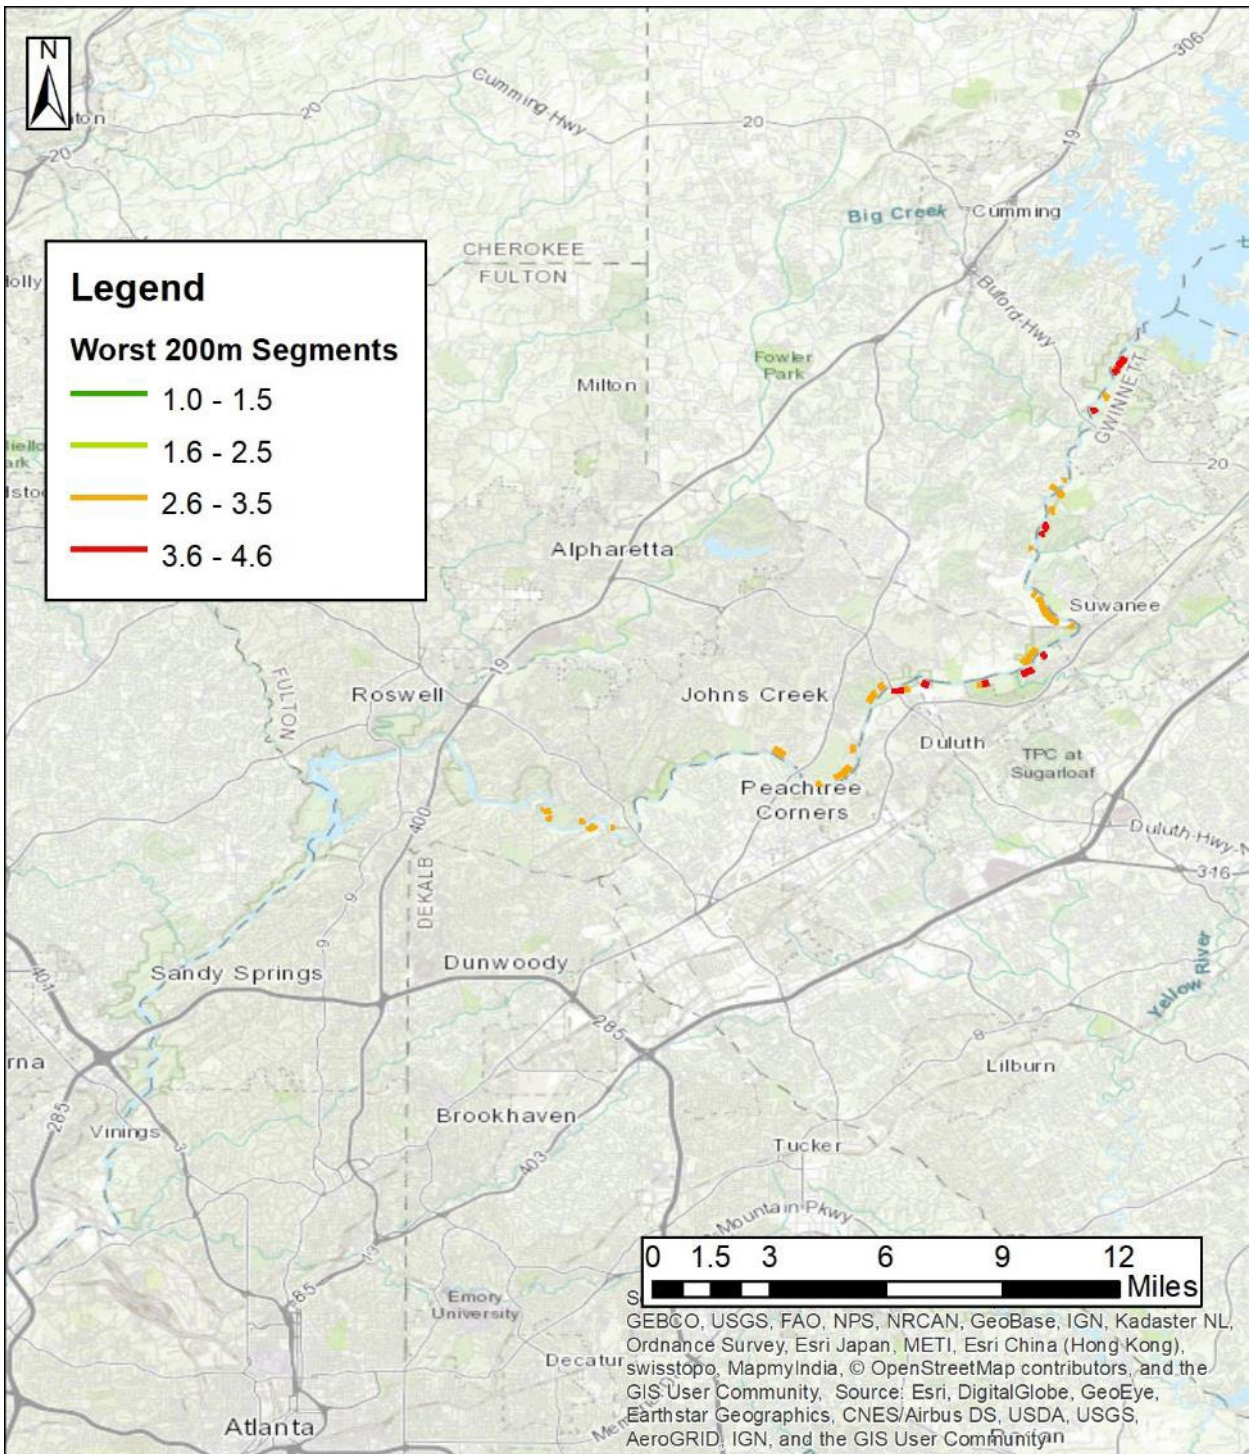
Figure 56: Worst Bank Condition Areas from the HDSS results for the Chattahoochee River National Recreation Area.

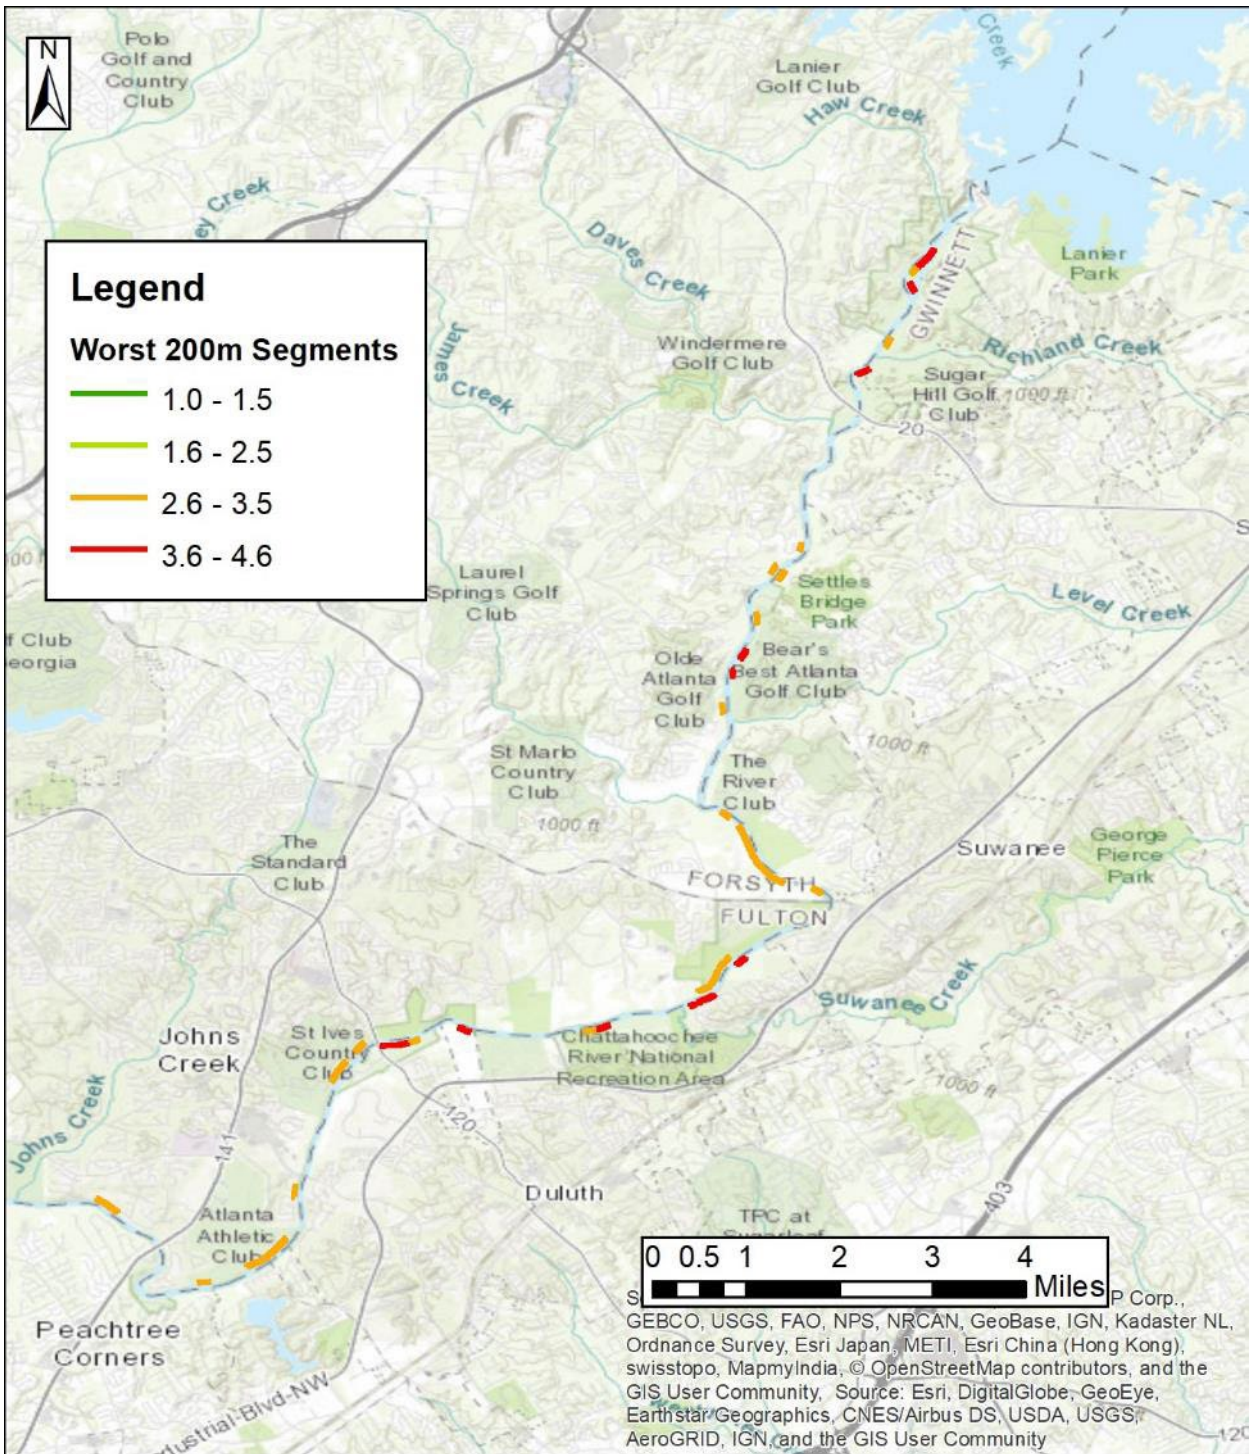
Figure 57: Worst Bank Condition Areas from the HDSS results for the upper survey section of the Chattahoochee River National Recreation Area.

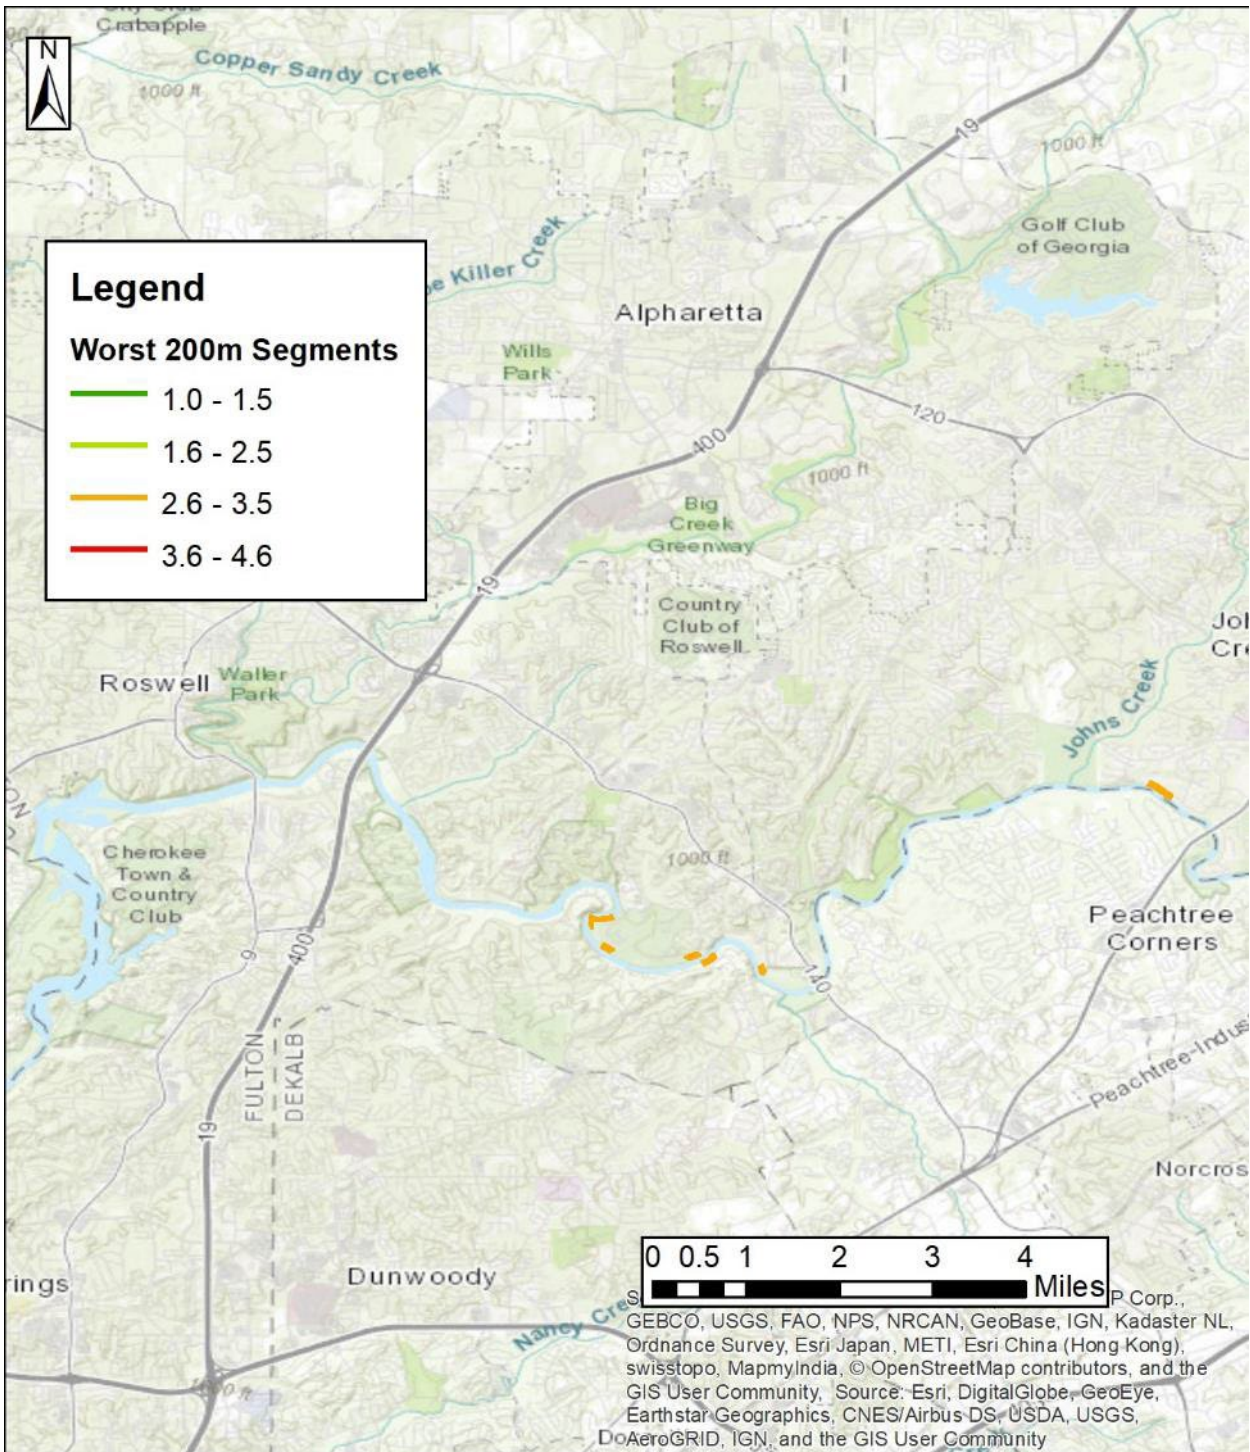
Figure 58: Worst Bank Condition Areas from the HDSS results for the middle survey section of the Chattahoochee River National Recreation Area.

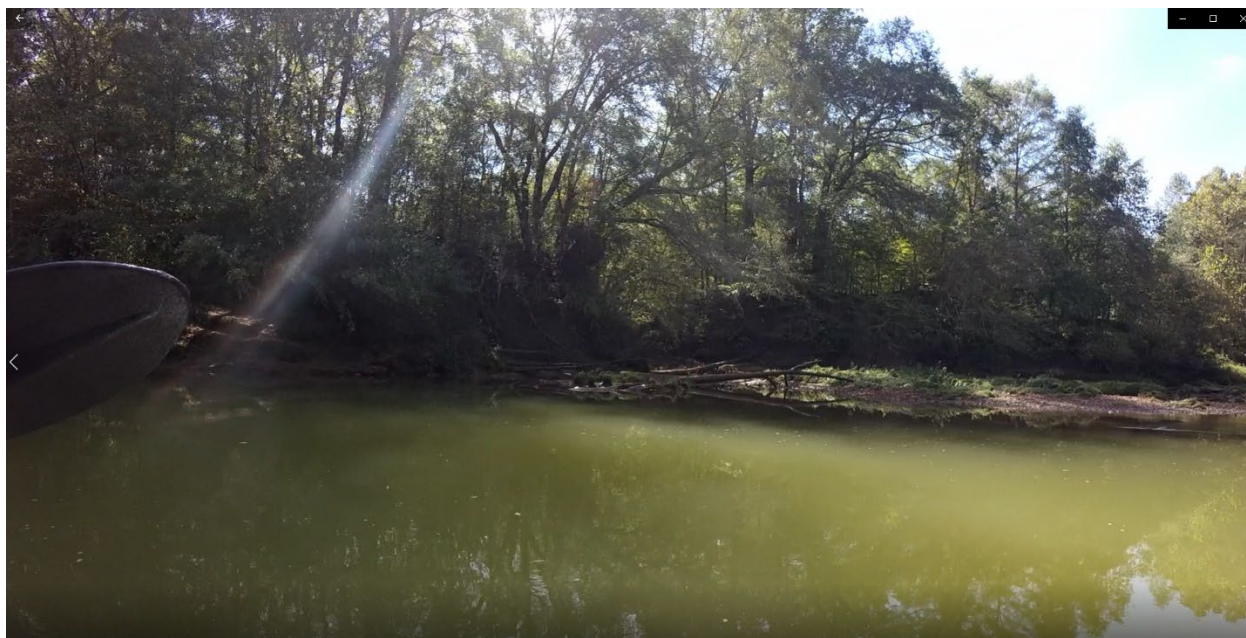
Figure 61: Confluence of Crayfish Creek and Chattahoochee River along the CHAT. Left streambank image enlarged from Track 111 at 11:52:59 recorded on October 3, 2018.

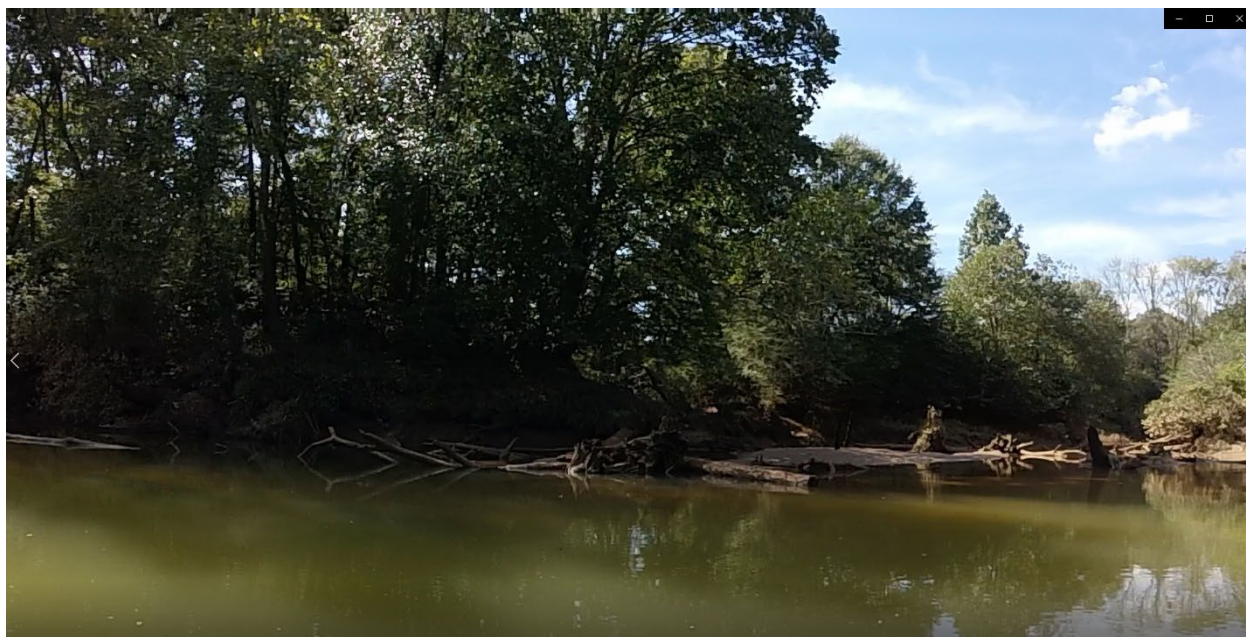
Figure 62: Confluence of Dick Creek and Chattahoochee River along the CHAT. Right streambank image enlarged from Track 121 at 11:00:50 recorded on October 3, 2018.

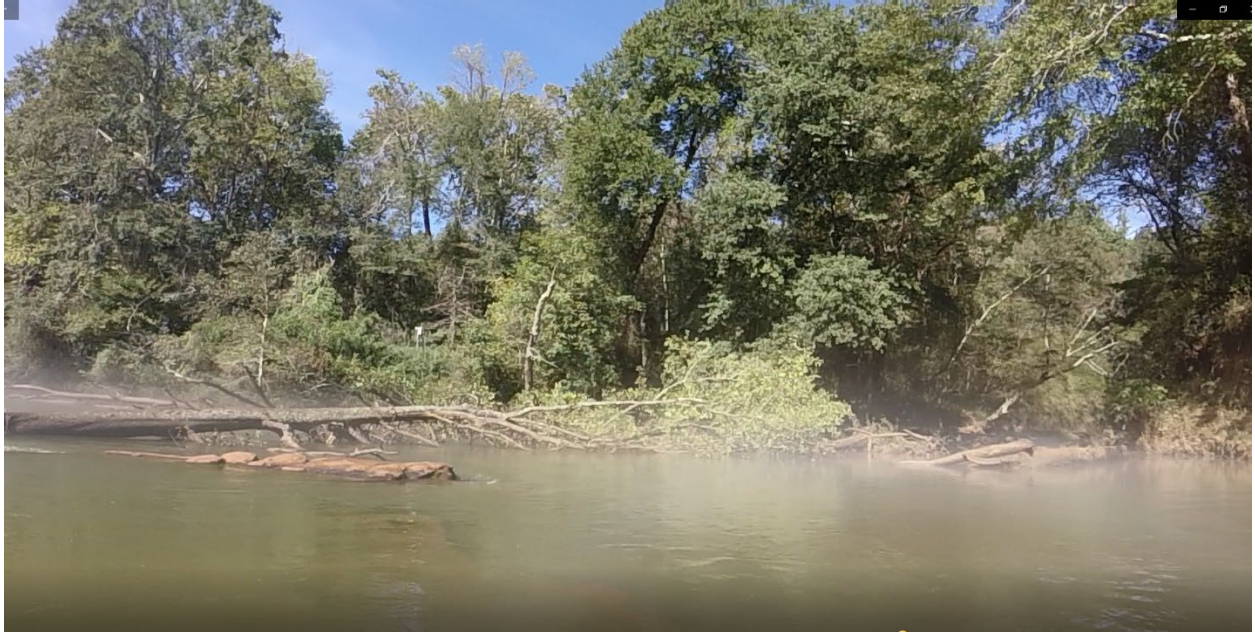
Figure 63: Confluence of Haw Creek and Chattahoochee River along the CHAT. Right streambank image enlarged from Track 122 at 13:19:43 recorded on October 3, 2018.

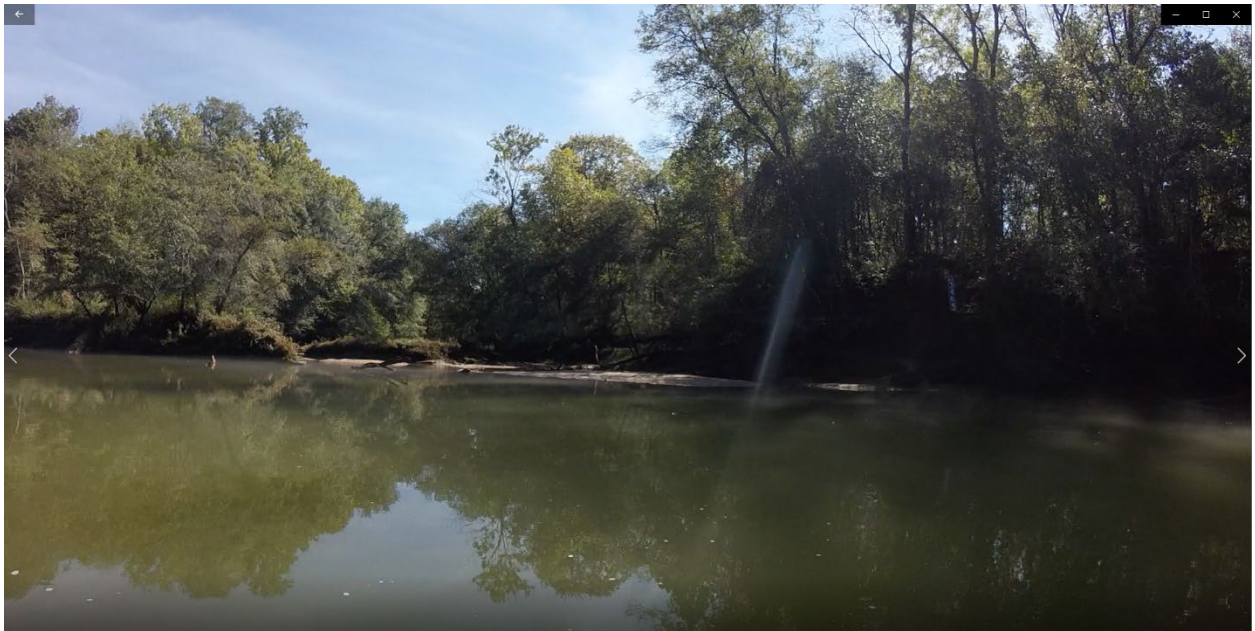
Figure 64: Confluence of Richland Creek and Chattahoochee River along the CHAT. Right streambank image enlarged from Track 111 at 11:35:43 recorded on October 3, 2018.

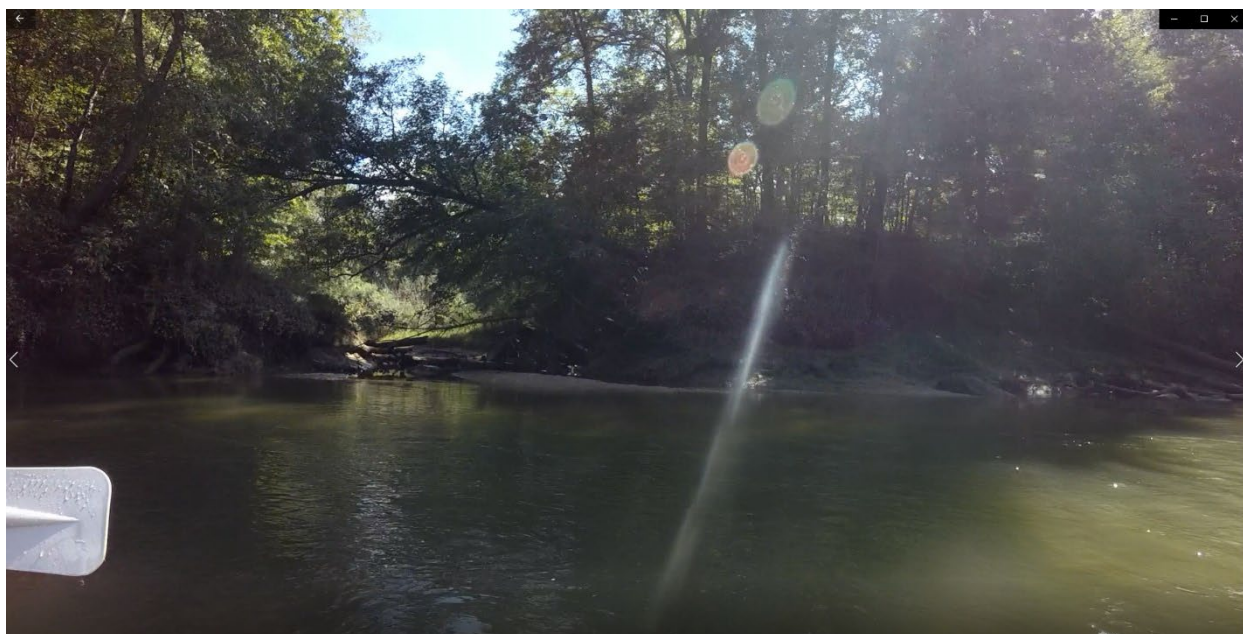
Figure 65: Confluence of Brushy Creek and Chattahoochee River along the CHAT. Right streambank image enlarged from Track 112 at 14:06:04 recorded on October 3, 2018.
