Assessment for Geraldine Coffman  
Historic Crawford/Shoaf Barn  
<https://khri.kansasgis.org/index.cjm?in=045-6833>  
Inspection on September 24, 2020  
November 6, 2020

Assessment for Eric Jackson  
Historic McQuillan Barn <https://khri.kansasgis.org/index.cfm?in=045-6057>  
Inspection Performed 9/24/2020  
November 6, 2020

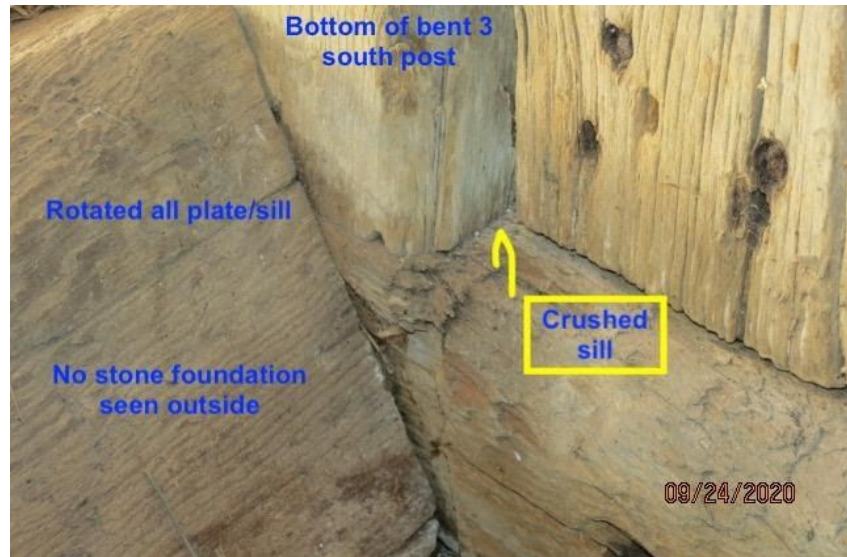
Where the wall plate is accessible, which includes most of the east and west and multiple points in the north and south, it is rotted, compressed under posts and often the top is at the elevation of the adjoining soil. It would appear that the stone foundation has sunken, allowing the entire barn to settle. This can be seen at the threshold for the storage room door which has been repaired with concrete. The replaced bottom of the SE corner post now sits on the concrete at grade in stead of on a timber wall plate.

| PRIORITY | RECOMMENDATION IN ORDER OF PROCESS | ROUGH COST |
|---|---|---|
| 6 | Replace all wall/sill plates. 204', 16 M/T joints, 6 Scarf joints | Approximately \$6,100 - \$10,100 |

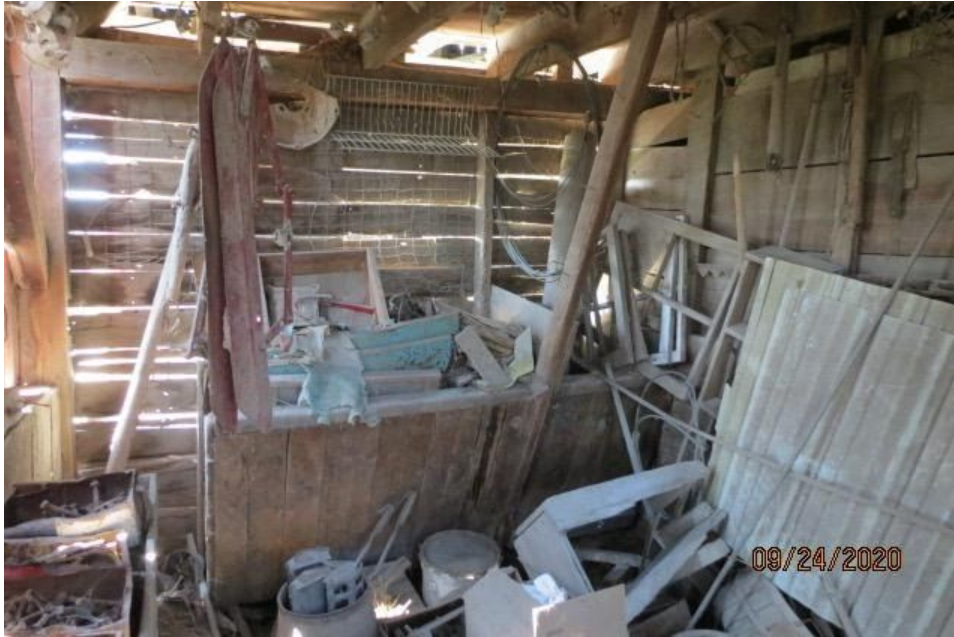
The NE rooms have thin concrete floors cracked and broken up. The others are dirt.

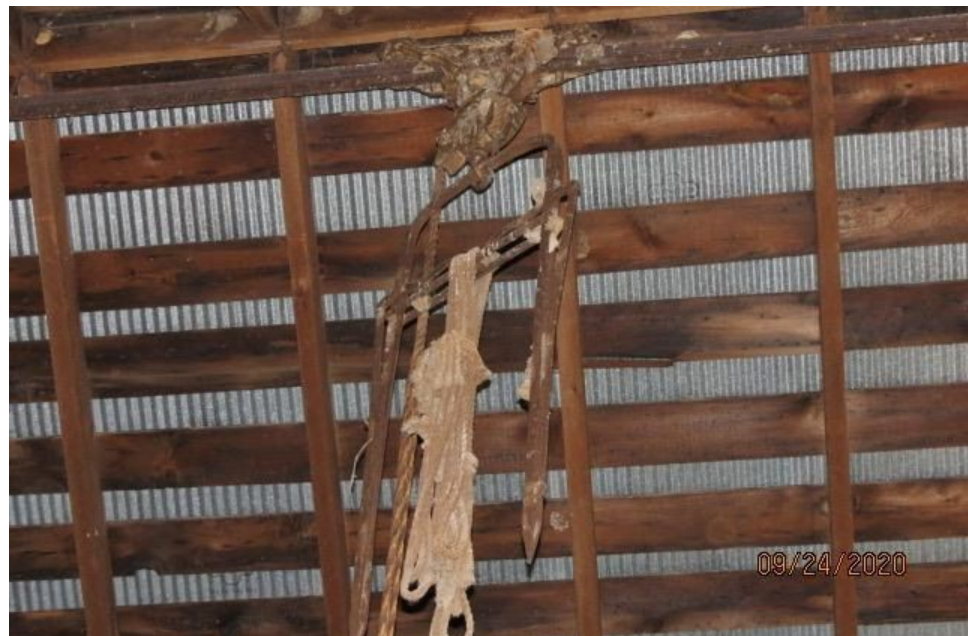
The wiring I saw was non-metallic conductor decades old but still in serviceable condition. There was one situation of exposed bare wires.

| 9 | Repair the wiring, removing that which has been abandoned. | Approximately<br>\$100 |

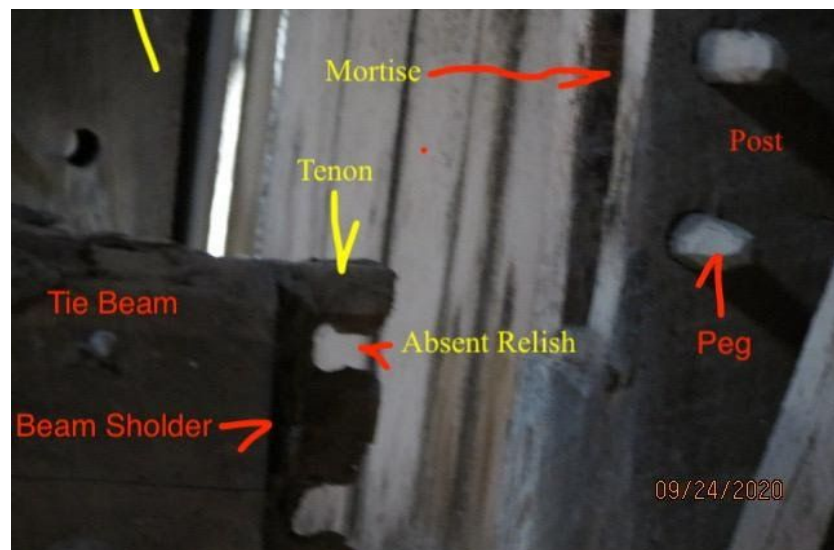
A comment about installing pegs: the connection of the tie beam of bent 2 to the north post is the basis of the following where the mortise is empty of the tenon. The tenon on the end of the beam has holes for the pegs but no beam between the peg and the end of the tenon. That missing material is called "relish". When there is not enough relish (that is the distance of material from the side of the peg to the end of the tenon) there's not enough strength to hold the tenon in the mortise when there is tension on it. Pegging instructions guide making strong joints. A peg should be installed so that there is at least 4 times the diameter of the peg to the end of the tenon and 1 1/2 diameters to the side of the post or a beam sholder. If the post does not have enough relish material it will break out when

tension is applied just like you see the relish broken out of the tenon in this application. The dimension for the relish is even less than the distance from the side of the post to the peg. When you pull against crossgrain, you are pulling against the weakest grain, the end grain, and the the relish will split away.

| Priority | Recommendation | Rough Cost |
|---|---|---|
| 6 | Repair the spreading condition in the loft by pulling the barn back together. Rather than having to replace the entire beams, where the relish has been pulled out of tenons, the post mortise could be deepened and a spline installed to replace the short tenon with a longer one. Then when the barn is pulled back together the joints can be held together with pegs after gluing plugs in the old peg holes and drilling appropriately located holes for maximum strength. 4 joints. Come-a-longs. 4 @ 6hr | Approximately \$1,200 - \$3,600 |

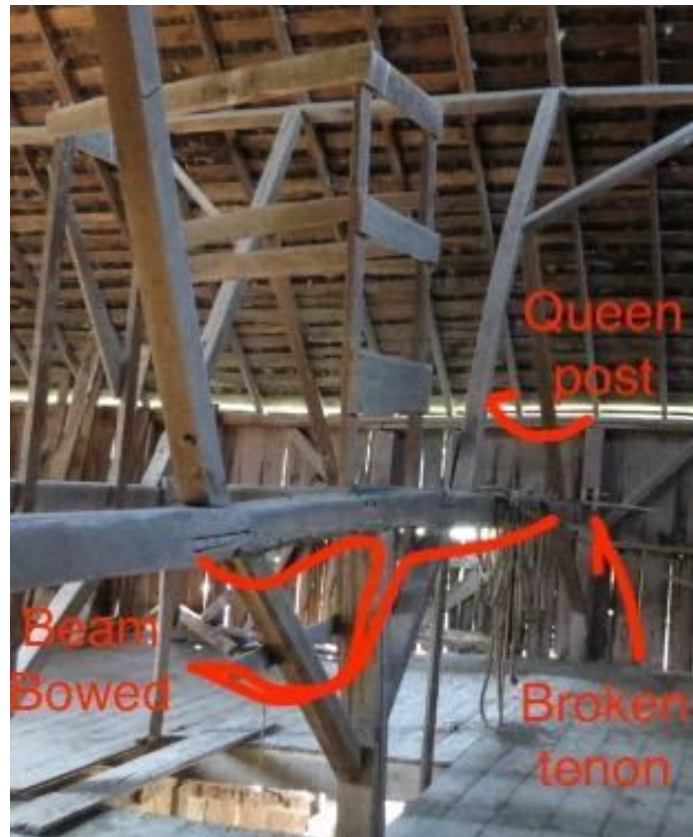
To the degree that the queen posts resist the roof lowering, as the weight falls on these angular members they tend to push the bottom of the roof slope outward. So on both north and south sides the main tie beam tenons have pulled out of their mortises and damaged the brace connections between that tie beam and the post in the outer wall, as is seen mostly on the north side. Had the brace connections been of the older style mortise and tenon, and peg, they would have resisted more the tie beam's movement from the post.

As well, the tie beam is pushed down by the queen post. Since its weight is cantilevered from the center post it has bent down and is lower than the mortise intended for it.

| 11 | Reinstall the loose braces and install some new2 braces. Add a second brace to each of the 4 center queen posts. Also move the electric service panel and add a brace in the third bent. The age of the wood will require pre-drilling and the use of 1/4" to 5/16" lag-bolts 4" and 6" long rather than nails | Approximately<br>\$400 - \$800 |

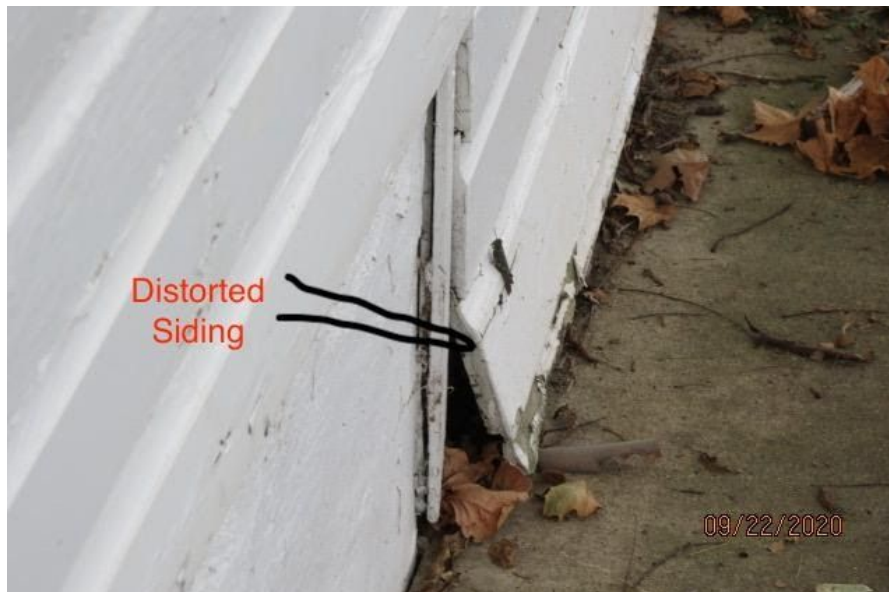
Siding is pressed down against the walkway and outward showing it is under pressure.

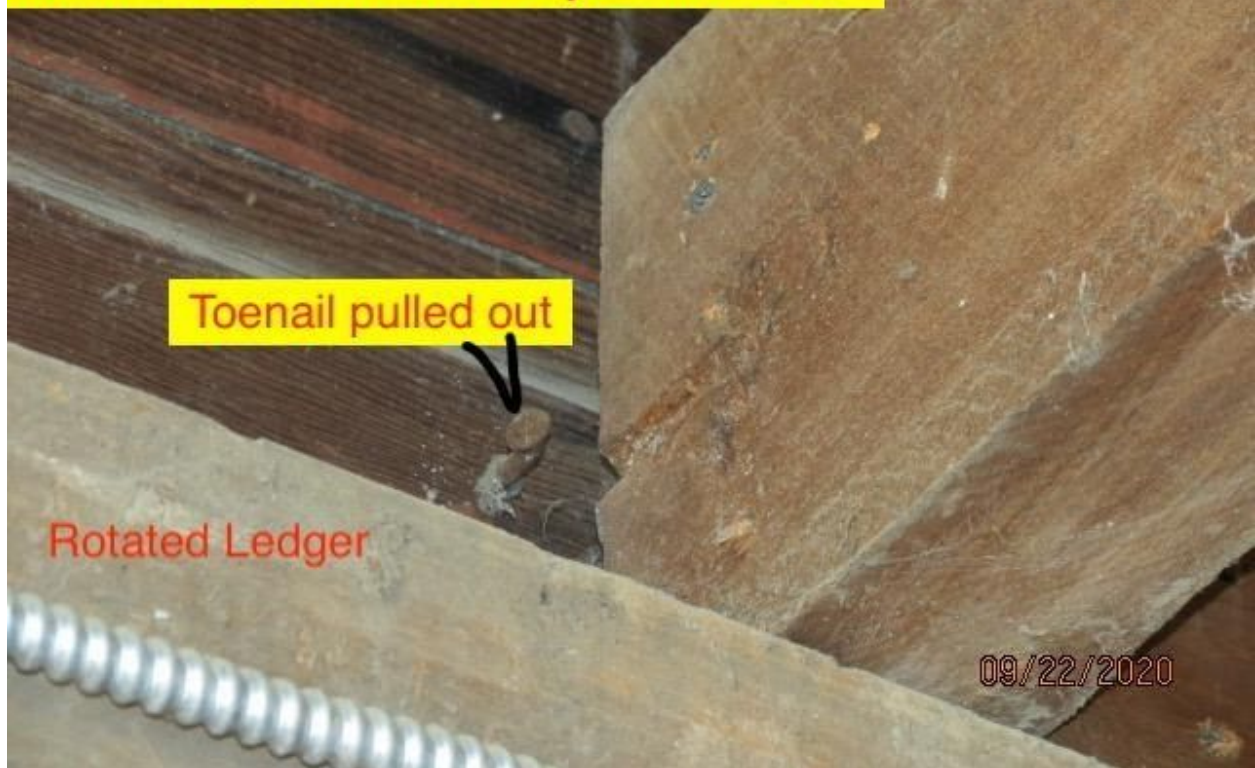
North shed, south end 4th joist from east.

Some joists from a north “shed” loft with a 6 foot ceiling height pass through the main barn siding and are nailed onto the side of the 2 x 6 studs of the main barn extension.

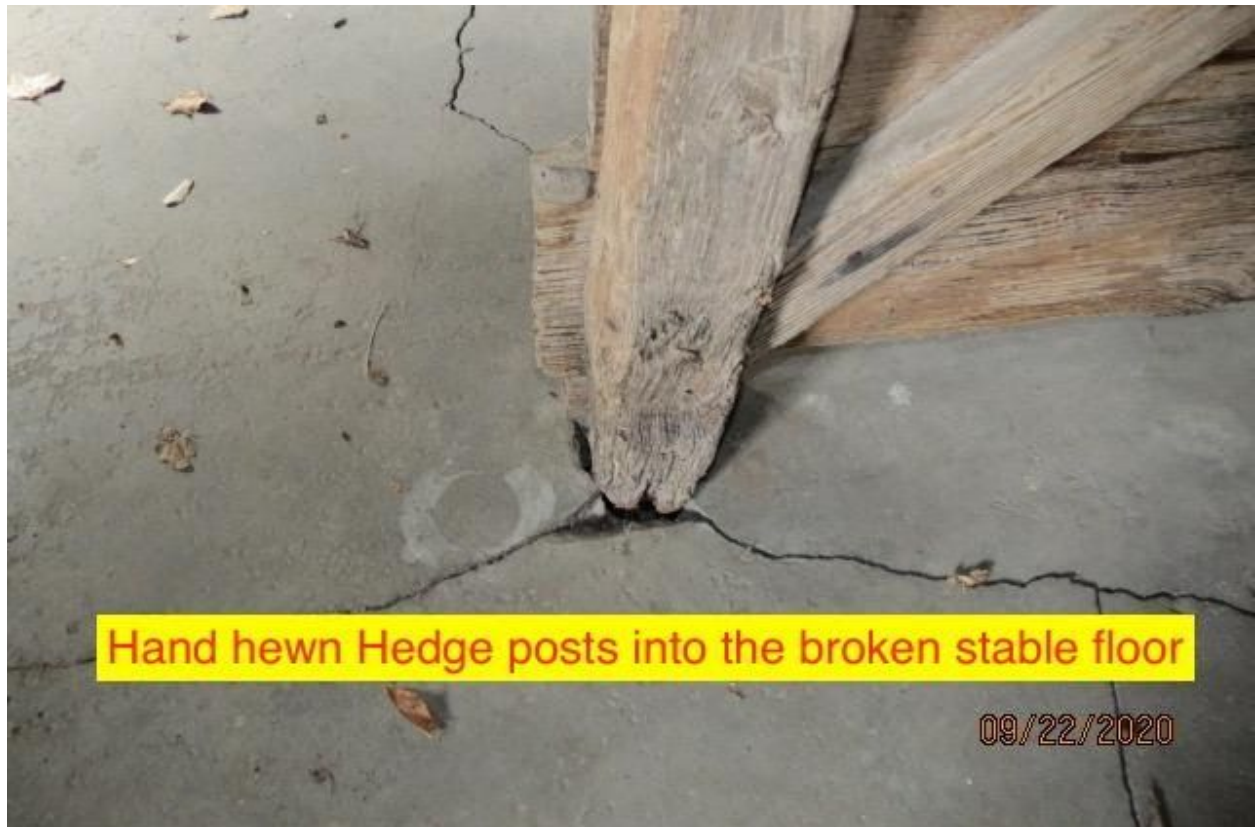
The concrete in the stall area exhibits no expansion joints so it is no surprise that the floor has cracked and heaved in this building subject to freezing soil. These tripping hazards should be eliminated and the floor repaired so it can drain to the exterior.

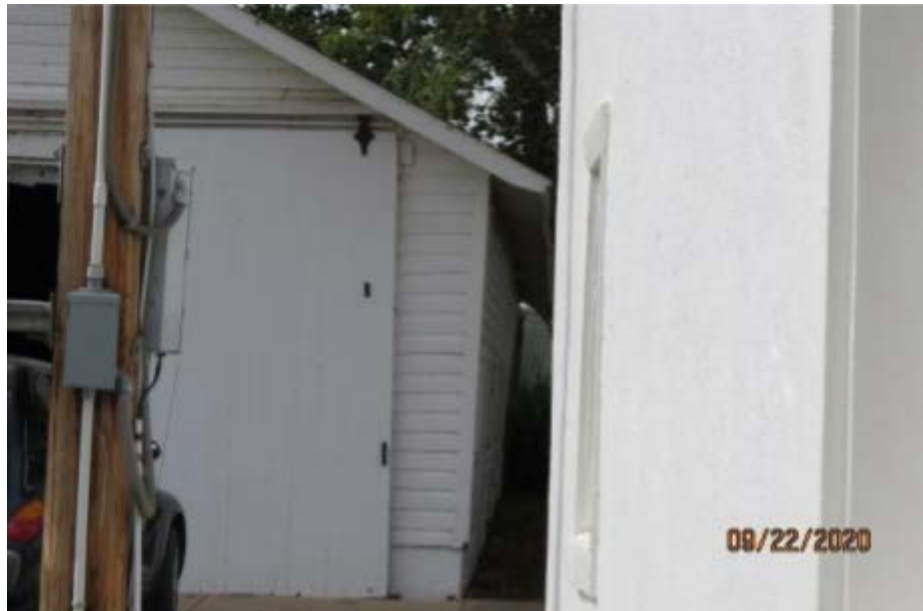
The NE corner, from the east, is not parallel to the neighboring plumb building nor the relatively plumb sliding door on the north addition.  
The north wall bows toward the north.

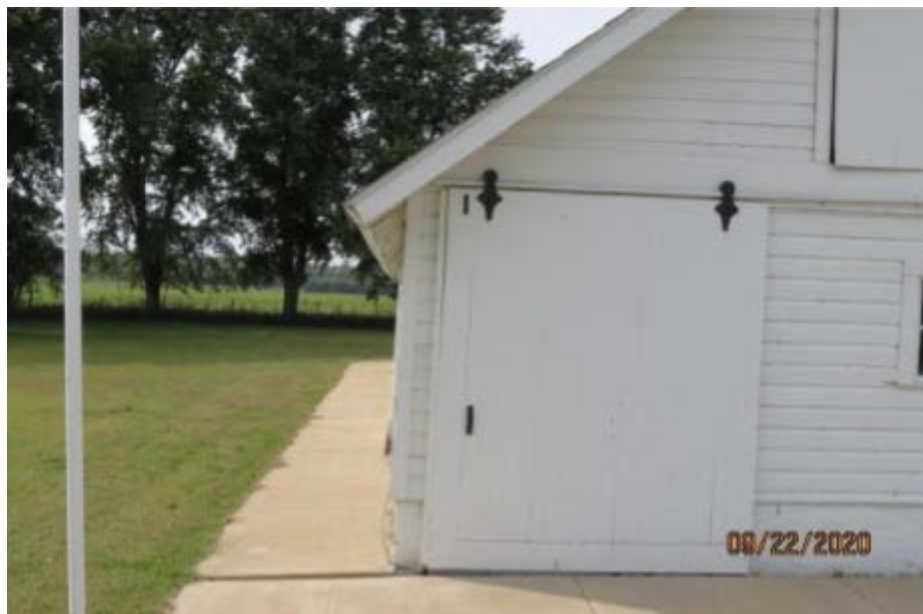
Though the SE corner trim, seen from the east, is relatively square with the siding and the trim over the door it is not parallel with the plumb white pole to the left/south.

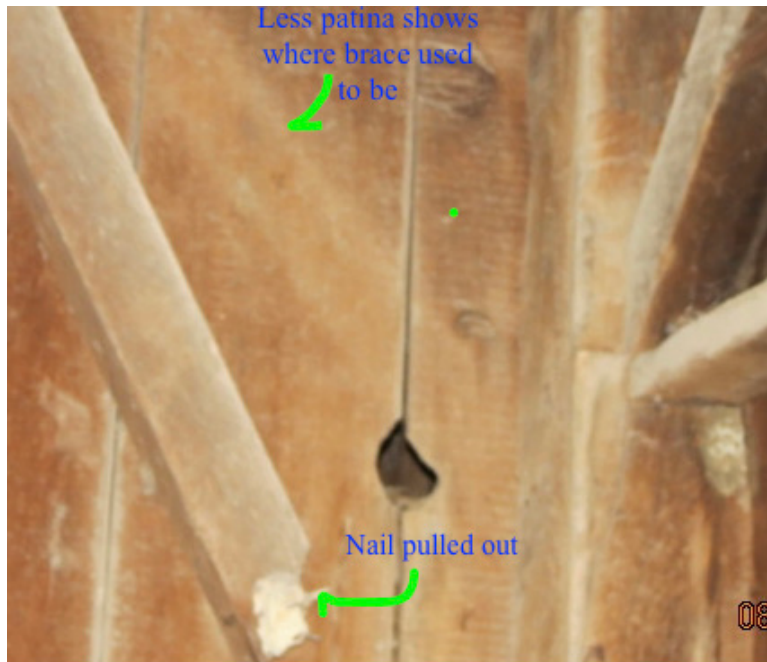
The west diagonal brace, originally nailed in place, is separated from the northeast post at the brace's bottom. The brace hangs by nails at its top. The south end of this space also has braces that are loosened, pulled away about 3/8 of an inch, from their nail connections.

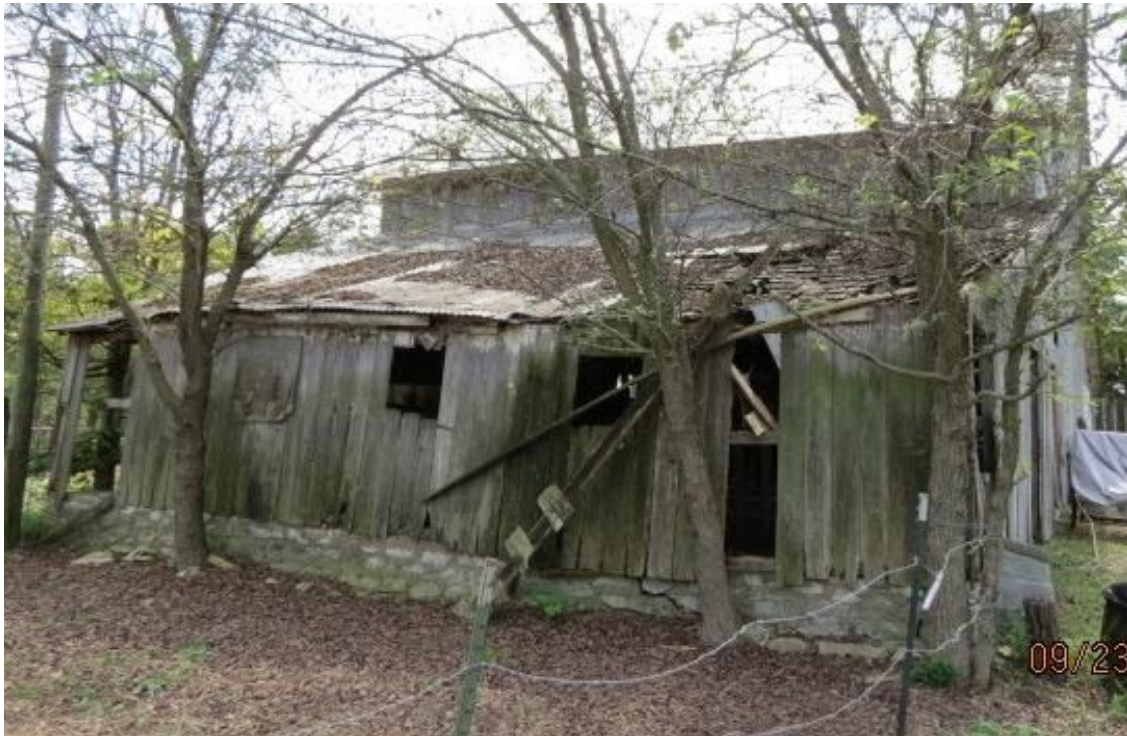
Corrugated steel has been laid over shake shingles. The roof edge is damaged high and low on the east end of the south shed. Sheet roofing is absent from about 18" of the north main roof. Rust is seen on the shed roofs. The pitch of the shed roofs is less steep than the main roof. The roof of the north shed joins the main barn wall a few feet below the eaves of the main barn roof. The roof of the west end of the north shed is full of holes and is caved in; the rafters, purlin, plates, and sheathing are rotted.

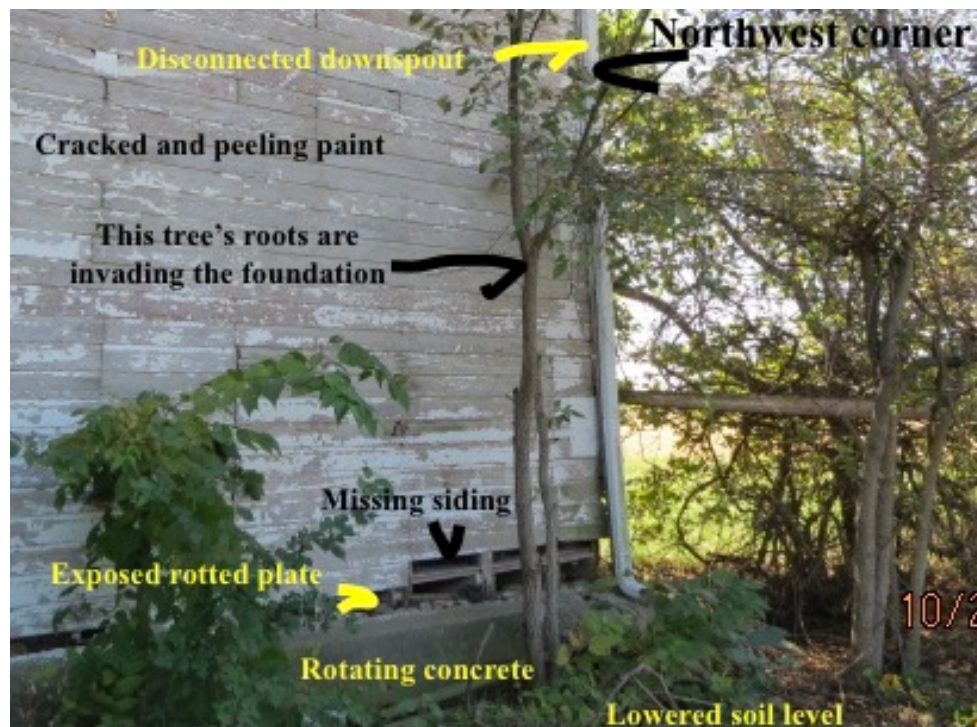
the building is lower so exposed stone was covered with mortar. This has cracked and rotated out from the building at its top allowing water in, water expands when it freezes so it breaks concrete.

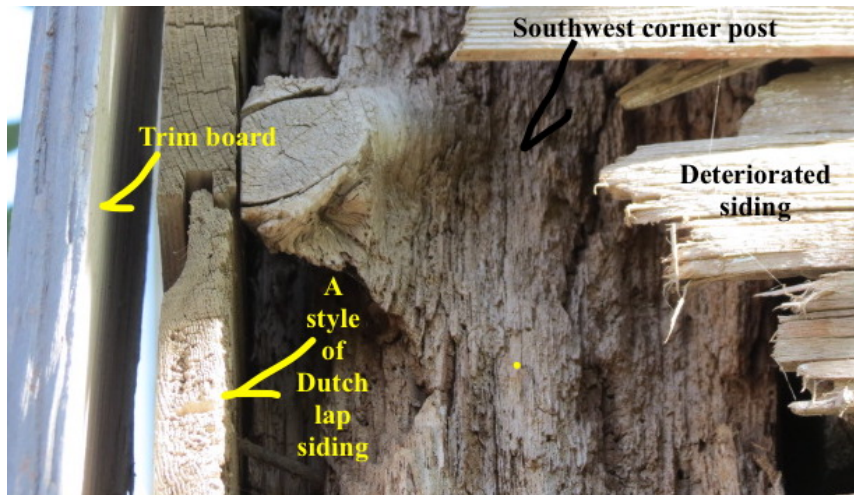
**Envelope/Siding-** The Dutch lap siding is horizontally installed. At the east end and the bottom of the north wall, the north end of the west wall, and the west end of the south wall siding has rotted away allowing water to enter and rot the structure behind it. Other siding is absent from the south wall. The cracked and peeling paint does not provide adequate weather protection.
