**FACADE INVESTIGATION  
VISITOR CENTER  
FLOYD BENNETT FIELD**

**TONETTI ASSOCIATES**

January 30, 1984

The following is our report on the conditions of the exterior shell of the William Ryan Visitor's Building at Floyd Bennett Field, Gateway National Recreation Area. We trust that this report will serve as a documentation of the conditions at present and as a tool for evaluating future repairs and restoration.

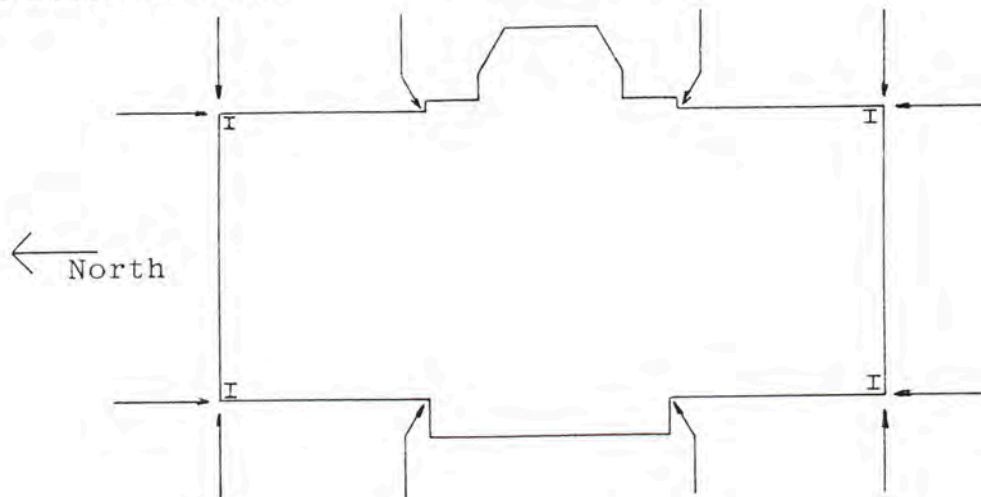
± Steel Columns

Cracks by steel columns are addressed in Section 1. Other cracks are caused by roof drains within 2" of the brick surface, lack of expansion joints, and miscellaneous rusted conduit and other abandoned electrical equipment. The four roof drains which have caused structural cracks should be rerouted towards the interior of the building, the broken and displaced brick removed, and replaced with brick to match. The abandoned electrical equipment should be removed and damaged brick replaced. A total of eight expansion joints should be cut on the East and West facade, as shown in the sketch below.

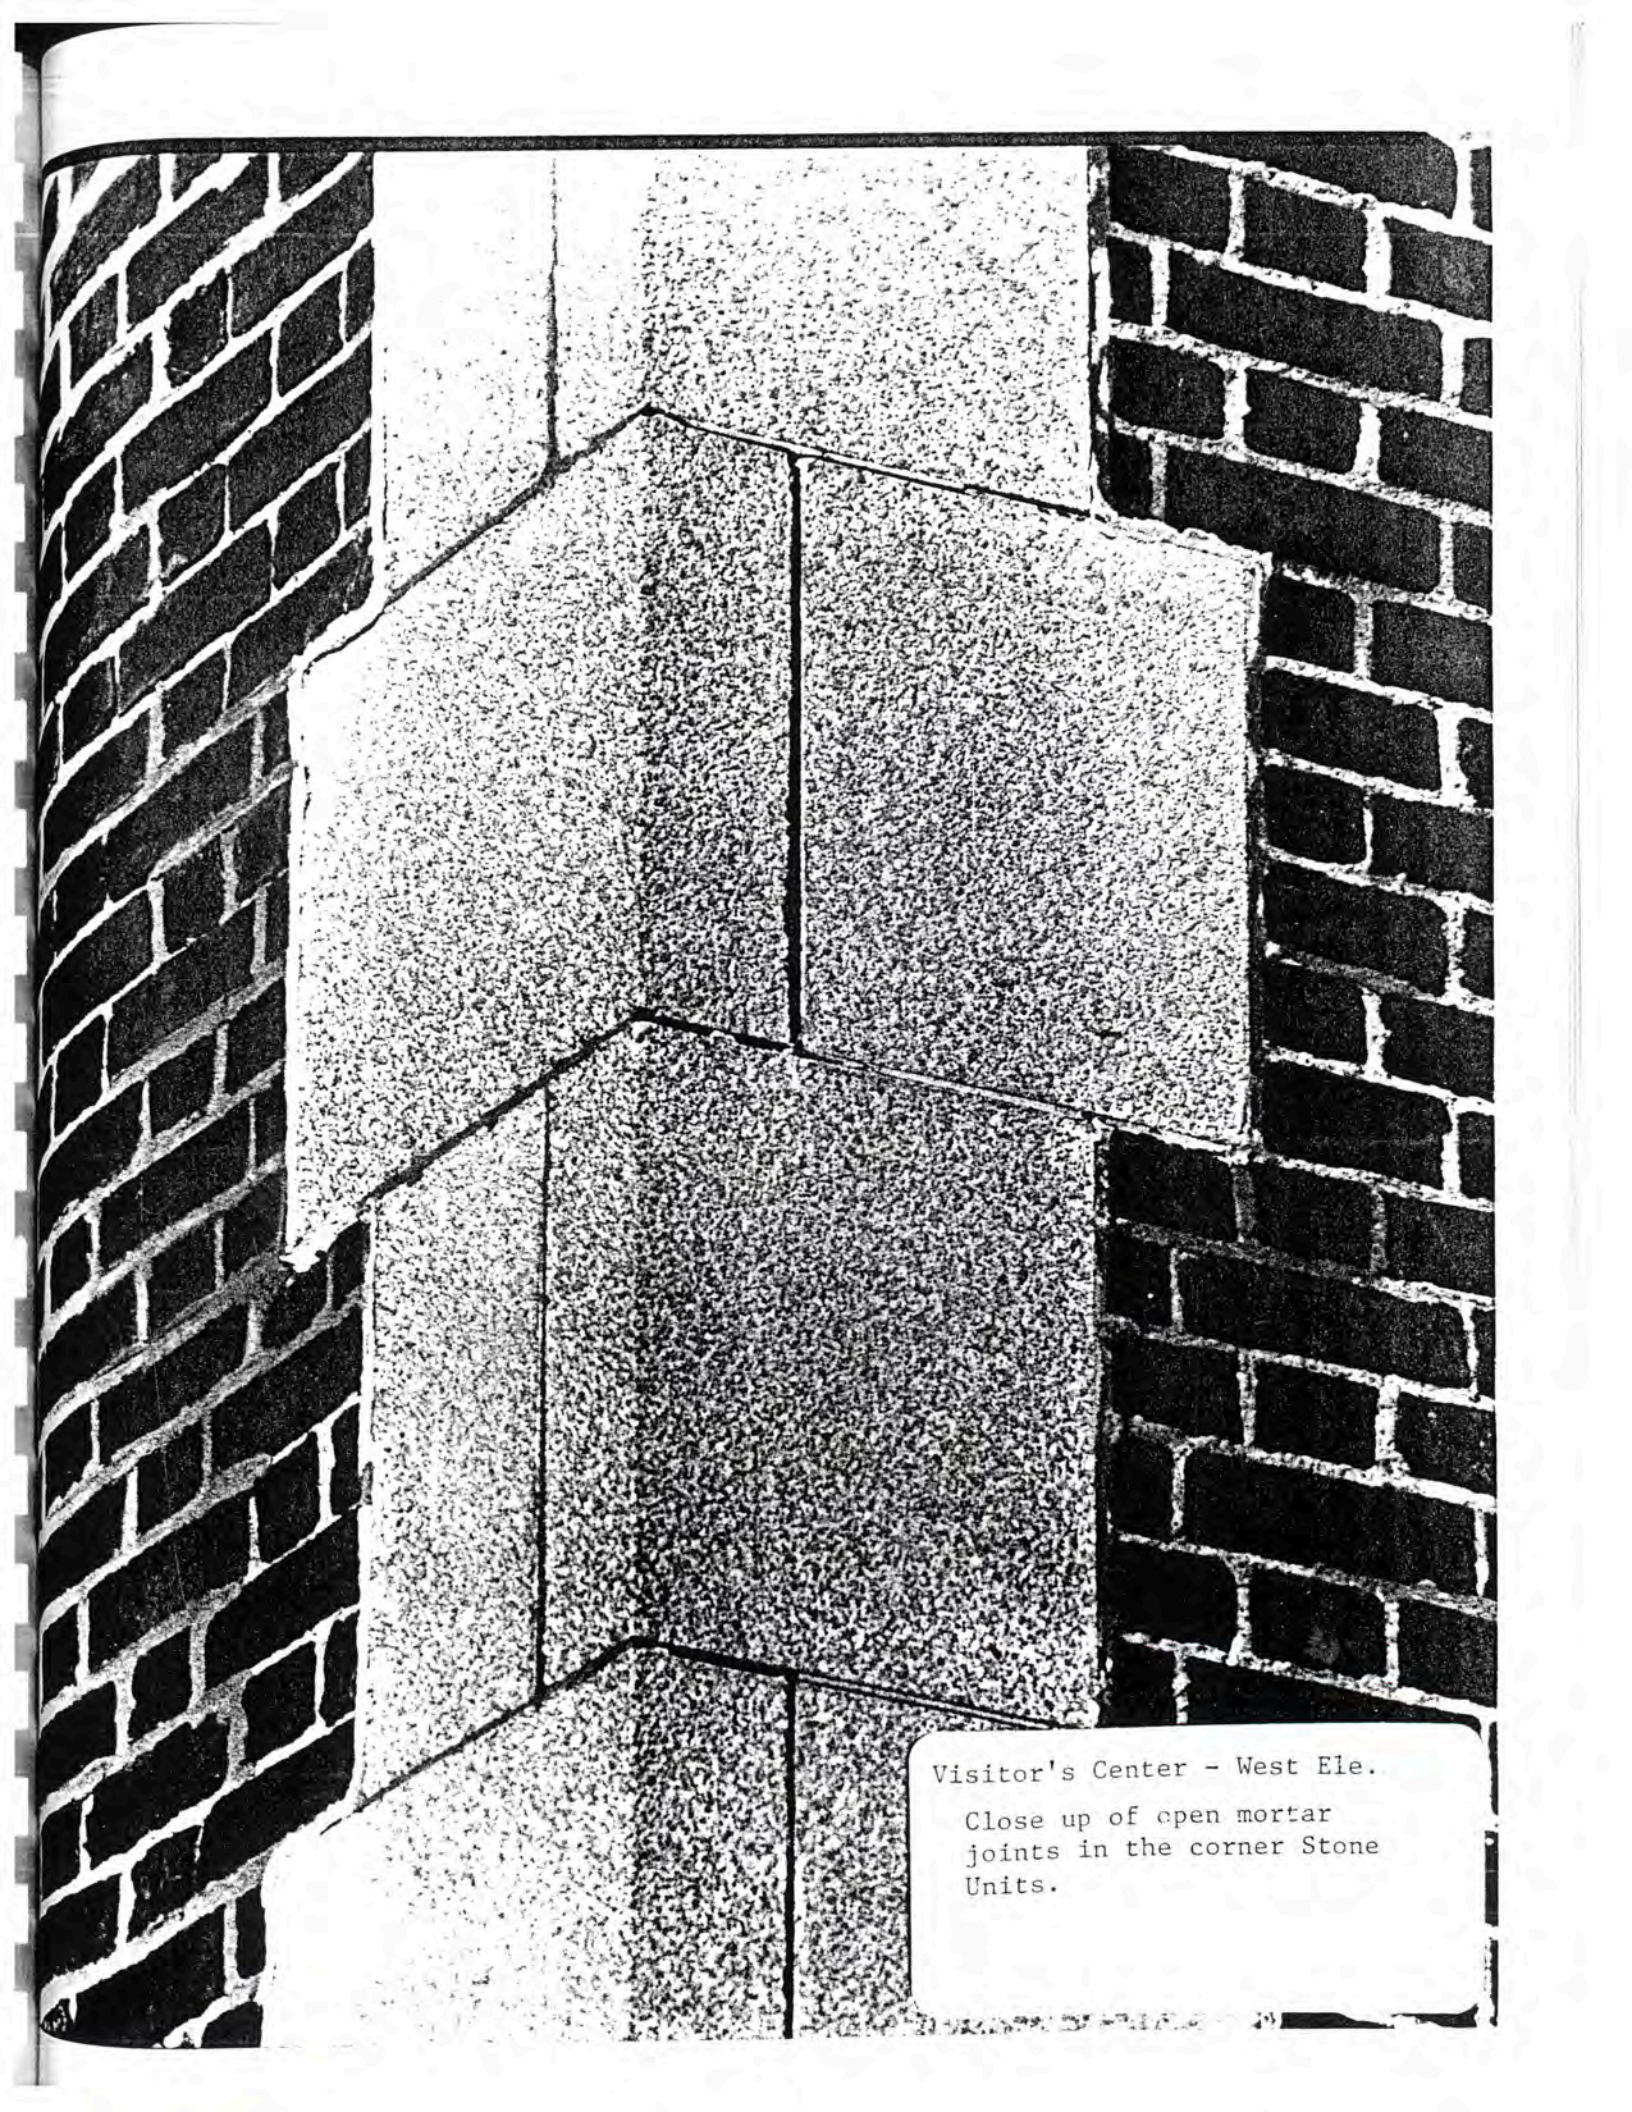
Visitor's Center - West Ele.

Close up of open mortar  
joints in the corner Stone  
Units.

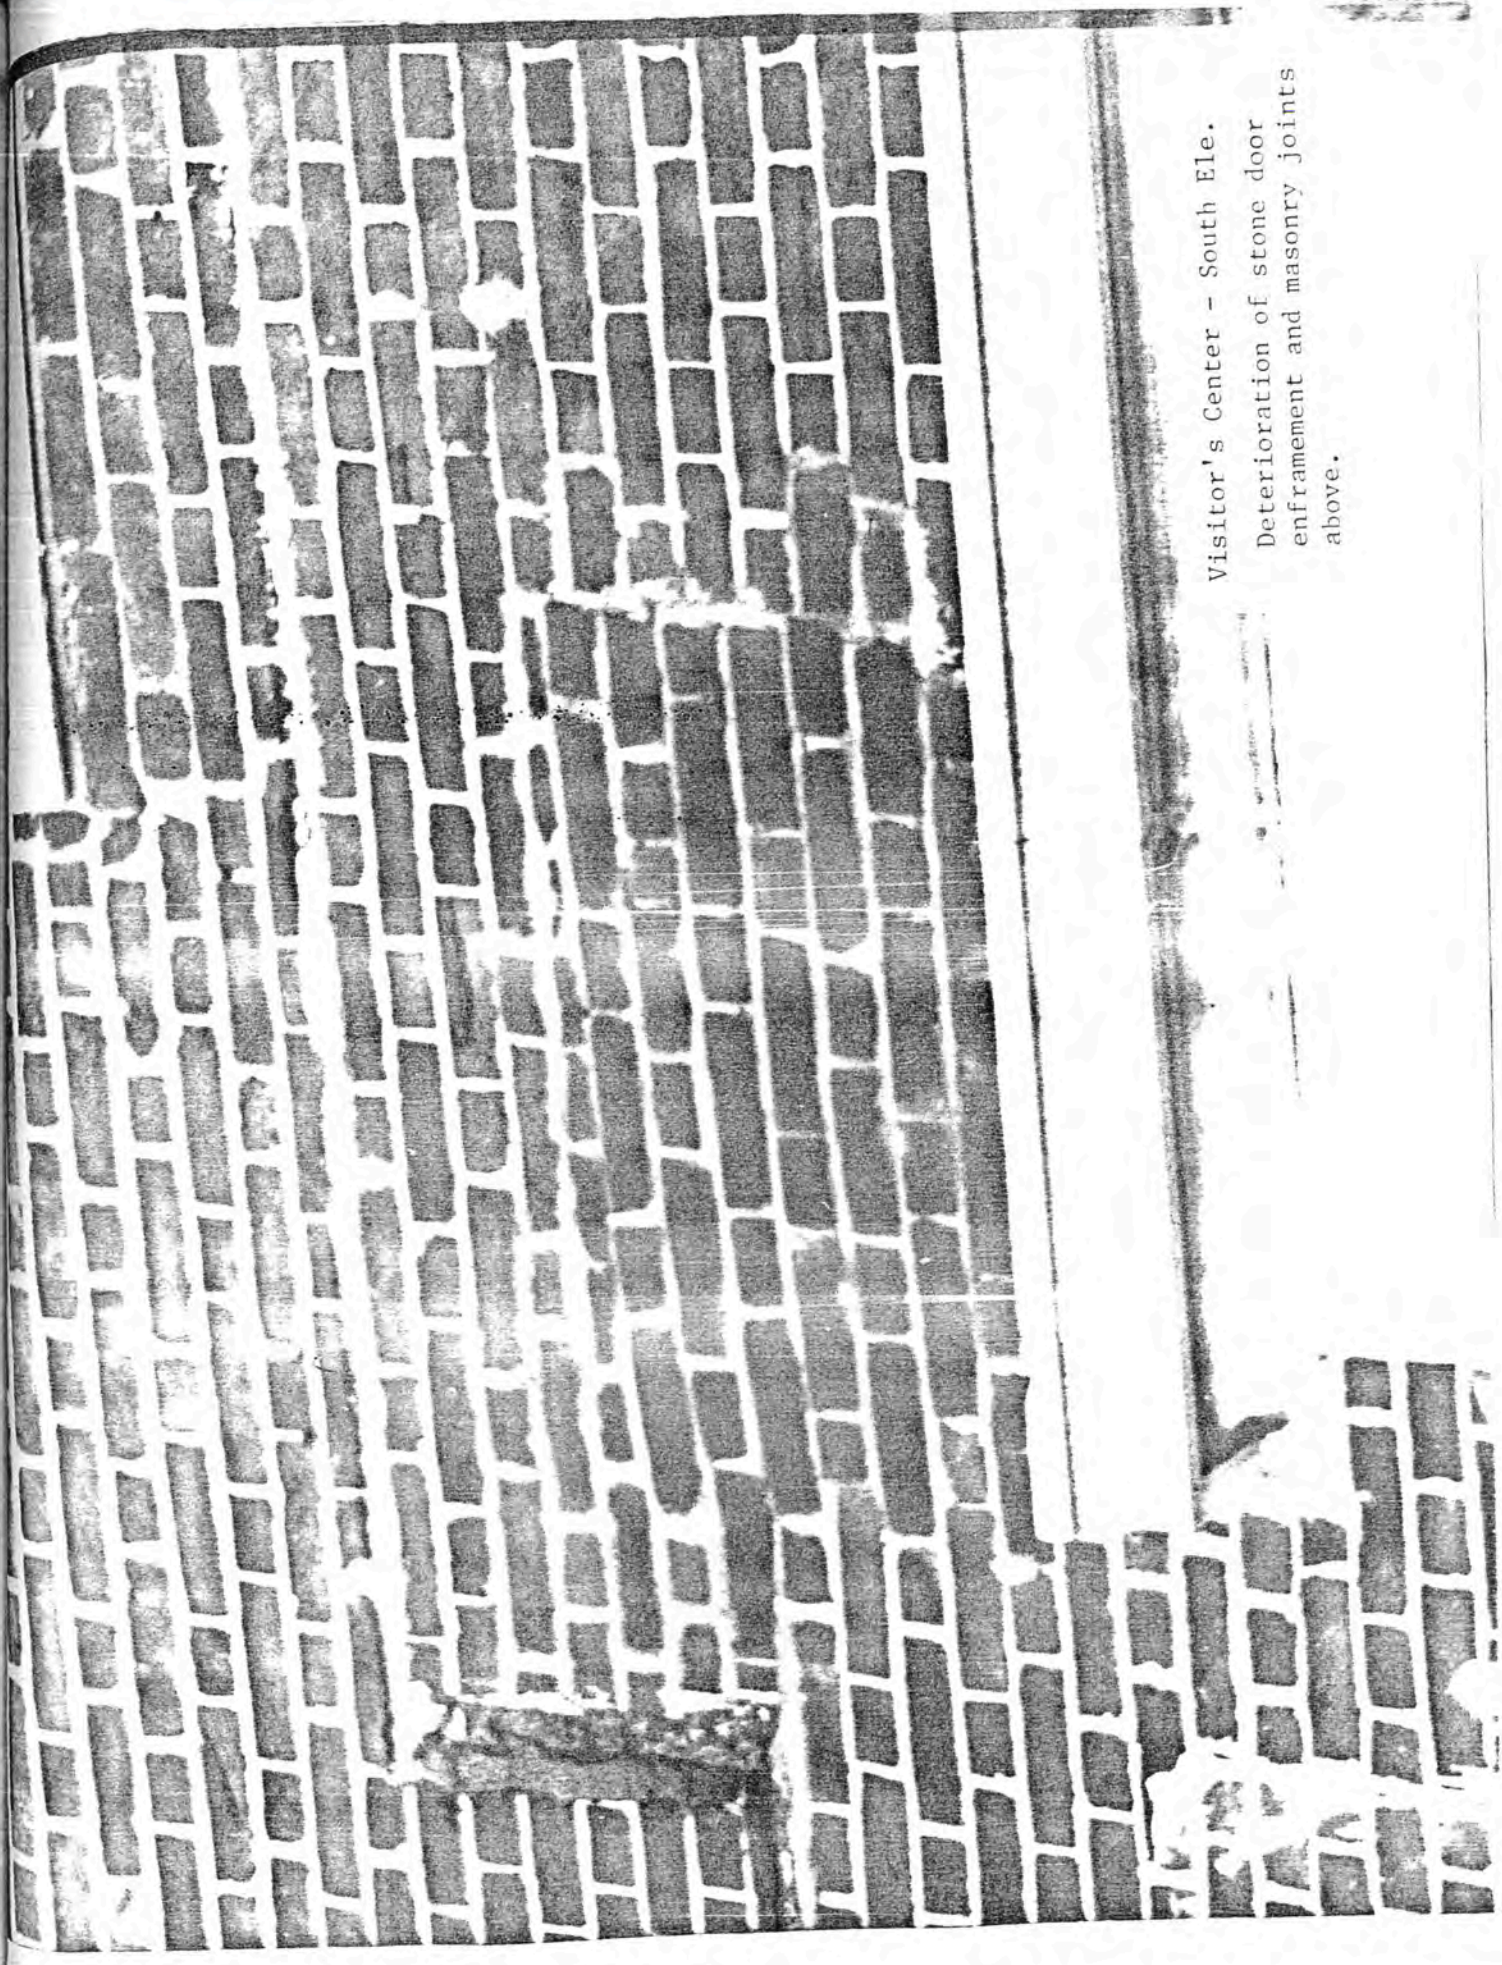
Visitor's Center - South Ele.  
Deterioration of stone door  
enframement and masonry joints  
above.

The cast stone door enframements require patching and re-pointing. These are noted on drawings. Approximately 25% of the balusters have eroded to the point where they should be replaced. The railing is in adequate condition. The precast cap stones of the chimney should be replaced.

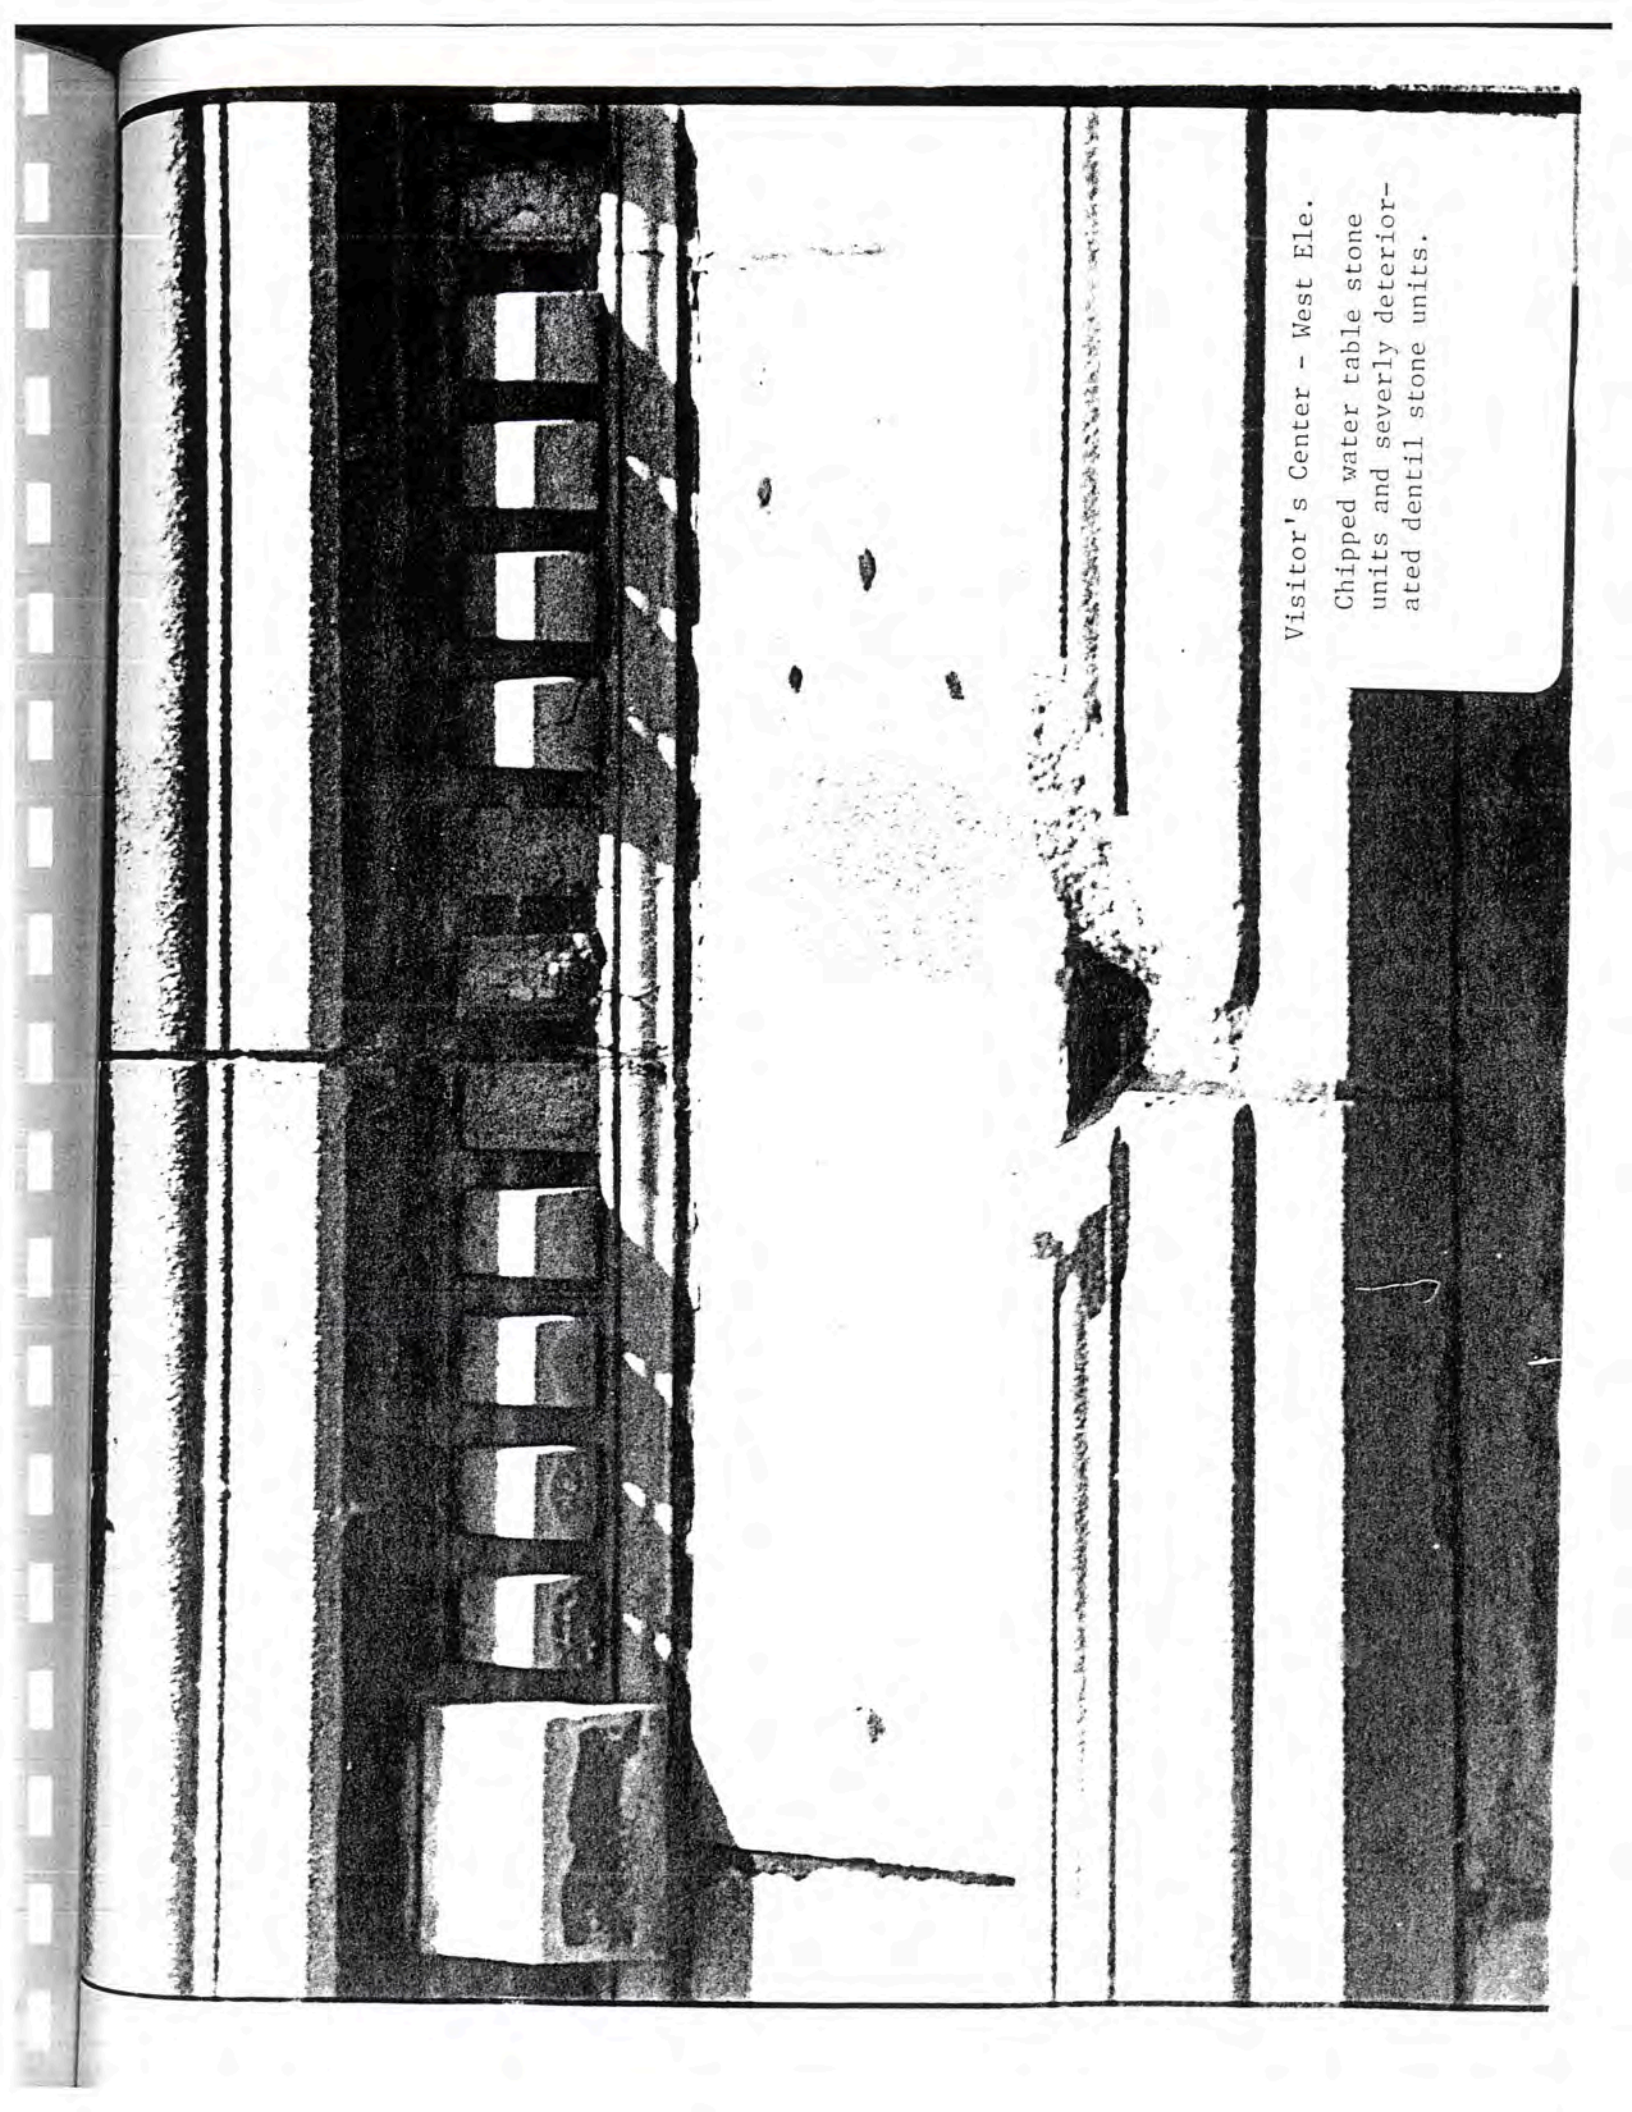
Visitor's Center - West Ele.

Chipped water table stone  
units and severely deterior-  
ated dentil stone units.

The cornice is composed of dentils and a string course of moulding. These elements have deteriorated in certain areas and units have also been displaced as noted on drawings. The severely deteriorated units should be recast to match in color, texture, and contours. This is approximately 5% of the total linear footage. They should be doweled to substrate and set in portland cement with epoxy bonding agent. An additional approximately 35% of the units are deteriorated but can be repaired. All units should be tested for soundness, any evidence of loose or spalled cement, and removed back to sound substrate. Those which are judged repairable shall be patch with mortar and exposed marble aggregate to match existing surfaces. We would recommend that a continuous cap flashing be considered to protect the exposed ledge of the cornices. The flashing would be set in a reglet in the parapet wall and, following the contour of the top cornice, extend to the outer edge of the moulding. This flashing would protect the cornice joints and aid in water run-off. The cornice units which have been displaced but are otherwise intact should be removed and reset as described above.

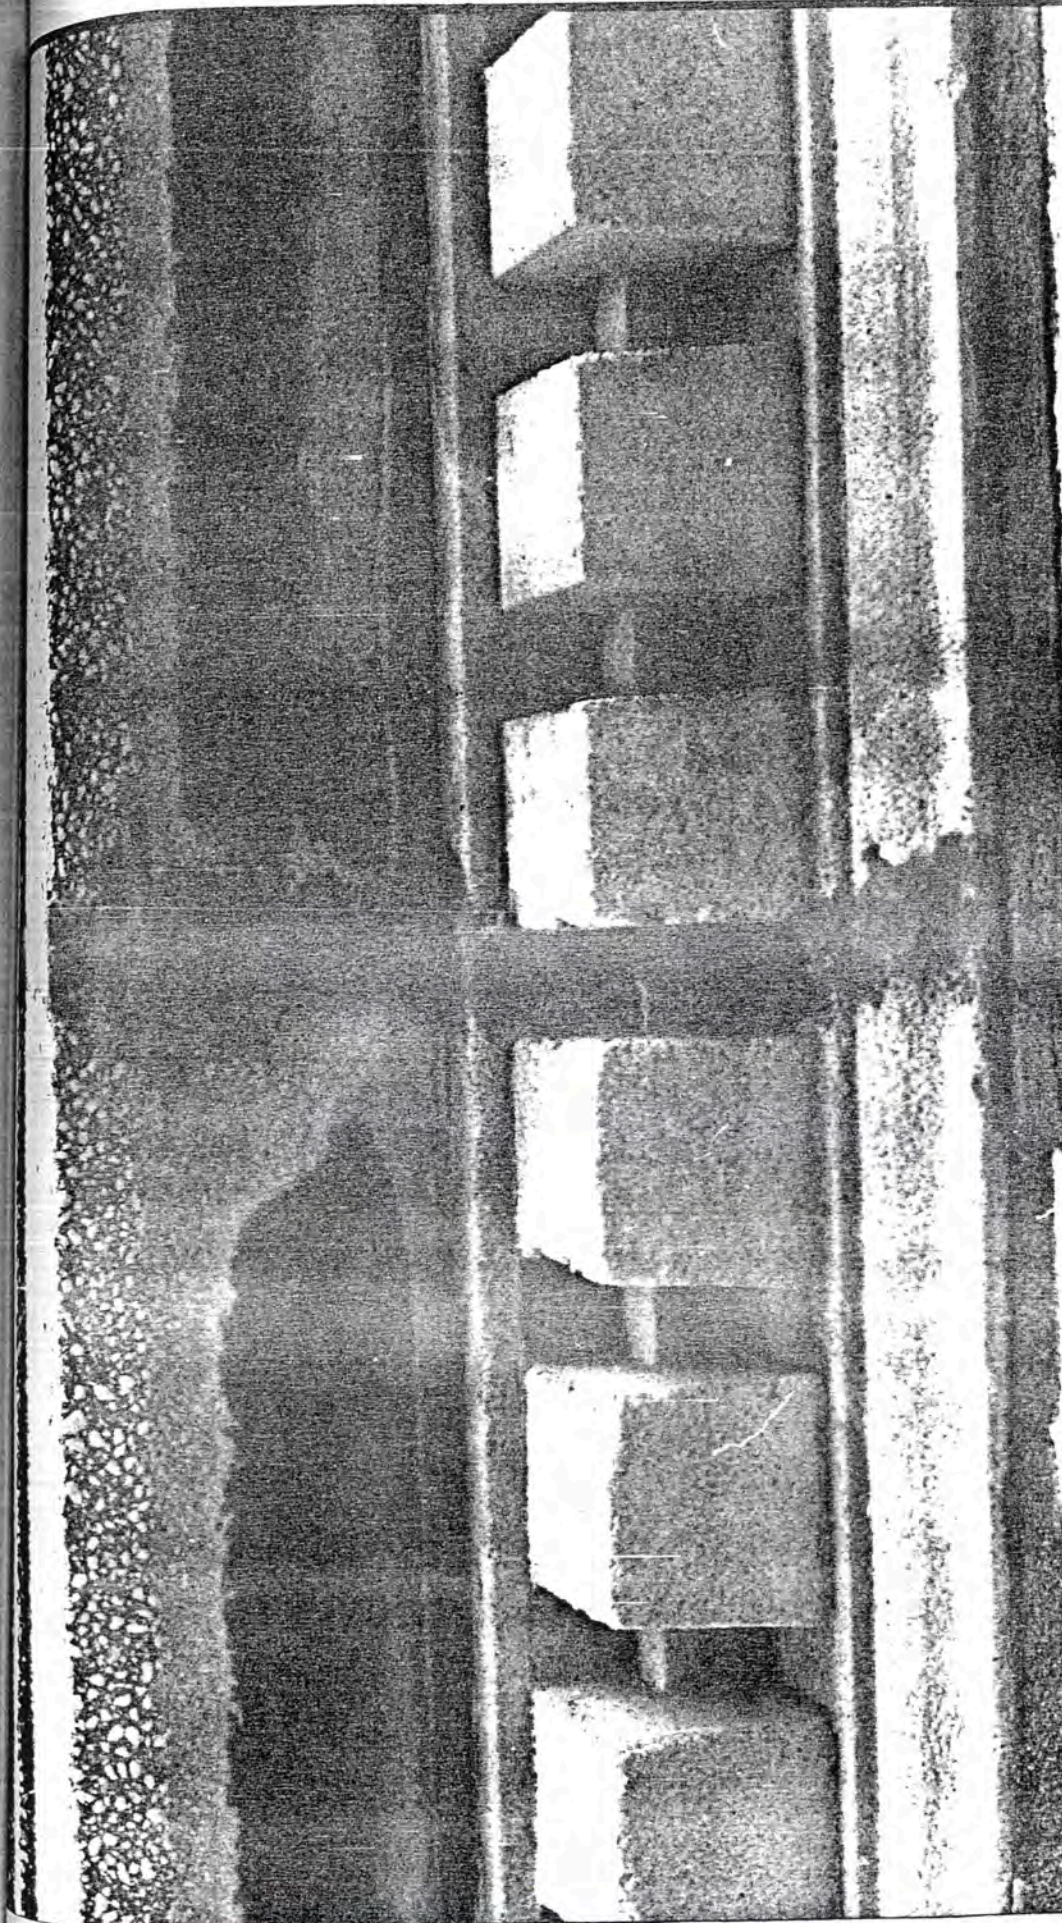
Visitor's Center - West Ele.

Water table below parapet wall.  
Notice defective cross joints.

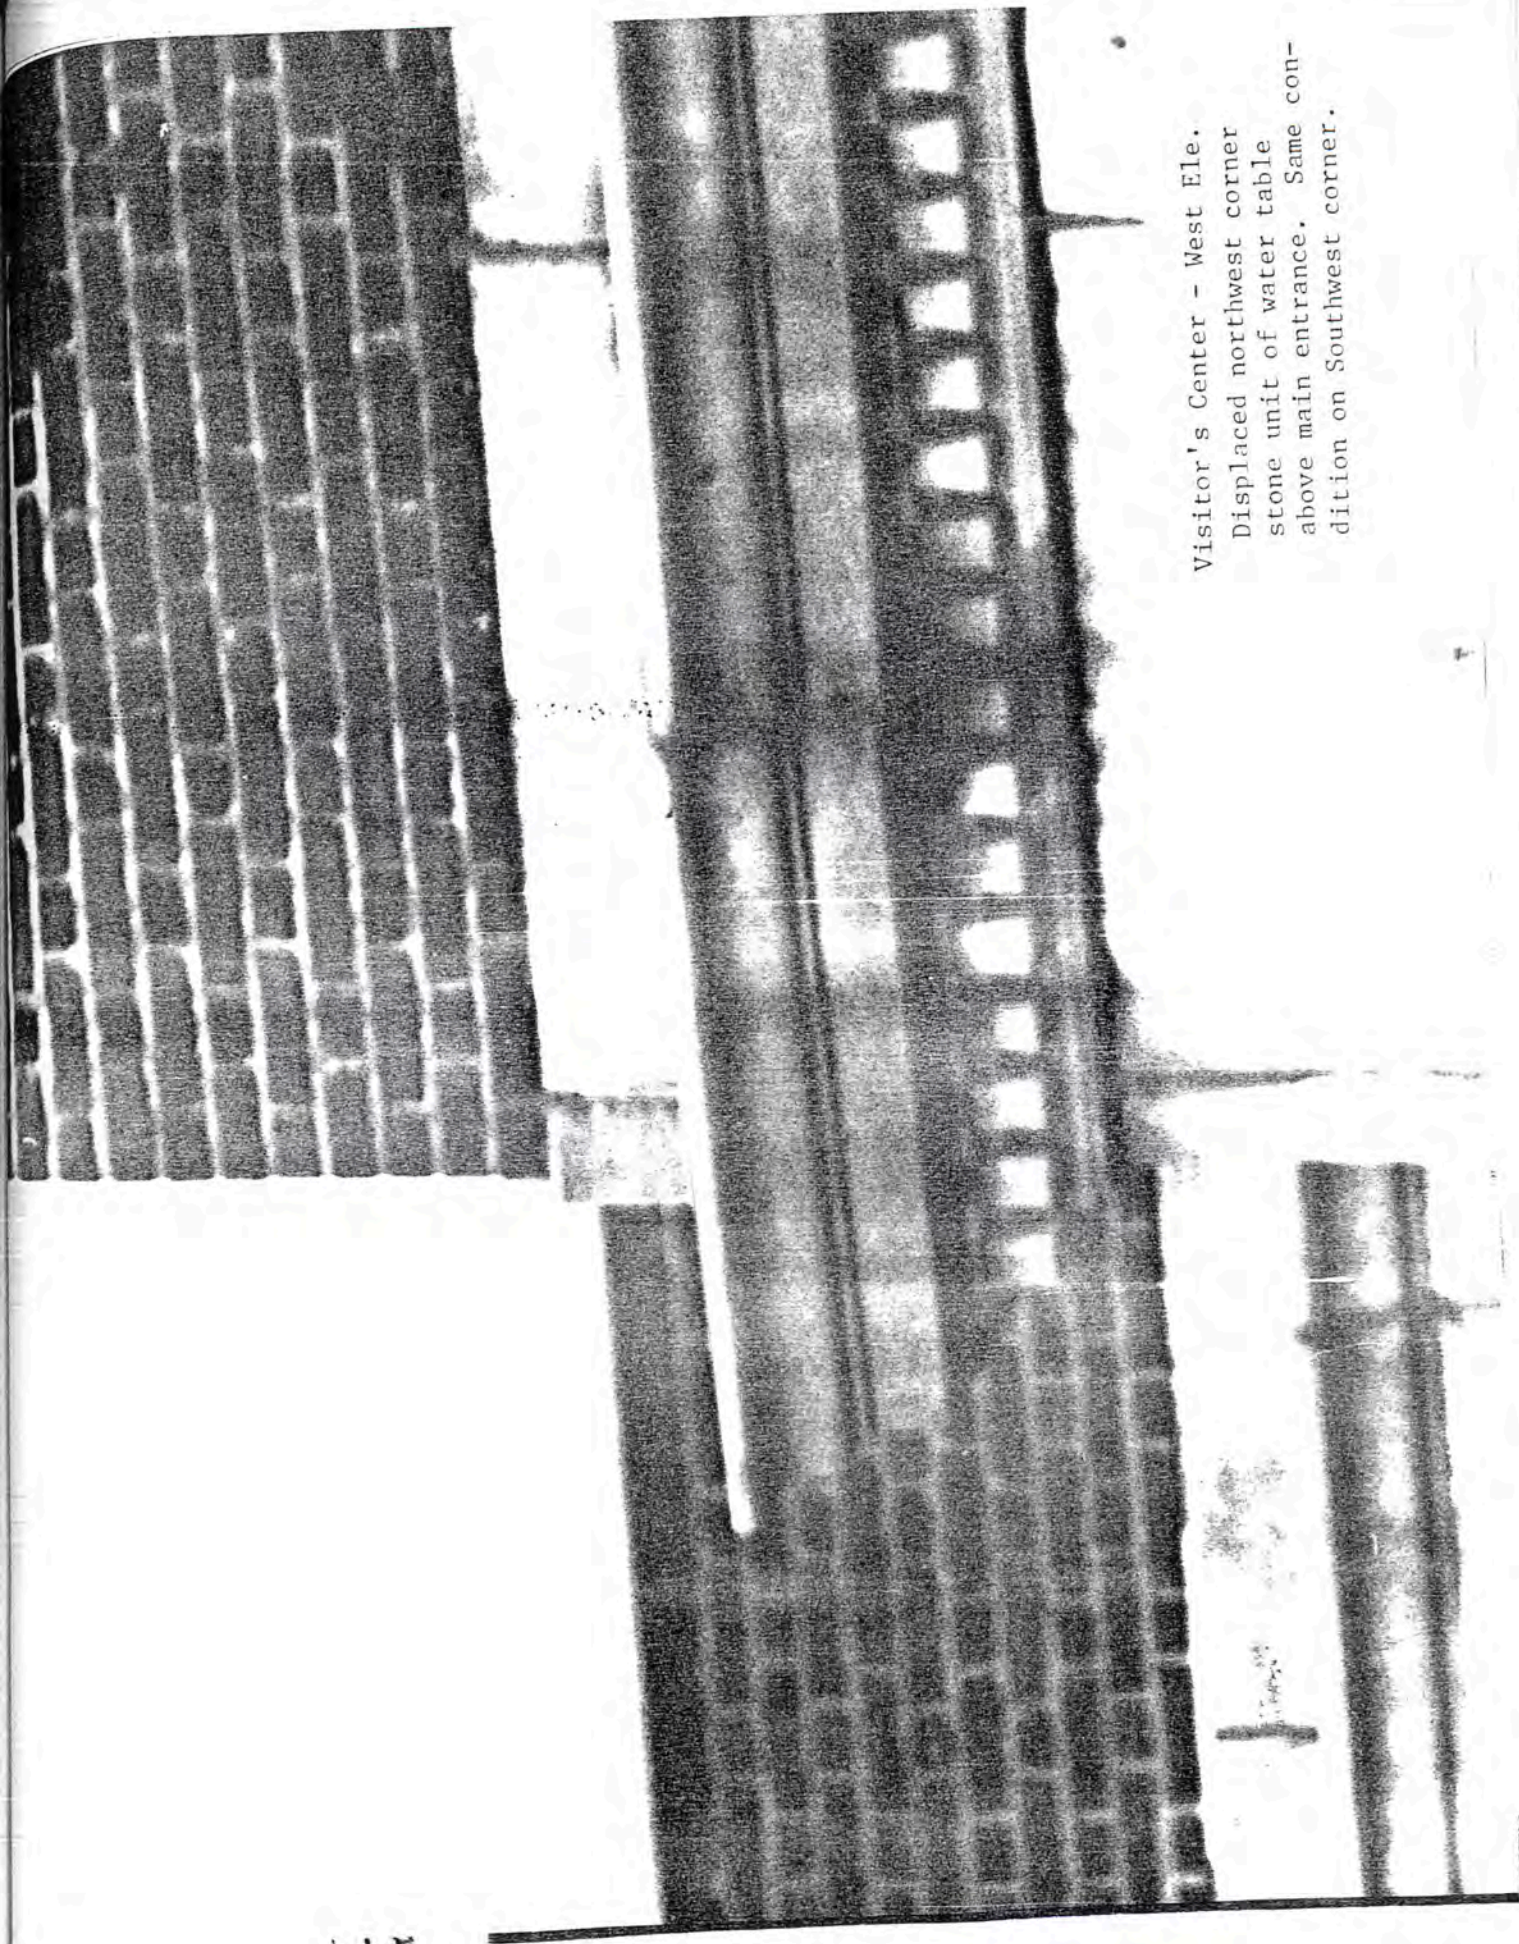
Visitor's Center - West Ele.  
Displaced northwest corner  
stone unit of water table  
above main entrance. Same con-  
dition on Southwest corner.

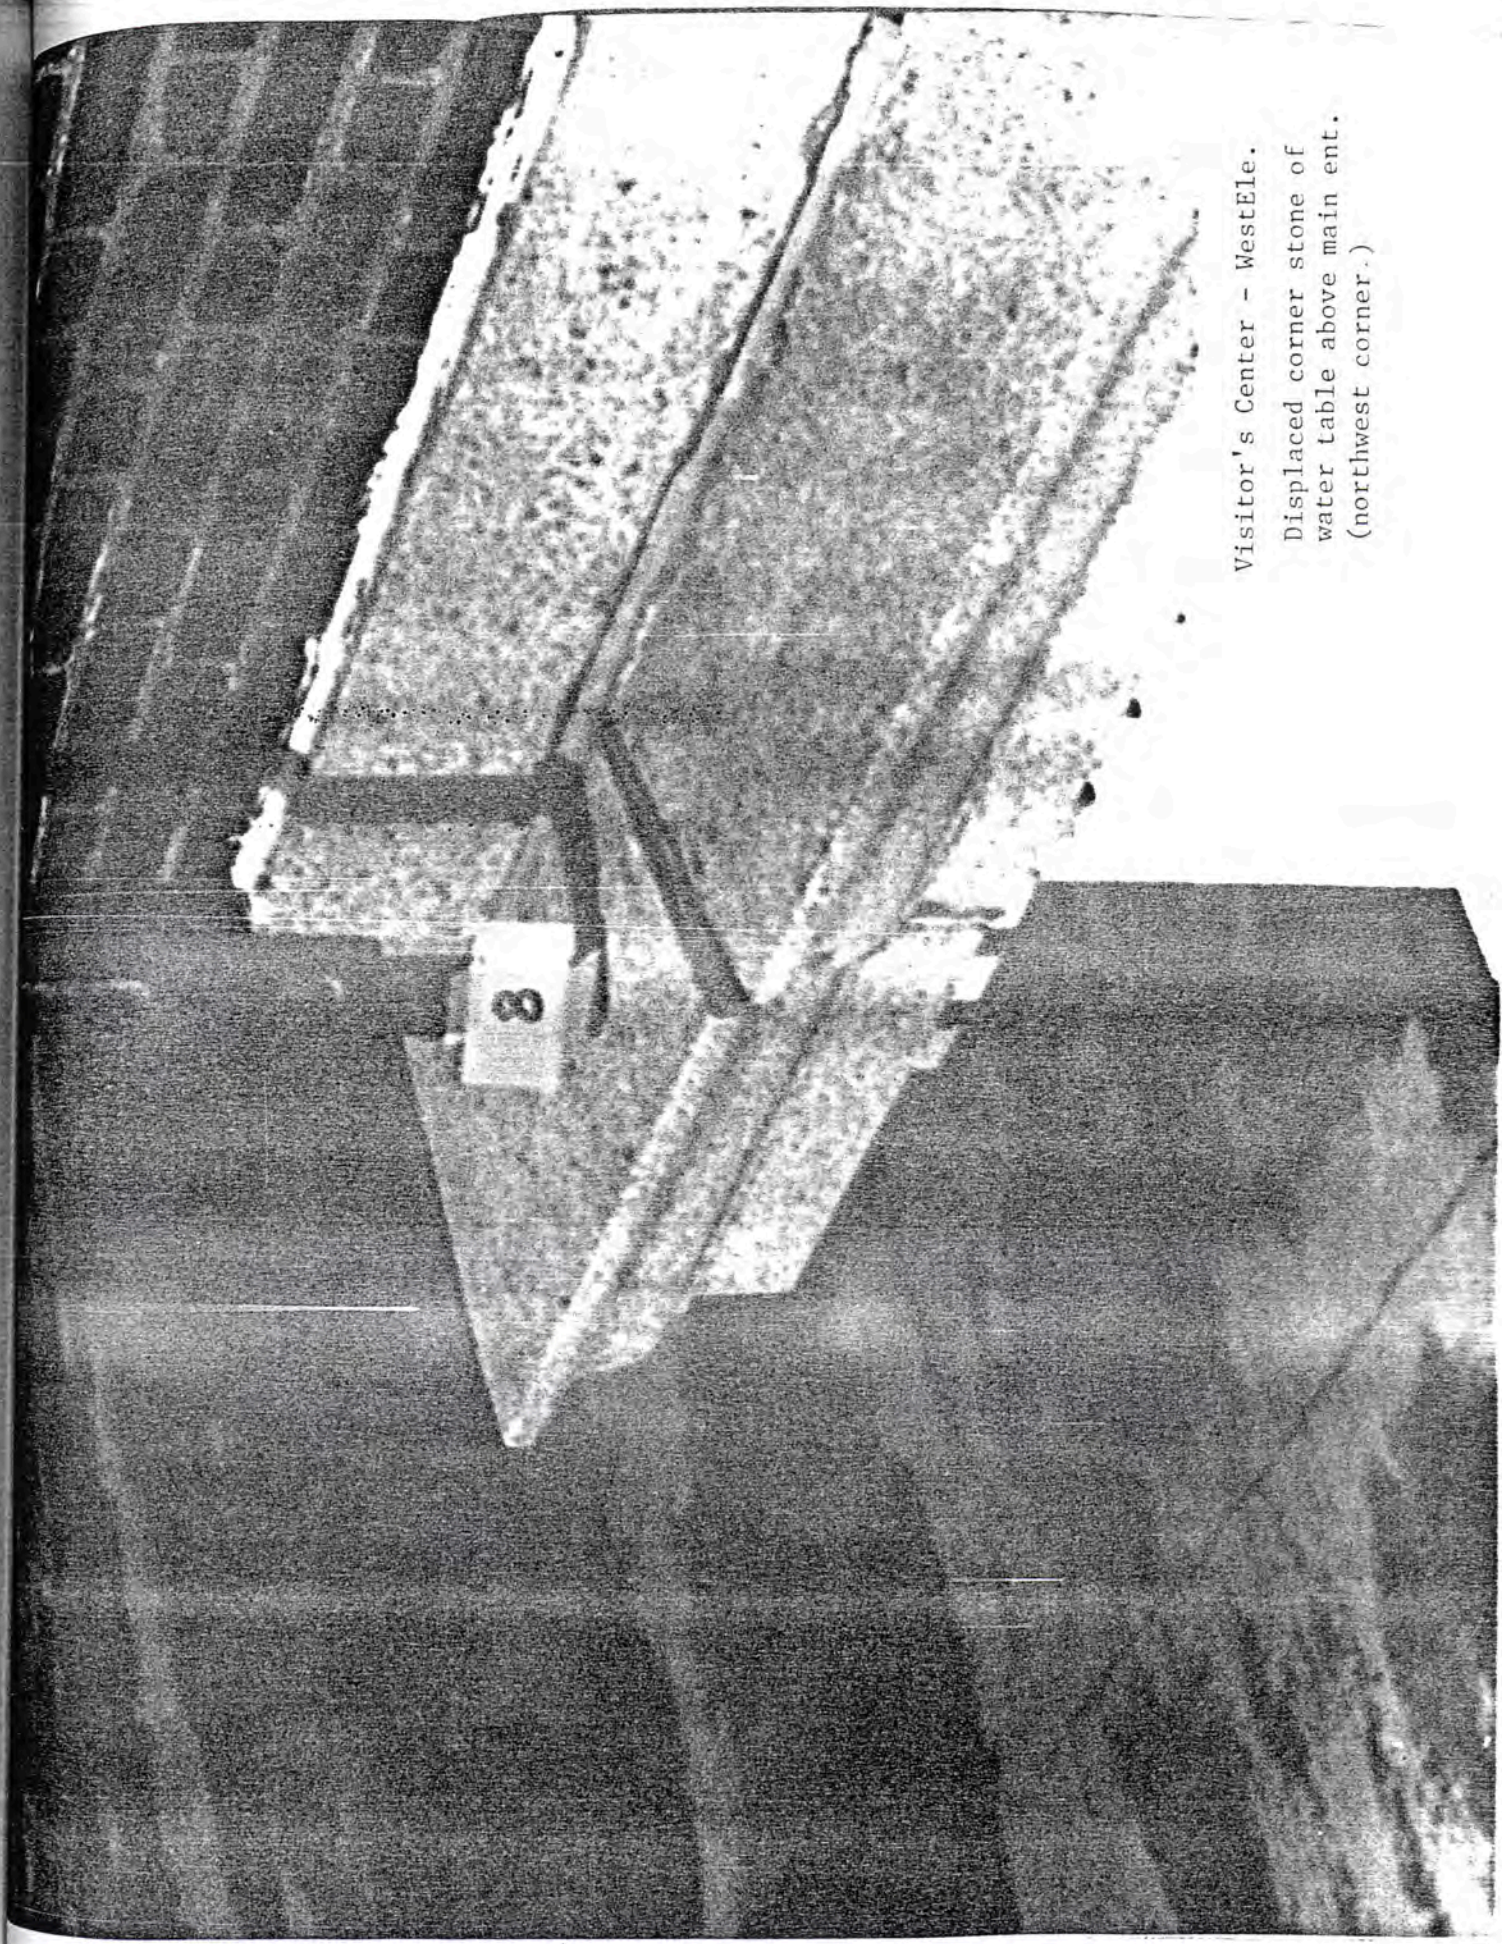
Visitor's Center - WestEle.

Displaced corner stone of  
water table above main ent.  
(northwest corner.)

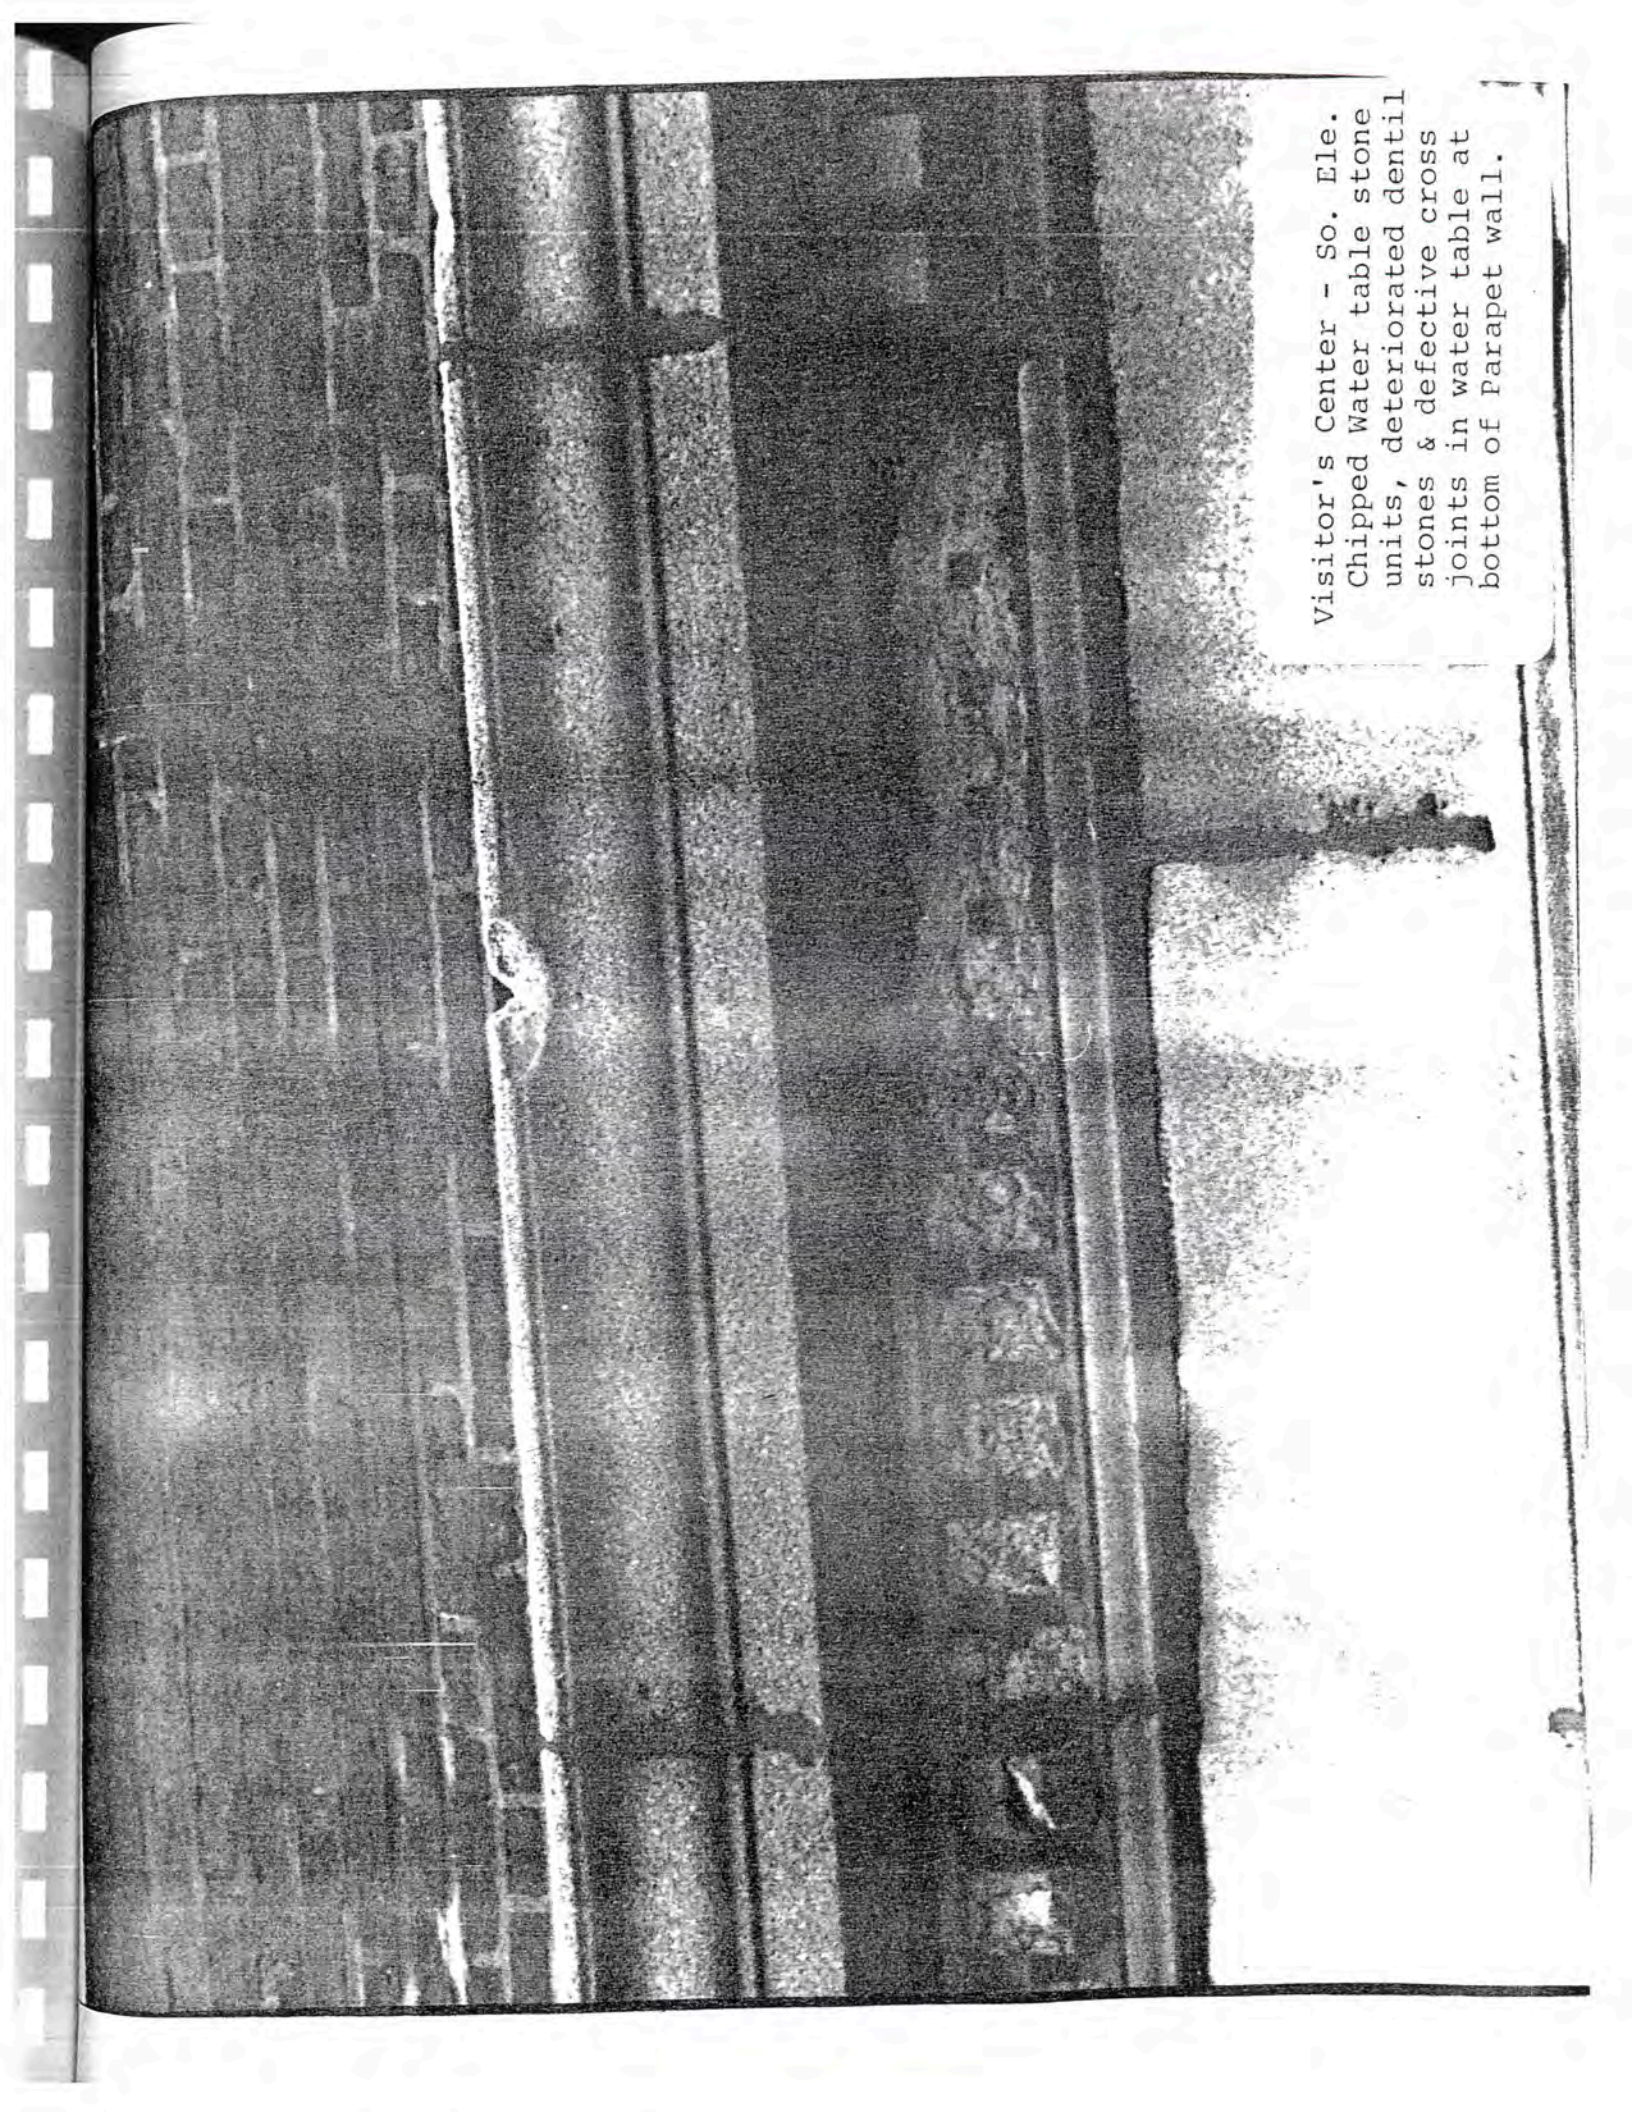
Visitor's Center - So. Ele.  
Chipped water table stone  
units, deteriorated dentil  
stones & defective cross  
joints in water table at  
bottom of parapet wall.
