**FACADE INVESTIGATION  
VISITOR CENTER  
FLOYD BENNETT FIELD**

**TONETTI ASSOCIATES**

January 30, 1984

The following is our report on the conditions of the exterior shell of the William Ryan Visitor's Building at Floyd Bennett Field, Gateway National Recreation Area. We trust that this report will serve as a documentation of the conditions at present and as a tool for evaluating future repairs and restoration.

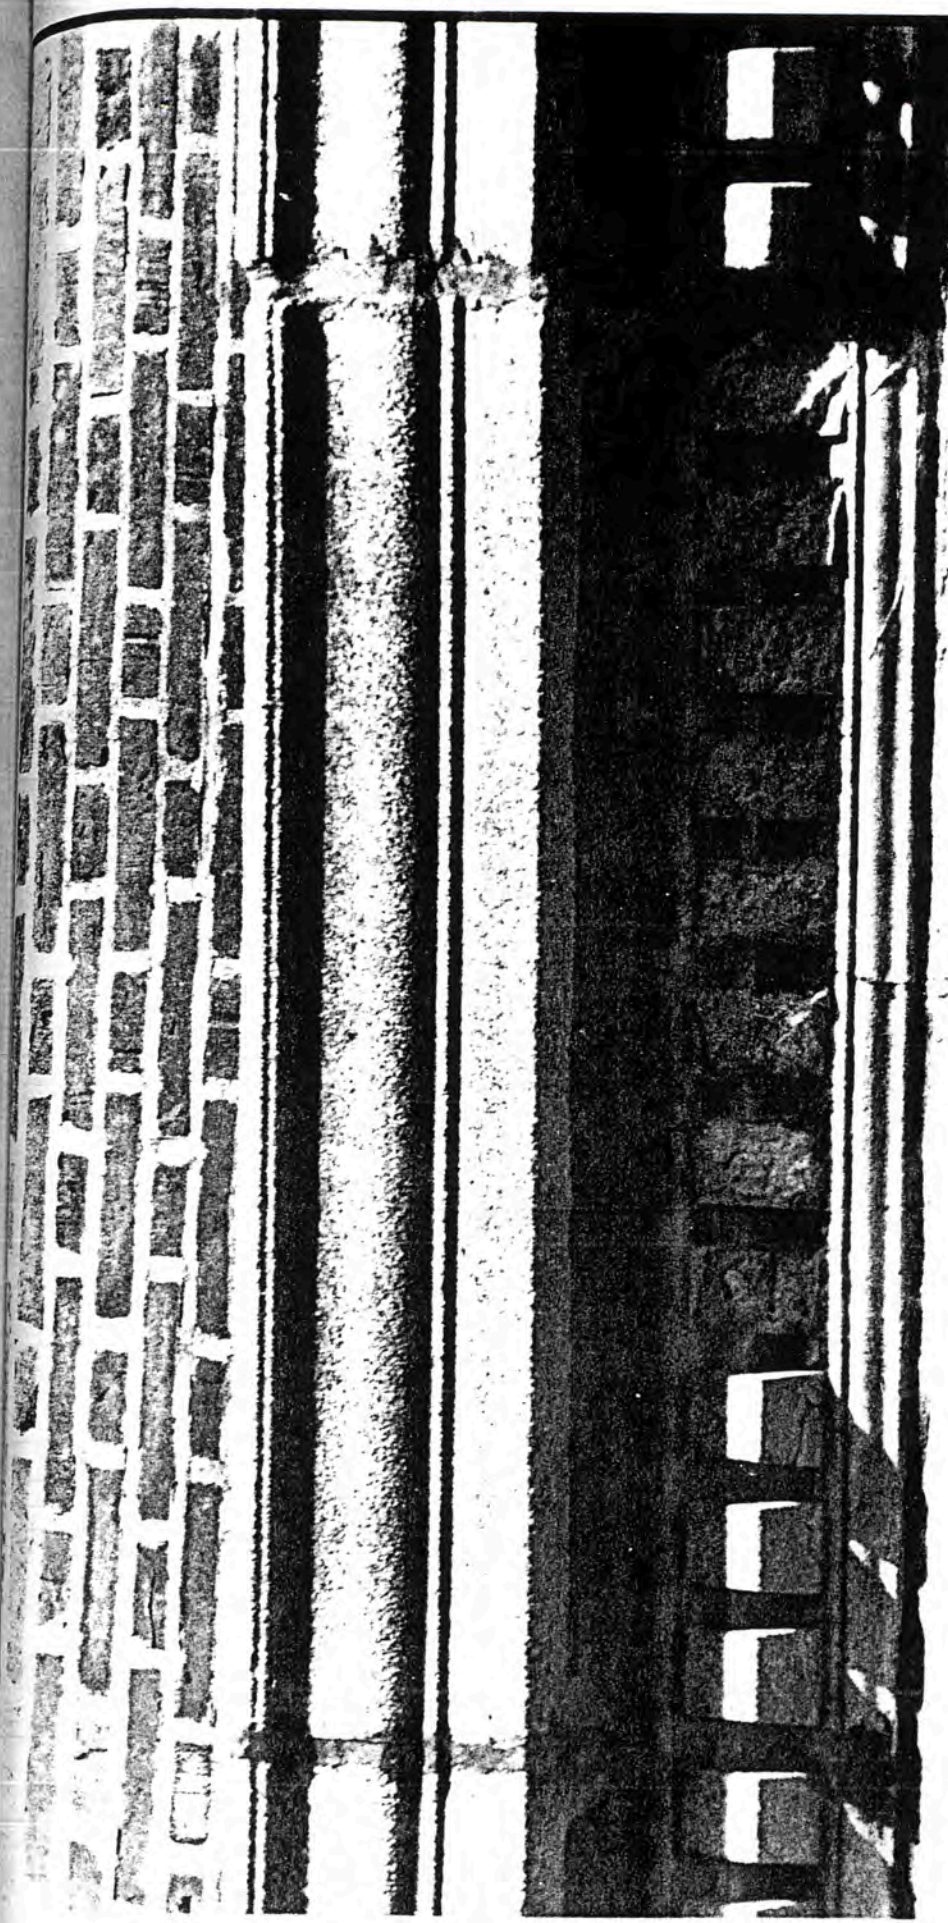
Visitor's Center, North Ele.

Deteriorated dentil stone units,  
defective water table cross  
joints & displaced corner stone  
unit.

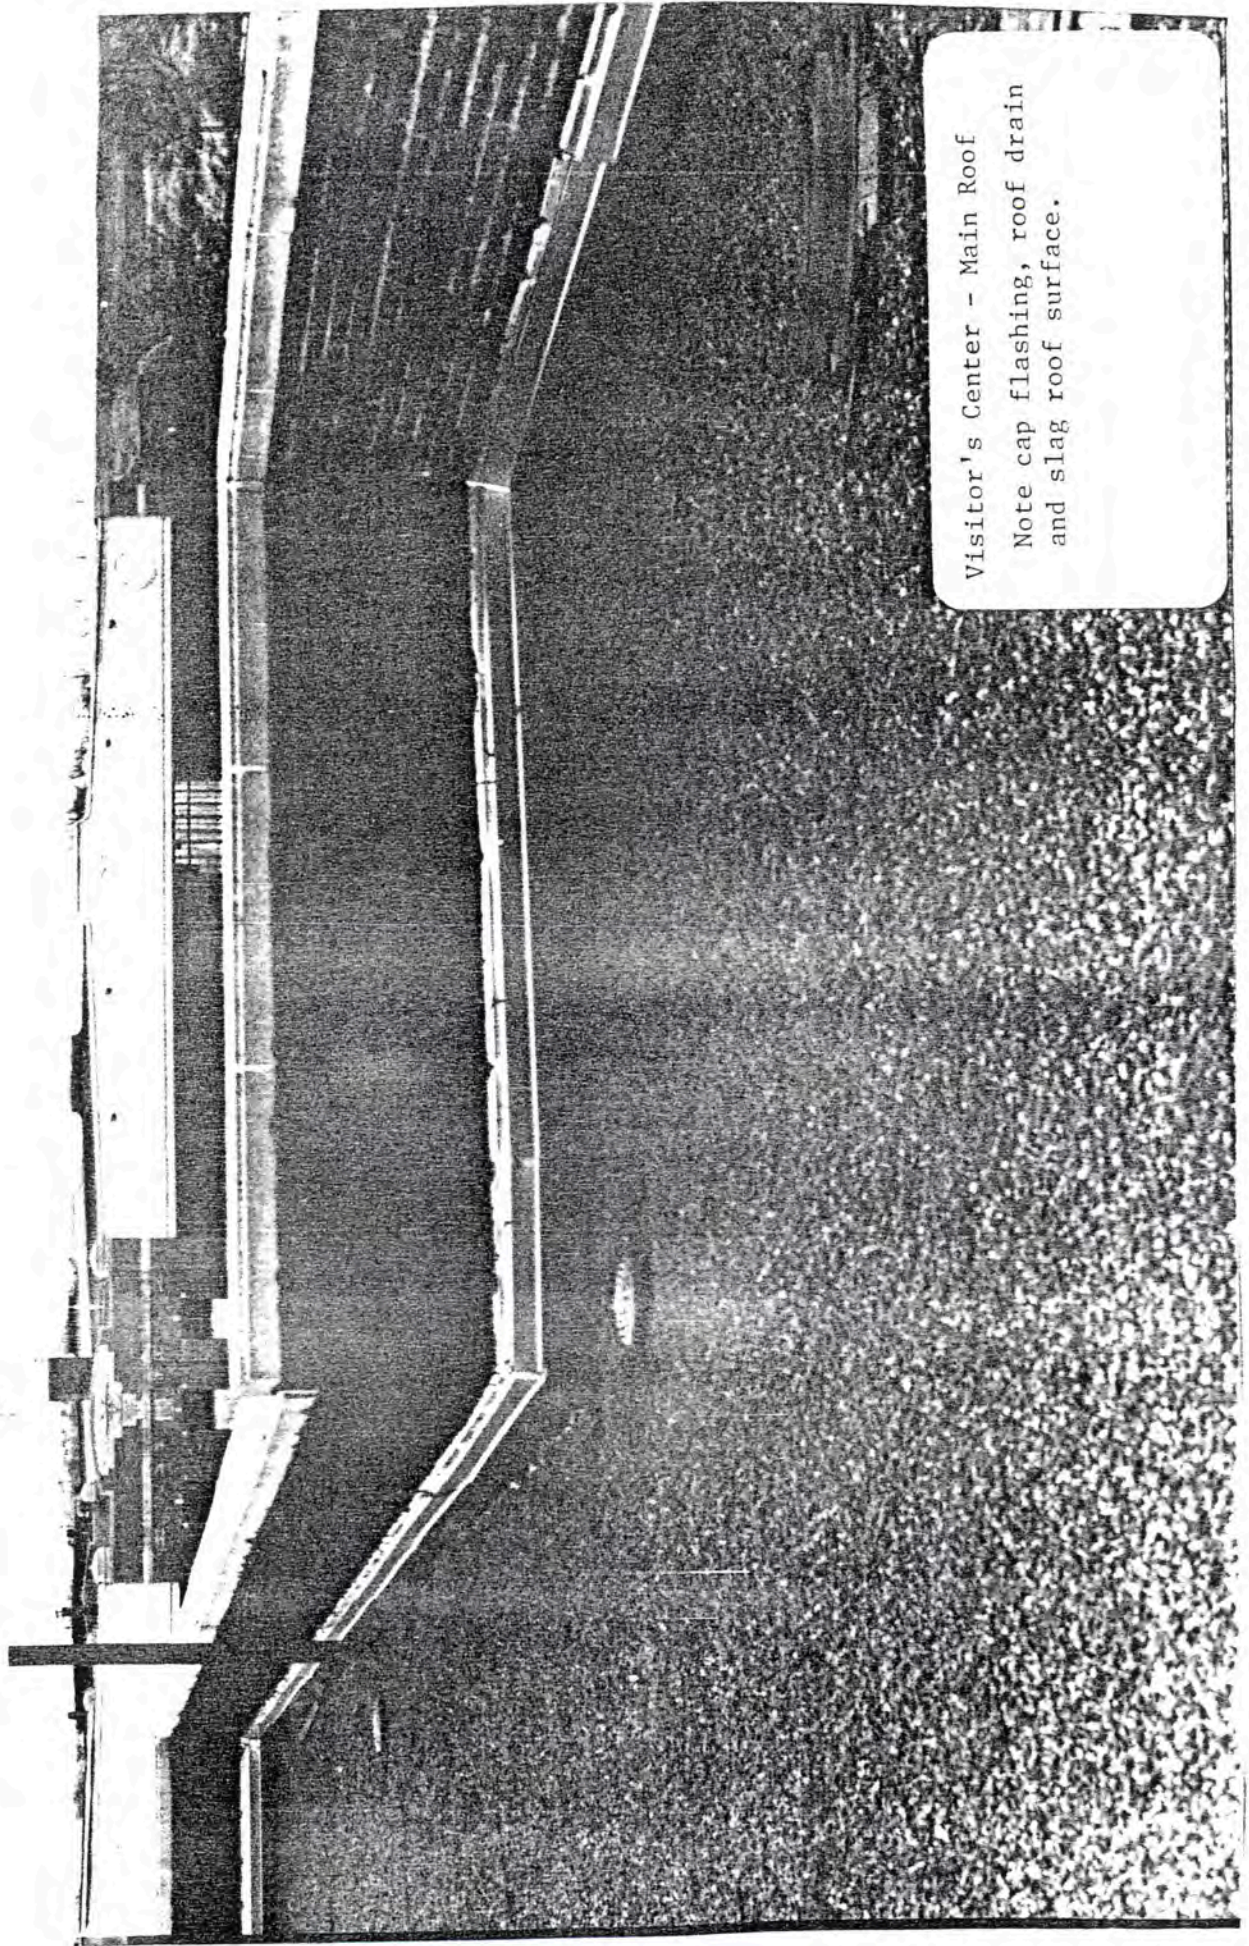
Visitor's Center - Main Roof  
Note cap flashing, roof drain  
and slag roof surface.

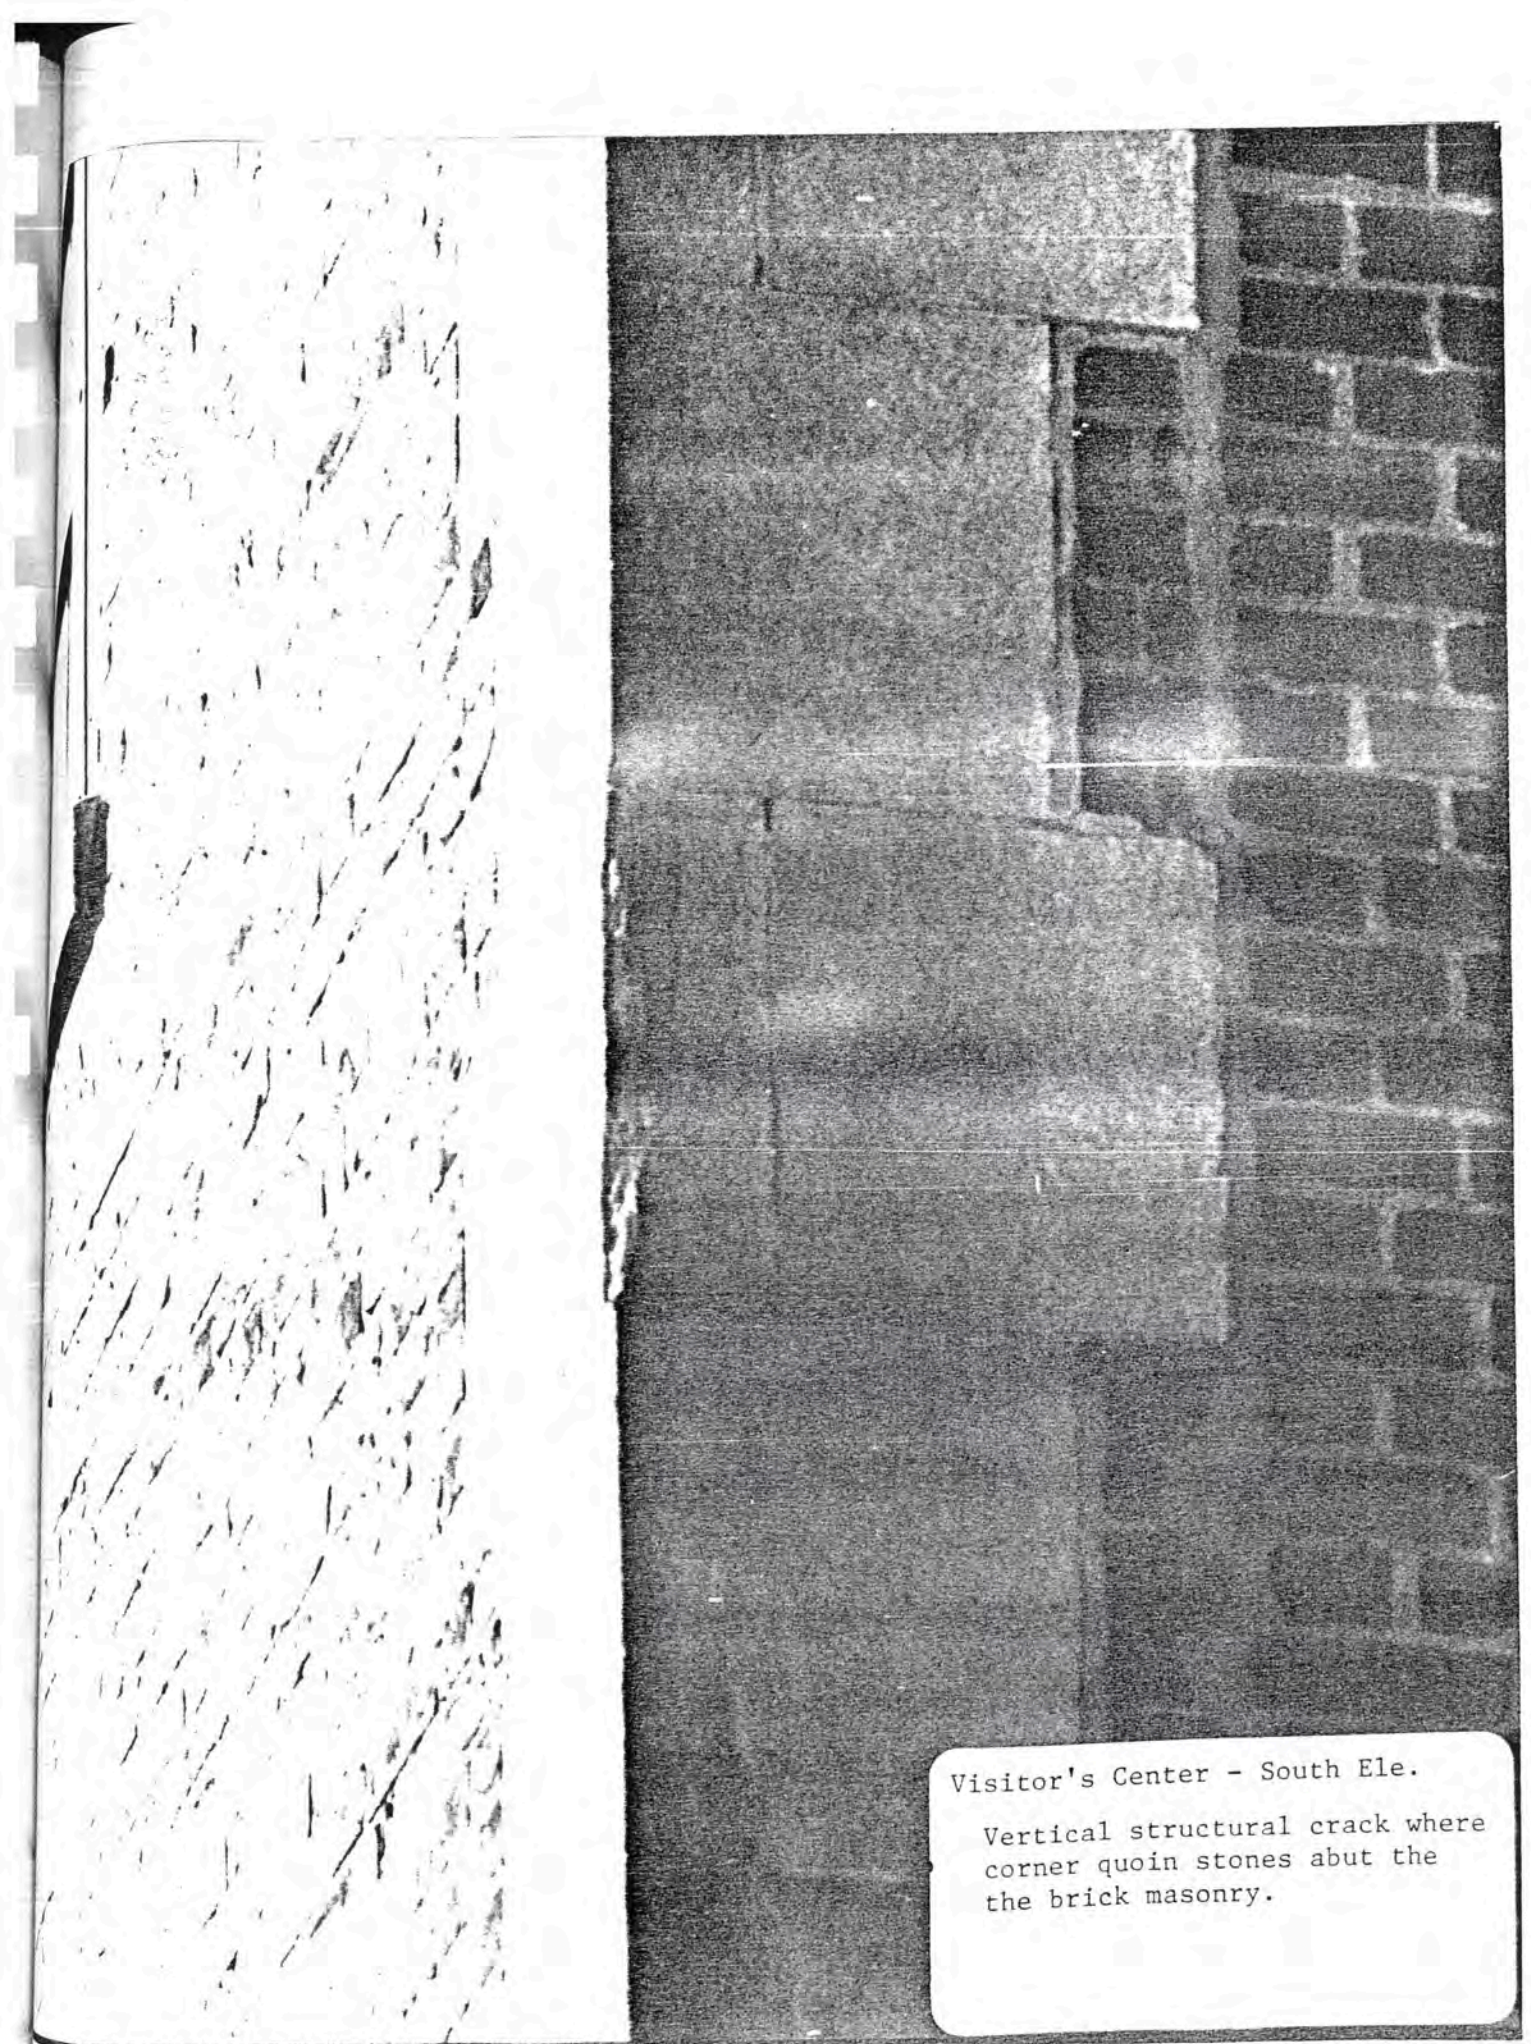
Visitor's Center - South Ele.

Vertical structural crack where  
corner quoin stones abut the  
the brick masonry.

The joint between the existing quoins and new brickwork should be treated as an expansion joint. It should be filled with backer rod and pressure sealed with polysulfide sealant pigmented to match mortar.

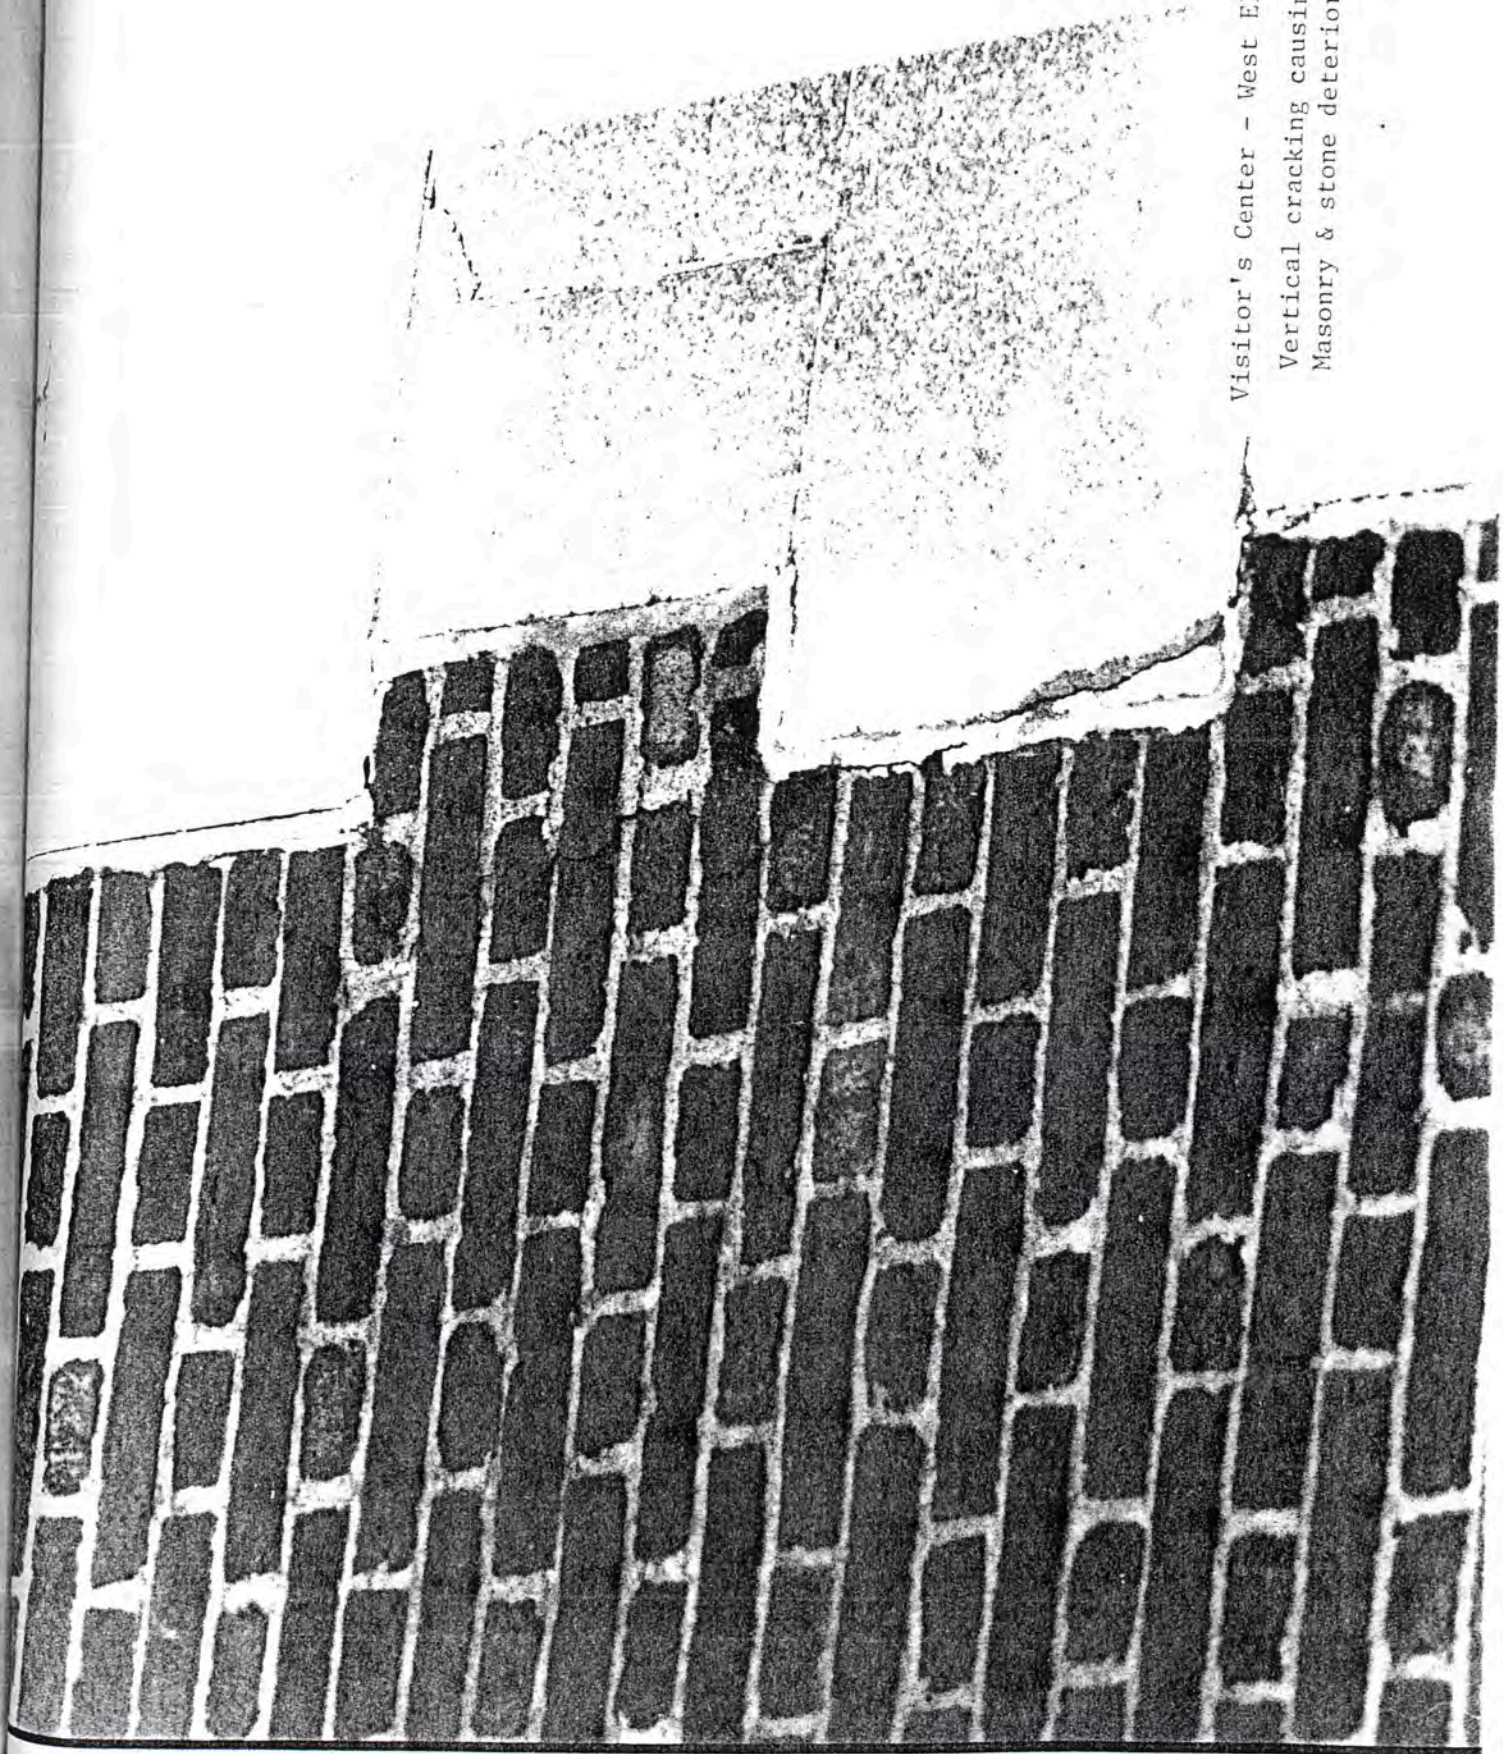
Visitor's Center - West Ele.  
Vertical cracking causing  
Masonry & stone deterioration.

2.1 All vertical structural cracks throughout the facade should be repaired. This includes resolving the underlying problems of the steel columns and piping as detailed in paragraph 1.2 of the Work Required section. If these are allowed to remain open the deterioration of the steel, masonry and interior finishes will be extremely destructive.

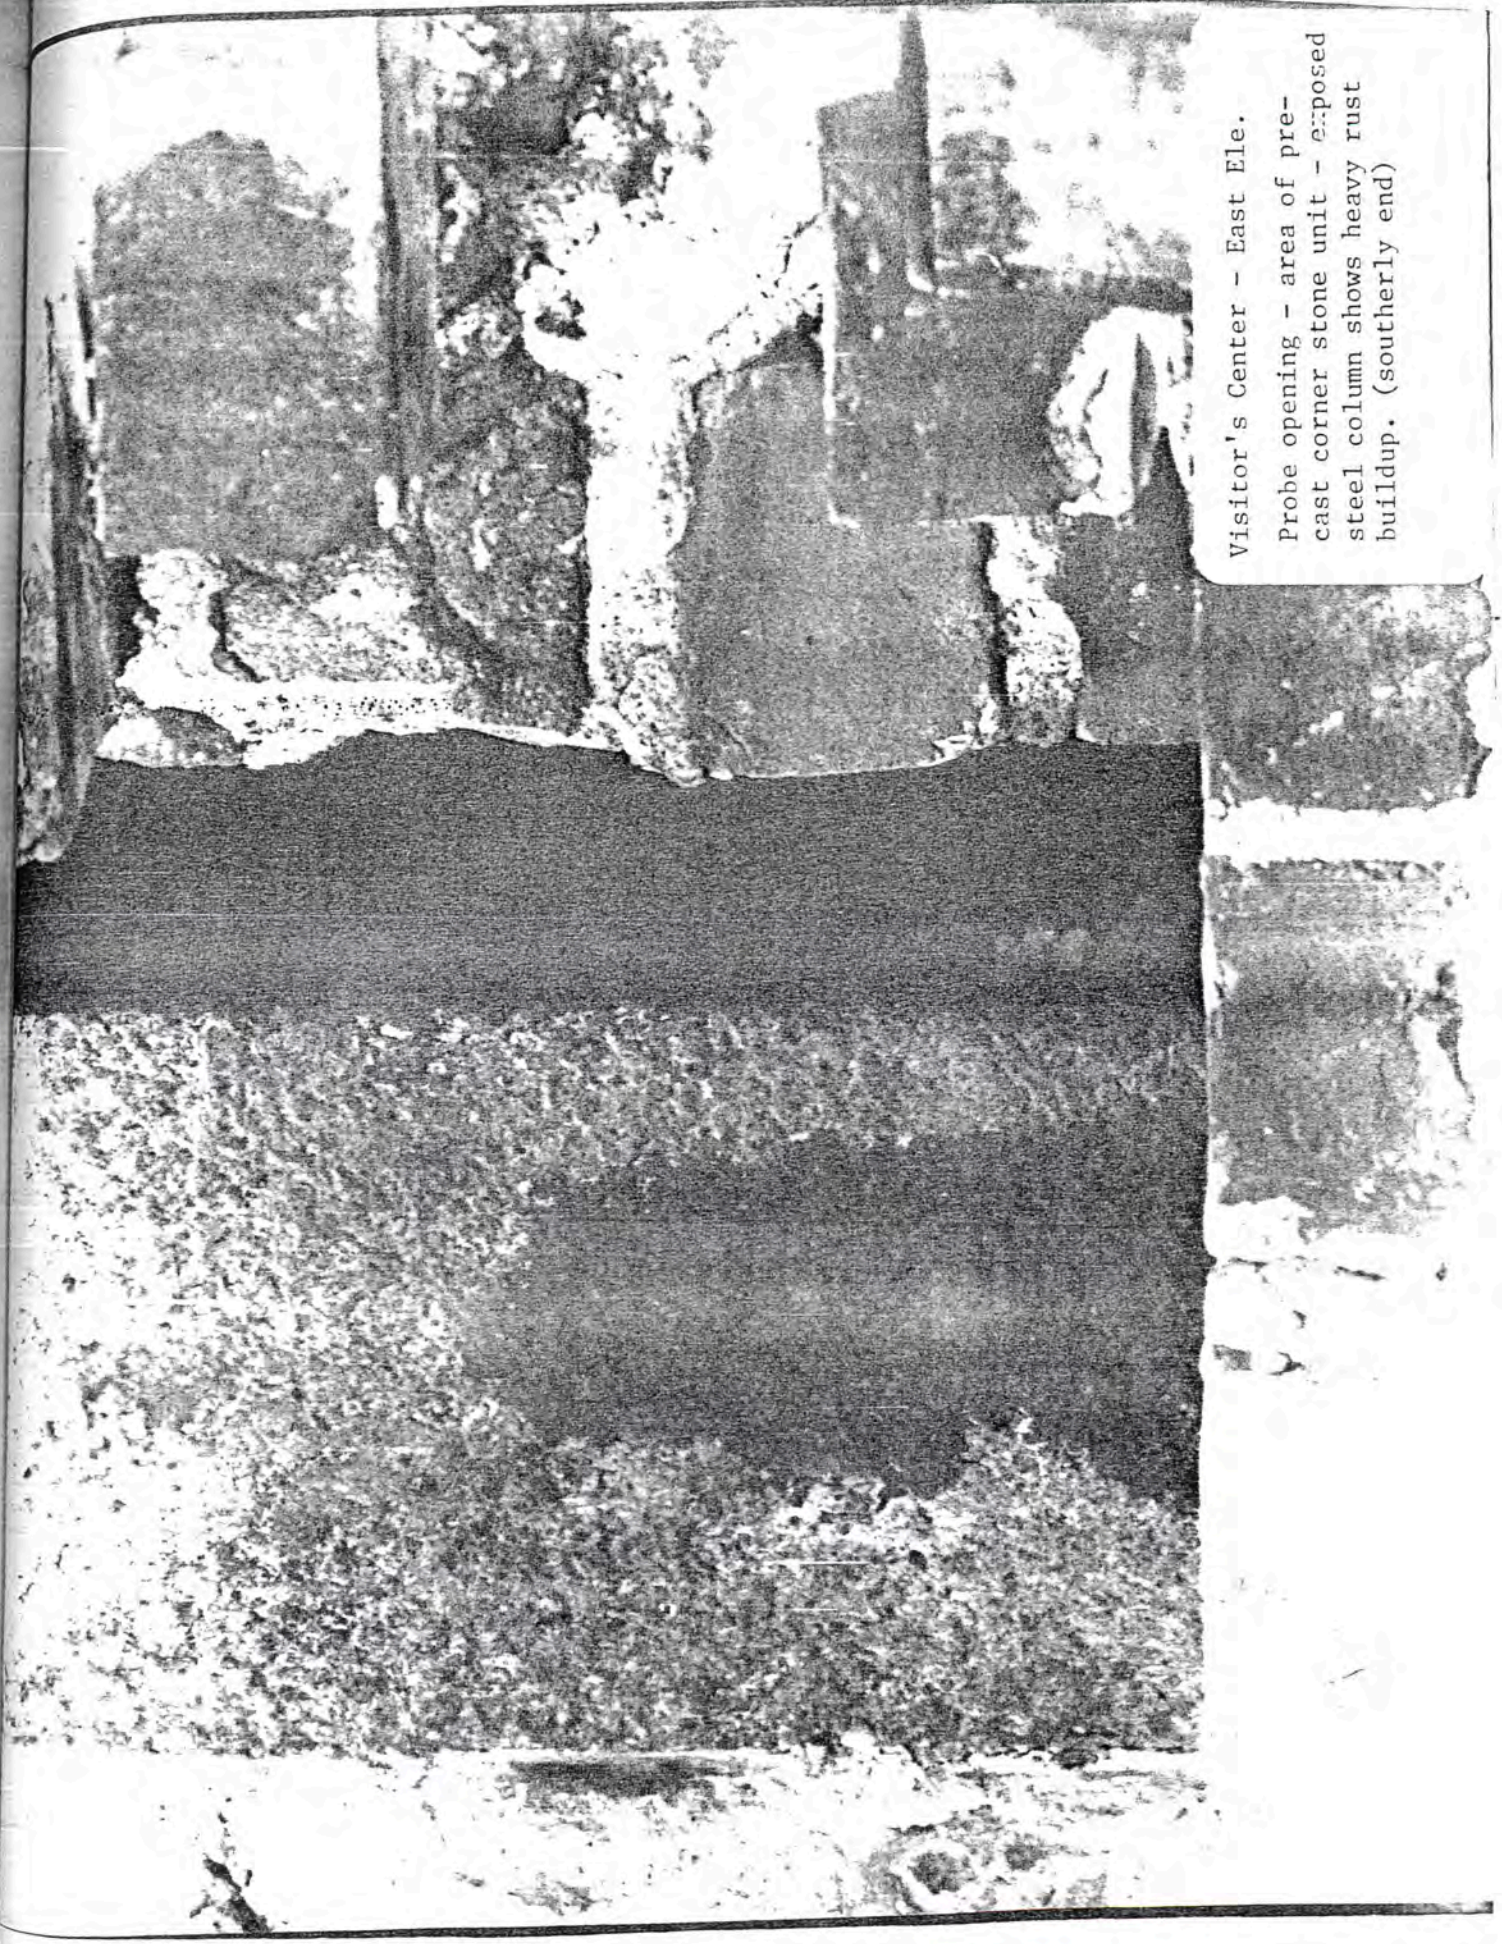
Visitor's Center - East Ele.

Probe opening - area of pre-cast corner stone unit - exposed steel column shows heavy rust buildup. (southerly end)

At the four corners of the building the steel columns have rusted, expanded and cracked the surrounding brick. A sufficient amount of brick will have to be removed from basement to cornice to reveal the column behind. The pre-cast quoins should be reinforced and left in place. The columns would then be scraped clean, primed and painted with highest quality paint. New brick matching the existing should be keyed and reset in full mortar bed.

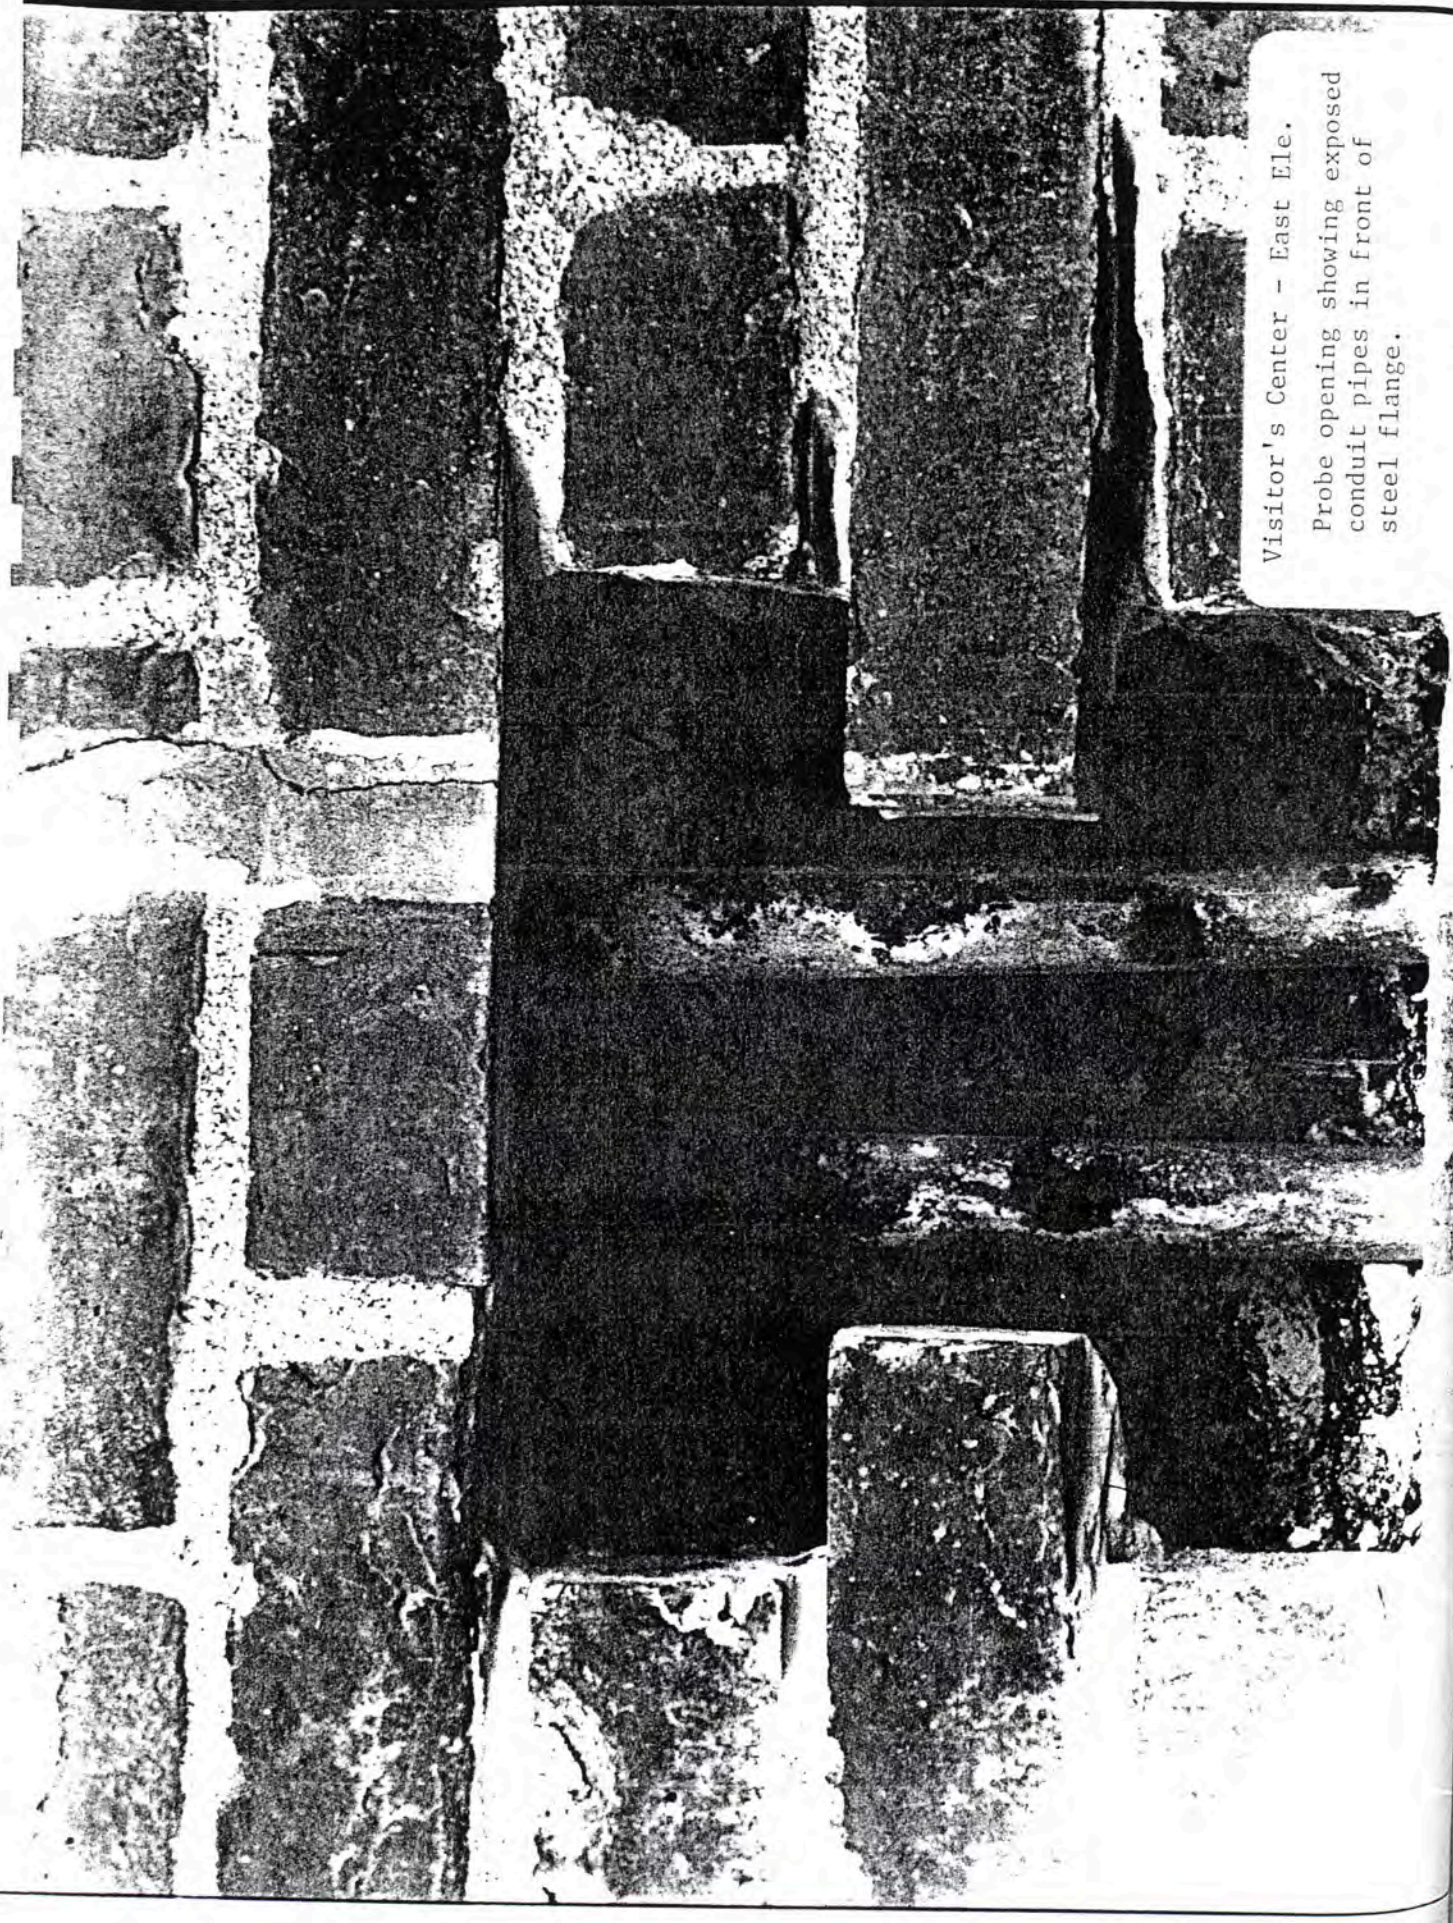
Visitor's Center - East Ele.

Probe opening showing exposed  
conduit pipes in front of  
steel flange.

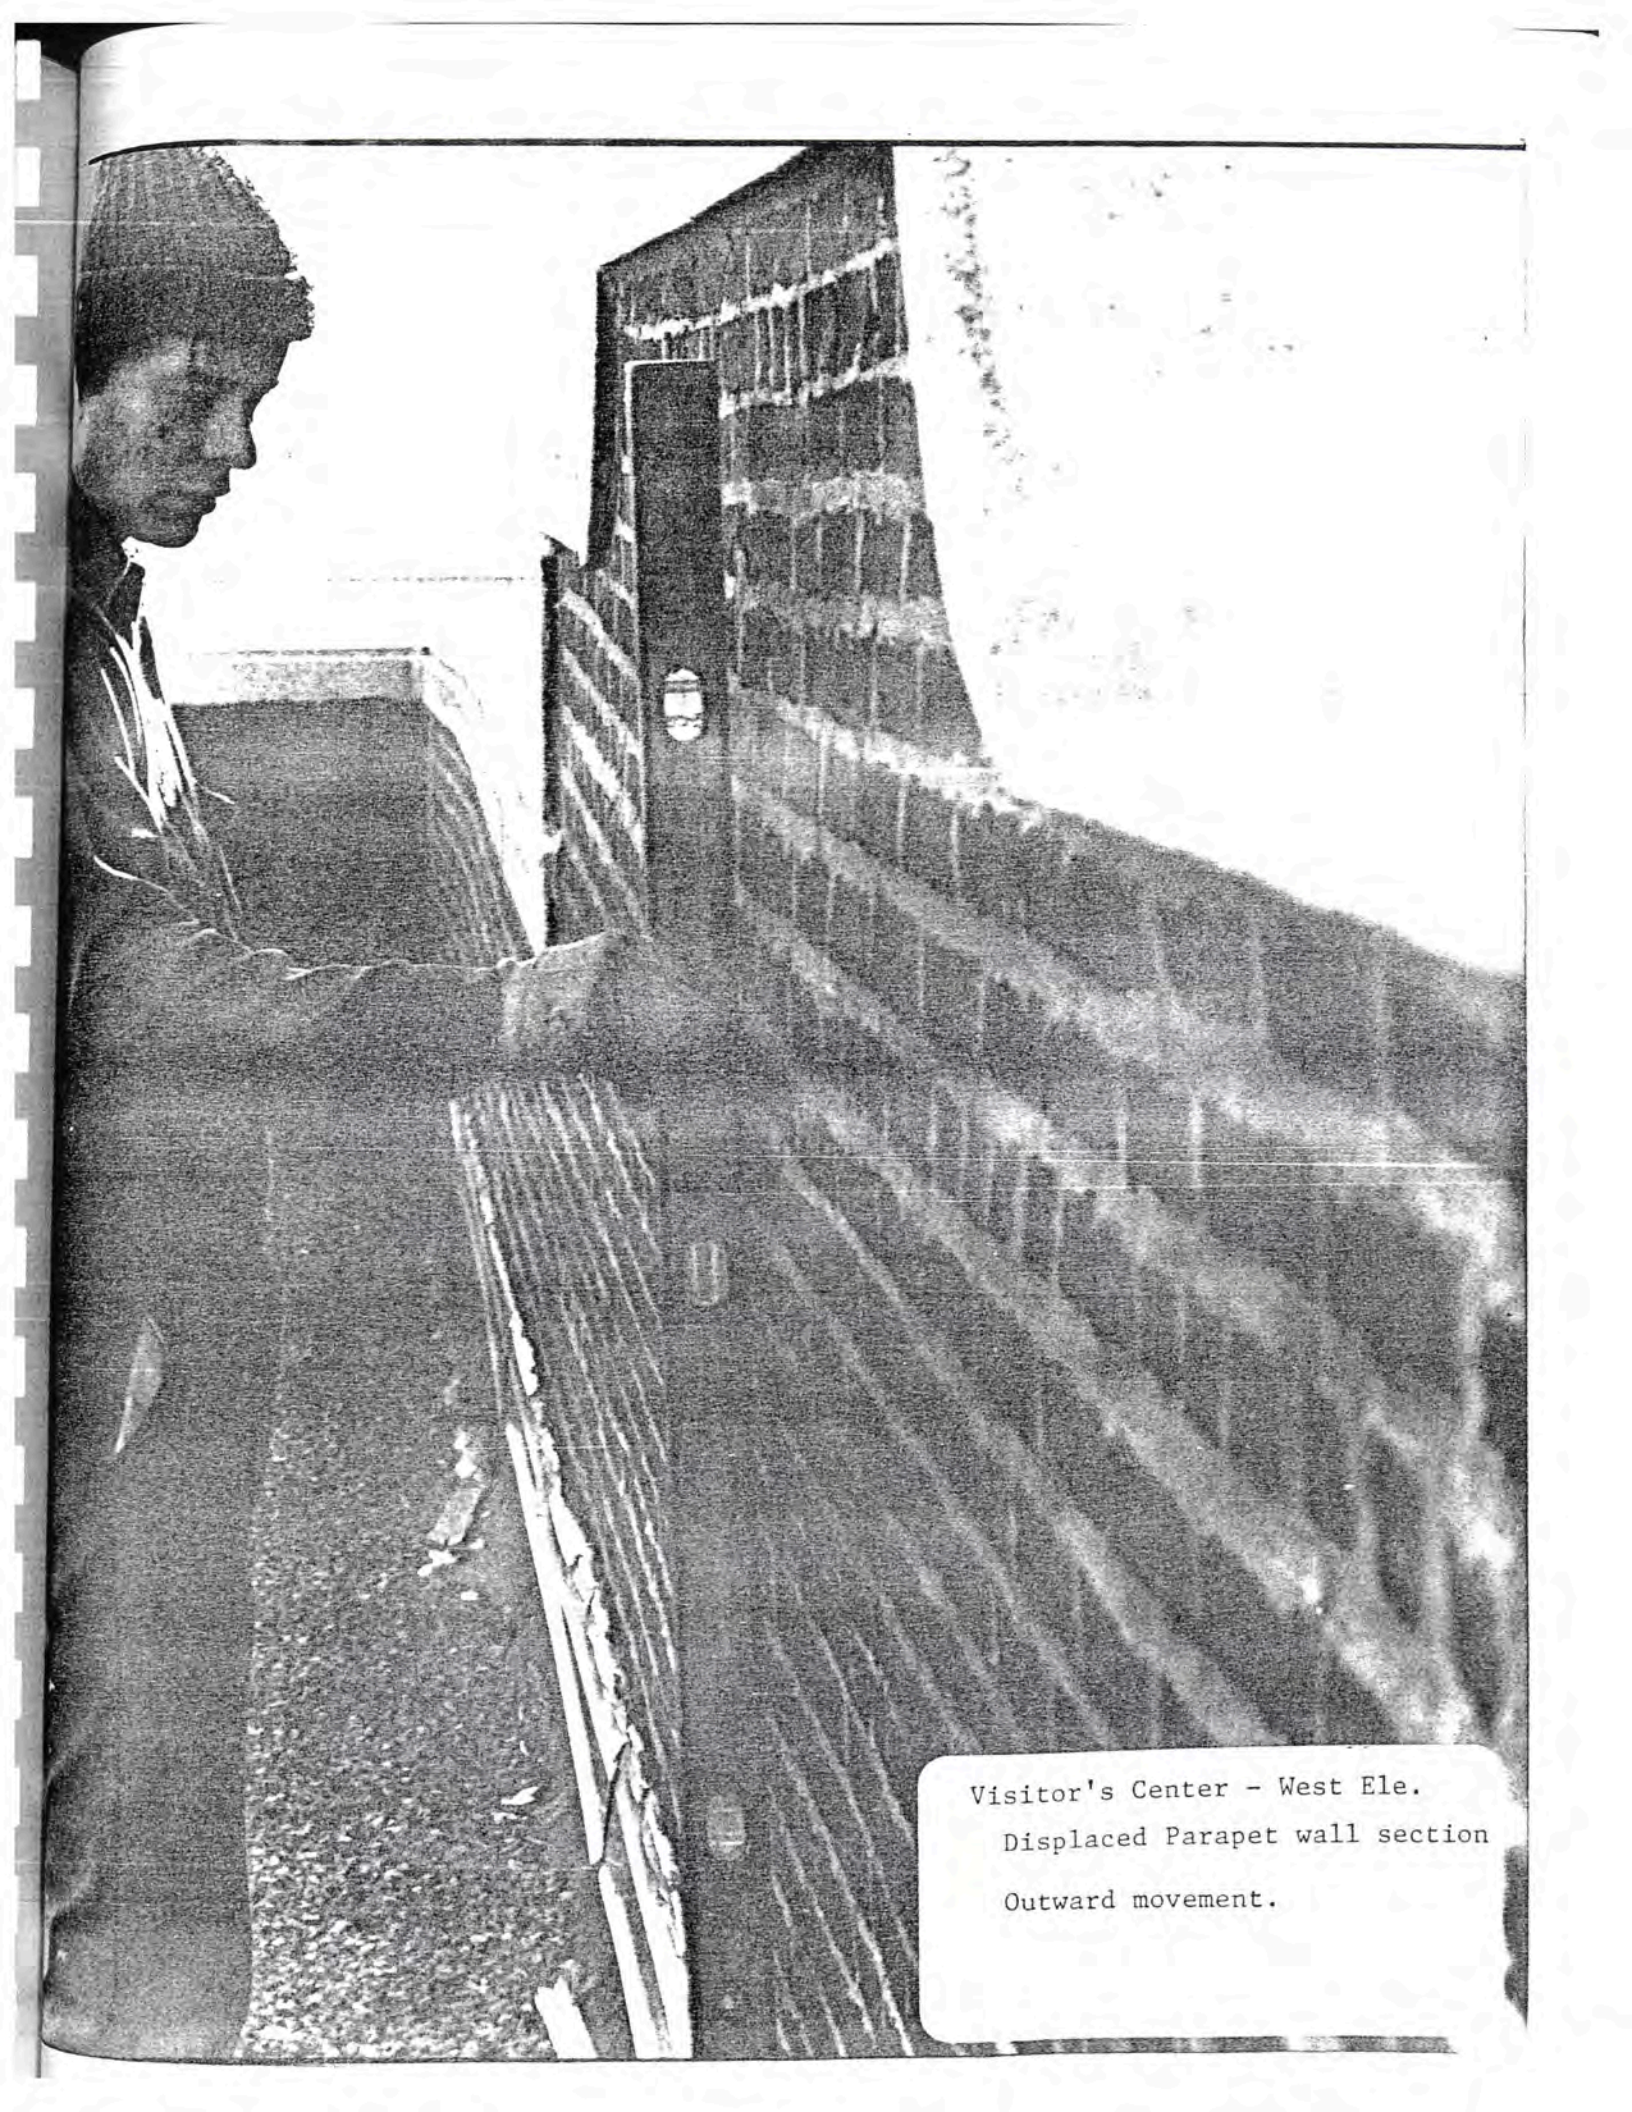
Visitor's Center - West Ele.  
Displaced Parapet wall section  
Outward movement.

For these reasons, we are recommending that the entire parapet wall be dismantled and properly rebuilt with new masonry. This would entail tying the inner two wythes to the roof slab, creating a cavity and then connecting outer wythe to the inner with flexible ladder reinforcing. Vertical control joints should be constructed at each corner of the parapet. The precast "World Medallion" and the coping units which are reusable would be cleaned and reset. Additional units would be cast to match originals and then placed in sequence so that the subtle variations would not be so easily noticed. Proper thru-wall and counter flashing would be installed. It should be noted that the brick and mortar of the parapet is of another color than the remainder of the building so that the juxtaposition of old and new work would not be so evident.

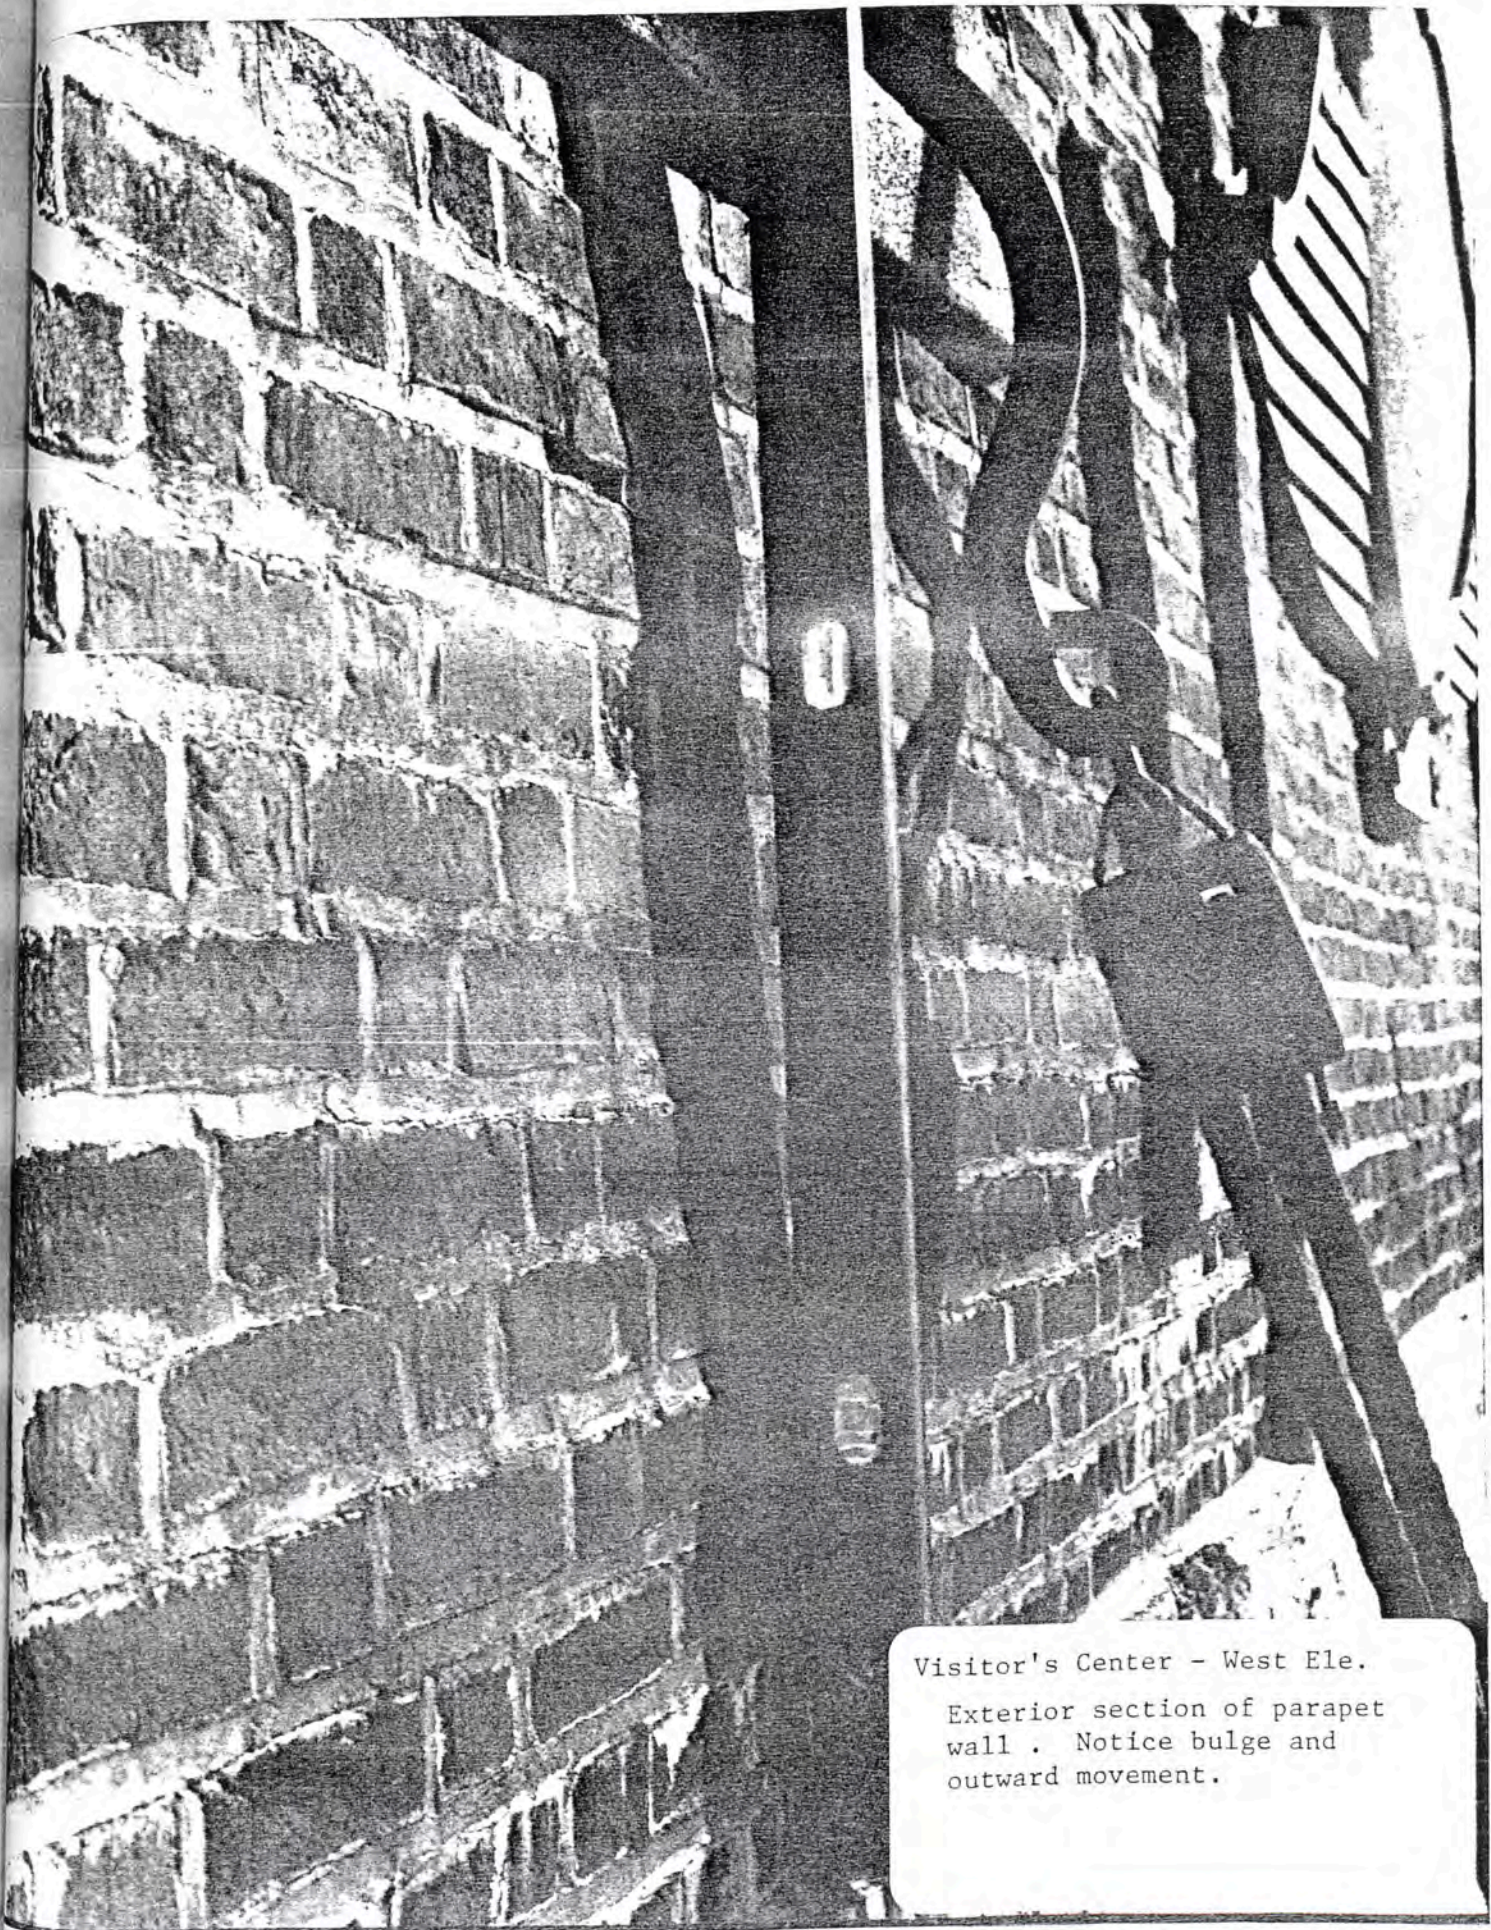
Visitor's Center - West Ele.

Exterior section of parapet wall . Notice bulge and outward movement.
