**FACADE INVESTIGATION  
VISITOR CENTER  
FLOYD BENNETT FIELD**

**TONETTI ASSOCIATES**

January 30, 1984

The following is our report on the conditions of the exterior shell of the William Ryan Visitor's Building at Floyd Bennett Field, Gateway National Recreation Area. We trust that this report will serve as a documentation of the conditions at present and as a tool for evaluating future repairs and restoration.

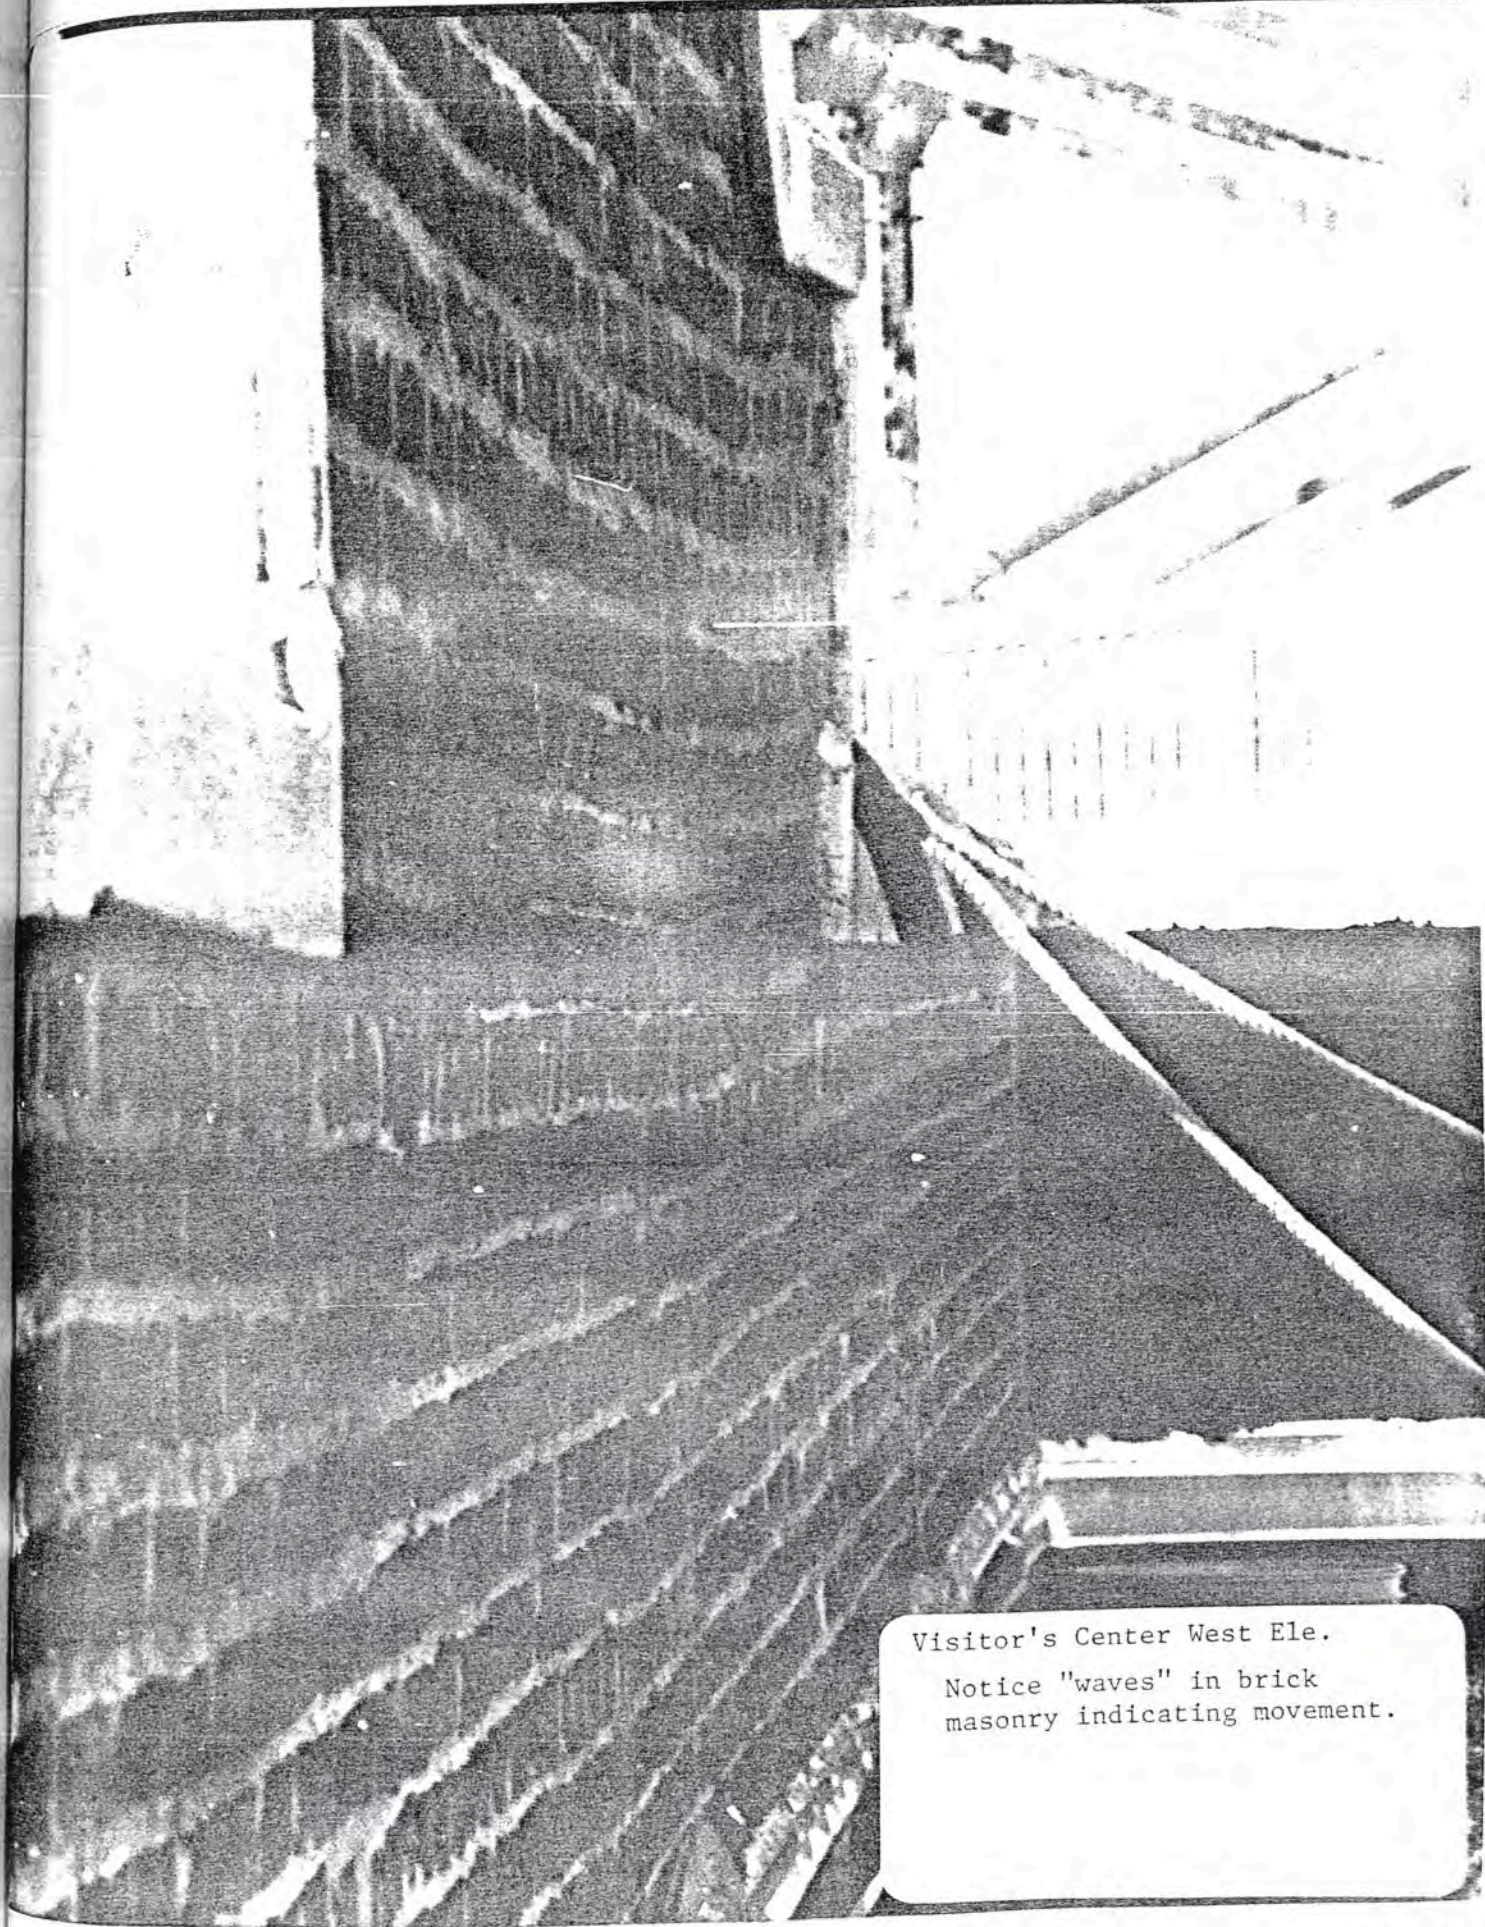
Visitor's Center West Ele.

Notice "waves" in brick  
masonry indicating movement.

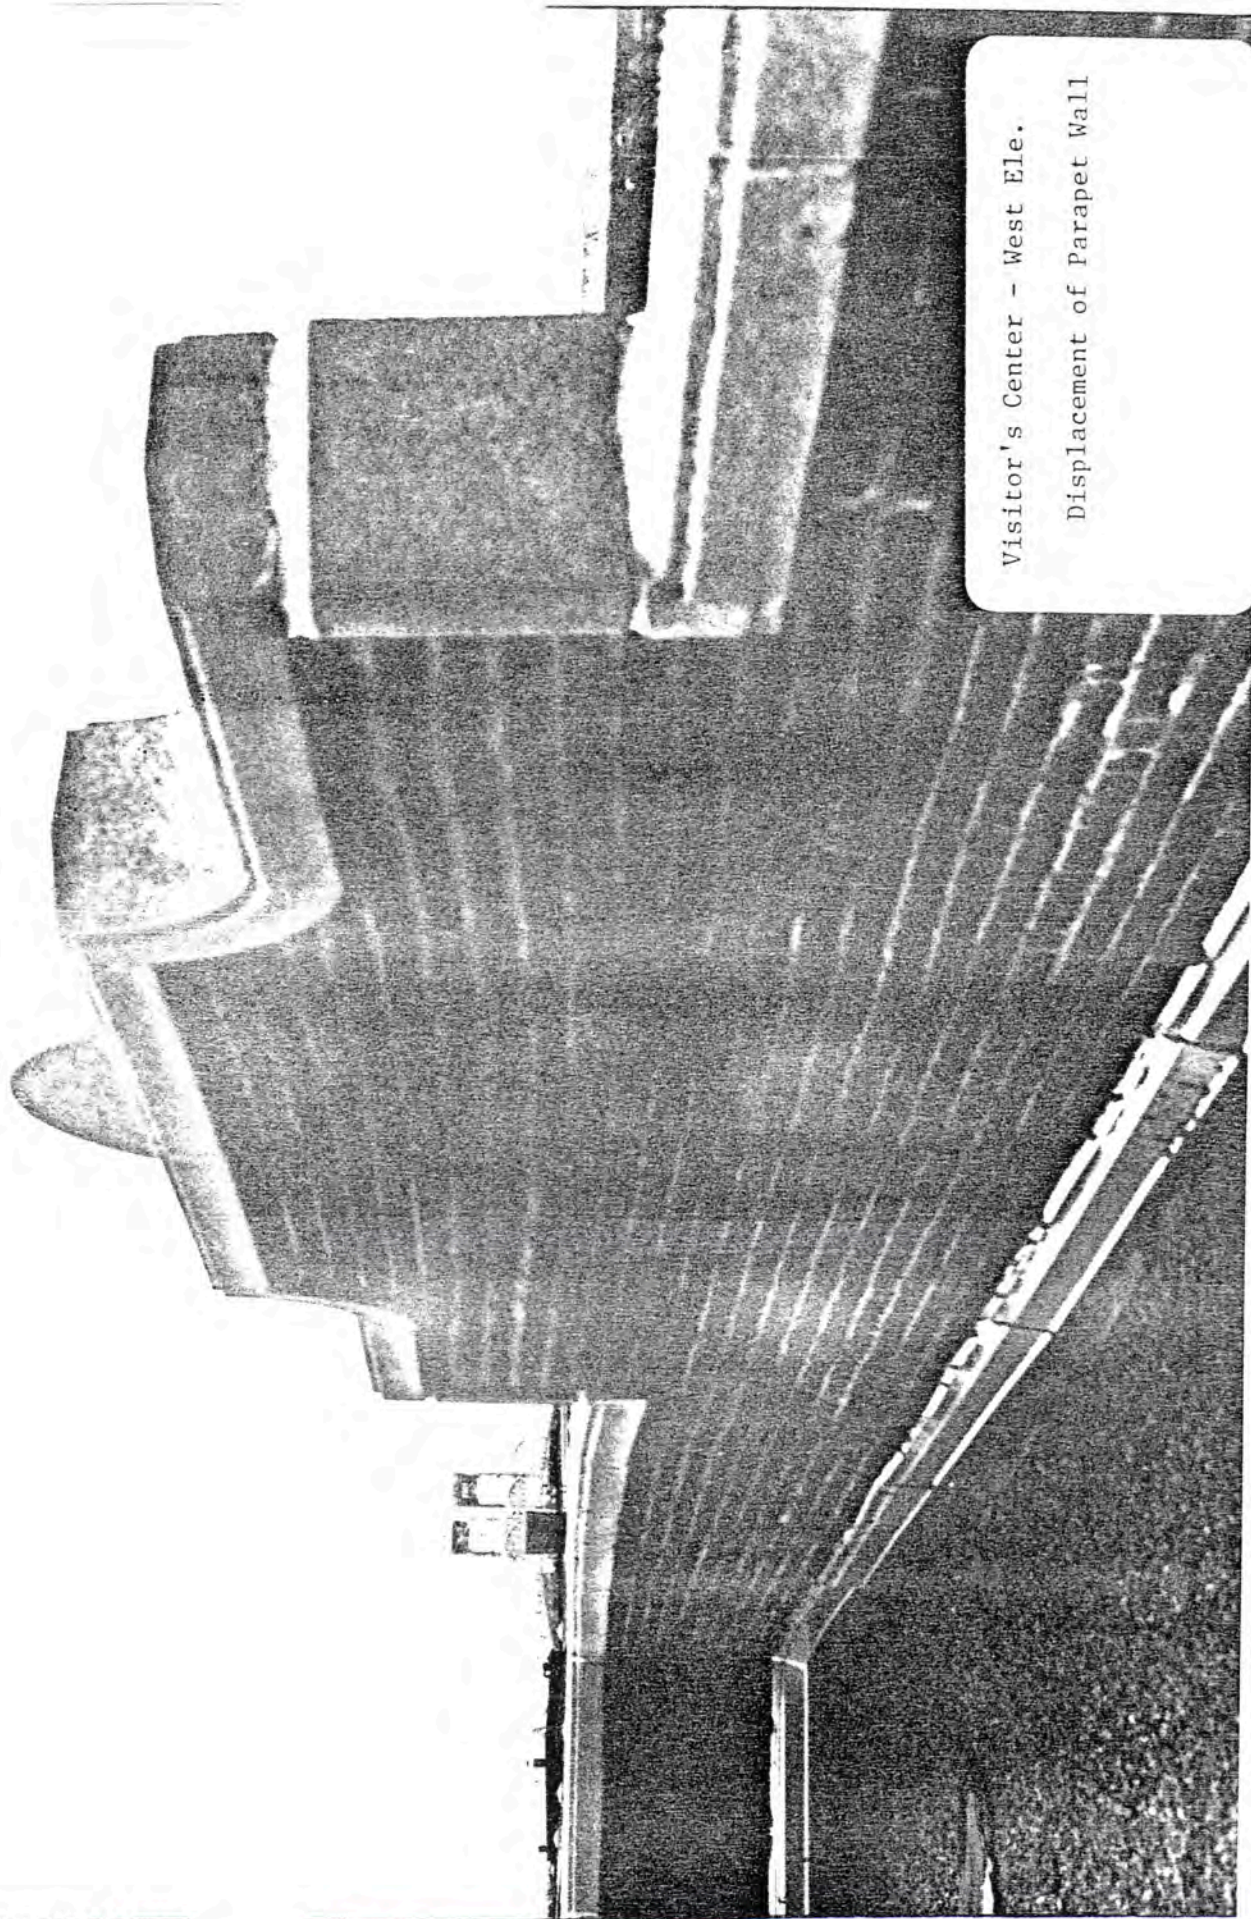
Visitor's Center - West Ele.

Displacement of Parapet Wall

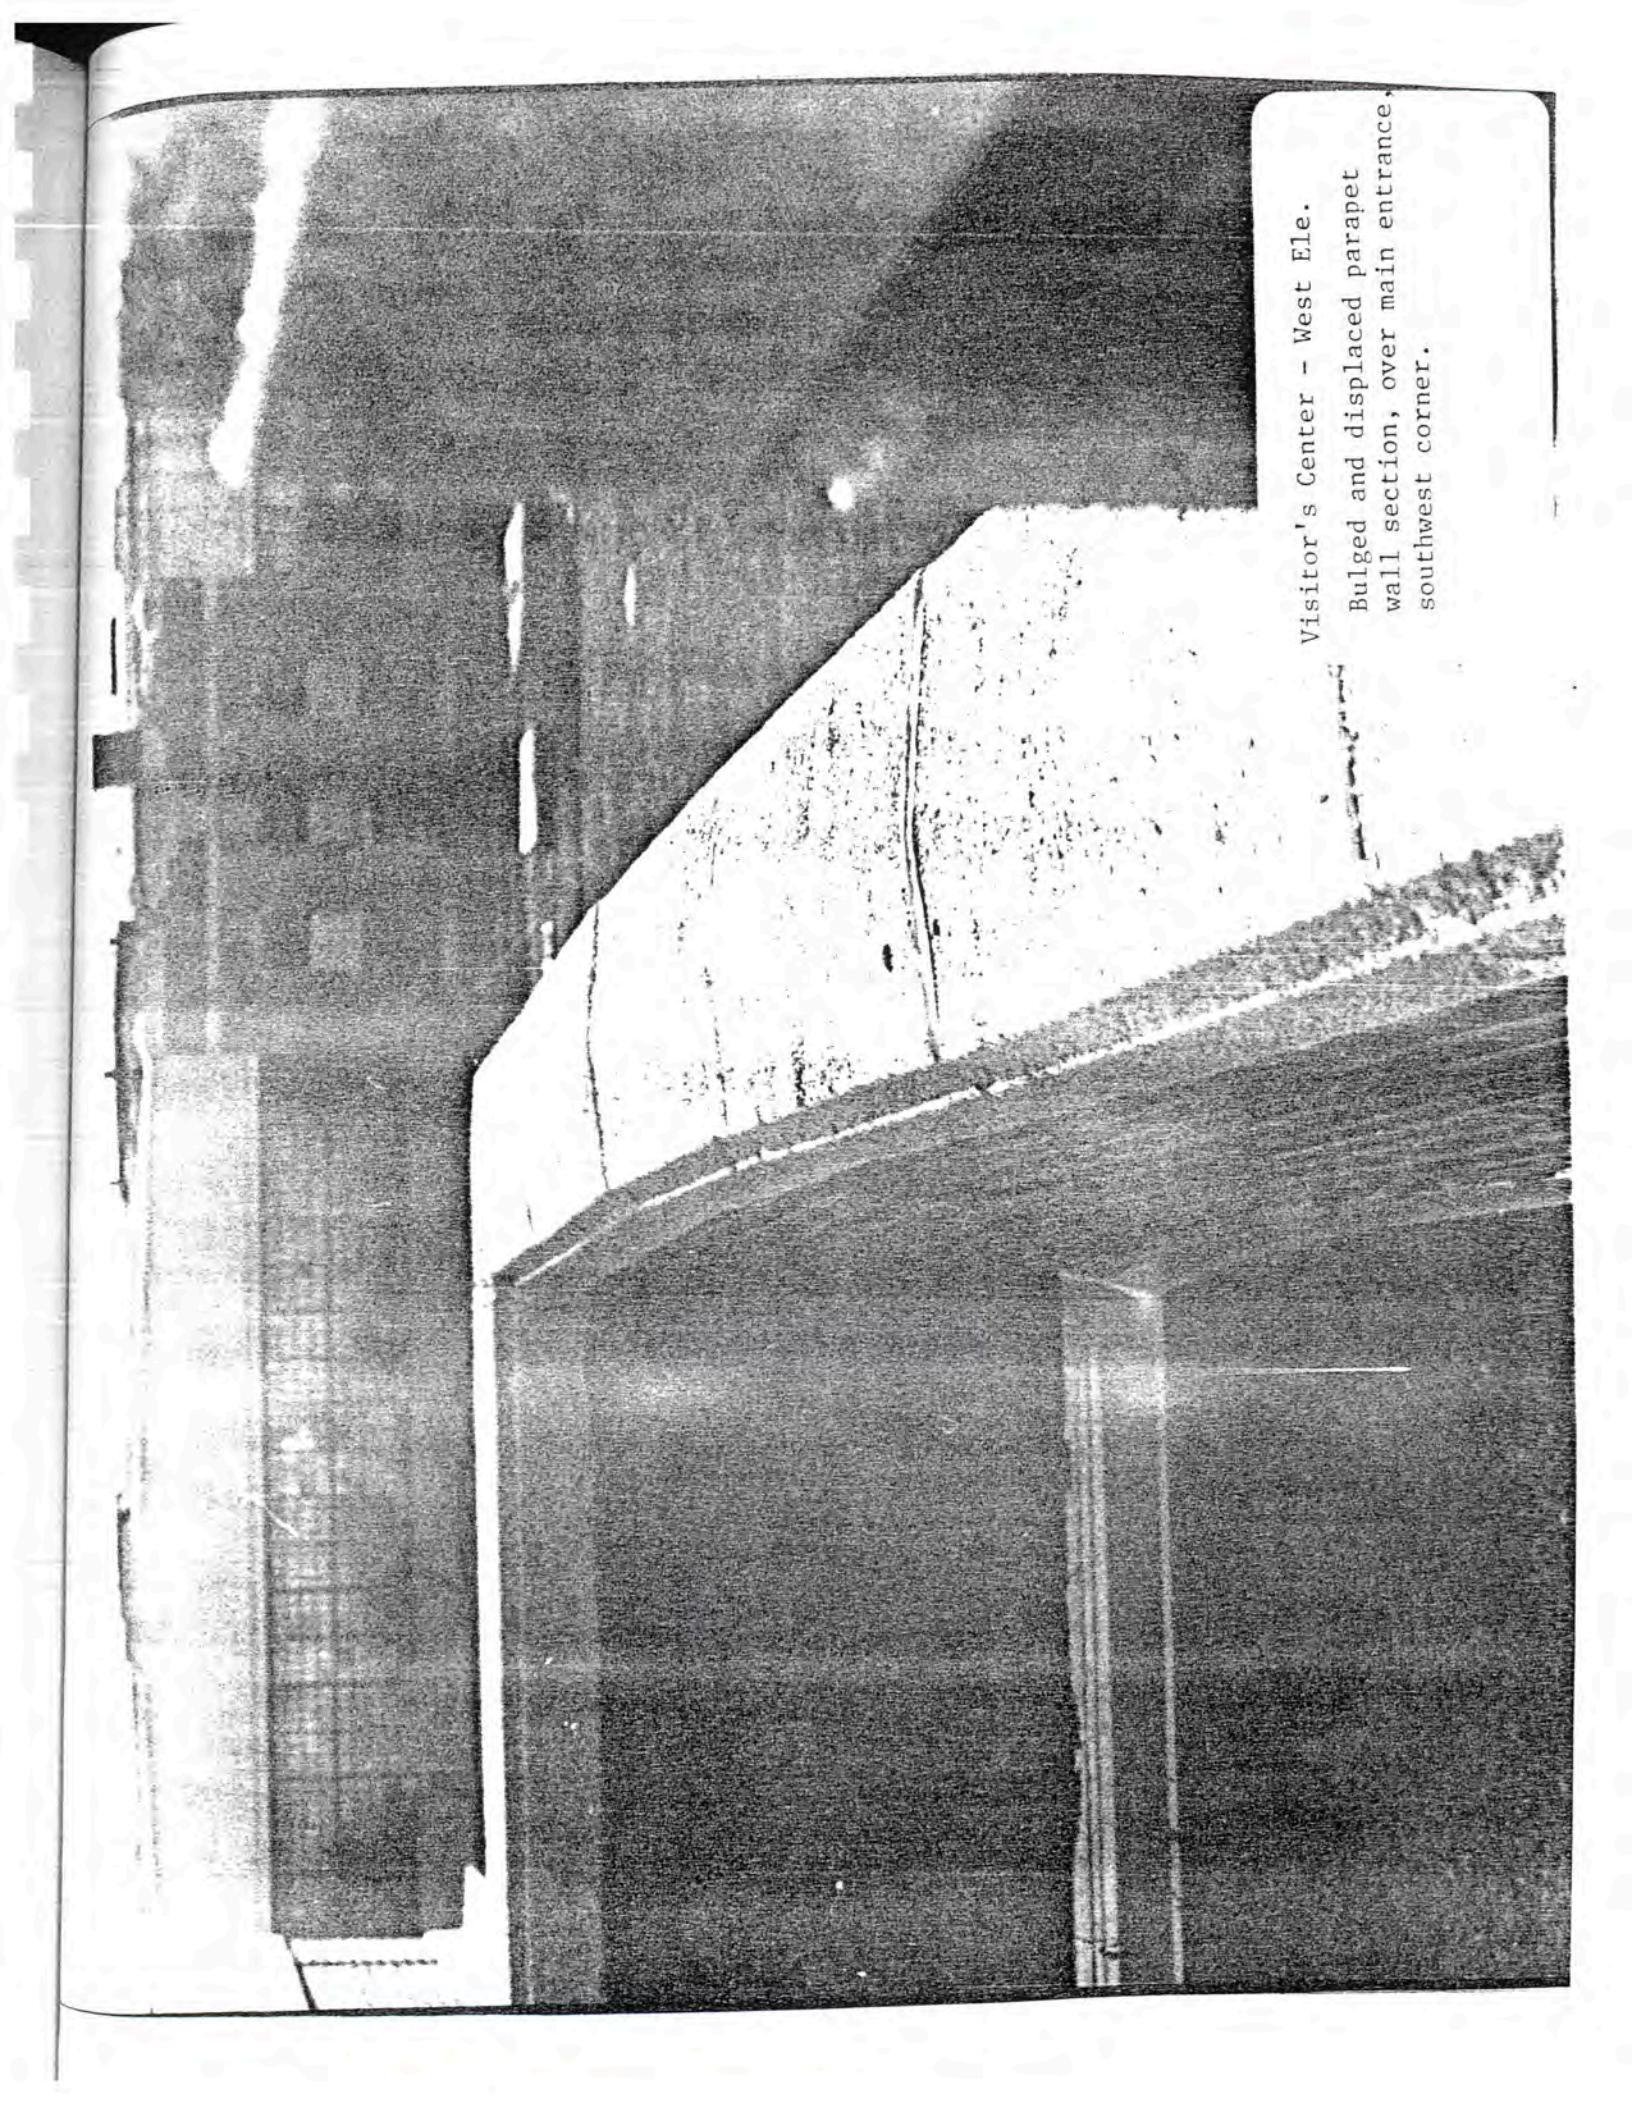
The parapet wall is seriously deformed, coping stones are visably displaced and elements of the cast stone entablature are spalled and chipped. Some elements have recently fallen. This section which is approximately sixty feet long plus the two return sections of five feet are seriously weak.

Visitor's Center - West Ele.  
Bulged and displaced parapet  
wall section, over main entrance,  
southwest corner.

A sidewalk bridge spanning the main entrance and stairs should be erected to protect individuals. Then working from pipe staging the parapet should be taken down and rebuilt as described in paragraph 2.1 of the Work Required section. The construction estimate is \$69,000. for rebuilding, plus \$8,000. for sidewalk bridge and \$2,800. for pipe staging.

If the funds are not immediately available for the full repair, as a temporary measure the sidewalk bridge should be erected and the parapet and loose section of the entablature removed. The exposed brickwork should then be temporarily flashed to prevent further water damage.

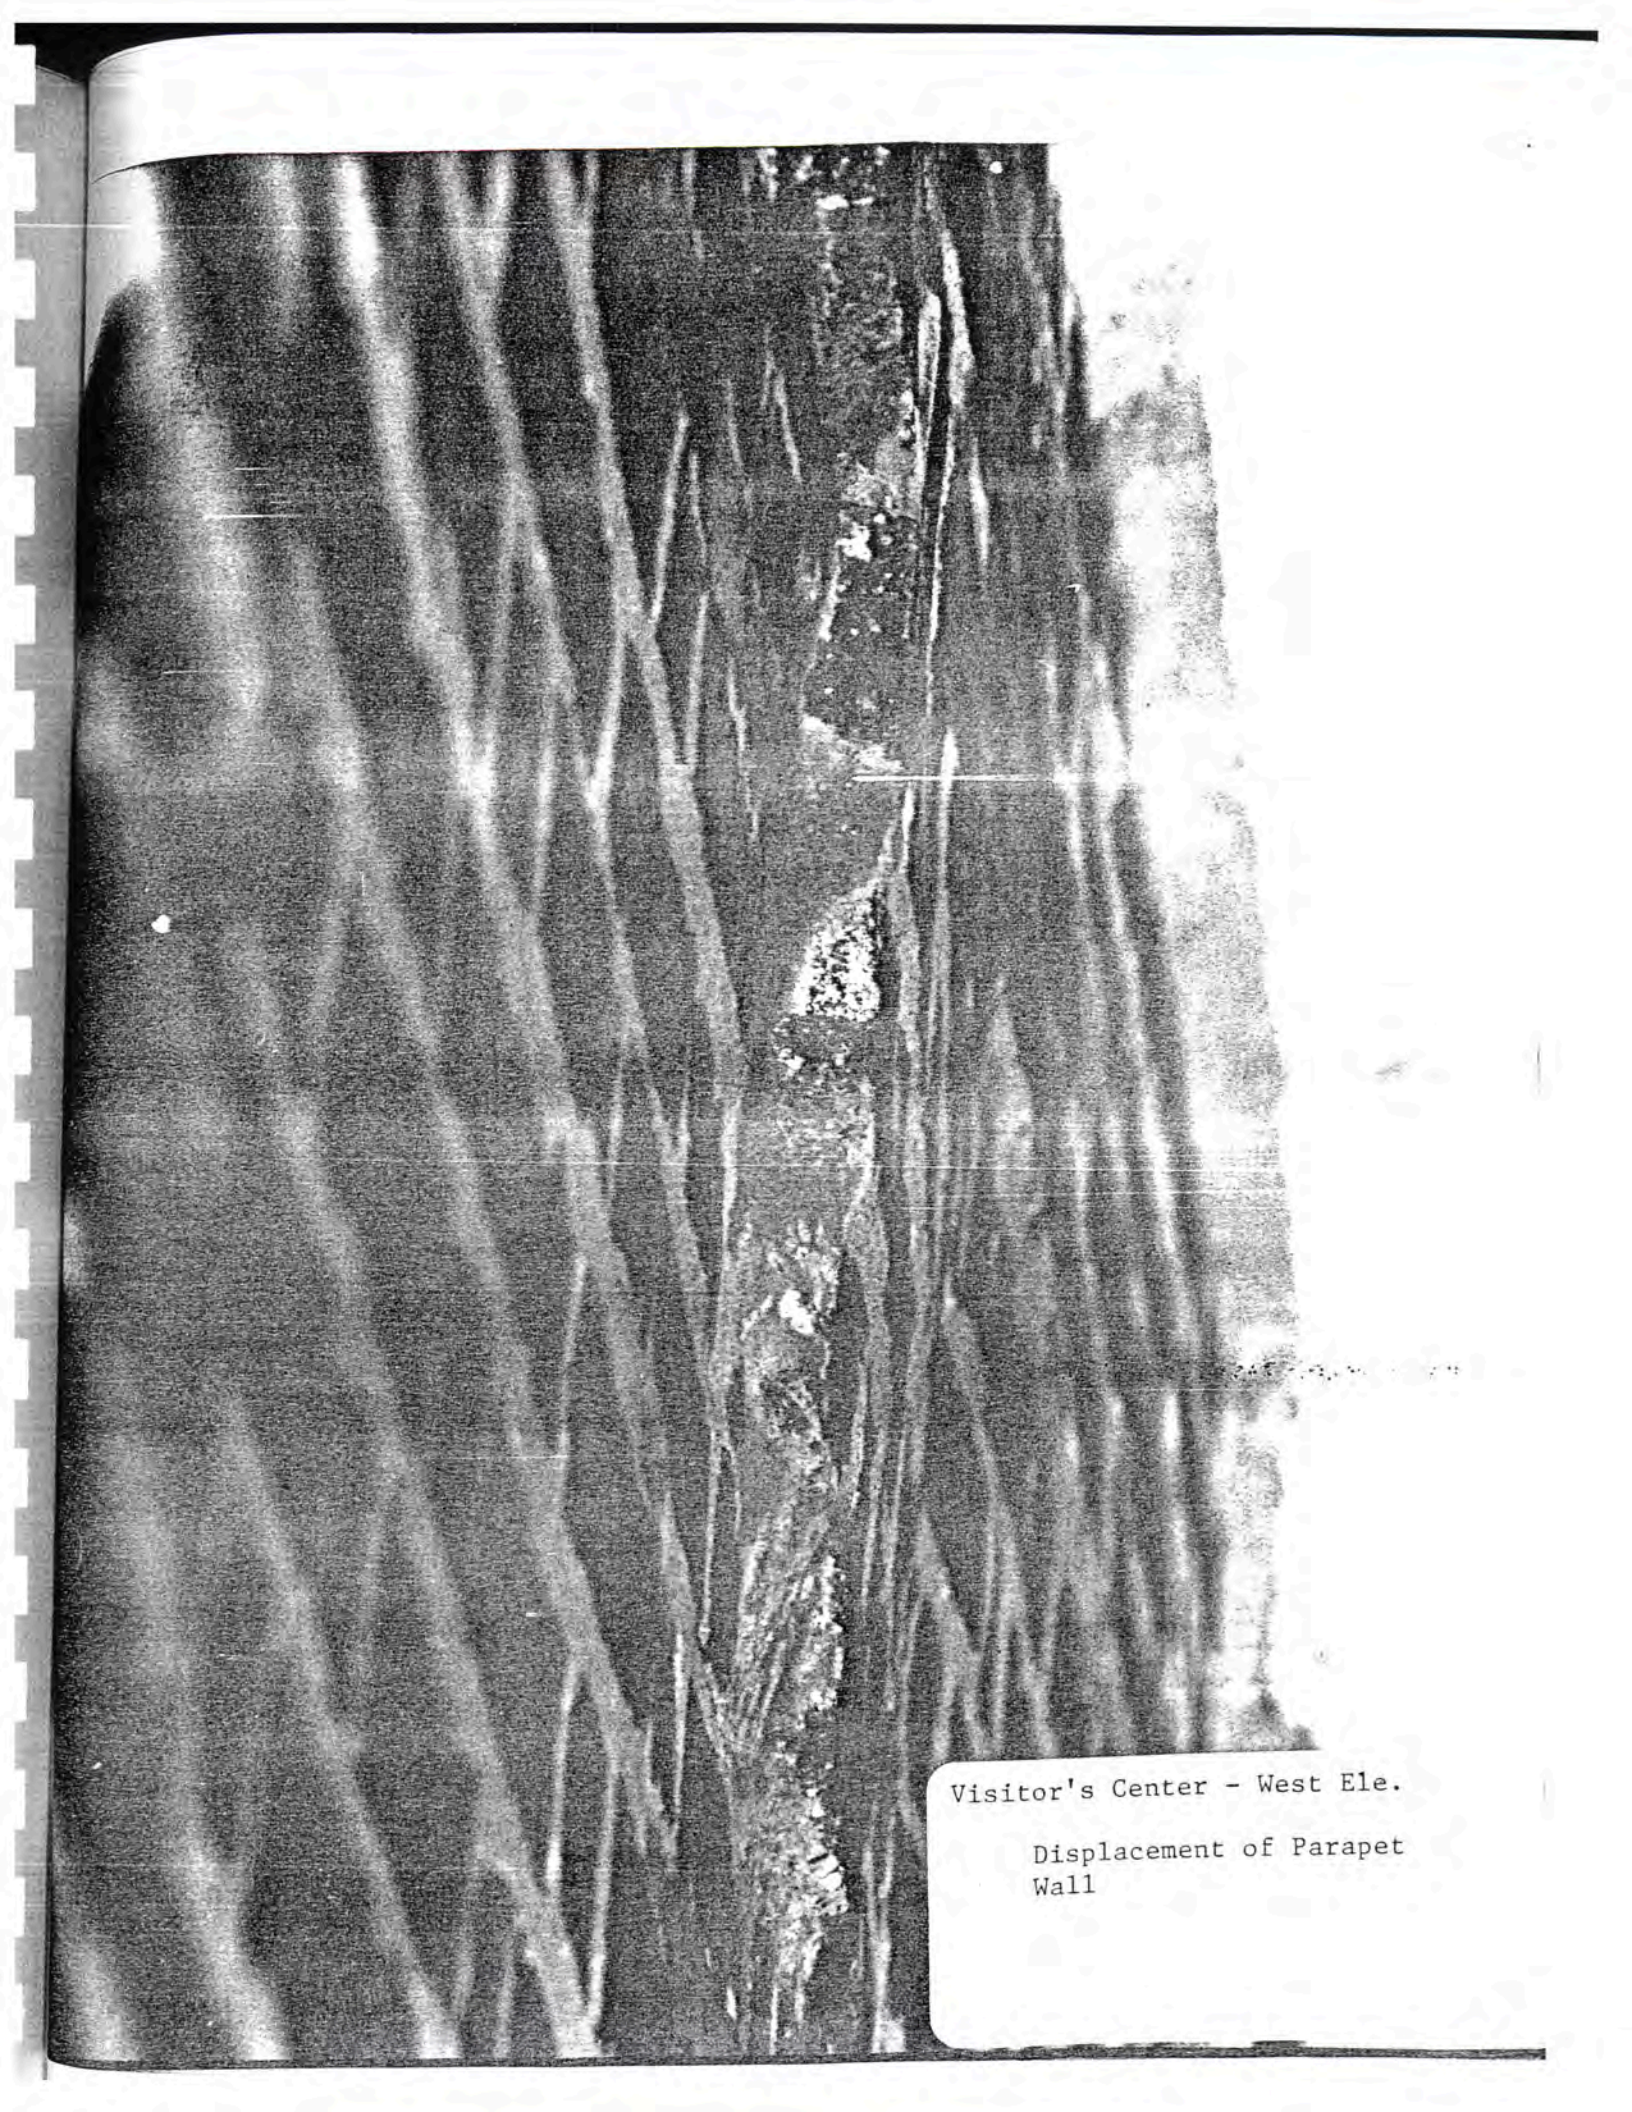
Visitor's Center - West Ele.

Displacement of Parapet  
Wall

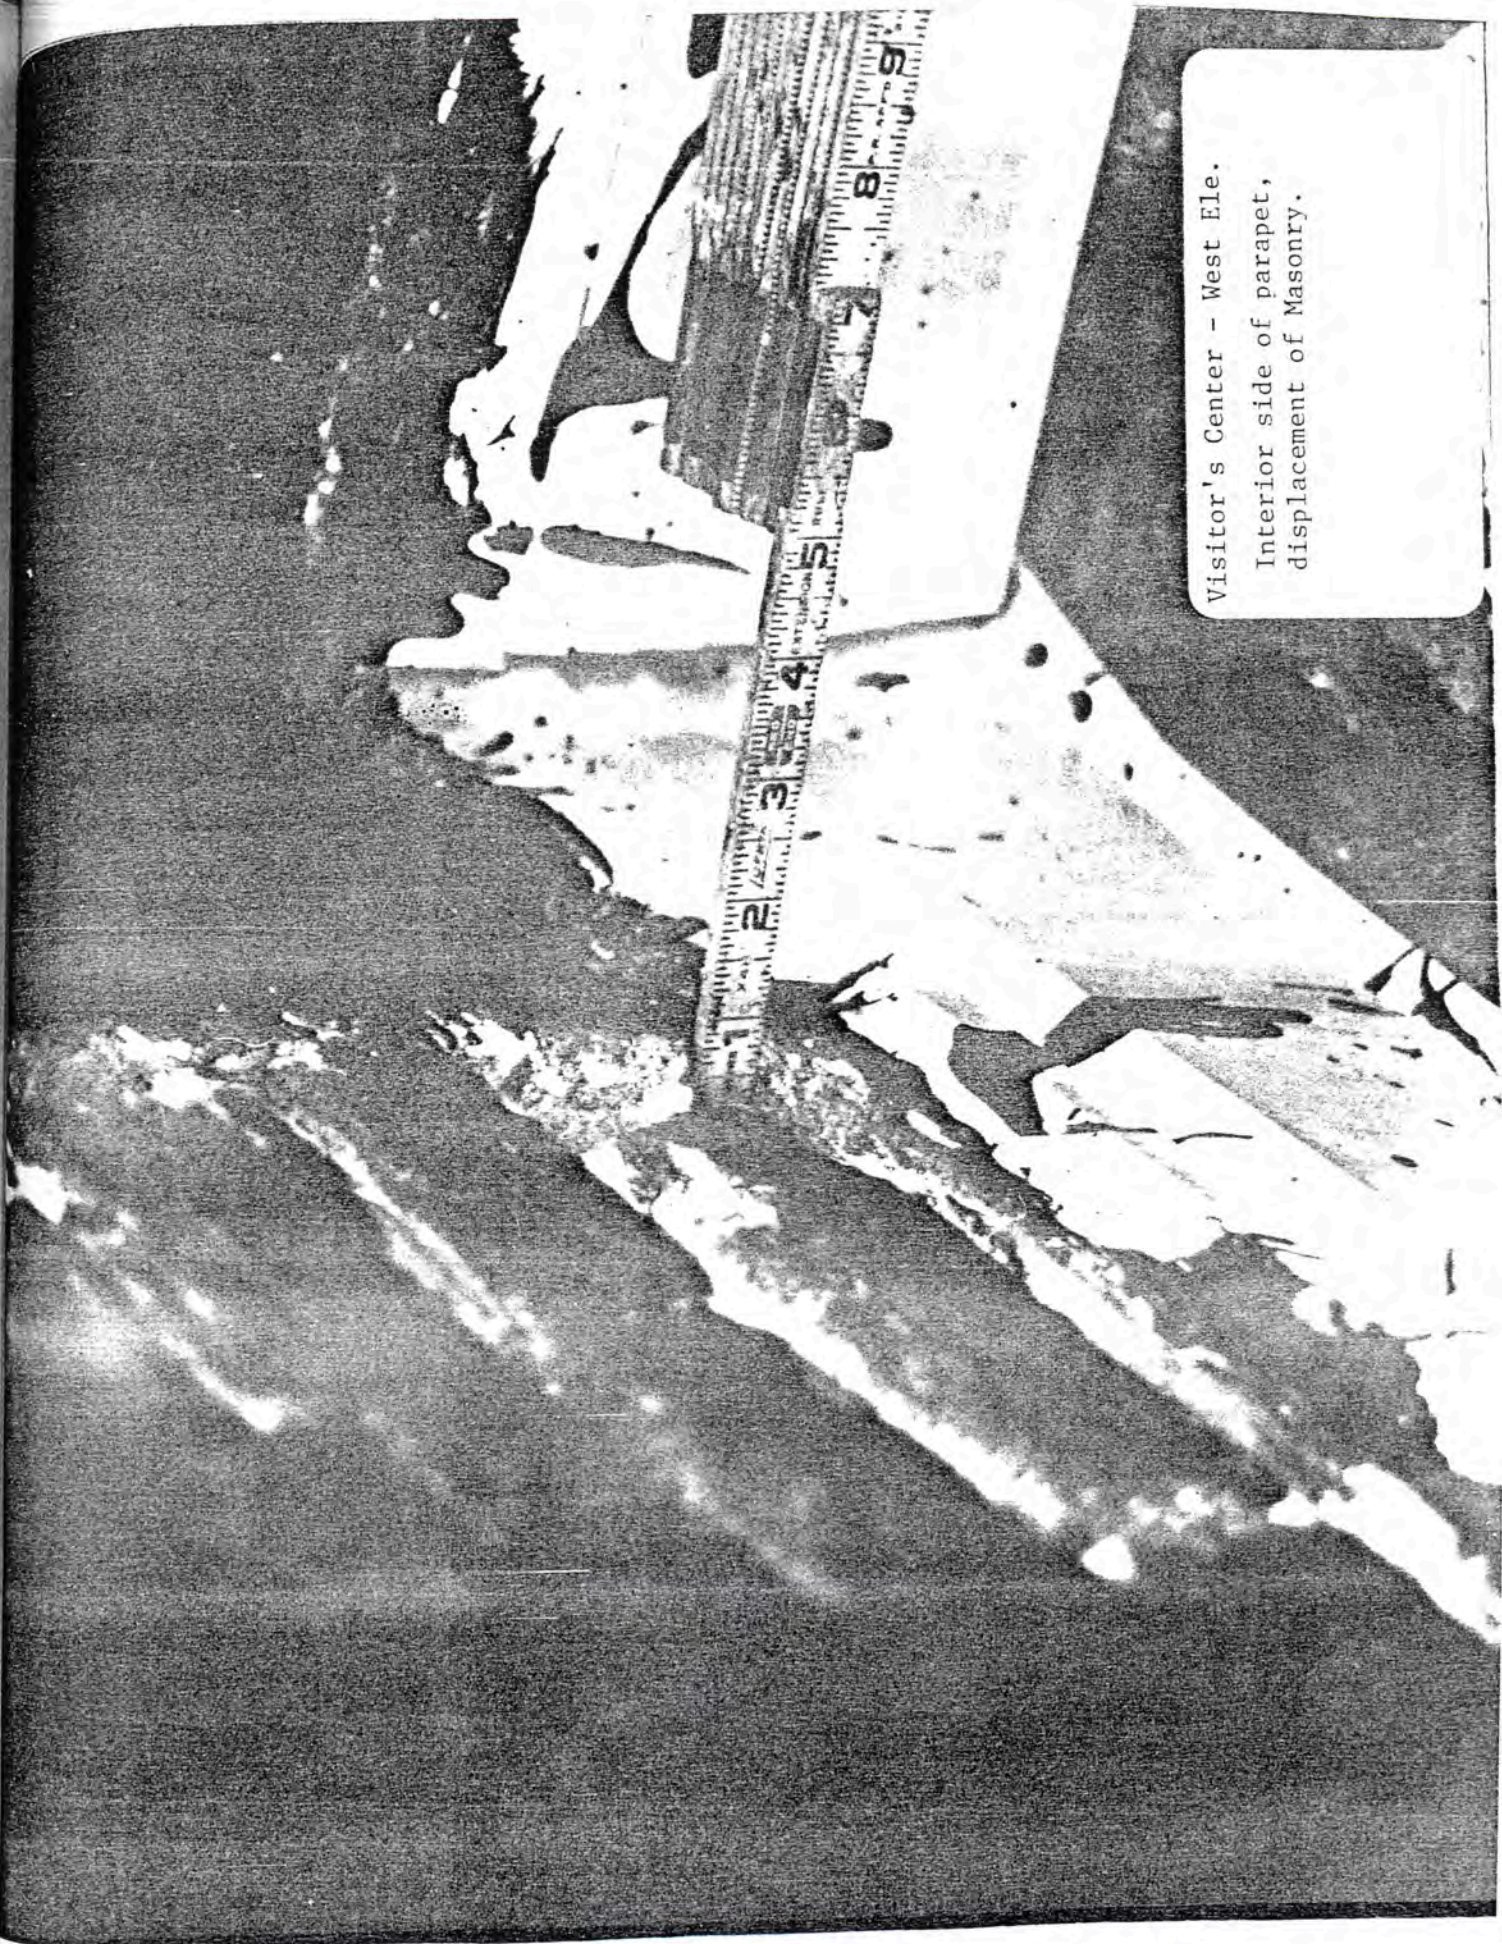
Visitor's Center - West Ele.  
Interior side of parapet,  
displacement of Masonry.

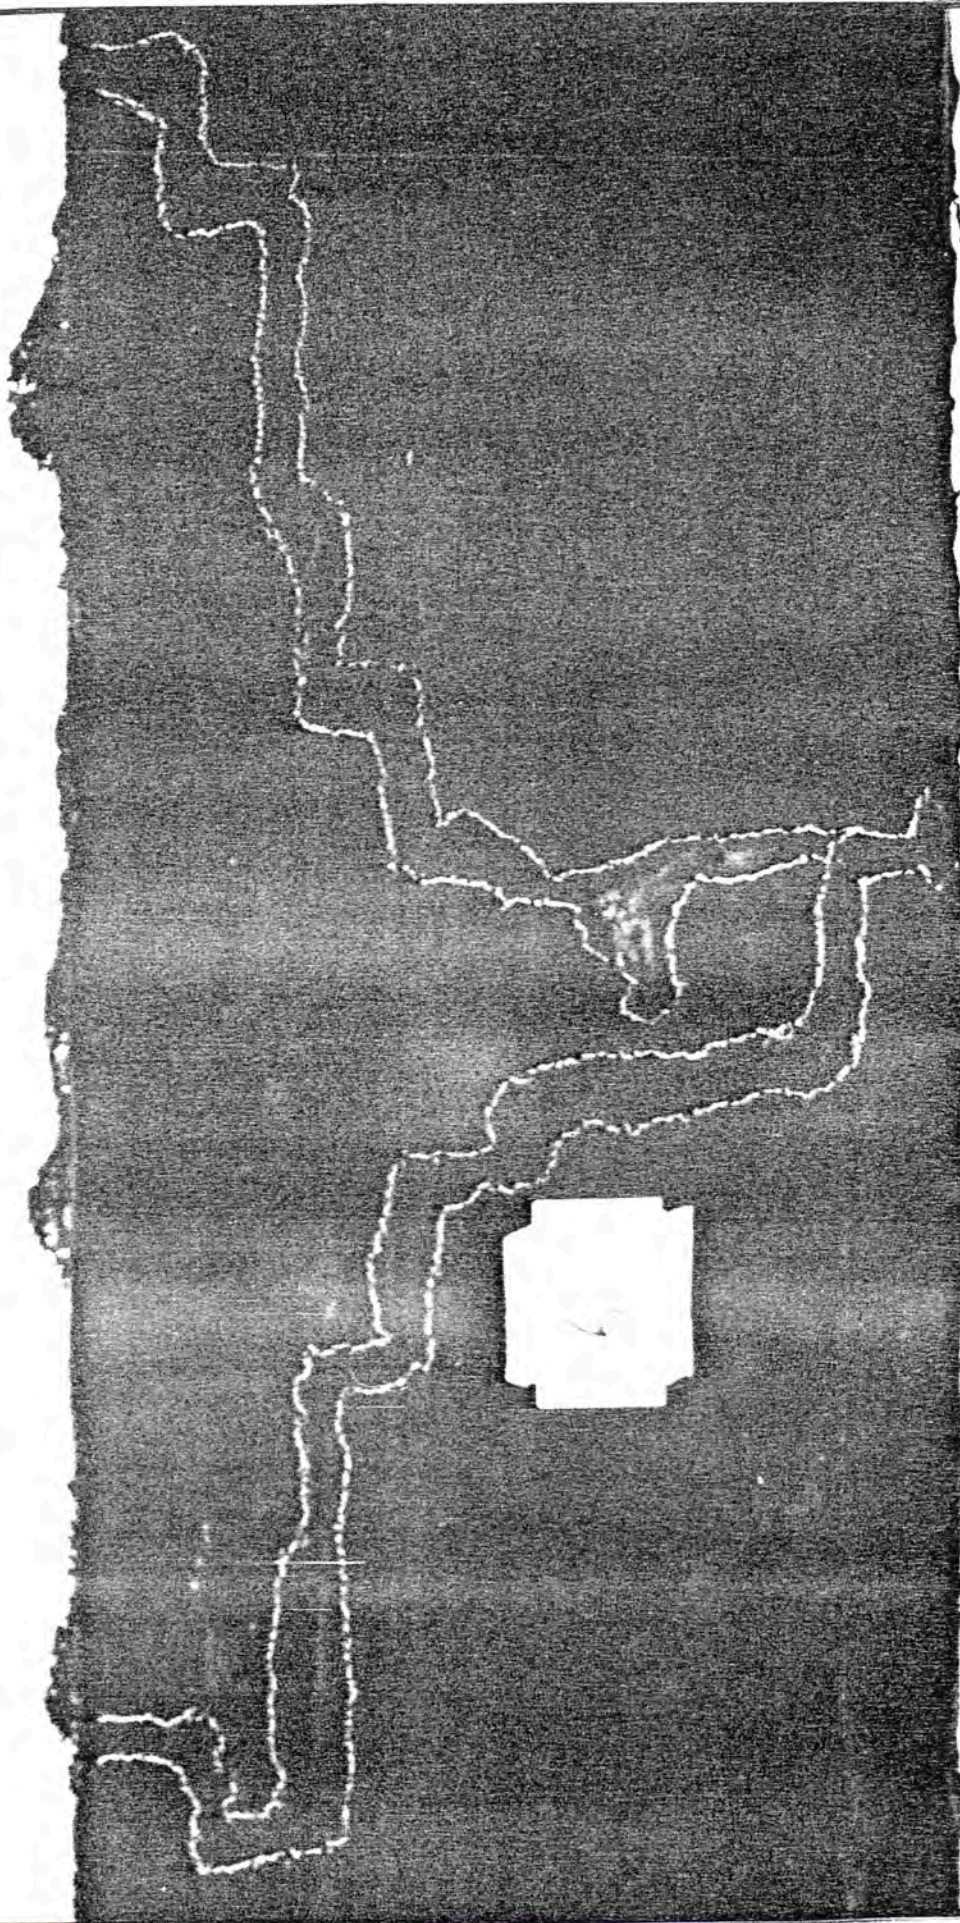
Visitor's Center - West Ele.  
Interior side of Parapet.  
Extensive step cracking is  
visible.

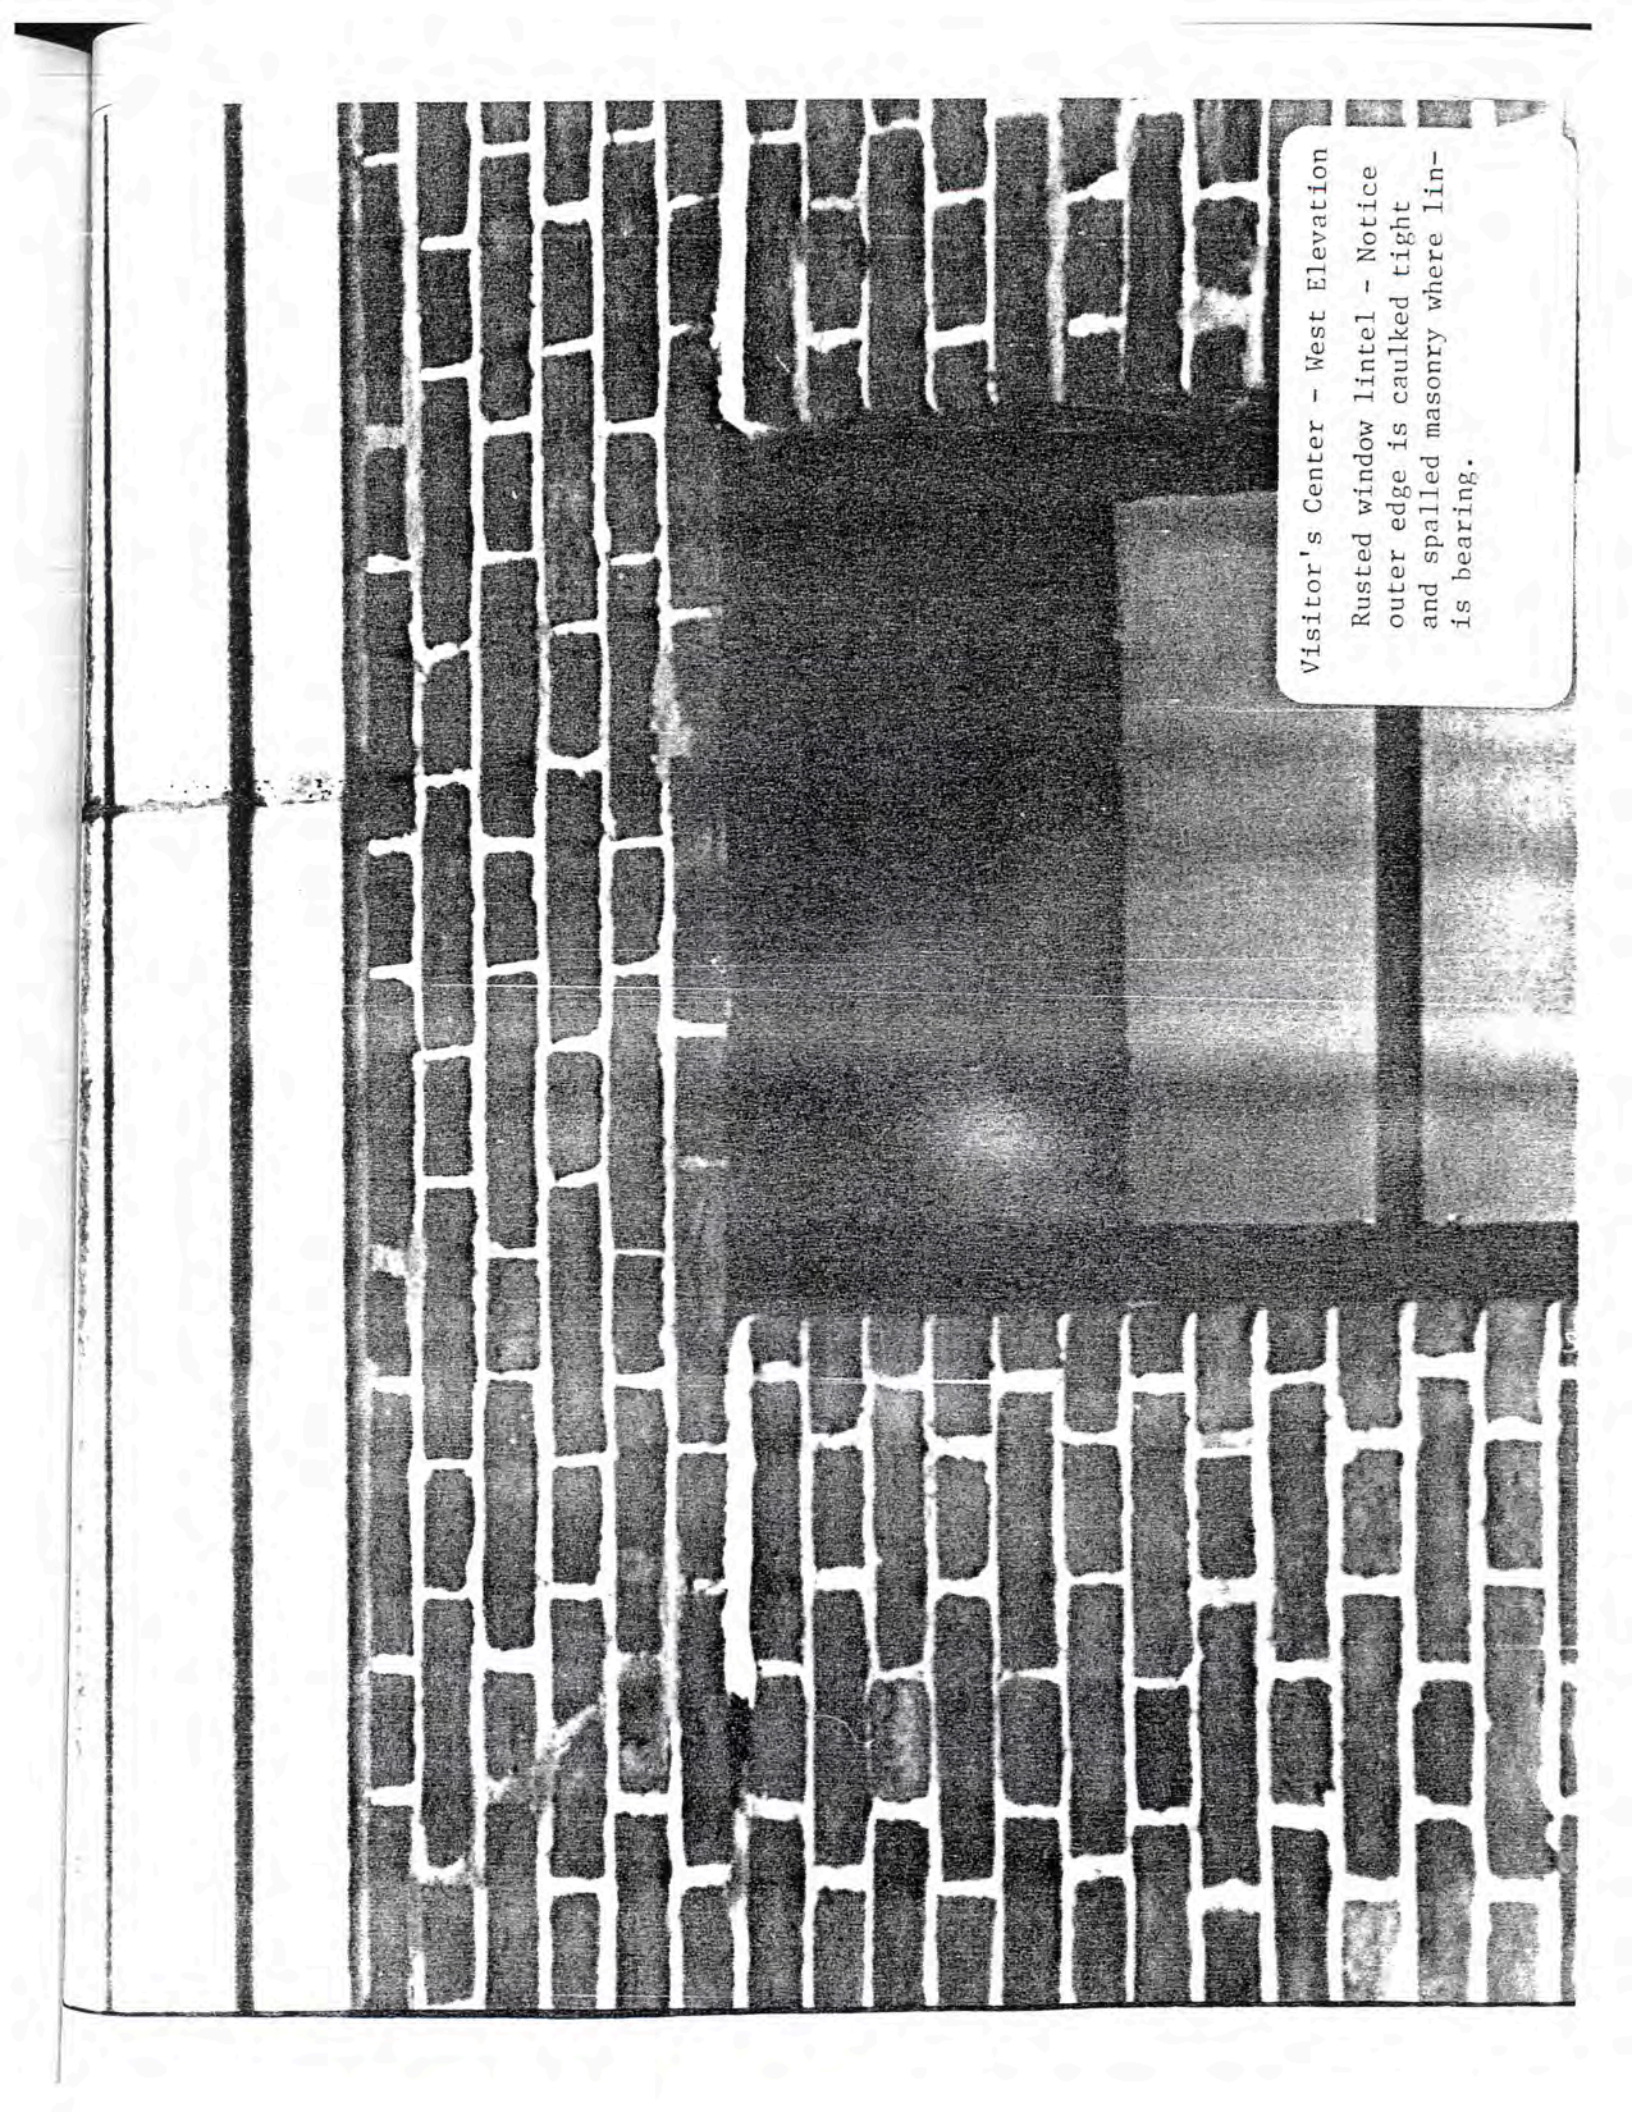
Visitor's Center - West Elevation

Rusted window lintel - Notice  
outer edge is caulked tight  
and spalled masonry where lin-  
tel is bearing.

Severely deteriorated lintels should be replaced with new galvanized steel angles. This will require removal of surrounding brick, which must be reused or matched in kind. Lightly rusted lintels (all lintels not noted as severely deteriorated) should be scraped to bare metal, primed and painted with appropriate rust inhibitive paint. All joints between the pair of angles which have been caulked should be raked clean and left open, as well as the joint on the outer edge of the lintel.

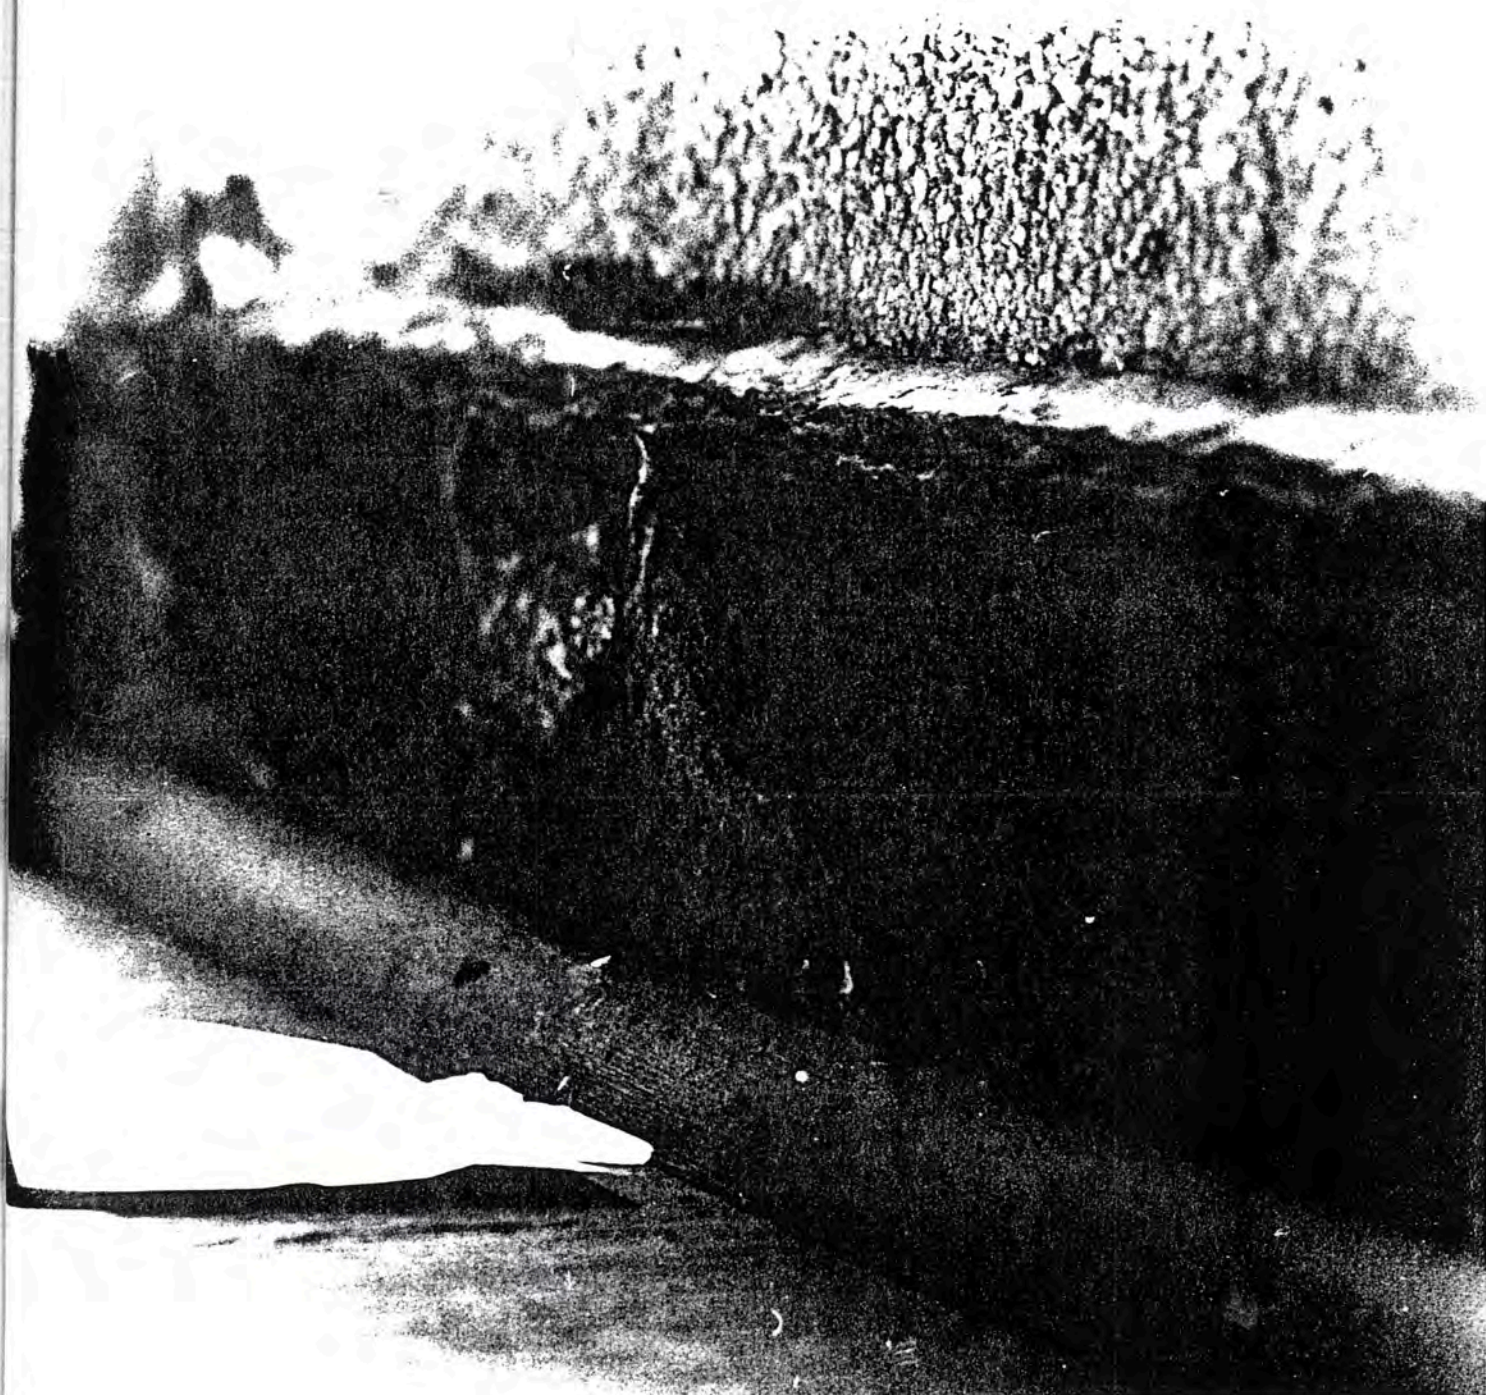
Visitor's Center - East Ele.

Rust Buildup on Steel Lintel.  
This condition is typical  
throughout the building.
