**FACADE INVESTIGATION  
VISITOR CENTER  
FLOYD BENNETT FIELD**

**TONETTI ASSOCIATES**

January 30, 1984

The following is our report on the conditions of the exterior shell of the William Ryan Visitor's Building at Floyd Bennett Field, Gateway National Recreation Area. We trust that this report will serve as a documentation of the conditions at present and as a tool for evaluating future repairs and restoration.

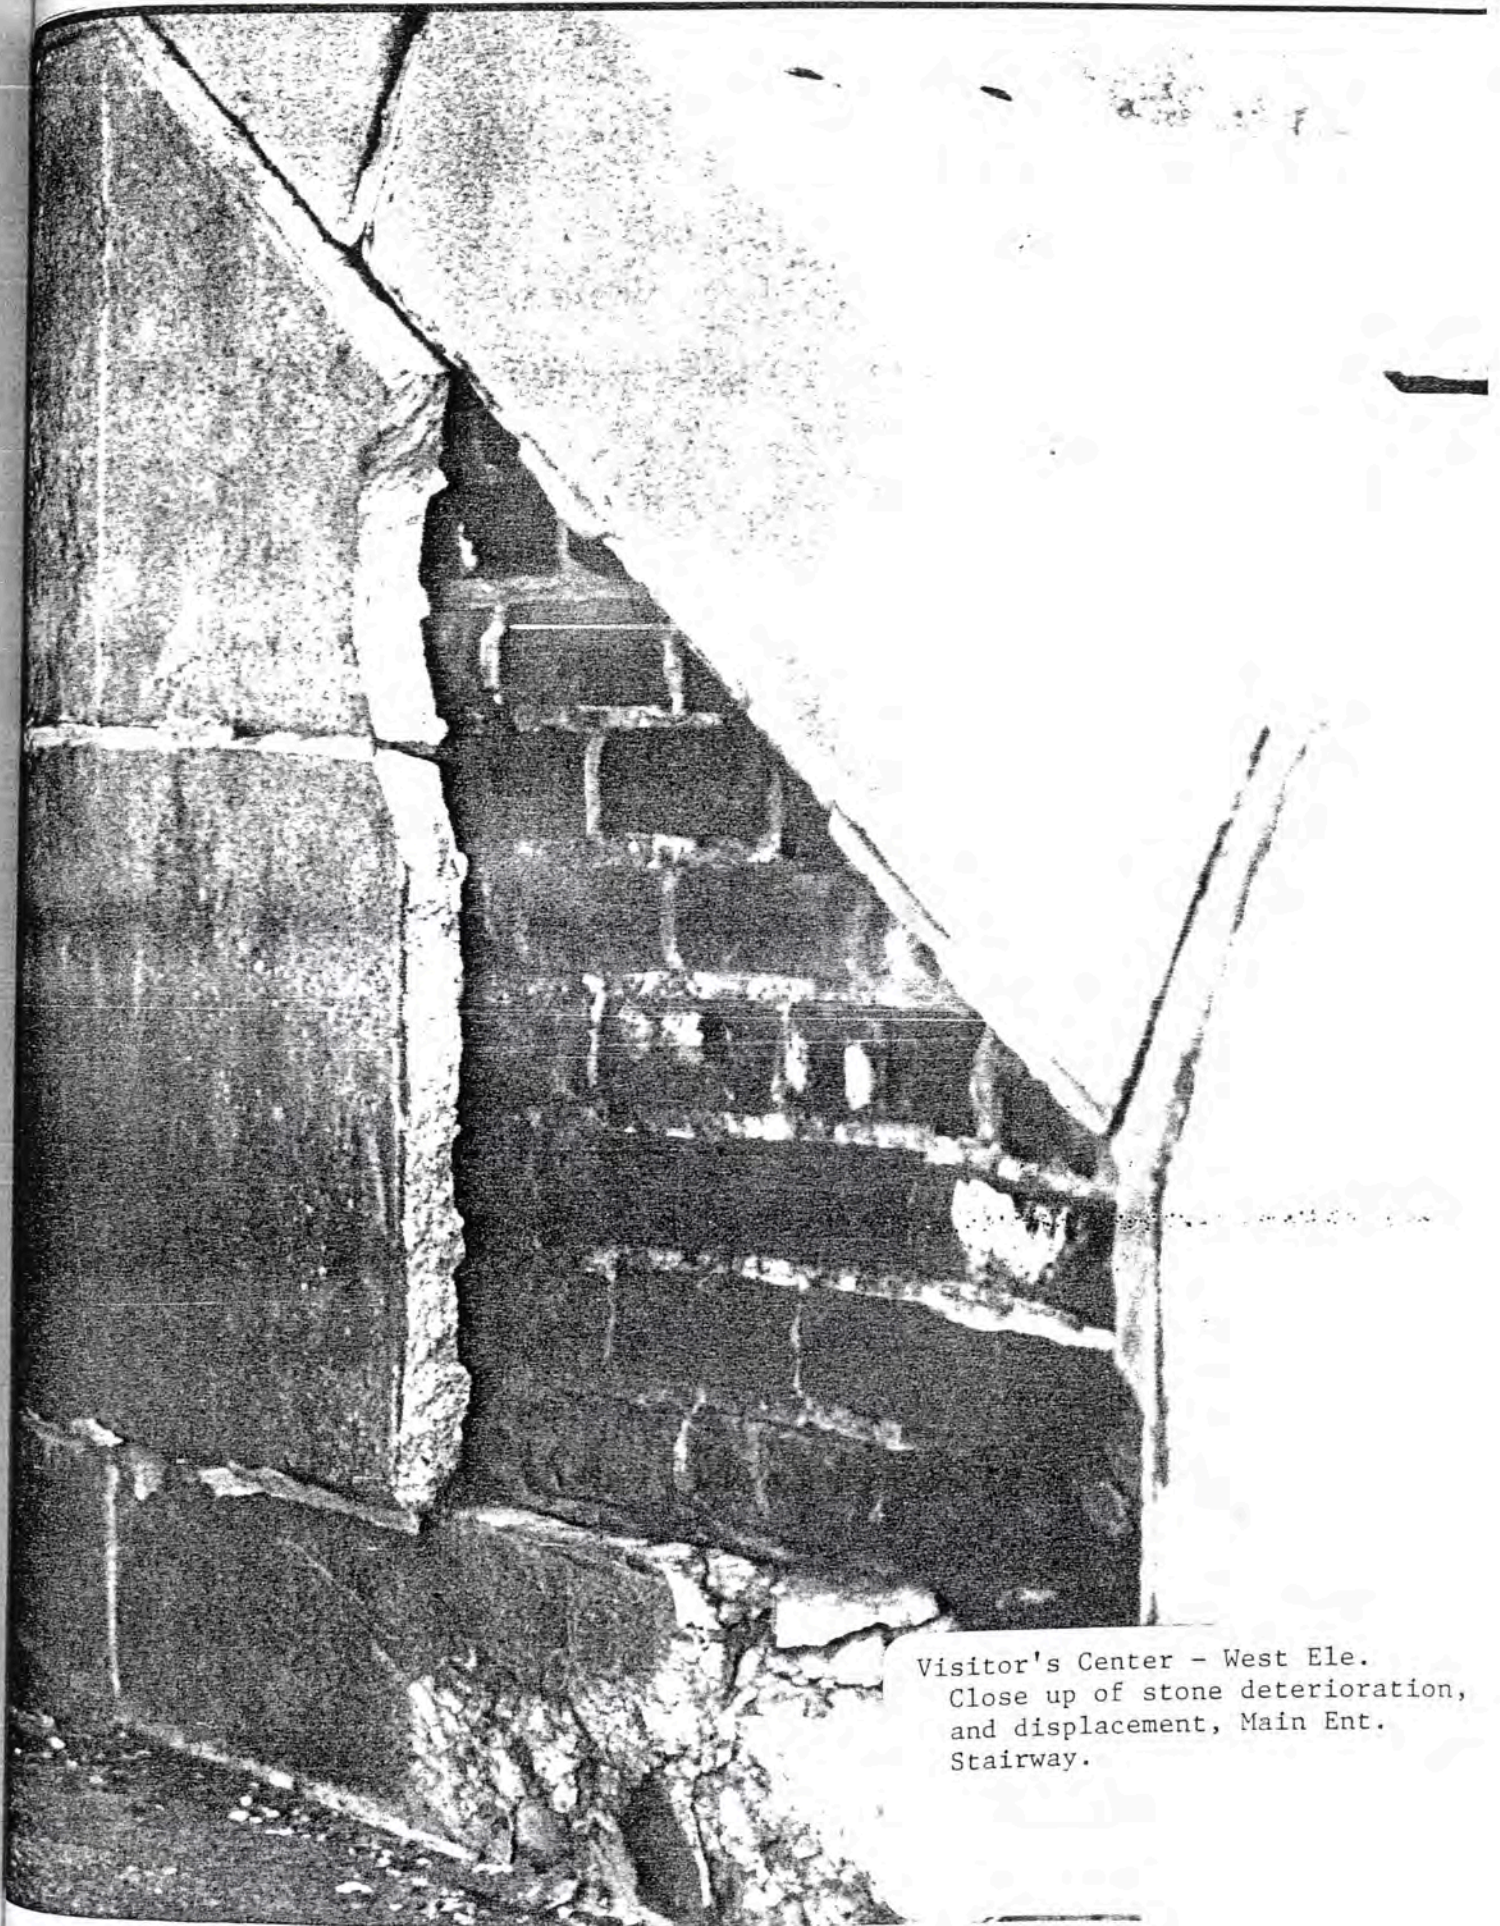
Visitor's Center - West Ele.  
Close up of stone deterioration,  
and displacement, Main Ent.  
Stairway.

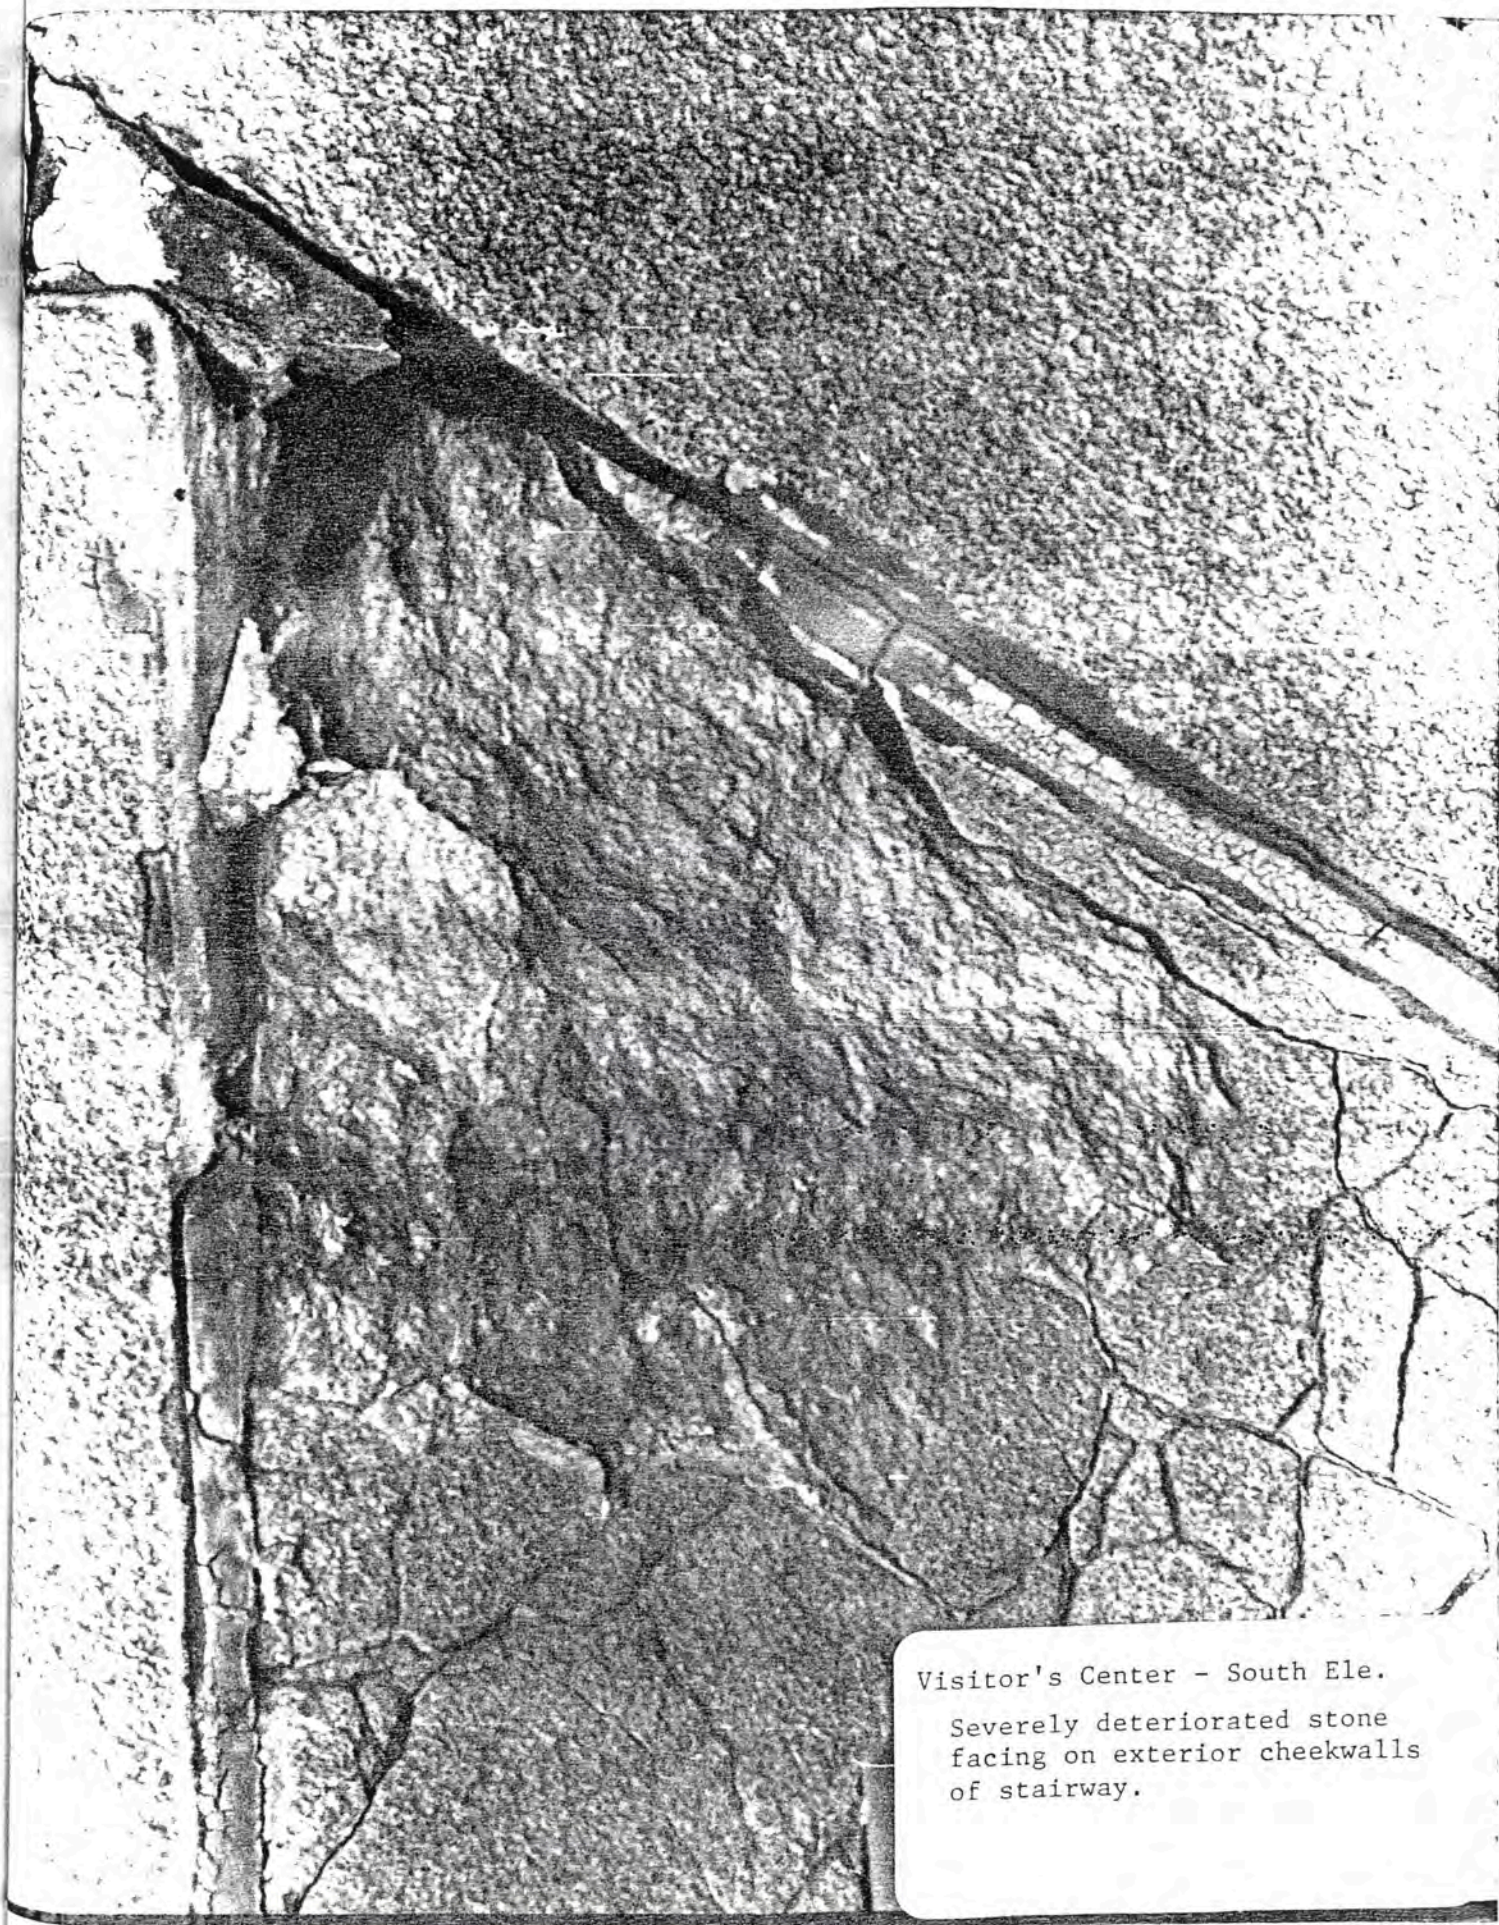
Visitor's Center - South Ele.  
Severely deteriorated stone  
facing on exterior cheekwalls  
of stairway.

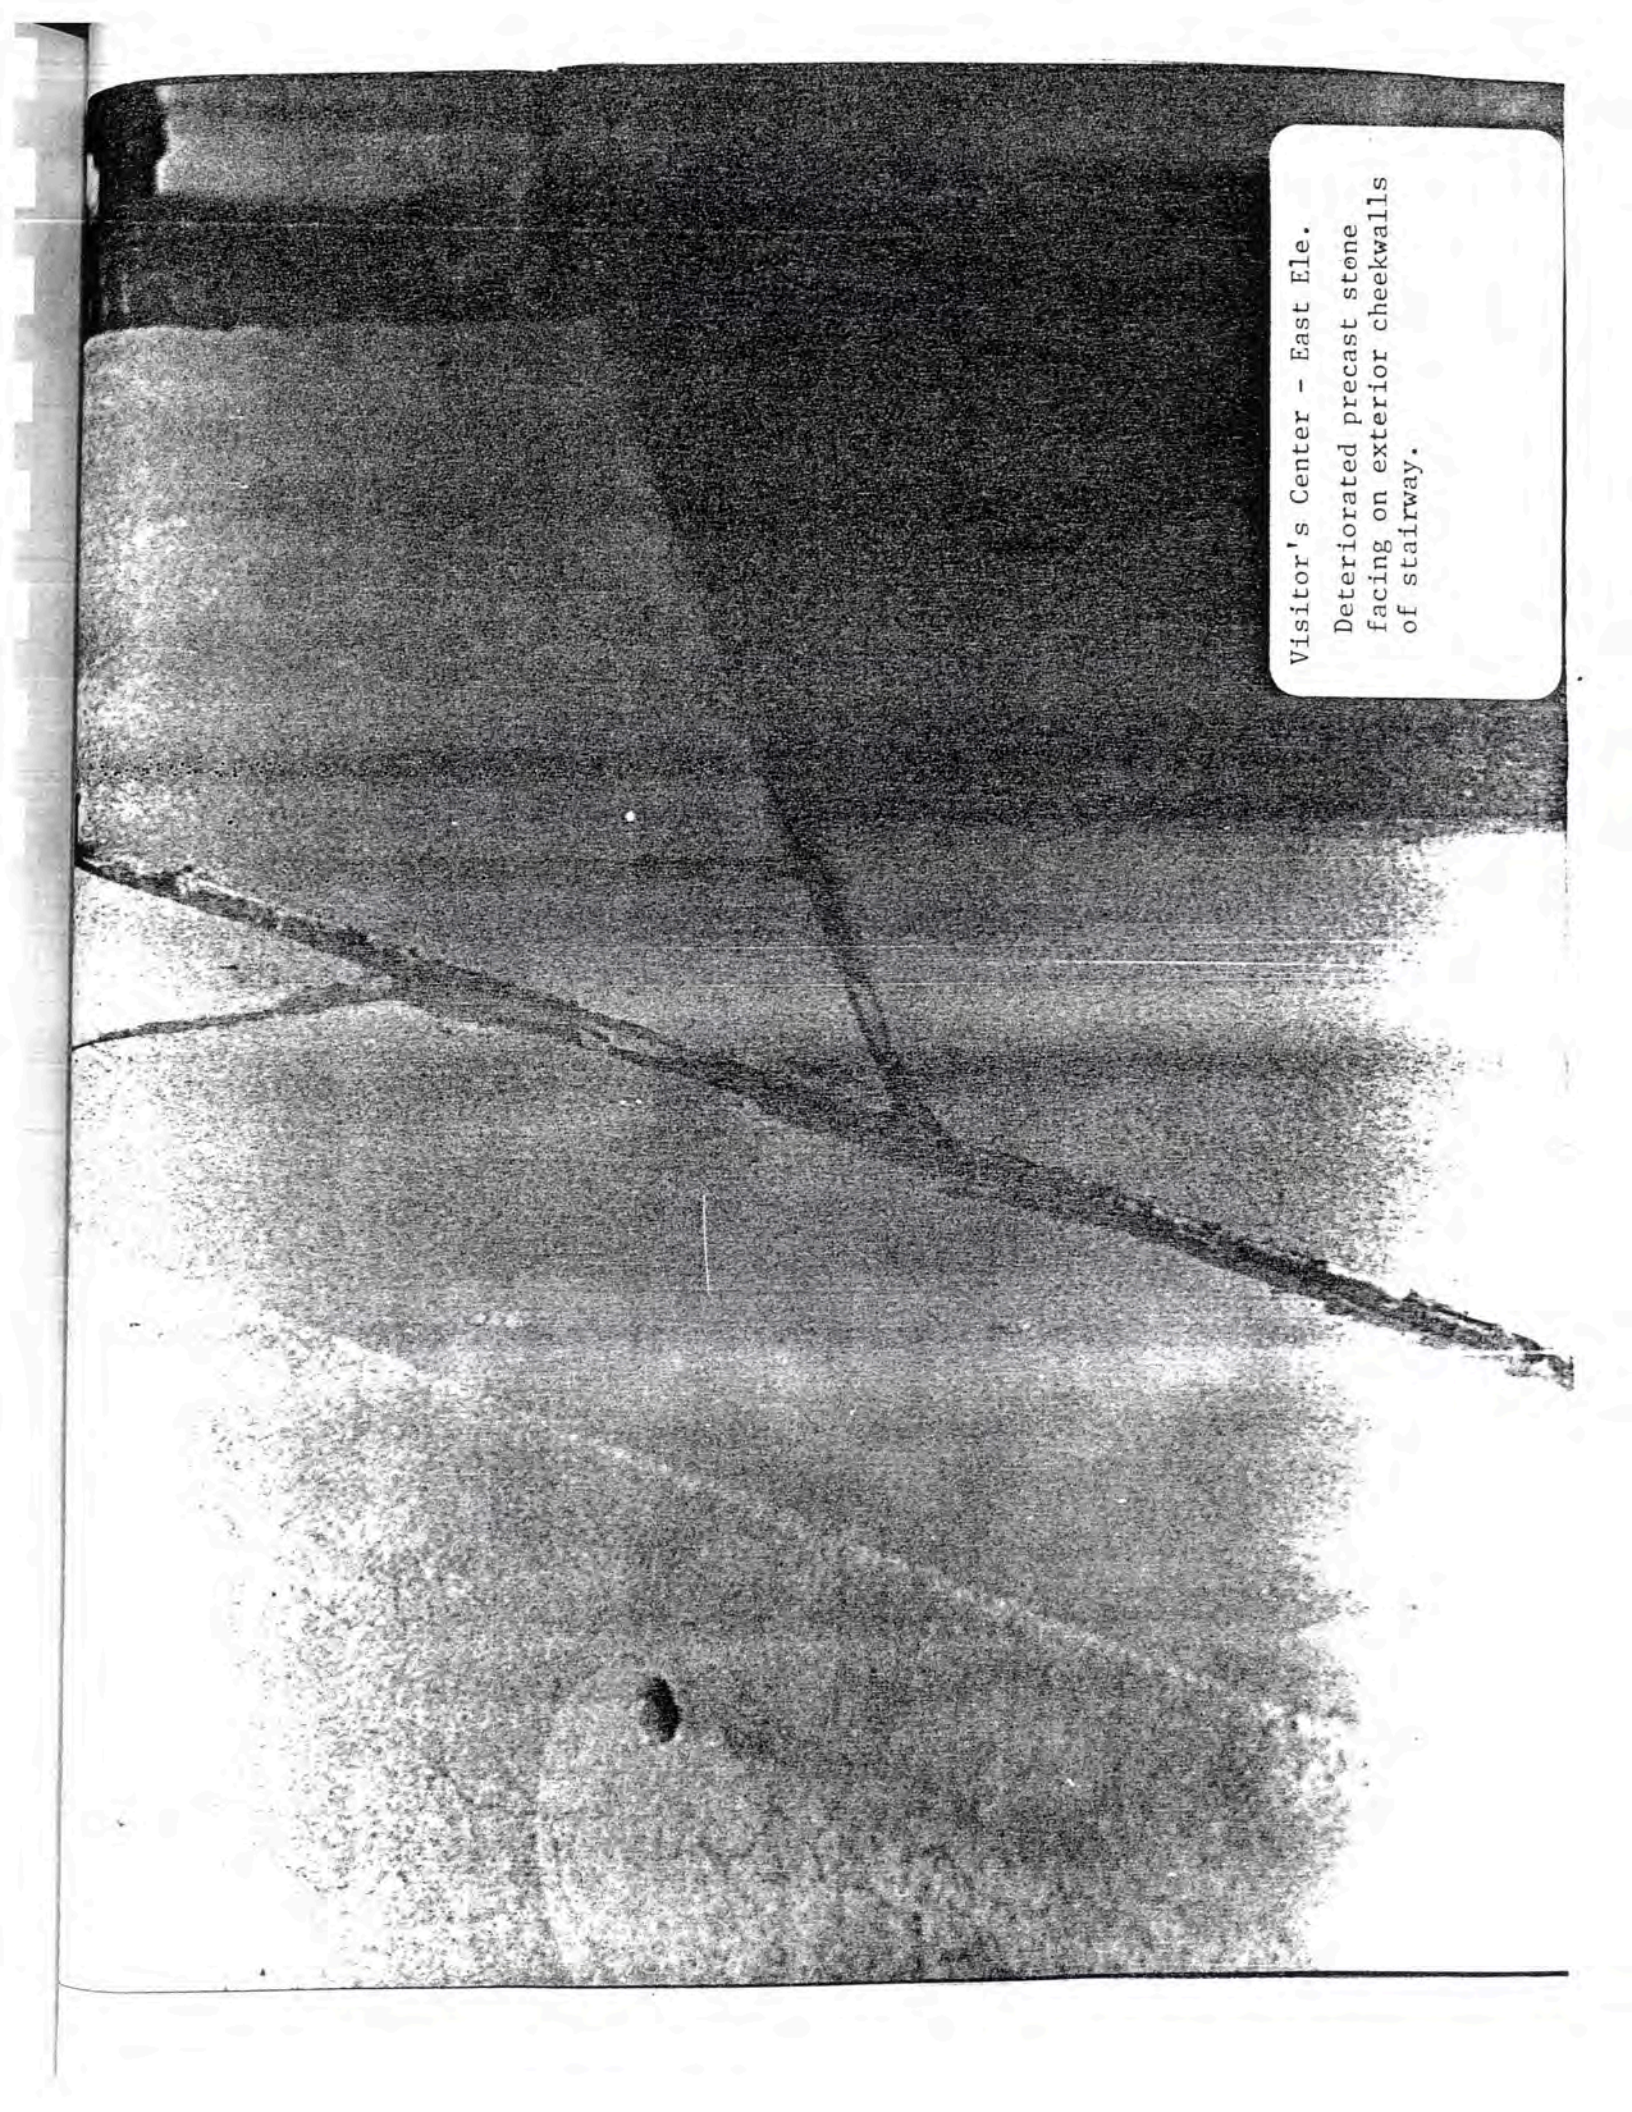
Visitor's Center - East Ele.

Deteriorated precast stone  
facing on exterior cheekwalls  
of stairway.

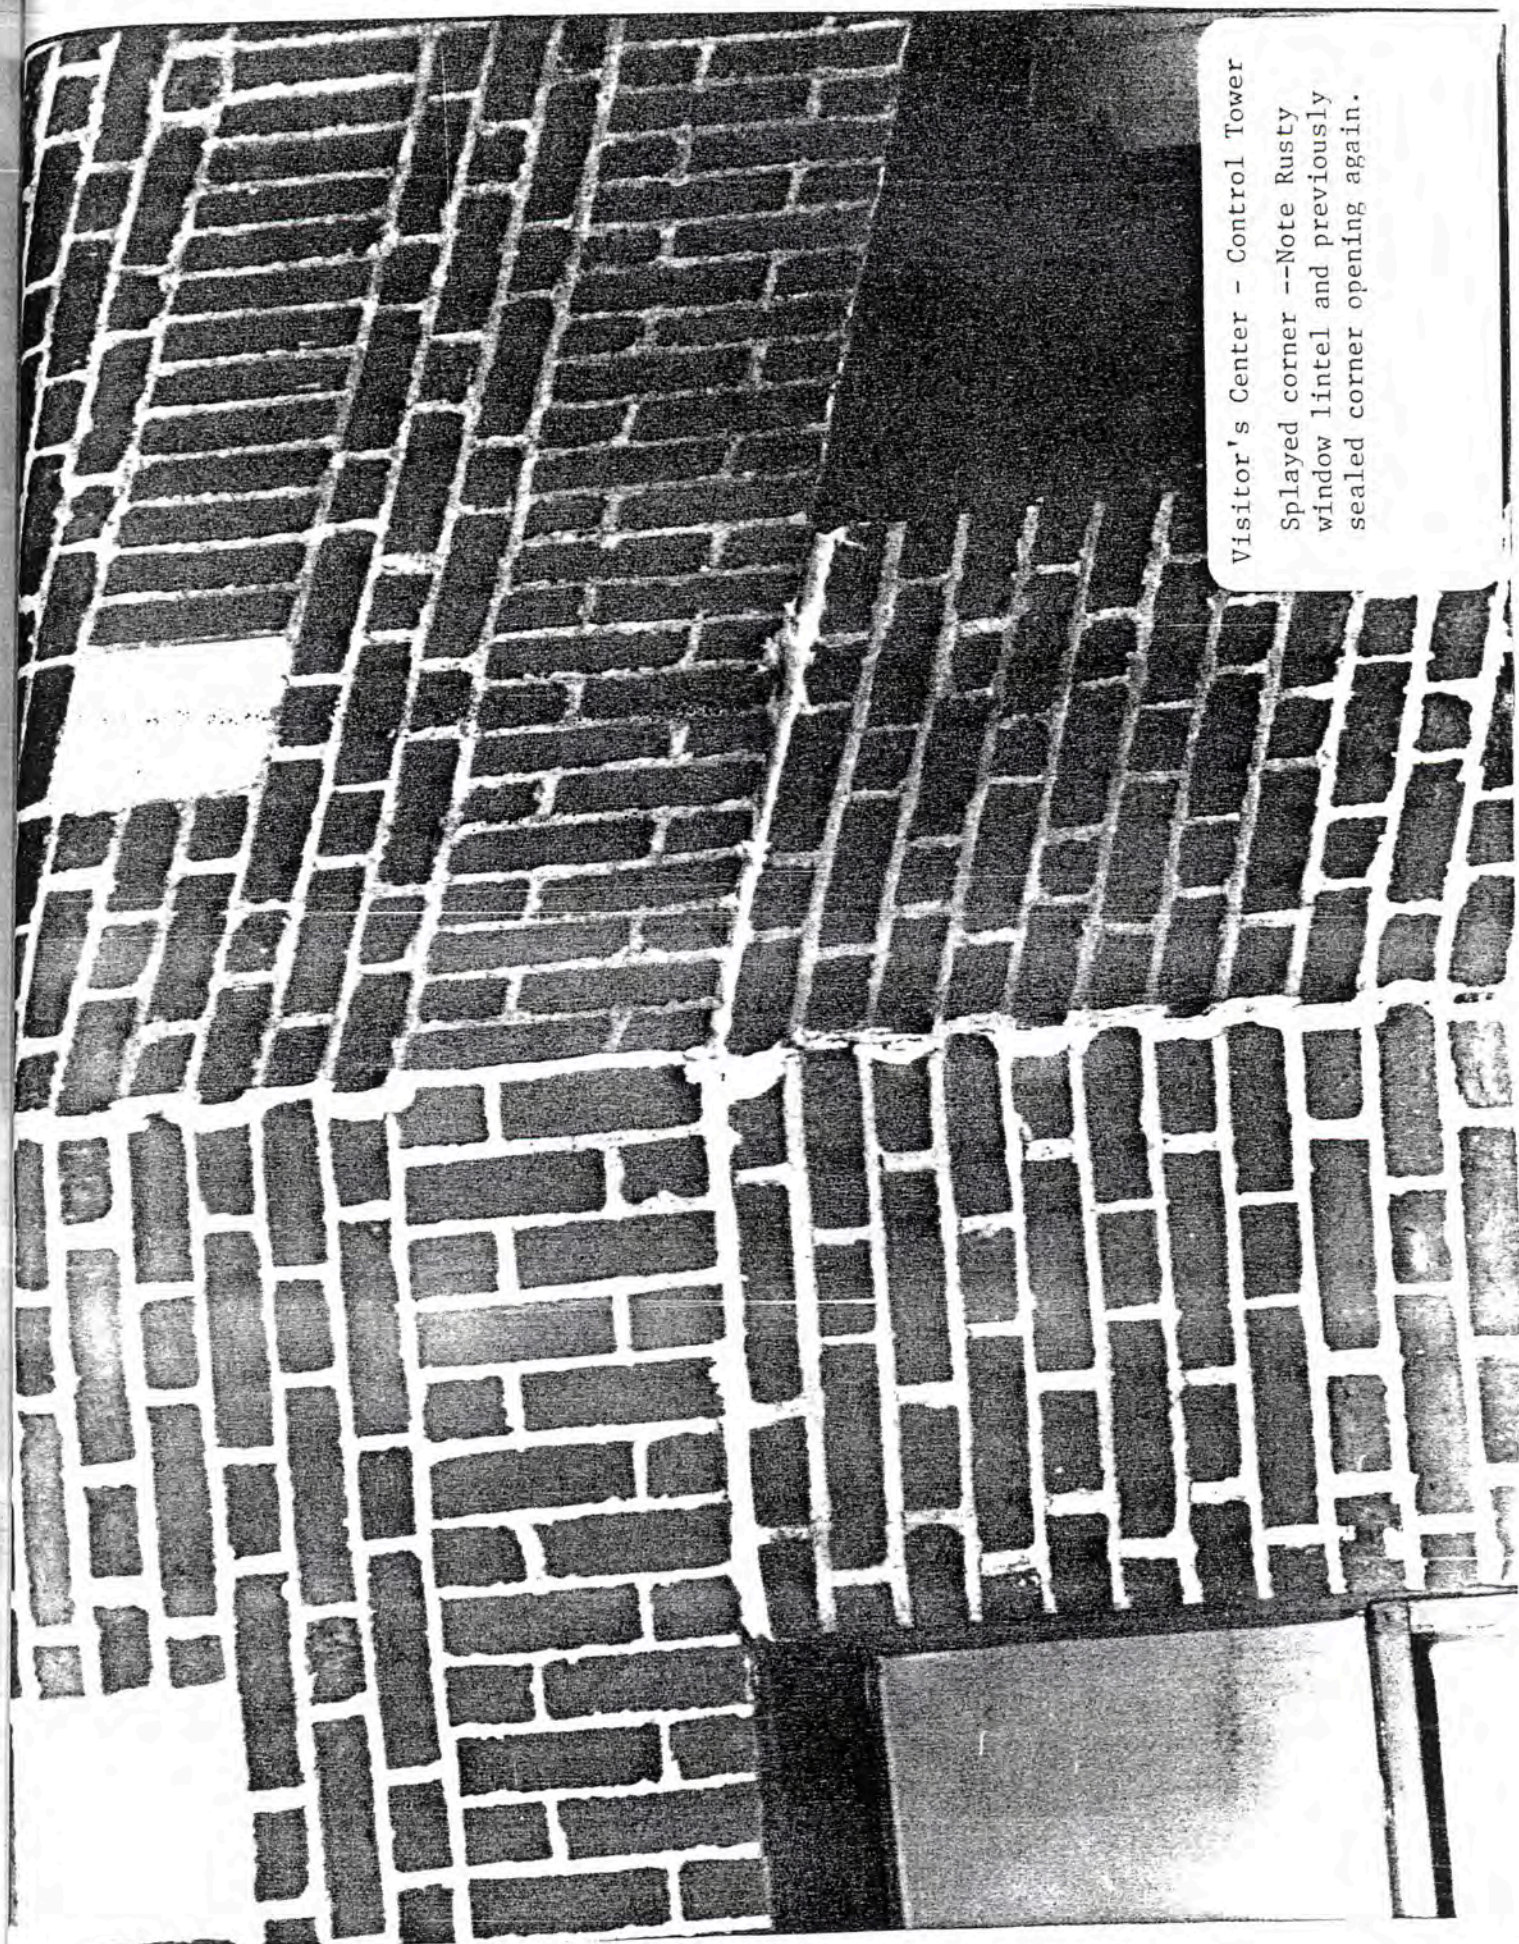
Visitor's Center - Control Tower

Splayed corner --Note Rusty  
window lintel and previously  
sealed corner opening again.

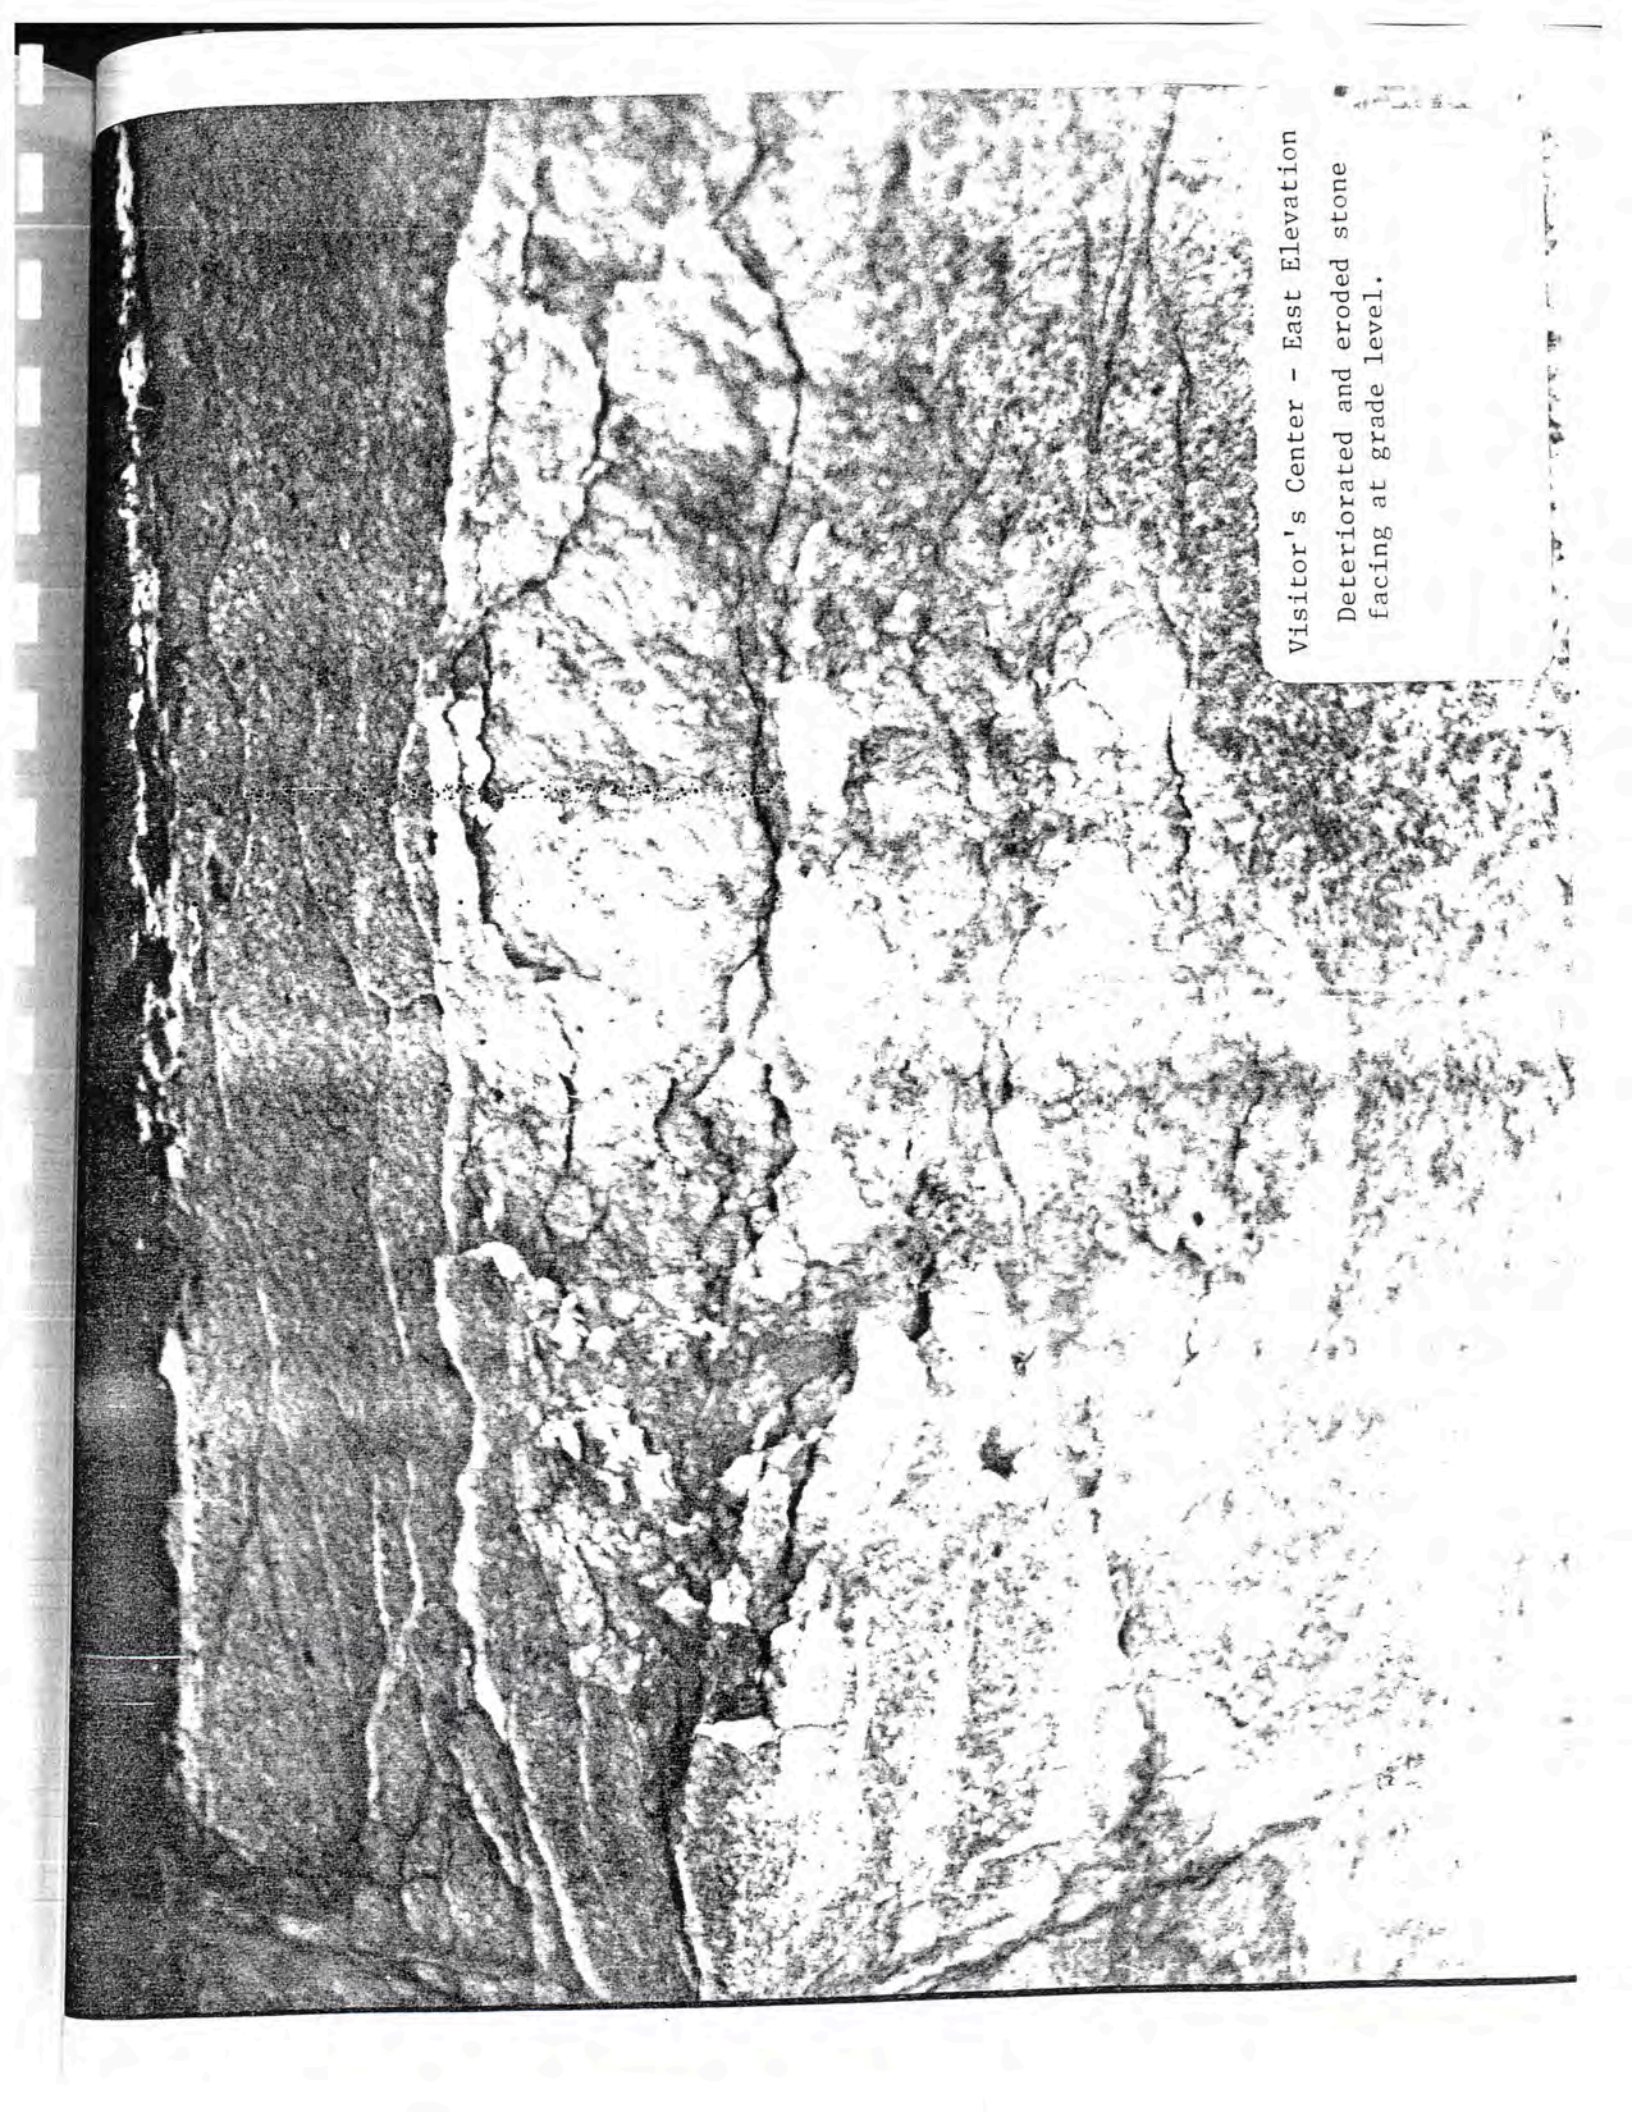
Visitor's Center - East Elevation  
Deteriorated and eroded stone  
facing at grade level.

On East elevation the cast stone of the base from the ground level to the terrace has become displaced and deteriorated. It is a general condition which requires the removal of the material, a review of the substrate and anchors and replacement of lintels. On the remainder of the elevations this stone requires removal and replacement in specific areas as noted on drawings.

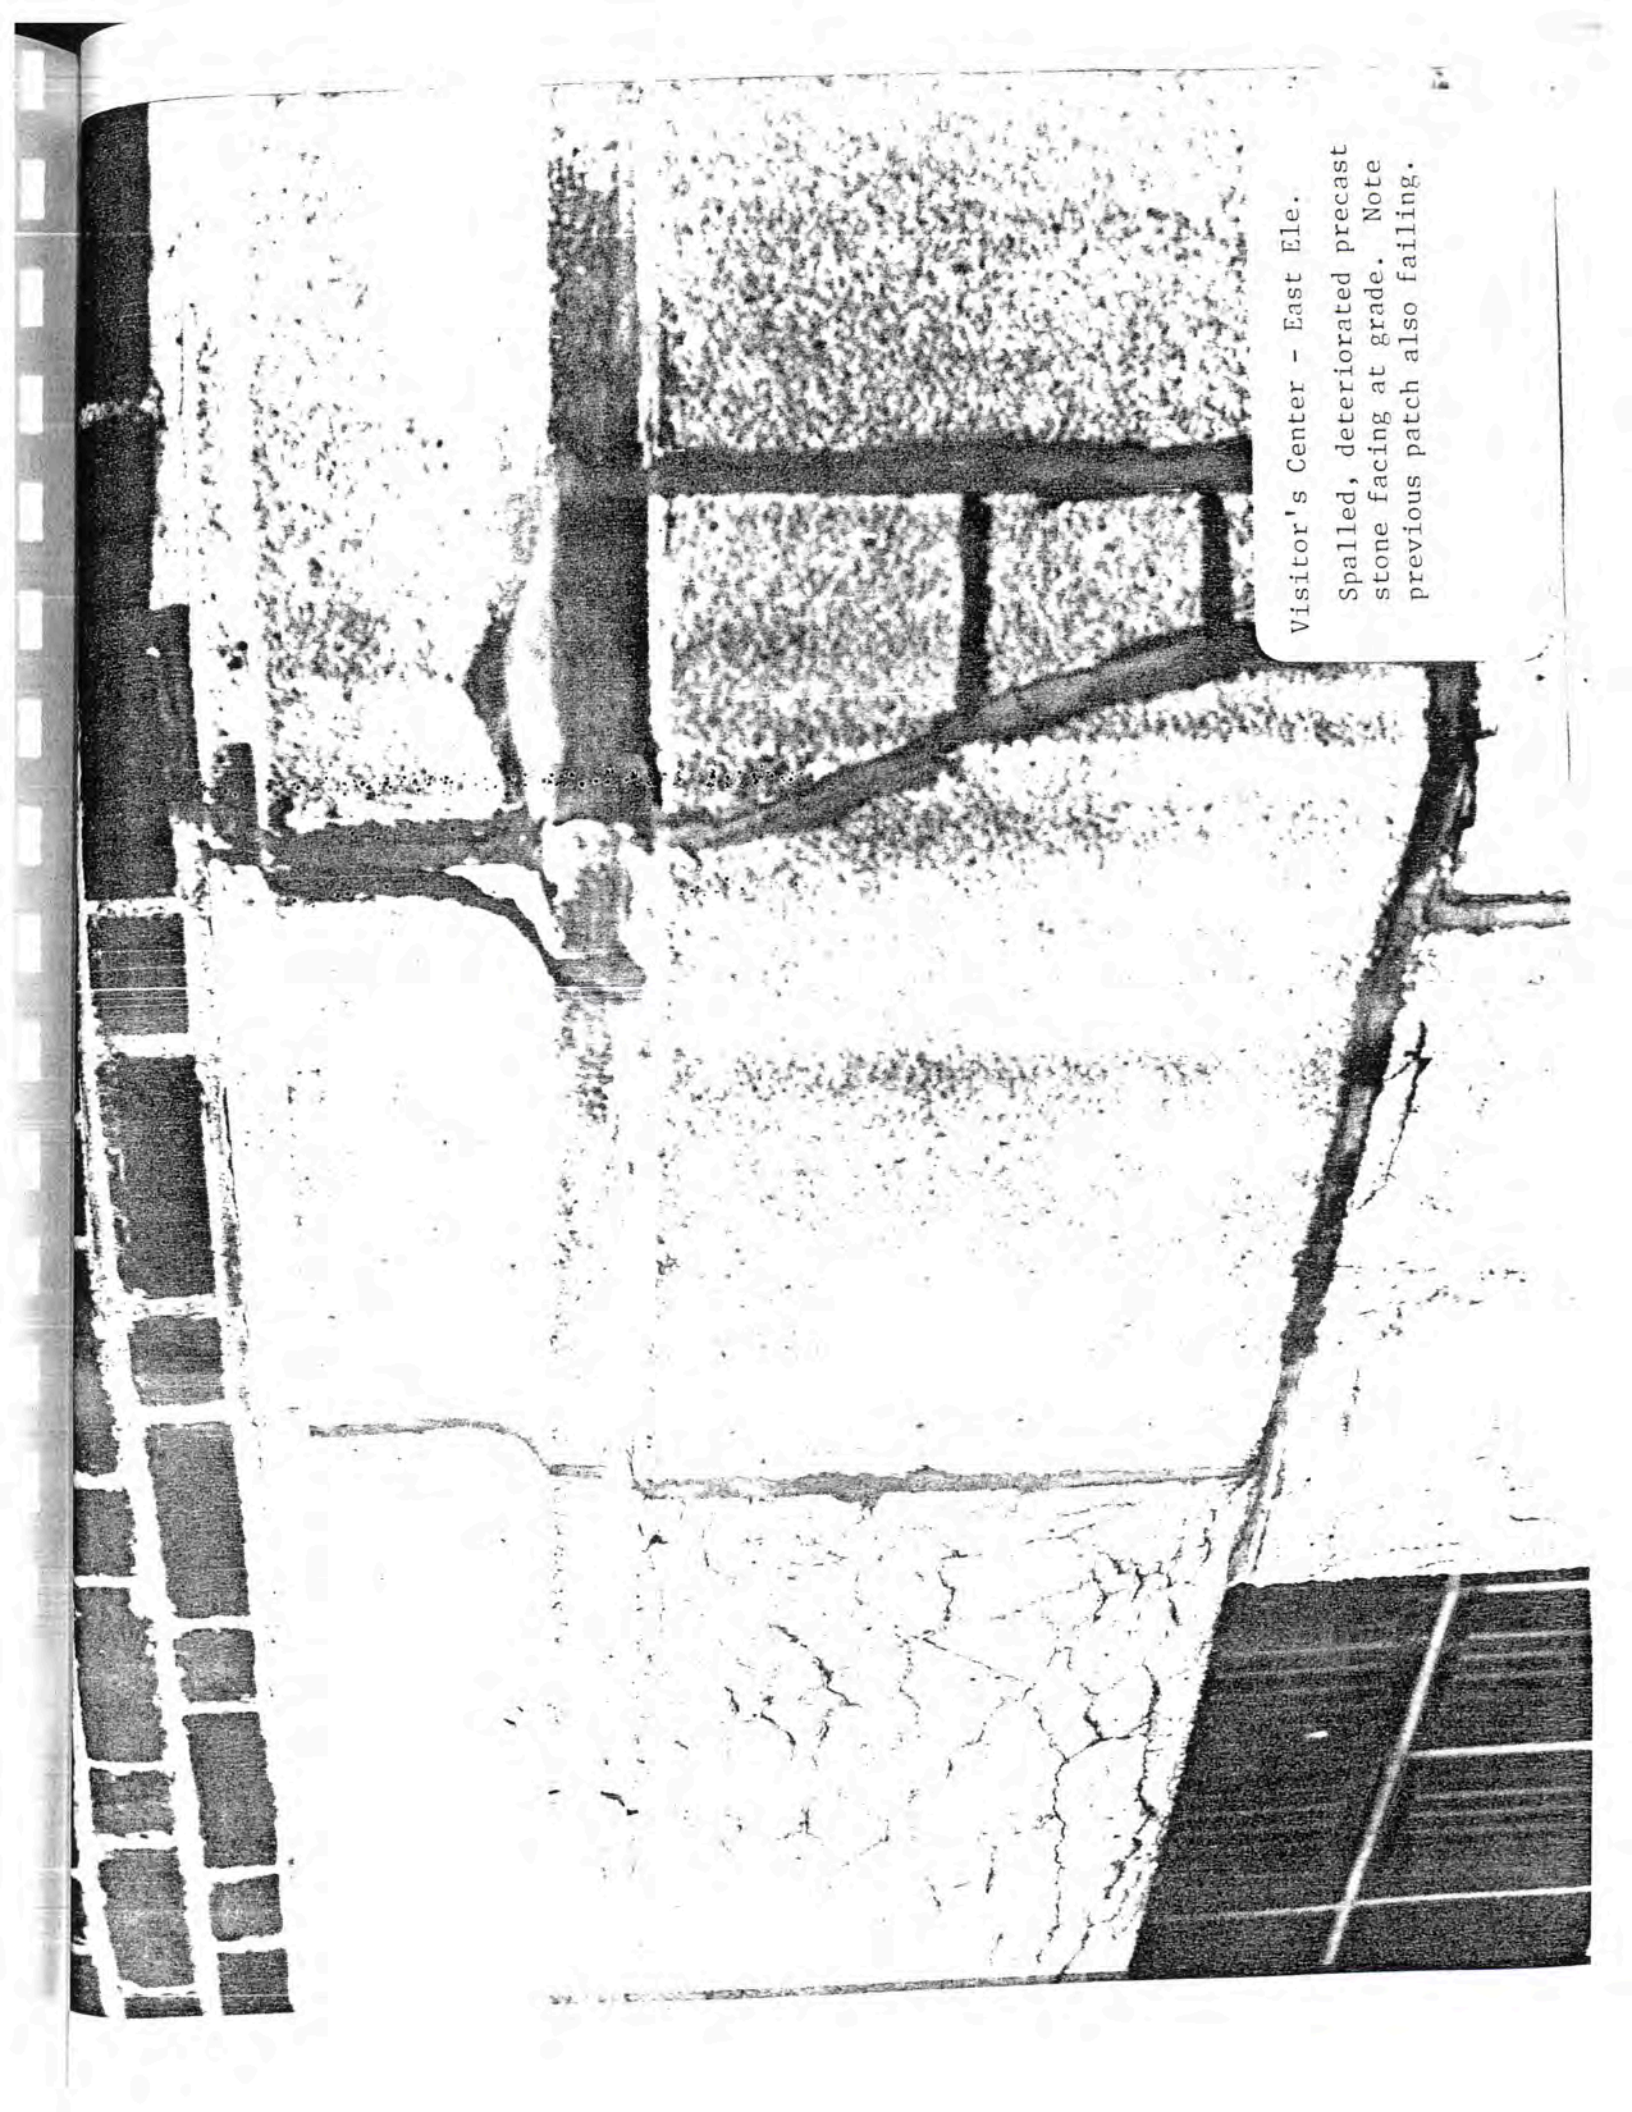
Visitor's Center - East Ele.  
Spalled, deteriorated precast  
stone facing at grade. Note  
previous patch also failing.

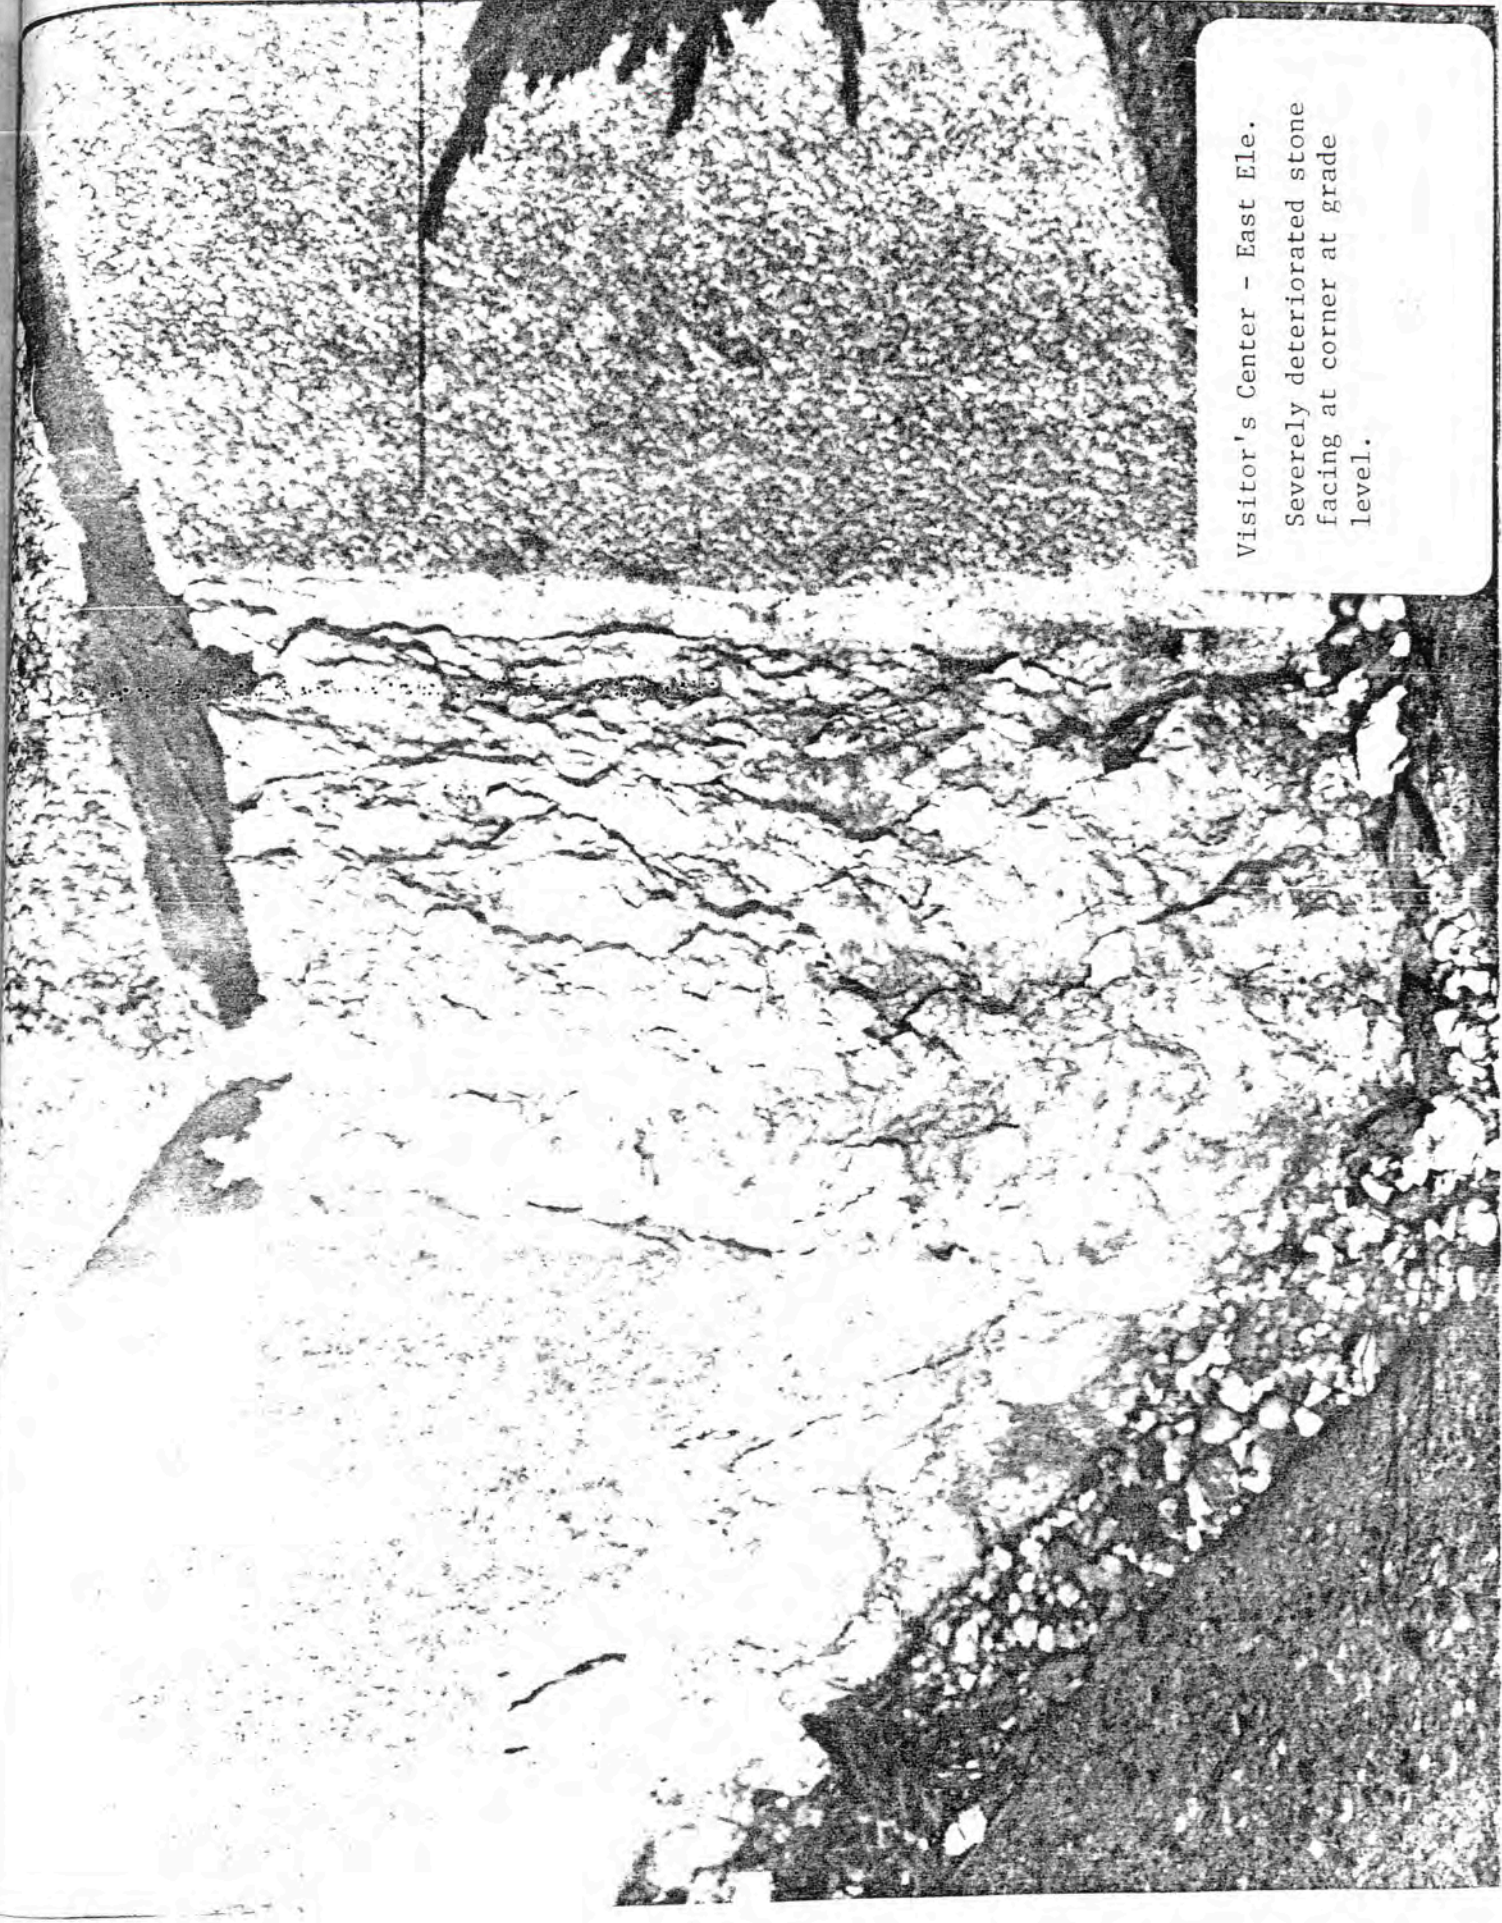
Visitor's Center - East Ele.

Severely deteriorated stone  
facing at corner at grade  
level.
