**FACADE INVESTIGATION  
VISITOR CENTER  
FLOYD BENNETT FIELD**

**TONETTI ASSOCIATES**

January 30, 1984

The following is our report on the conditions of the exterior shell of the William Ryan Visitor's Building at Floyd Bennett Field, Gateway National Recreation Area. We trust that this report will serve as a documentation of the conditions at present and as a tool for evaluating future repairs and restoration.

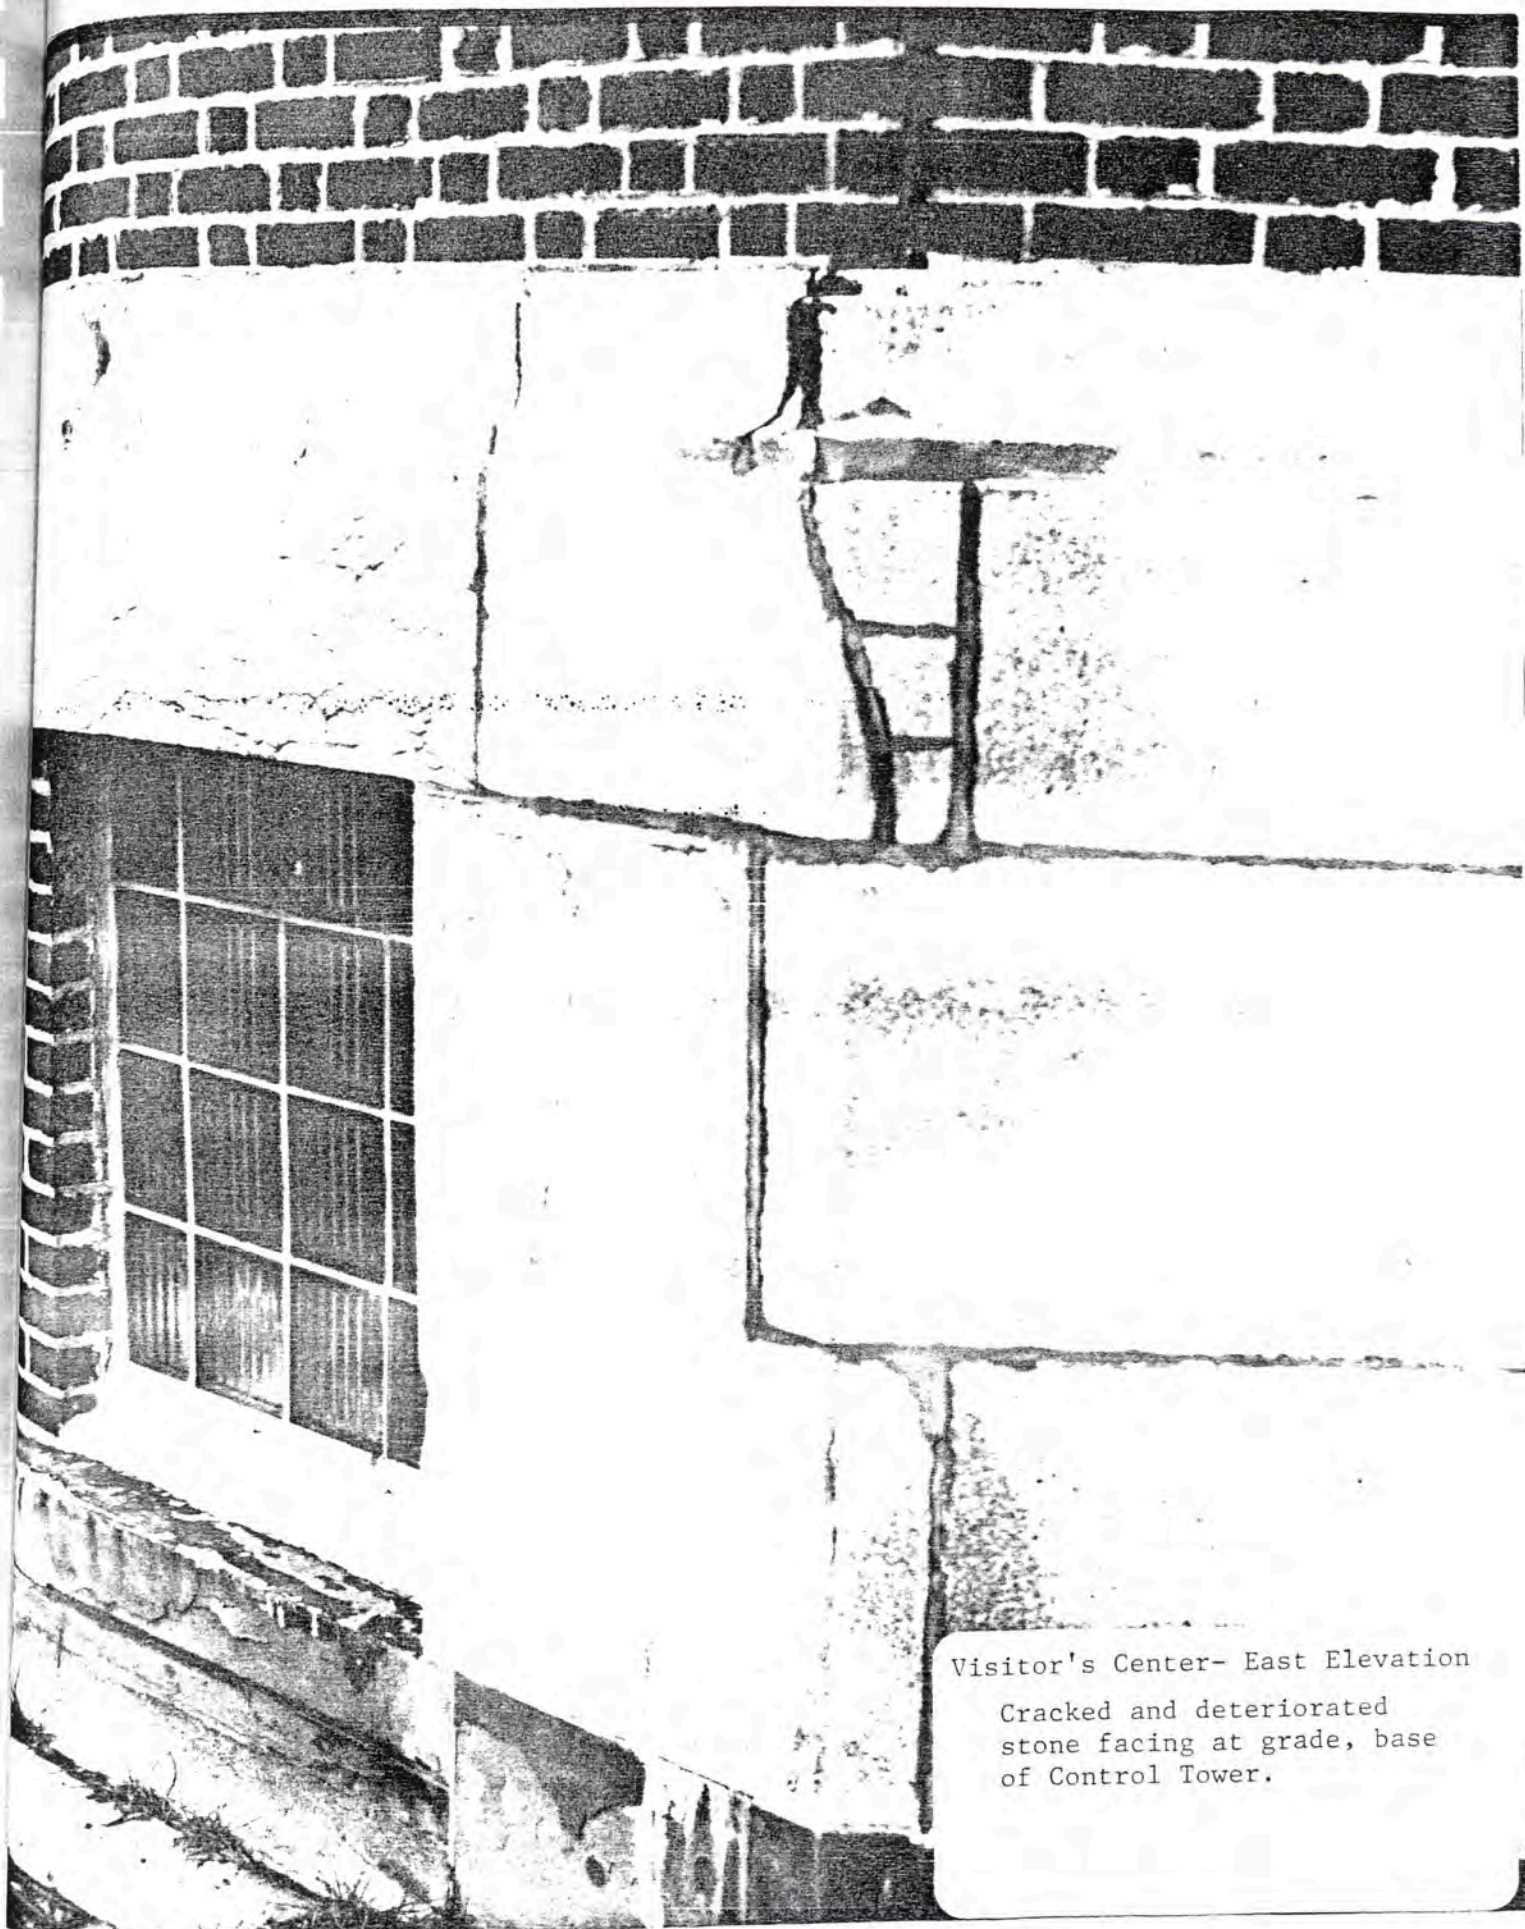
Visitor's Center- East Elevation

Cracked and deteriorated  
stone facing at grade, base  
of Control Tower.

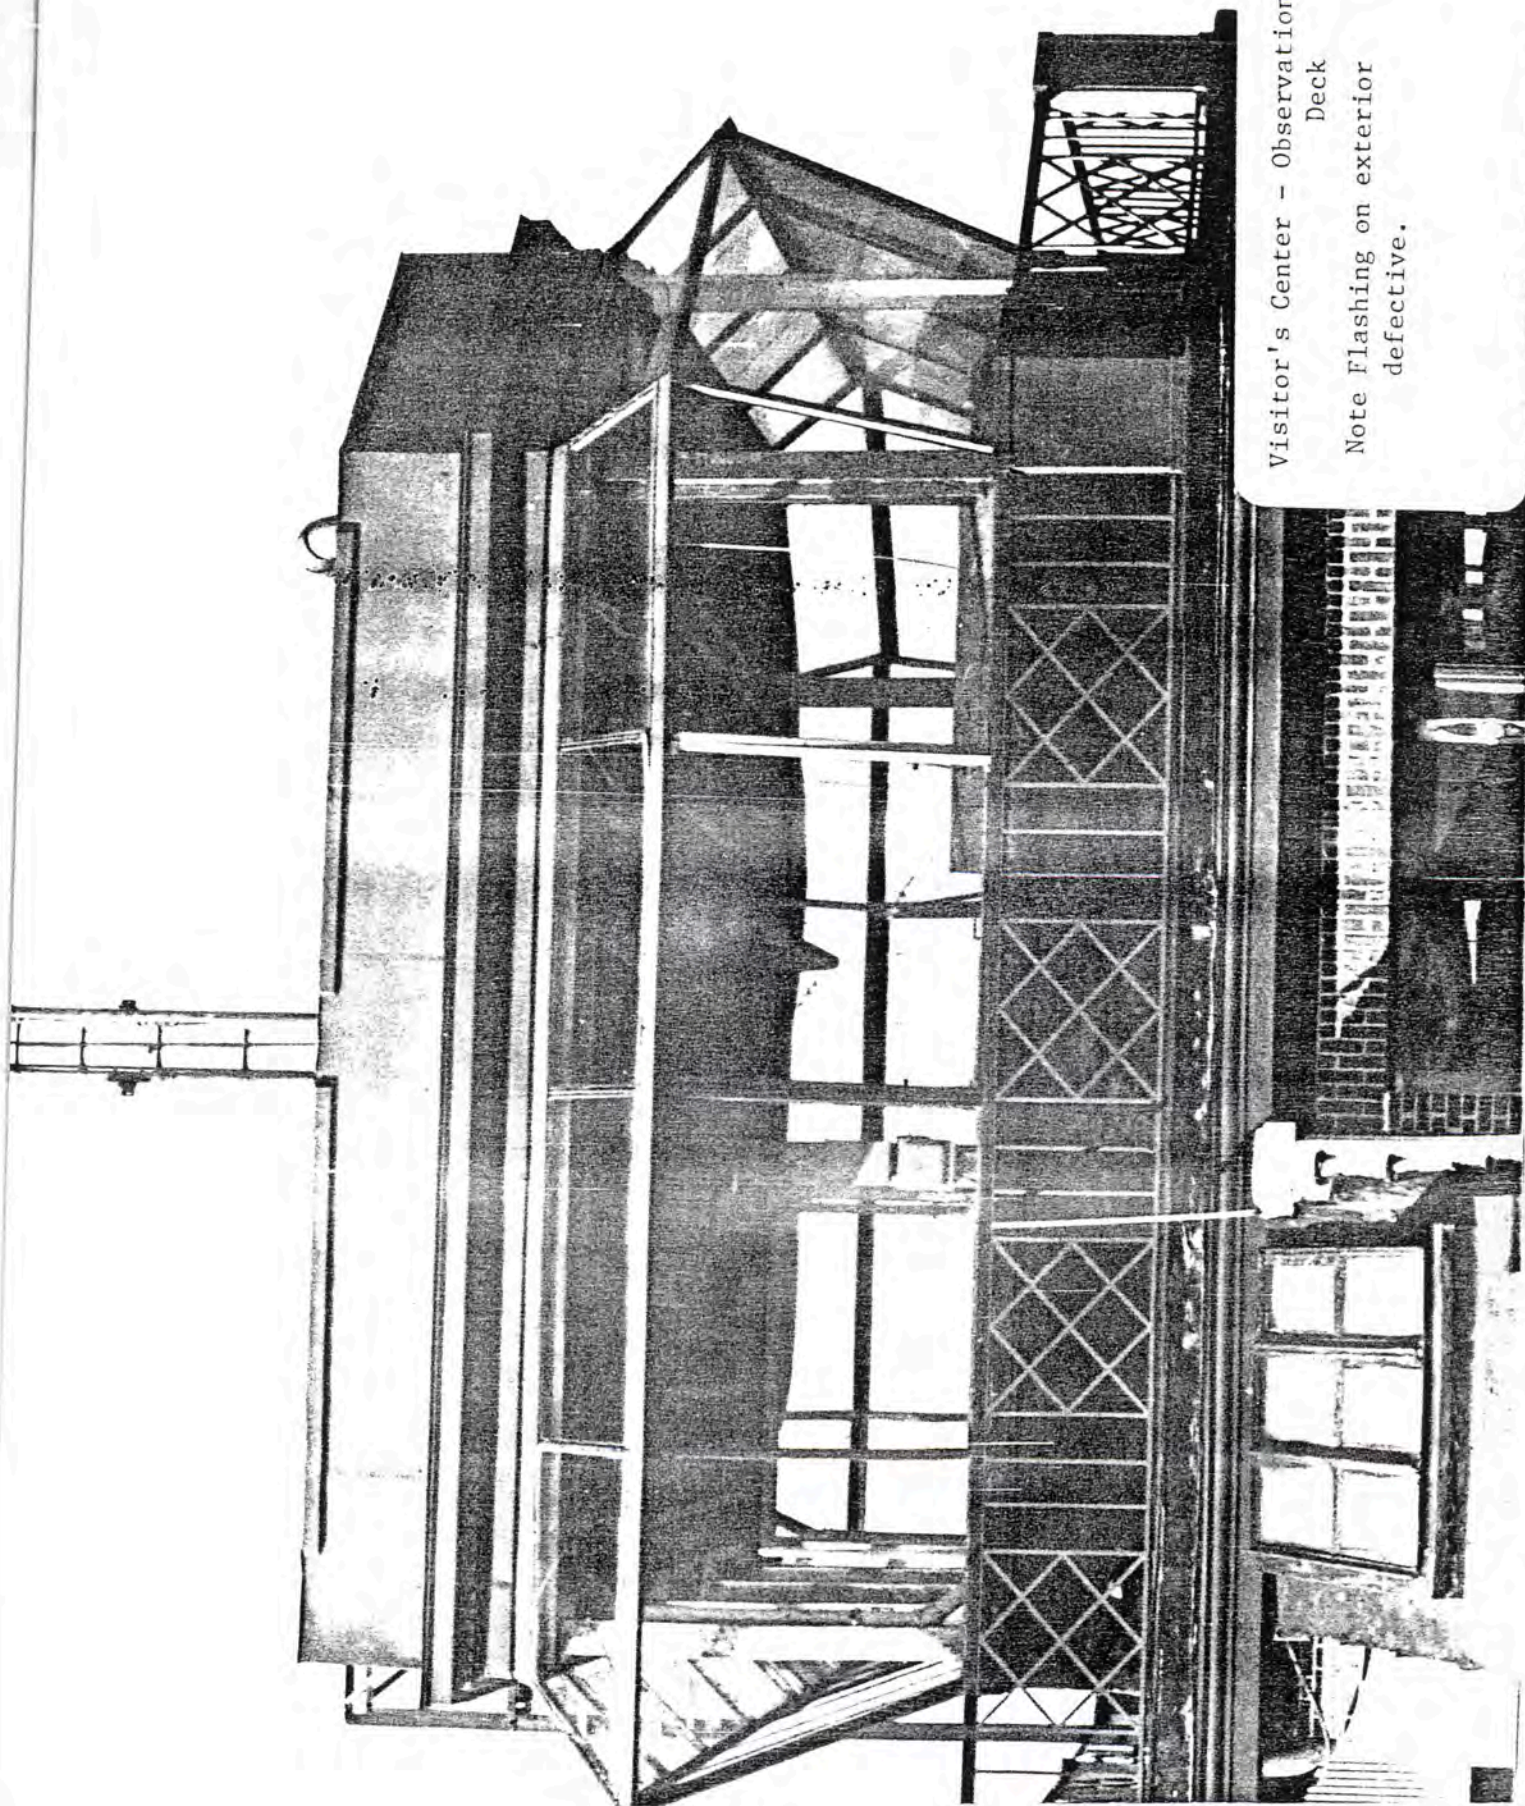
Visitor's Center - Observation  
Deck  
Note Flashing on exterior  
defective.

The three large windows under the control tower are deteriorated to the point where they must be replaced. The steel framing of the Control Tower glazing is in good enough condition to scrape, clean and paint though the flashing of the observation deck must be replaced. The skylights over the access stairs to the Control Tower should be replaced in kind. As a minor repair item the broken glazing in the north skylight should be replaced.

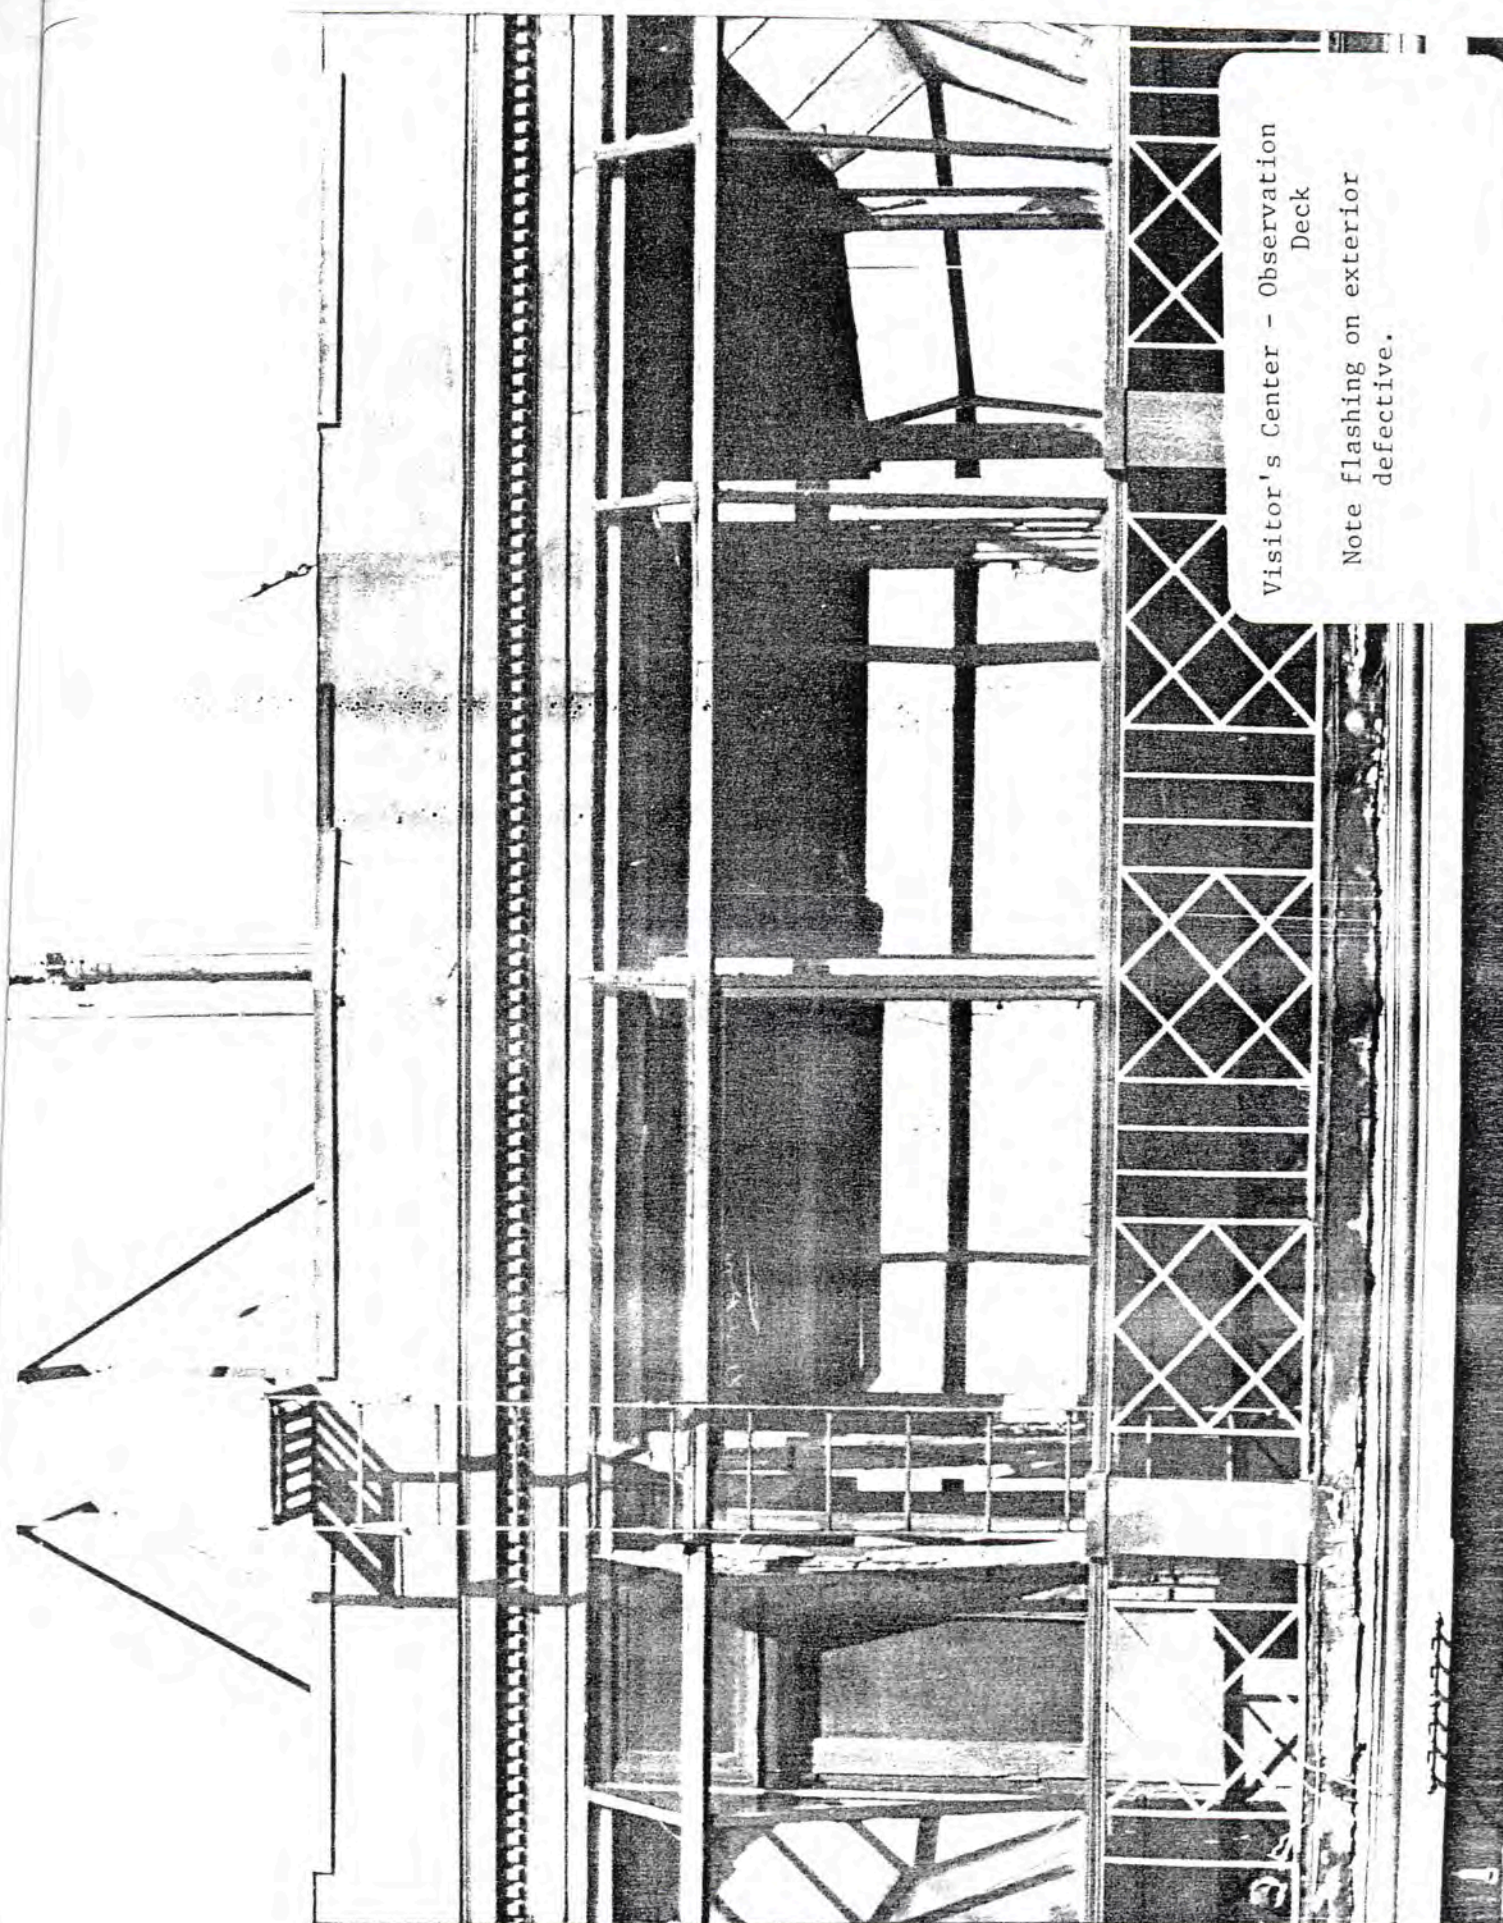
Visitor's Center - Observation  
Deck

Note flashing on exterior  
defective.

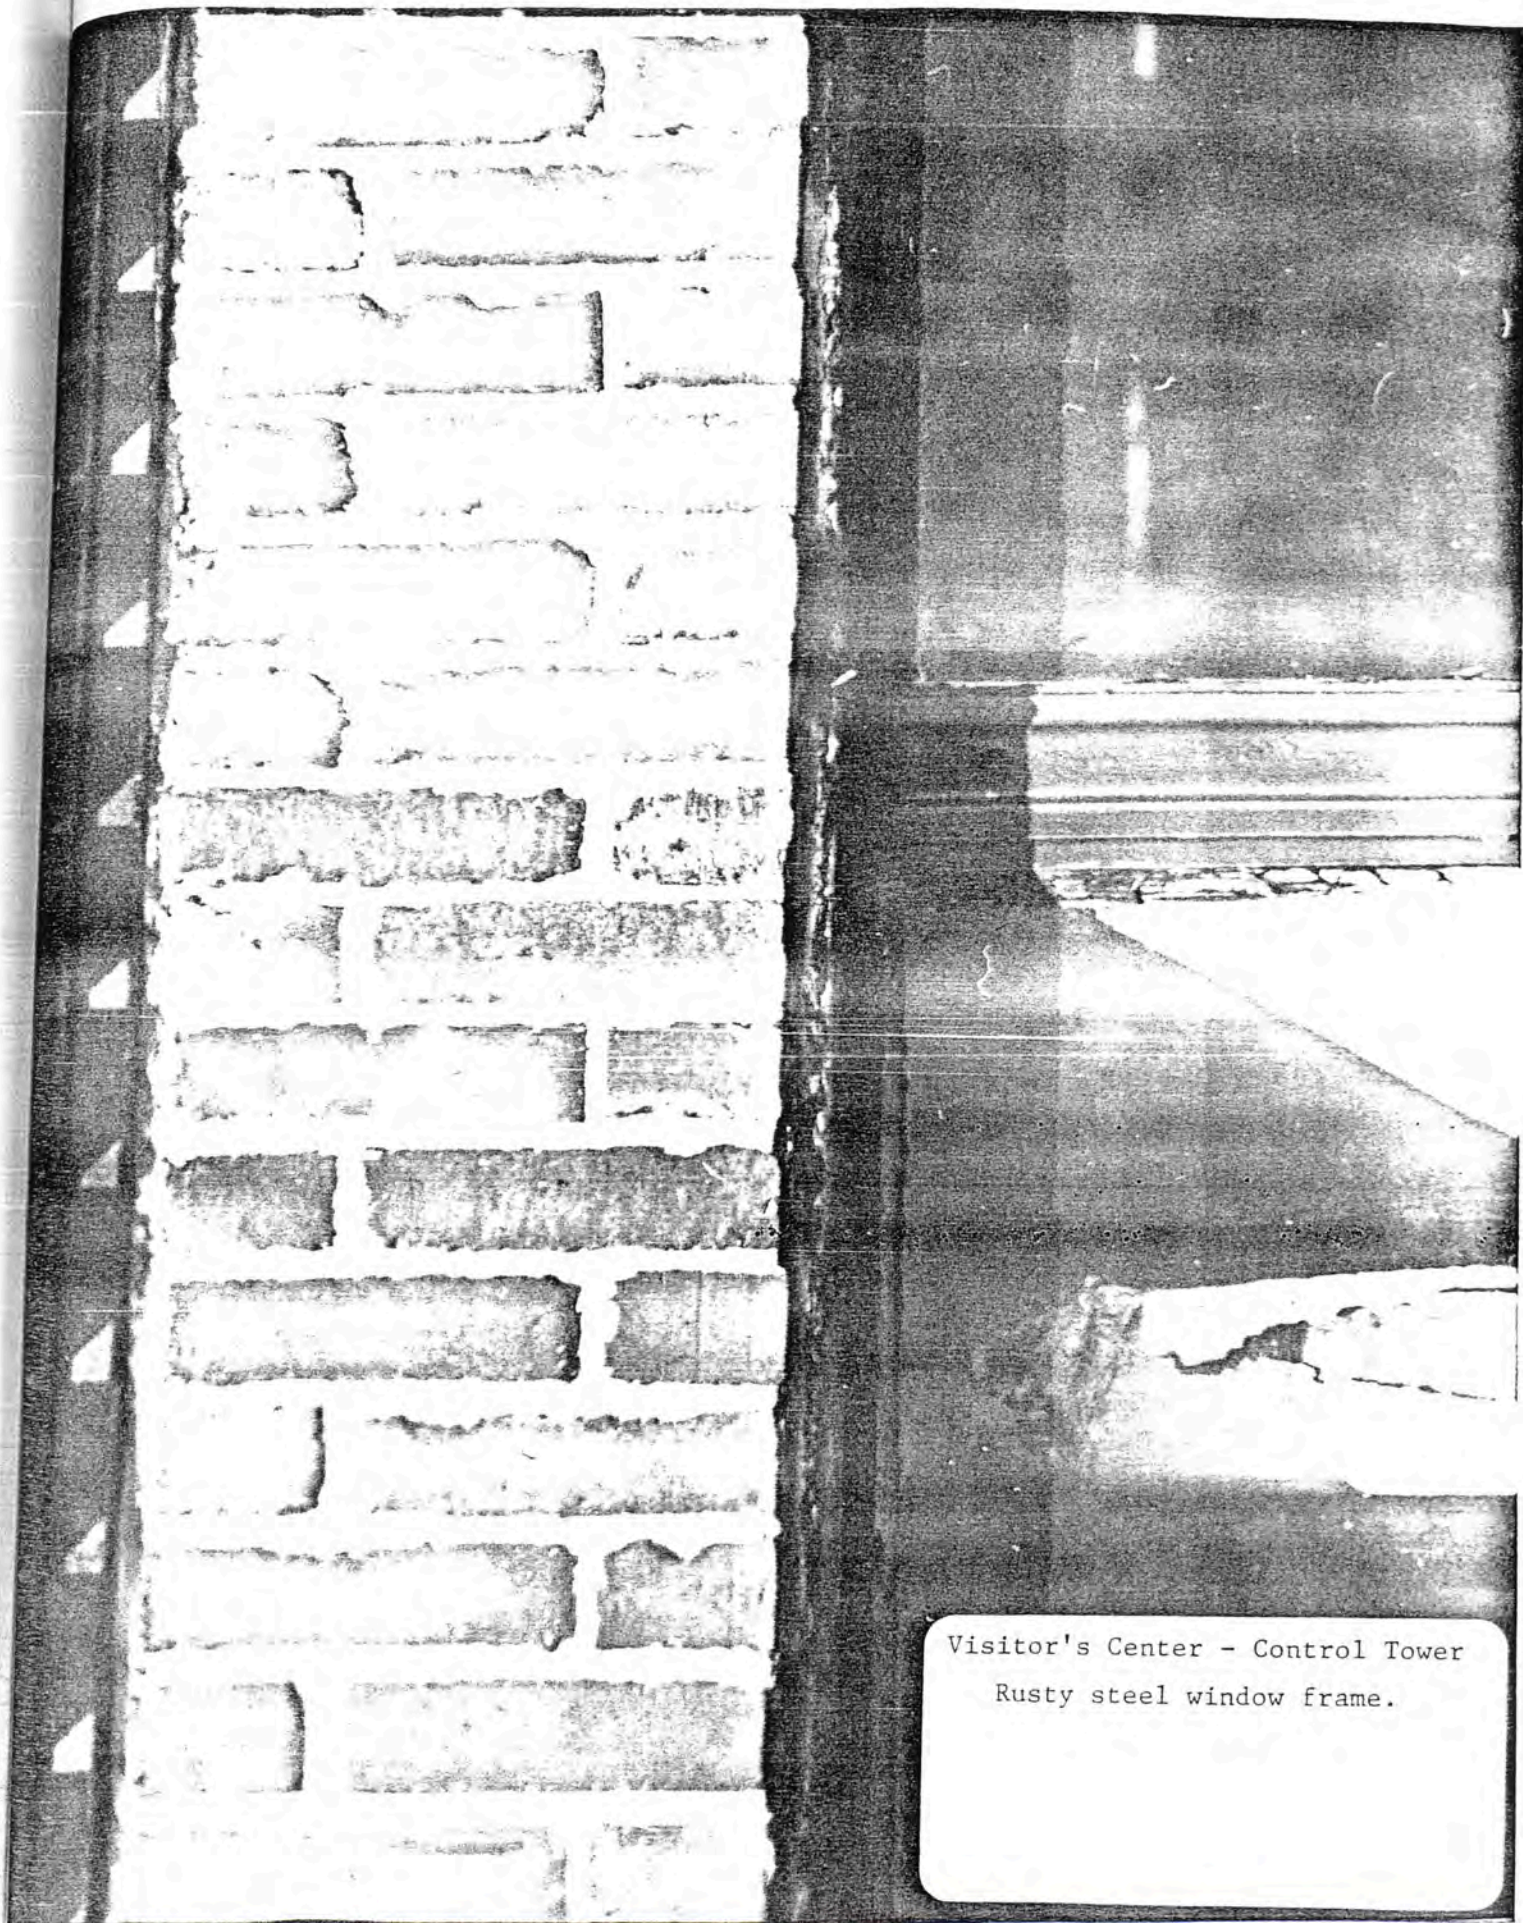
Visitor's Center - Control Tower  
Rusty steel window frame.
