**HIGH DEFINITION STREAM SURVEY OF  
TALLAPOOSA RIVER FOR THE HORSESHOE BEND  
NATIONAL MILITARY PARK, ALABAMA, USA**

Prepared for The U.S. National Park Service  
November 28, 2020

## **TRUTTA ENVIRONMENTAL SOLUTIONS, LLC**

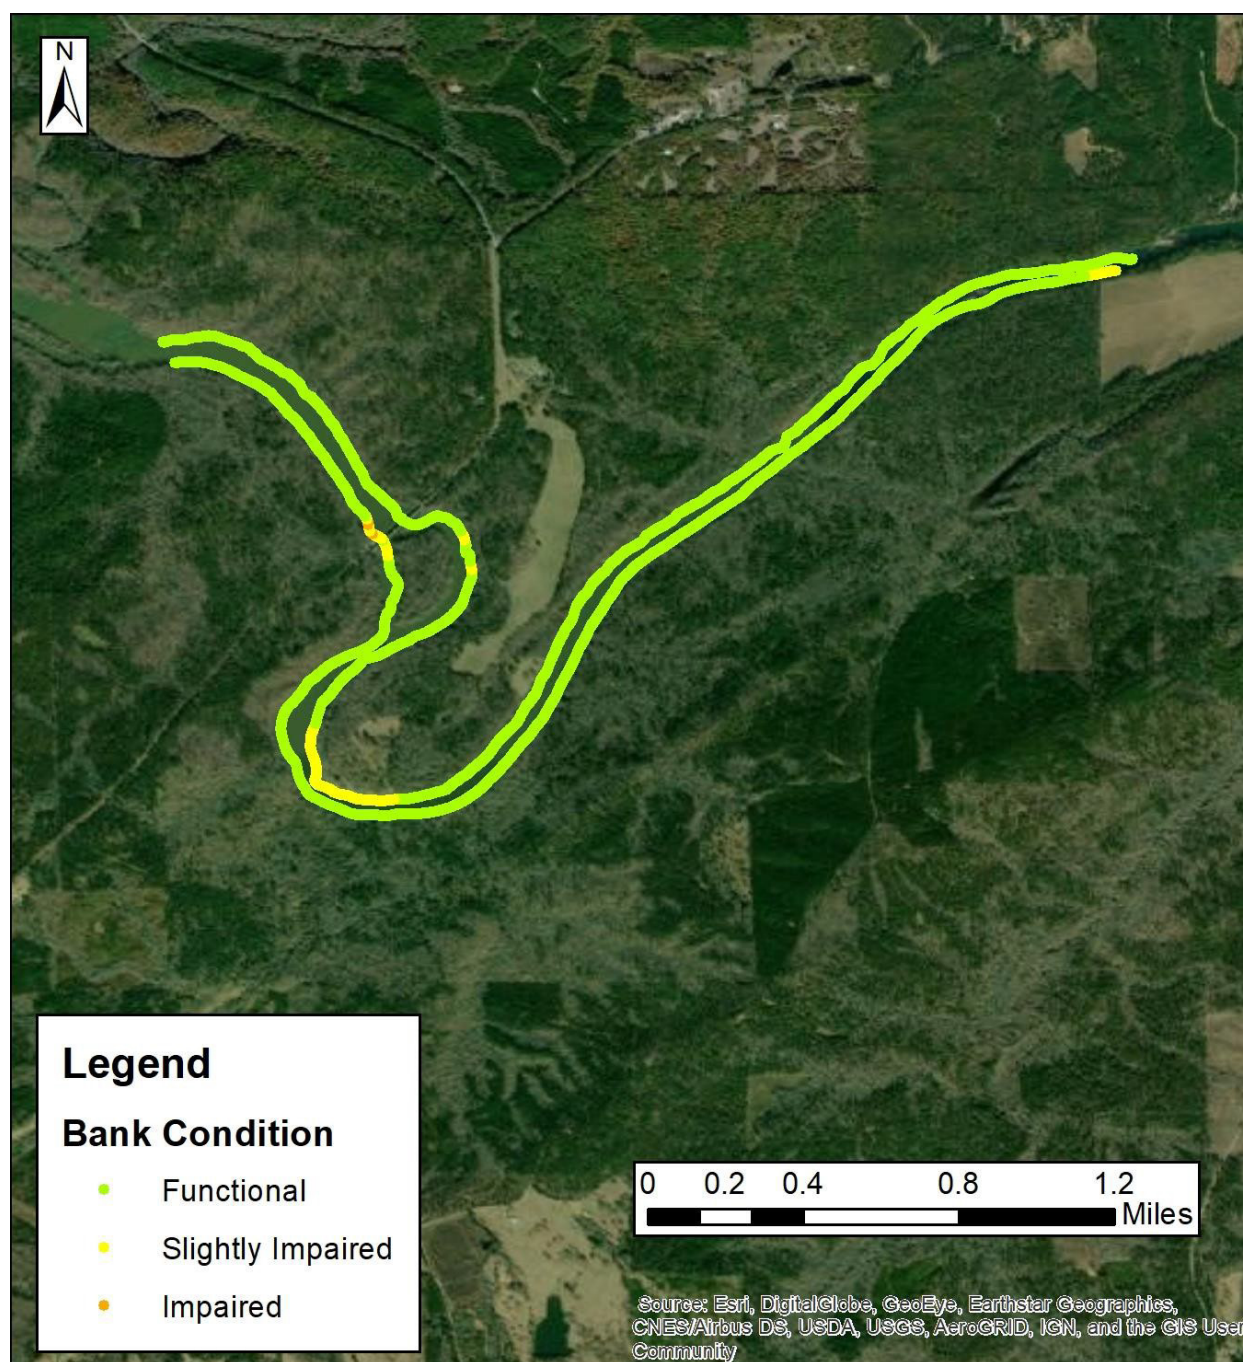
Streambanks were classified into one of five condition categories and one of three type categories. Condition categories represented the extent of impairment (fully functional (1) to non-functional (5)) on the streambank. In general, streambank conditions were in functional condition near the HOBE (Figure 18 & Figure 19). The majority of streambanks classified as functional and less than 10% was in the slightly impaired category. Only 1% of the streambanks were considered impaired and none were classified as non-functional. From a streambank function perspective, most of the river has intact riparian zone extending up to the upper lip of the streambank. There was vegetative cover on most of the banks and the banks were neither overly high nor steep considering the size of the river. We also reviewed the tributary confluences within the area including Soapstone Creek, Miller Creek, and an unnamed creek all on the left side of the river and none were causing observable issues.

Figure 19: Bank Condition Score for the Tallapoosa River HDSS project.

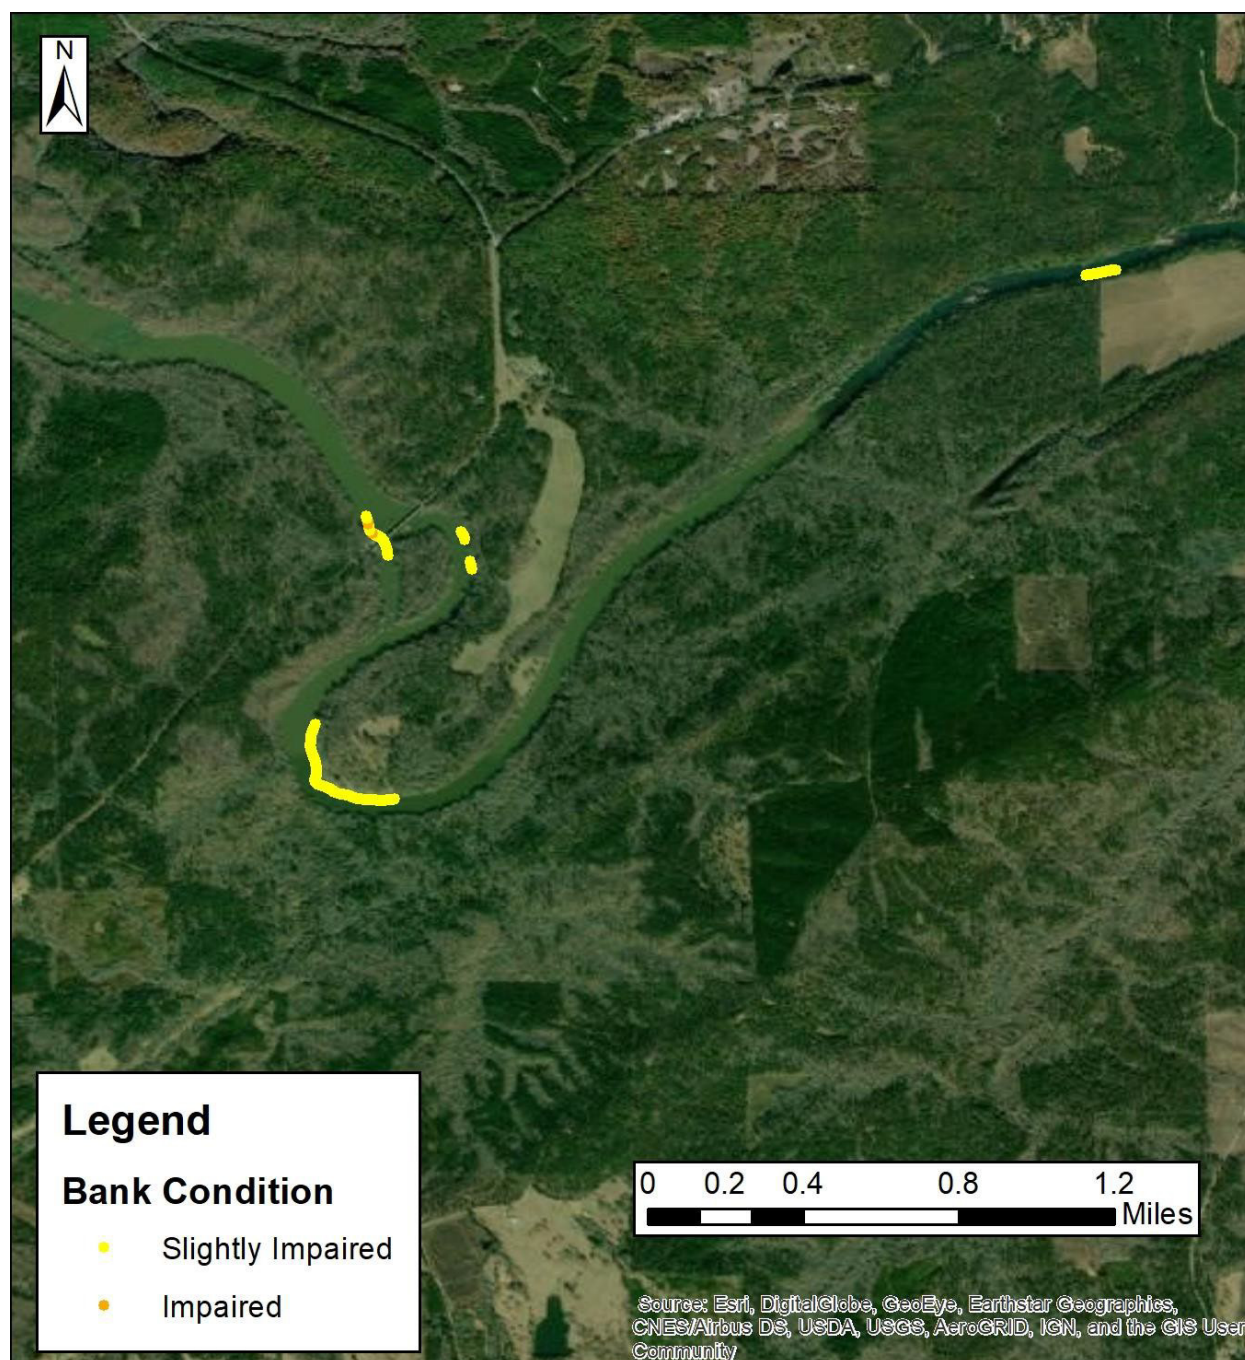
Another objective of the project was to identify the most degraded stretches on left and right streambank locations to allow managers to better understand specific areas where streambank management may be of importance at HOBE. Interestingly, only two very small areas just downstream of the Hwy 49 Bridge on the left bank scored as impaired. (Figure 20). Examples of the worst areas are shown in Figure 21 and Figure 22 and highlight the overall good condition of the streambanks.

Figure 20: Worst Bank Condition Areas from the HDSS results for the Tallapoosa River.

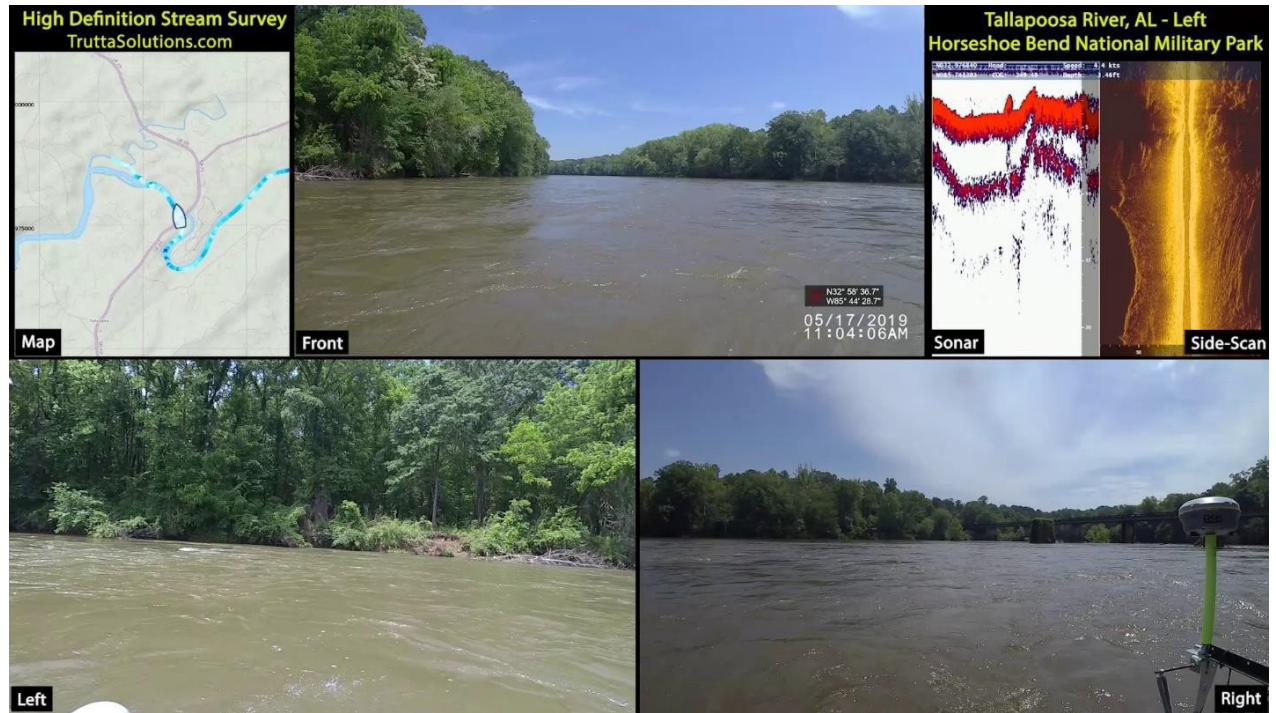
Figure 21: Example images of worst area on left bank of the Tallapoosa River just downstream of the Hwy 49 Bridge.

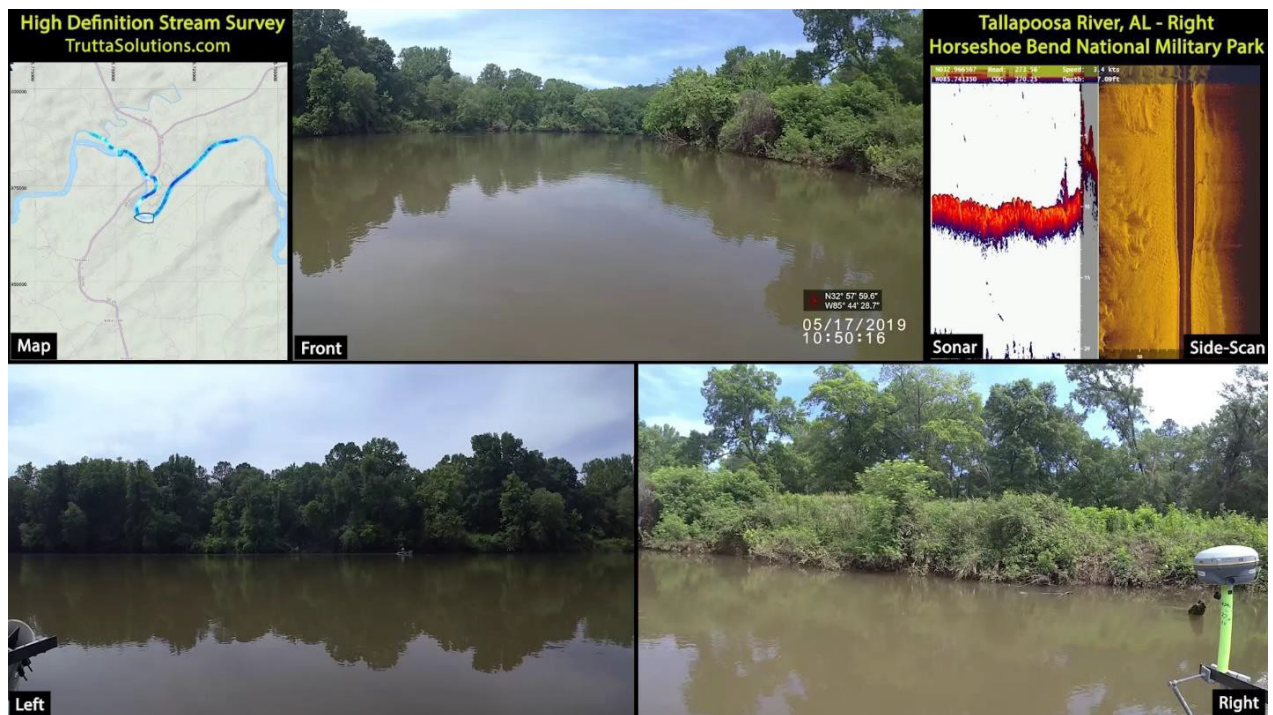
The largest area of concern was associated with the inside bend of HOBE and it scored as slightly impaired. This section showed some problems with the streambank condition which was most evident in areas where the trees or brush had been cleared to the streambank. While this section scored as slightly impaired, it is important to understand that the scoring system has been developed for use in a wide variety of streams and rivers. As a result, the scoring system was designed to be comparative among different streams, rivers, or reaches of the same river. The most degraded conditions are reserved for completely failing streambanks where active and extensive erosion is observed. For example, Figure 23 shows a degraded streambank on the Tallapoosa River above HOBE. In the image, the bank was actively eroding with extensive bank sloughing occurring. There was little to no riparian cover and only small plants on the streambank to provide stabilization. No areas with this level of degraded conditions were observed on the Tallapoosa River within HOBE.

Figure 22: Example images of worst area on right bank of the Tallapoosa River on the inside of Horseshoe Bend.

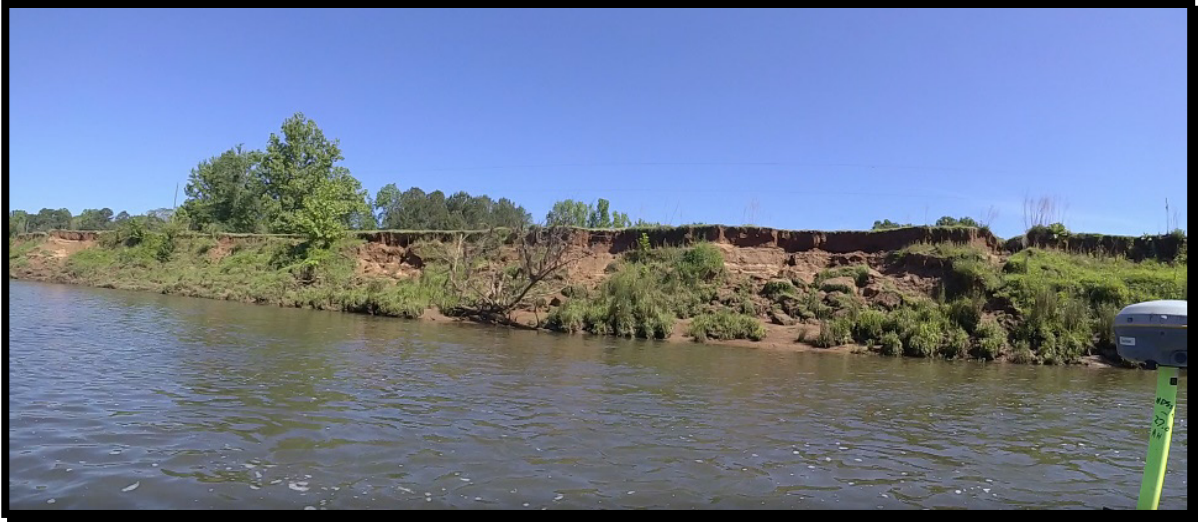
While the streambank classification system applied in this report was intended to be broadly comparable, when considering only those sites along the banks of the Tallapoosa River within HOBE, the sites highlighted here were the most degraded site observed. Thus, from a consideration of management actions within the jurisdiction of HOBE, streambank and riparian management would be important at these locations.

Figure 23: An example of a degraded streambank observed upstream of HOBE on the Tallapoosa River.
