# NPS Wildfire Risk Assessments

### Knife River Indian Villages National Historic Site

# NPS Wildand Fire Risk Assessment - Facility Wildfire Risk Assessment Summary

**Unit - Location: KNRI - KNRI**

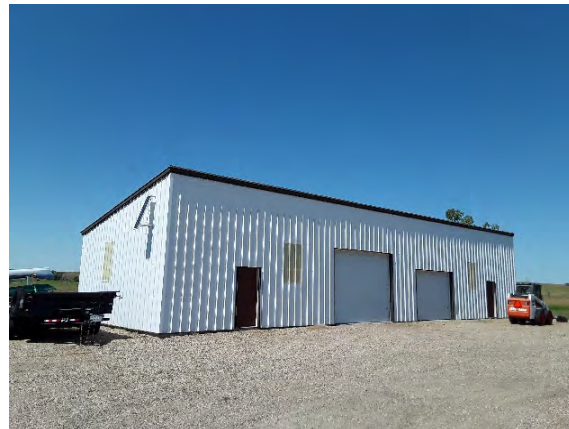
2022\_KNRI\_66841\_Cold Storage Building\_Front.jpg

**Additional Obstacles:** Hazmat, UXO,etc. , PLEASE COMMENT  
**Triage Category:**  
**Hazmat:** Diesel and fuel depot across parking lot.  
**Assessment Comments:**

**Score: 41**  
**Rating: Low**

| Label # | Facility/Community Name | Assessment Scale | Site Visit Type | Firewise Zone | Treatment | Treatment Description | Person Hours | Date |
|---|---|---|---|---|---|---|---|---|
| 1 | Cold Storage Building | Individual Facility | Initial | 1 | Mow dead/dying grass to less than 4 inches | Continue to mow in Zone 1. | 0.5 | 3/18/17 |

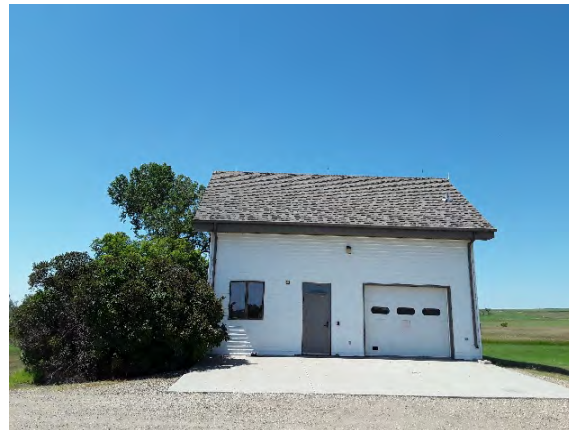
2022\_KNRI\_66832\_Maint. Office Building\_Front.jpg

Hazmat: Diesel and fuel depot across parking lot.

Score: 37  
Rating: Low

| Label # | Facility/Community Name | Assessment Scale | Site Visit Type | Firewise Zone | Treatment | Treatment Description | Person Hours | Date |
|---|---|---|---|---|---|---|---|---|
| 2 | Maint. Office Building | Individual Facility | Initial | 1 | Mow dead/dying grass to less than 4 inches | Continue to mow in Zone 1. | 0.5 | 3/18/17 |
| | | Individual Facility | Initial | 2 | Mow dead/dying grass to less than 4 inches | Continue to mow in Zone 2. | 1.0 | 3/18/17 |

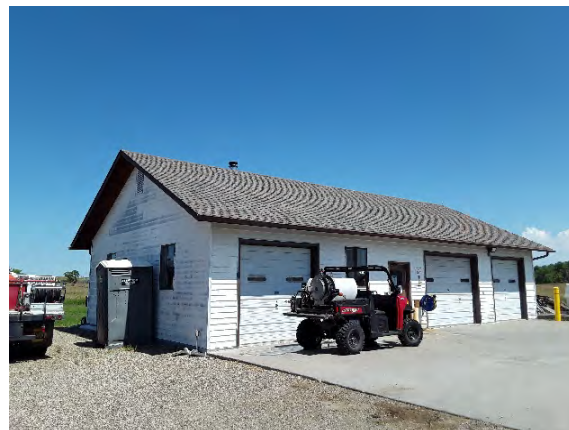
2022\_KNRI\_66840\_Maintenance Shop\_Front.jpg

Firewood: 5ft to 30ft from facility

Hazmat: Diesel and fuel depot in front of structure.

Score: 39  
Rating: Low

| Label # | Facility/Community Name | Assessment Scale | Site Visit Type | Firewise Zone | Treatment | Treatment Description | Person Hours | Date |
|---|---|---|---|---|---|---|---|---|
| 3 | Maintenance Shop | Individual Facility | Initial | 1 | Mow dead/dying grass to less than 4 inches | Continue to mow in Zone 1. | 0.5 | 3/18/17 |
| | | Individual Facility | Initial | 2 | Mow dead/dying grass to less than 4 inches | Continue to mow in Zone 2. | 1.0 | 3/18/17 |

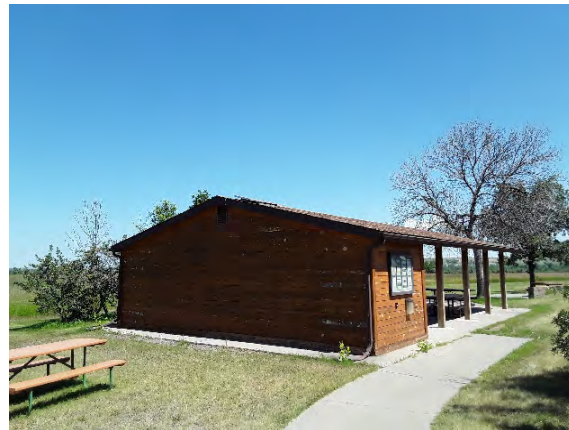
2022\_KNRI\_93352\_Interpretive Shelter\_Front.jpg

**Assessment Comments:** Closed structure with open sided shade roof attached.

**Score: 34**  
**Rating: Low**

| Label # | Facility/Community Name | Assessment Scale | Site Visit Type | Firewise Zone | Treatment | Treatment Description | Person Hours | Date |
|---|---|---|---|---|---|---|---|---|
| 4 | Interpretive Shelter | Individual Facility | Initial | 1 | Mow dead/dying grass to less than 4 inches | Continue to mow in Zone 1. | 0.5 | 3/18/17 |

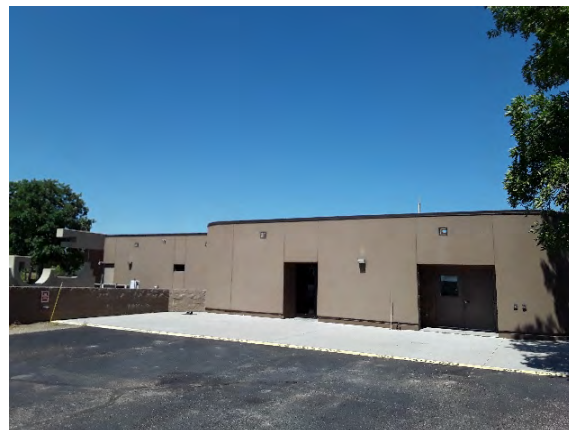
2022\_KNRI\_66810\_Visitor Center\_Front.jpg

**Score: 16**  
**Rating: Low**

| Label # | Facility/Community Name | Assessment Scale | Site Visit Type | Firewise Zone | Treatment | Treatment Description | Person Hours | Date |
|---|---|---|---|---|---|---|---|---|
| 5 | Visitor Center | Individual Facility | Initial | 1 | Mow dead/dying grass to less than 4 inches | Continue to mow in Zone 1. | 0.5 | 3/18/17 |

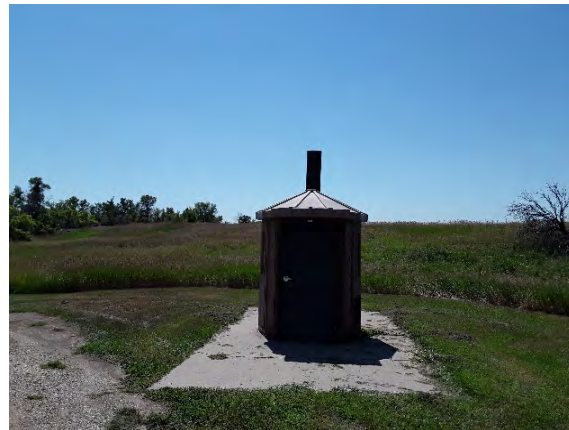
2022\_KNRI\_101926\_Romtec, Awitixa Trail Head\_Front.jpg

Roof Material: Combustible or no roof

Assessment Comments: Roof made of a plastic type material.

Score: 74  
Rating: High

| Label # | Facility/Community Name | Assessment Scale | Site Visit Type | Firewise Zone | Treatment | Treatment Description | Person Hours | Date |
|---|---|---|---|---|---|---|---|---|
| 6 | Romtec, Awitixa Trail Head | Individual Facility | Initial | 1 | Mow dead/dying grass to less than 4 inches | Mow in Zone 1. | 0.5 | 3/18/17 |

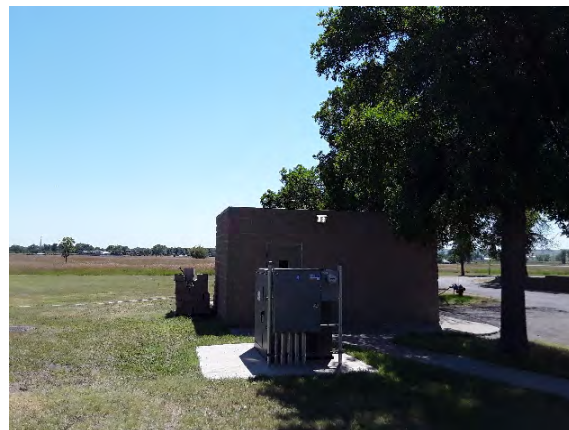
2022\_KNRI\_66811\_Tractor Storage Building\_Front.jpg

**Score: 19**  
**Rating: Low**

| Label # | Facility/Community Name | Assessment Scale | Site Visit Type | Firewise Zone | Treatment | Treatment Description | Person Hours | Date |
|---|---|---|---|---|---|---|---|---|
| 7 | Tractor Storage Building | Individual Facility | Initial | 1 | Mow dead/dying grass to less than 4 inches | Continue to mow in Zone 1. | 0.5 | 3/18/17 |
| | | Individual Facility | Initial | 2 | Mow dead/dying grass to less than 4 inches | Continue to mow in Zone 2. | 1.0 | 3/18/17 |

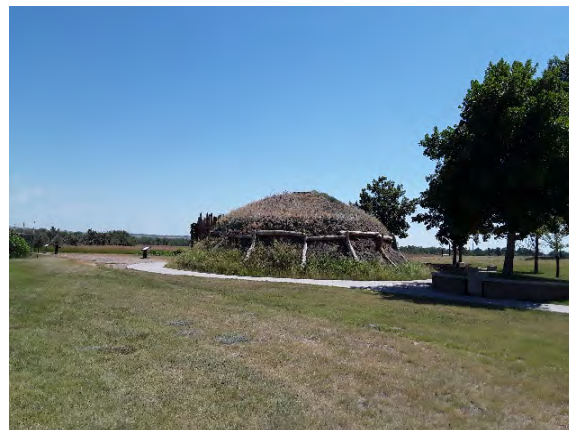
2022\_KNRI\_66812\_Earthlodge\_Front.jpg

**Assessment Comments:** Earth lodge structure made of sod with grasses growing in it and wooden doorway entrance.

**Score: 41**  
**Rating: Low**

| Label # | Facility/Community Name | Assessment Scale | Site Visit Type | Firewise Zone | Treatment | Treatment Description | Person Hours | Date |
|---|---|---|---|---|---|---|---|---|
| 8 | Earthlodge | Individual Facility | Initial | 1 | Mow dead/dying grass to less than 4 inches | Continue to mow in Zone 1. | 0.5 | 3/18/17 |

| 8 | Earthlodge | Individual Facility | Initial | 2 | Mow dead/dying grass to less than 4 inches | Continue to mow in Zone 2. | 1.0 | 3/18/17 |

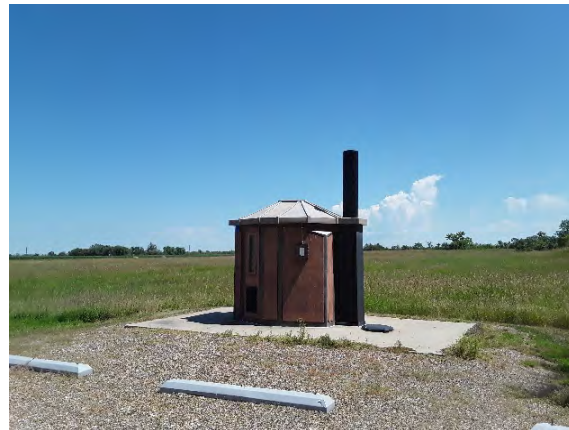
2022\_KNRI\_101939\_Romtec, Two Rivers Trailhead\_Front.jpg

**Assessment Comments:** Roof is made of plastic type material.

**Score: 57**  
**Rating: Moderate**

| 9 | Romtec, Two Rivers Trailhead | Individual Facility | Initial | 1 | Mow dead/dying grass to less than 4 inches | Mow in Zone 1. | 0.5 | 3/18/17 |
| | | Individual Facility | SiteVisit | 2 | Mow dead/dying grass to less than 4 inches | | 1.0 | 8/10/22 |

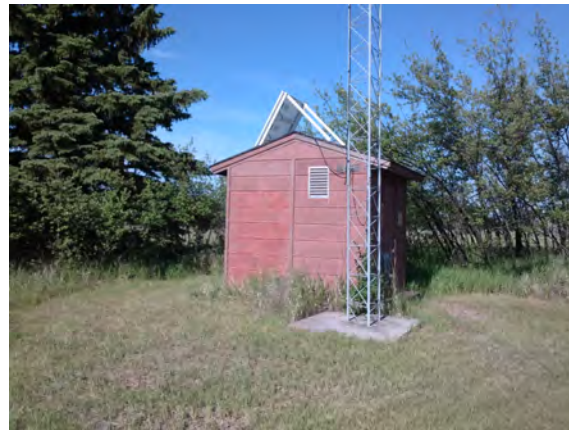
KNRI\_80915\_Radio Shack\_Front.jpg

**Assessment Comments:** Radio building with approximately 30 ft tower.

**Score: 63**  
**Rating: High**

| Label # | Facility/Community Name | Assessment Scale | Site Visit Type | Firewise Zone | Treatment | Treatment Description | Person Hours | Date |
|---|---|---|---|---|---|---|---|---|
| 11 | Radio Shack | Individual Facility | Initial | 1 | Mow dead/dying grass to less than 4 inches | Mow in Zone 1. | 0.5 | 3/18/17 |
