# NPS Wildfire Risk Assessments Assessment Locations

## CAGR - Casa Grande National Monument Overview

# NPS Wildand Fire Risk Assessment - Facility Assessment

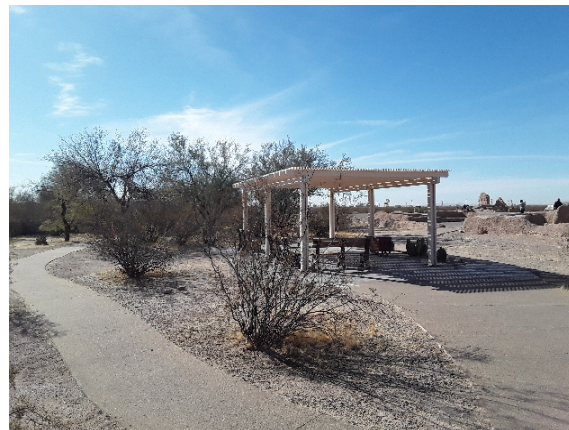
2021\_CAGR\_not found \_Shade Structure\_Front.jpg

**Score: 23**  
**Rating: Low**

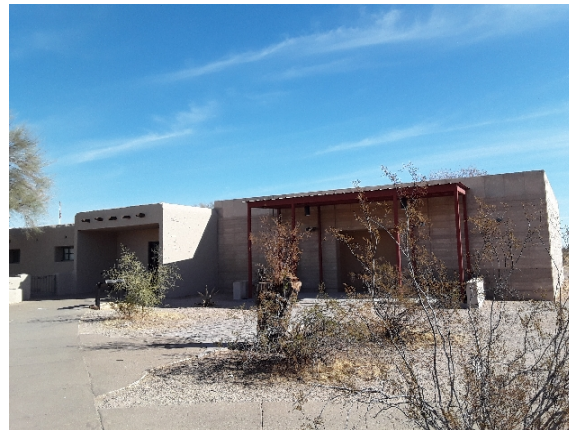
2021\_CAGR\_240829\_Auditorium\_Front.jpg

**Additional Obstacles:** None  
**Triage Category:**  
**Hazmat:**  
**Assessment Comments:** attached to visitor center

**Score: 16**  
**Rating: Low**

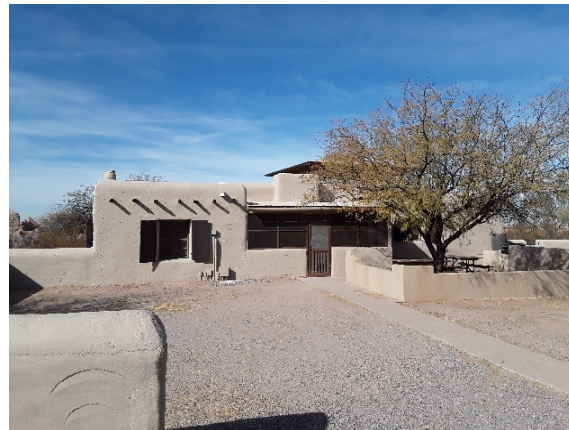
2021\_CAGR\_40405\_B-1 Administrative Building\_Front.jpg

**Score: 19**  
**Rating: Low**

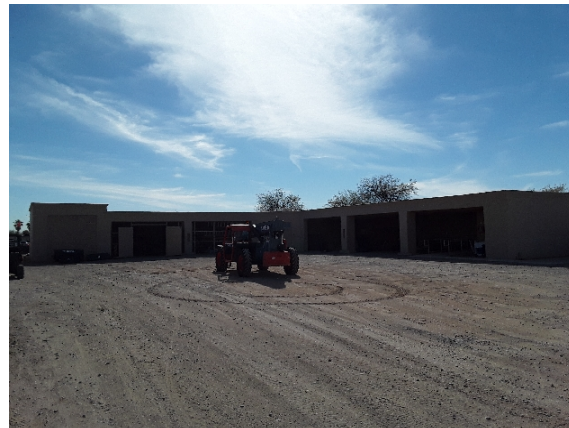
2021\_CAGR\_40386\_B-10 Equipment Shed\_Front.jpg

**Triage Category:**  
**Hazmat:** flammable fuel locker on NW side of building  
**Assessment Comments:**

**Score: 27**  
**Rating: Low**

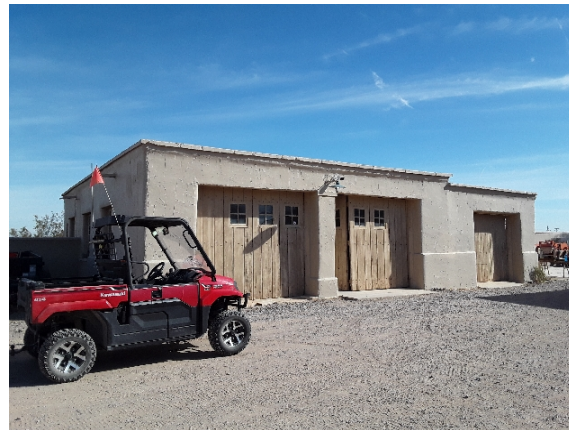
2021\_CAGR\_40390\_B-11 Maintenance Shop\_Front.jpg

**Triage Category:**  
**Hazmat:** flammable fuels locker on D side  
**Assessment Comments:**

**Score: 29**  
**Rating: Low**

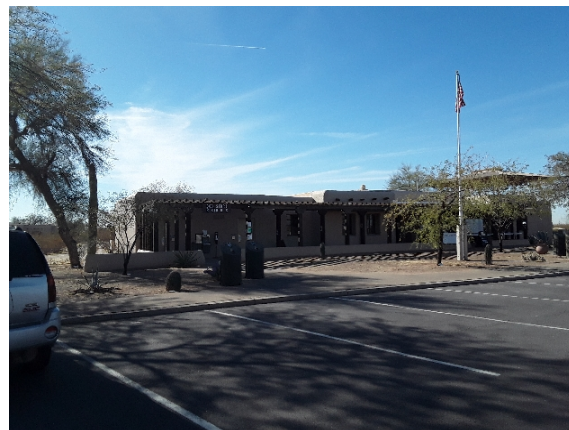
2021\_CAGR\_40353\_B-12 Visitor Center\_Front.jpg

Assessment Comments: The building contains irreplaceable artifacts.

Score: 16  
Rating: Low

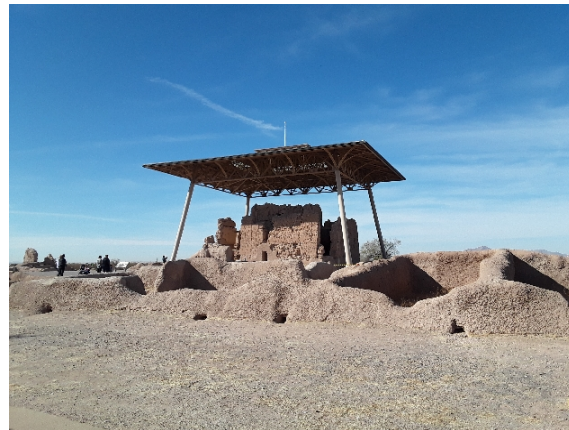
2021\_CAGR\_40395\_B-14 Ruins Shelter\_Front.jpg

**Additional Obstacles:** None  
**Triage Category:**  
**Hazmat:**  
**Assessment Comments:** Historic Native American Ruin

**Score: 20**  
**Rating: Low**

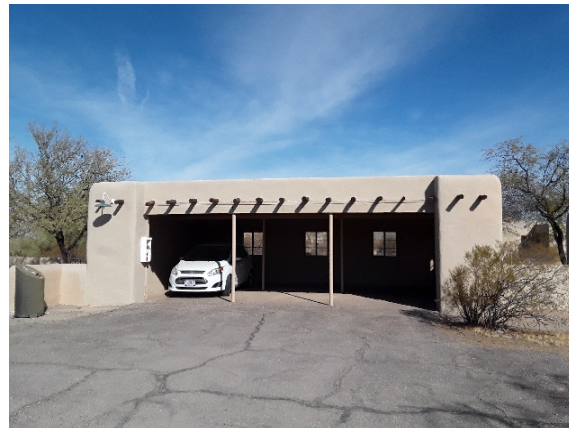
2021\_CAGR\_40411\_B-15 Parking Garage\_Front.jpg

**Score: 26**  
**Rating: Low**

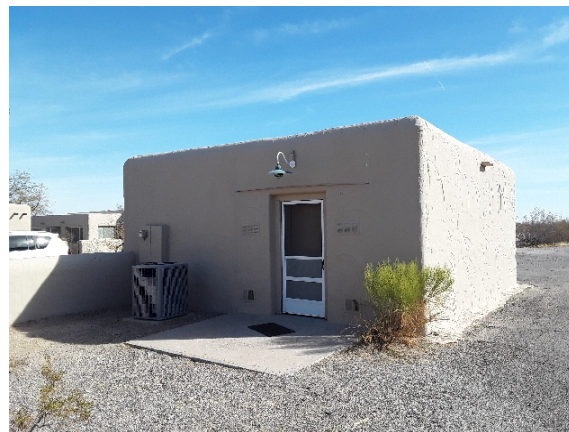
2021\_CAGR\_40412\_B-16 Library\_Front.jpg

**Score: 20**  
**Rating: Low**

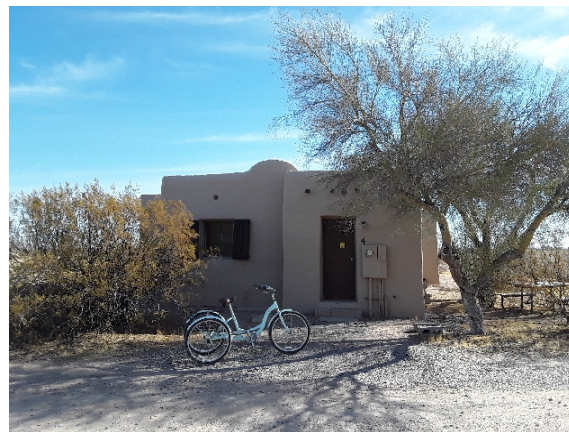
2021\_CAGR\_40409\_B-4 Resource Office\_Front.jpg

**Score: 18**  
**Rating: Low**

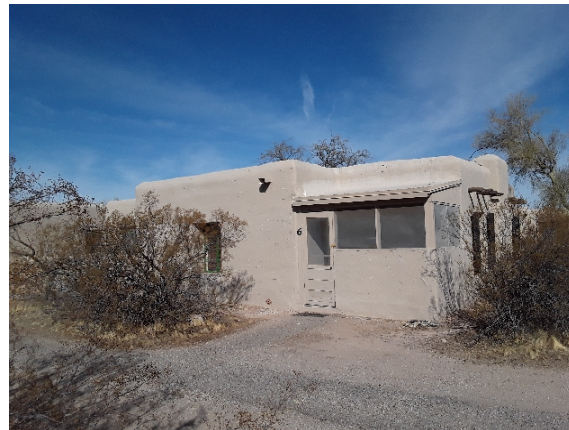
2021\_CAGR\_40410\_B-6 Seasonal Employee Housing\_Front.jpg

**Score: 20**  
**Rating: Low**

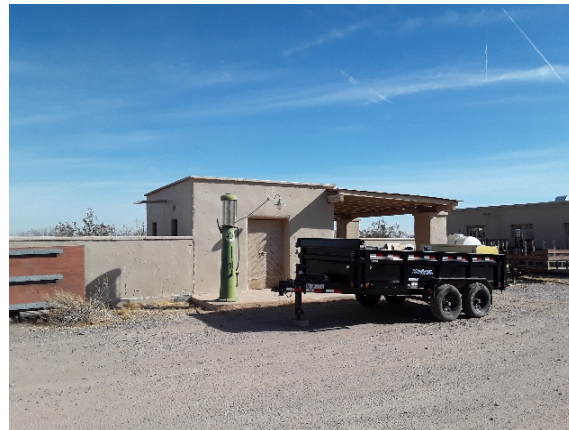
2021\_CAGR\_40383\_B-8 Oil House\_Front.jpg

**Triage Category:**  
**Hazmat:** old gas pump on A side, unsure if still used  
**Assessment Comments:**

**Score: 23**  
**Rating: Low**

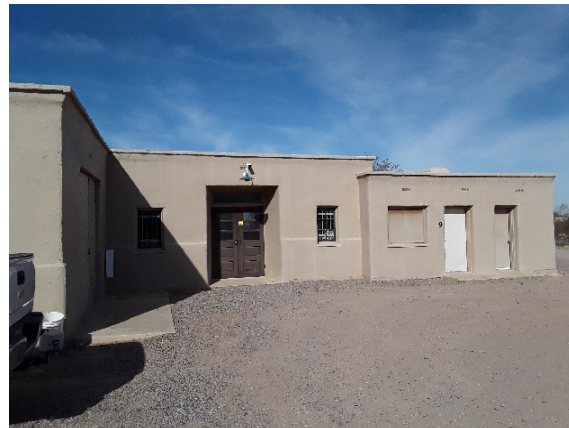
2021\_CAGR\_40384\_B-9 Maintenance Office\_Front.jpg

**Score: 20**  
**Rating: Low**

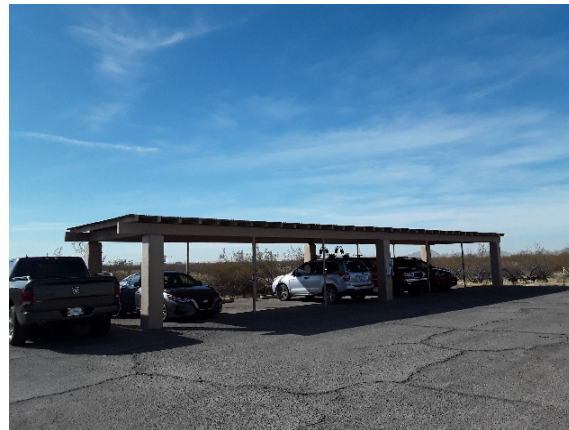
2021\_CAGR\_not found \_Carport\_Front.jpg

**Score: 20**  
**Rating: Low**

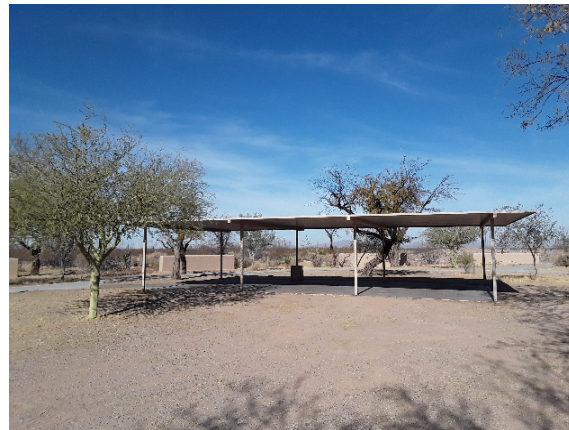
2021\_CAGR\_not found \_Picnic Shelter\_Front.jpg

**Score: 22**  
**Rating: Low**

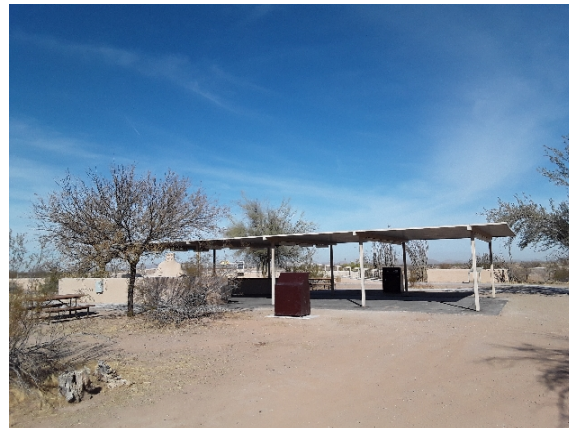
2021\_CAGR\_not found \_Picnic Shelter\_Front.jpg

**Score: 22**  
**Rating: Low**

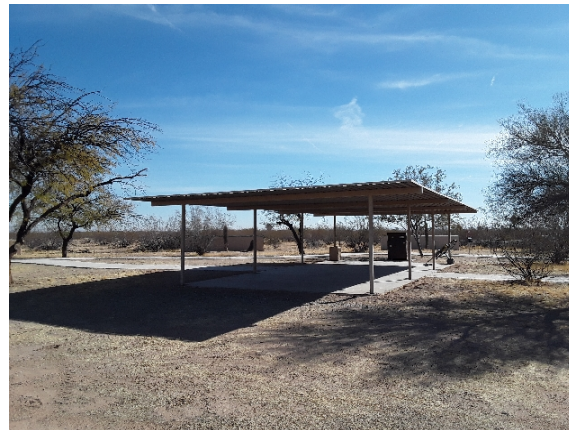
2021\_CAGR\_not found \_Picnic Shelter\_Front.jpg

**Score: 22**  
**Rating: Low**

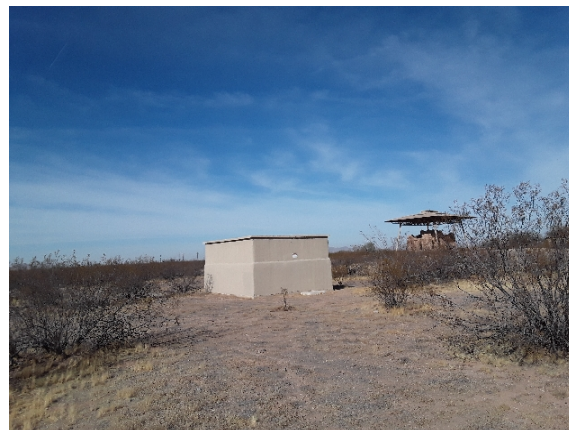
2021\_CAGR\_not found \_Pumphouse\_Front.jpg

**Score: 24**  
**Rating: Low**
