# NPS Wildfire Risk Assessments Assessment Locations

## Voyageurs National Park - Ash River Overview

# NPS Wildland Fire Risk Assessment - Facility Assessment

**Unit - Location:** VOYA - Ash River

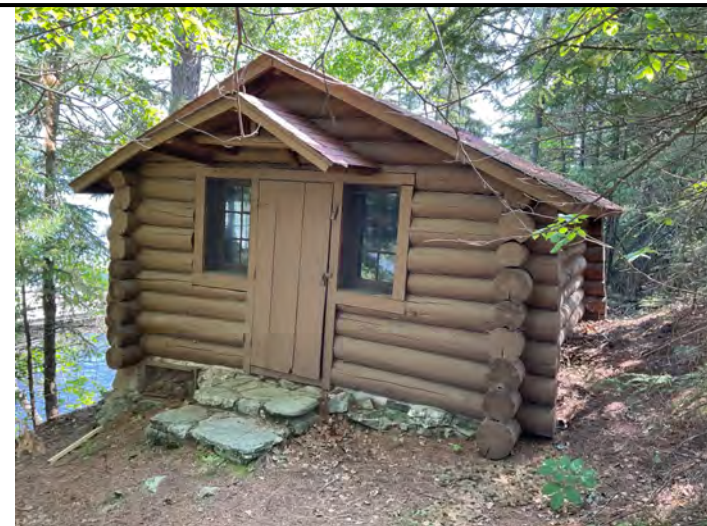
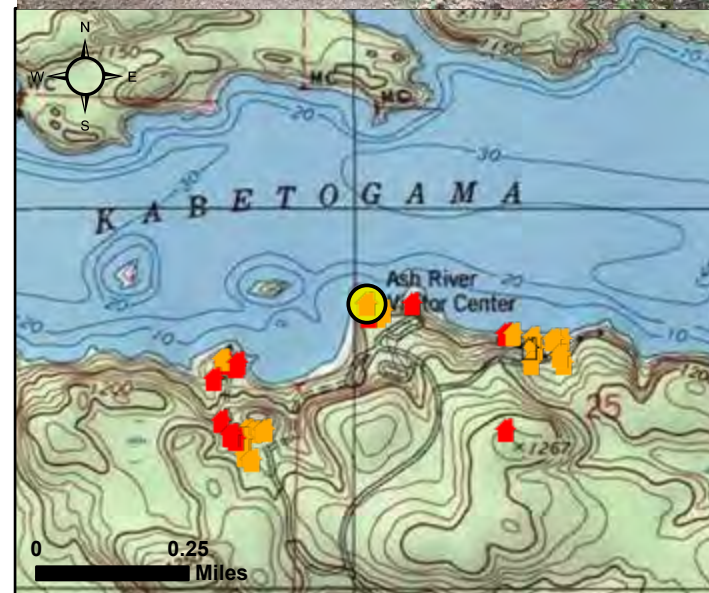
**Facility Name:** NAR BH016 Laundry bldg. at ARVC

**Rating:** Moderate

**Defensible Space:** No defensible space

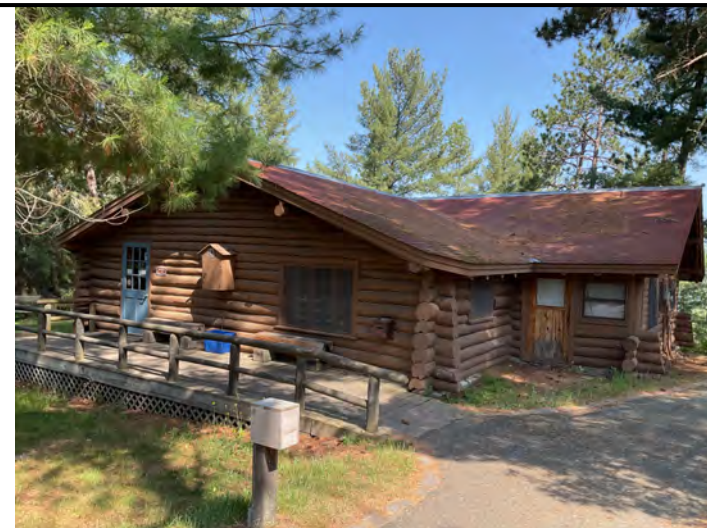
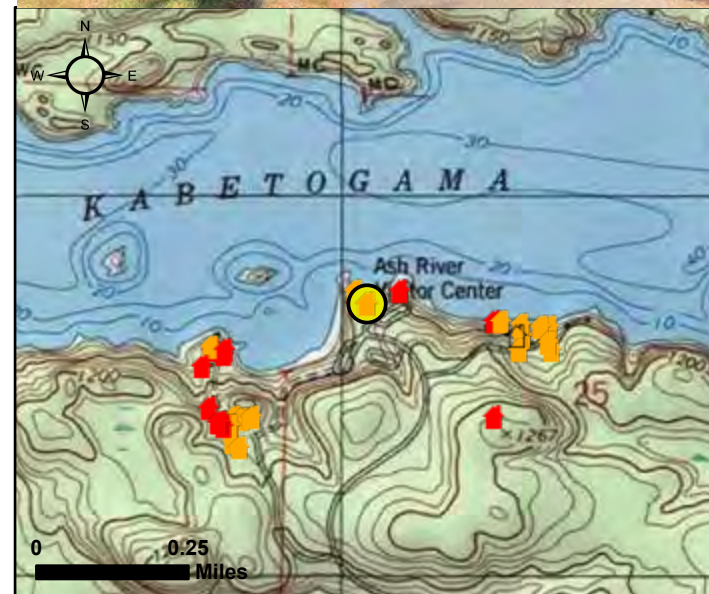
**Facility Name:** NAR BH017 Ash River V.C. Historic Log Structure

**Rating:** Moderate

**Defensible Space:** 30 ft treated

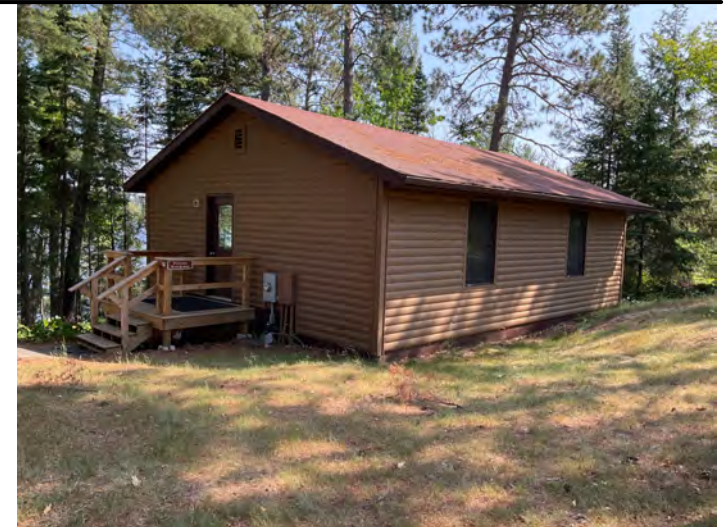
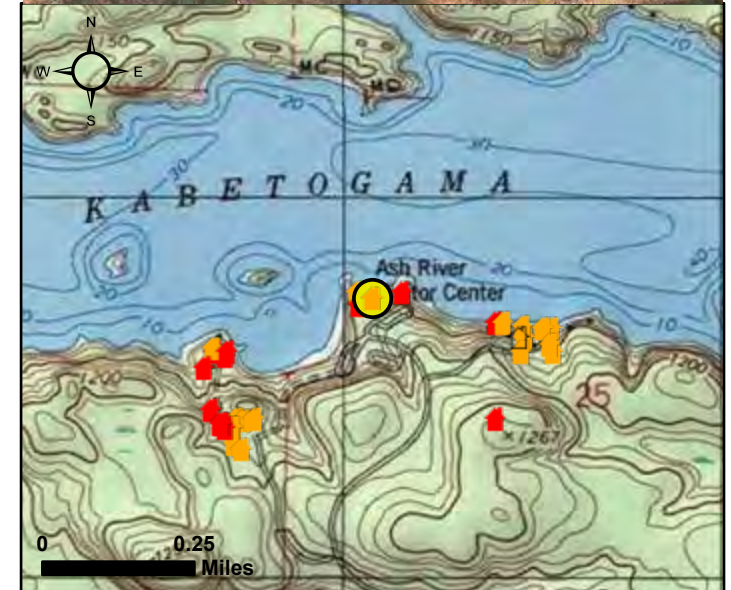
**Facility Name:** Q-0014 NAR BQ014 Qtrs at Ash River VC, Ranger Qtrs.00000014

**Rating:** Moderate

**Defensible Space:** Less than 30 ft treated

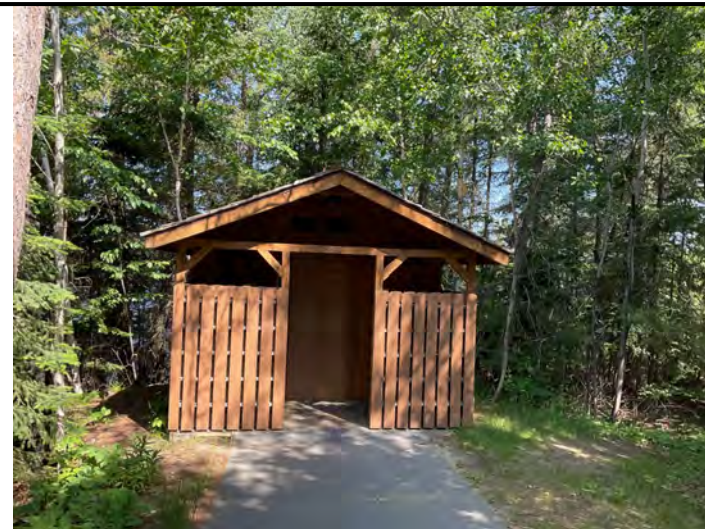
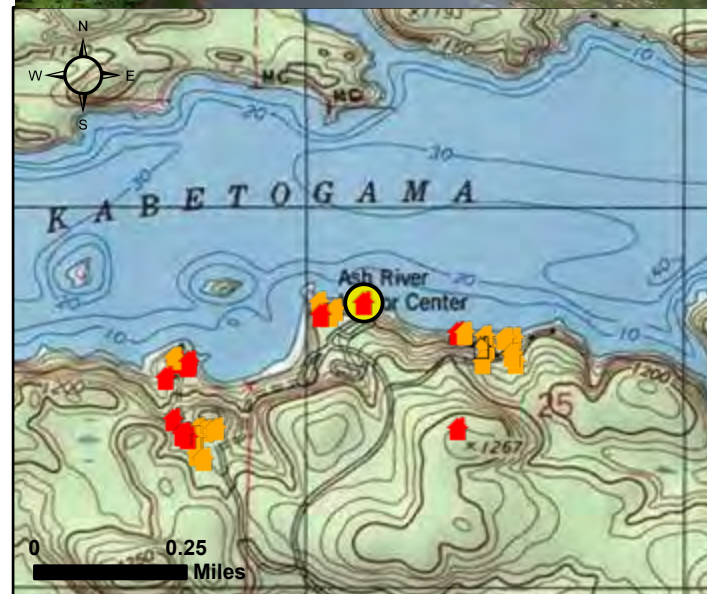
**Rating:** High  
**Protection Level:** Full,  
**Resources of Concern:** Unknown  
**Occupied:** No  
**In Community:** Yes, Ash River Visitor Center  
**Revisit Interval:** 5 yrs  
**Map Label:** 97

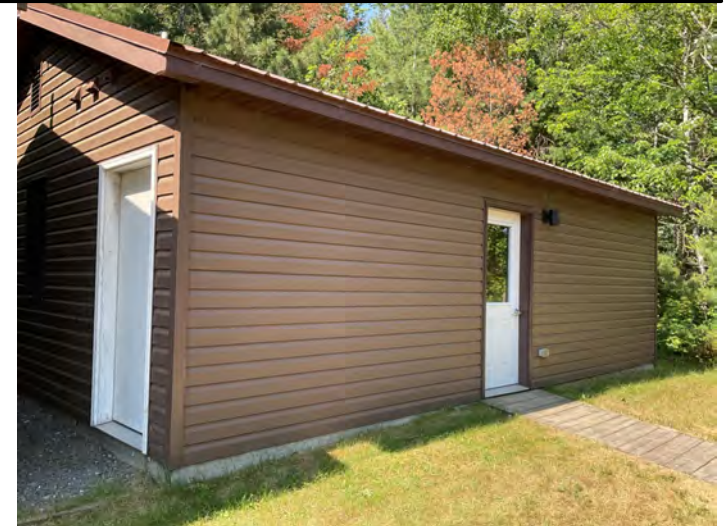
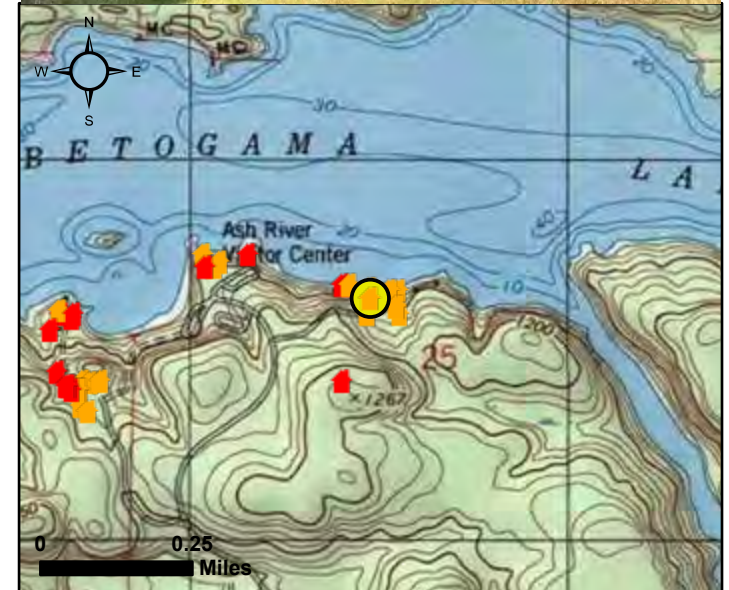
**Comments:** Facility join to Q-043B. Pictures for Q-043B are attached to this facility.

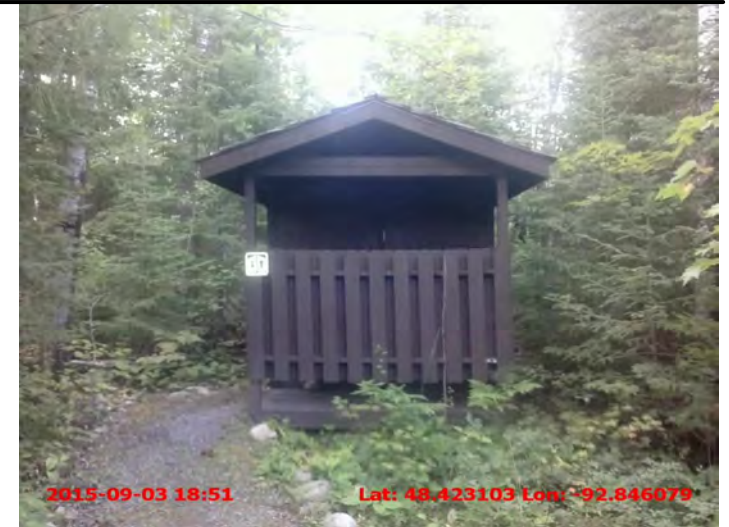
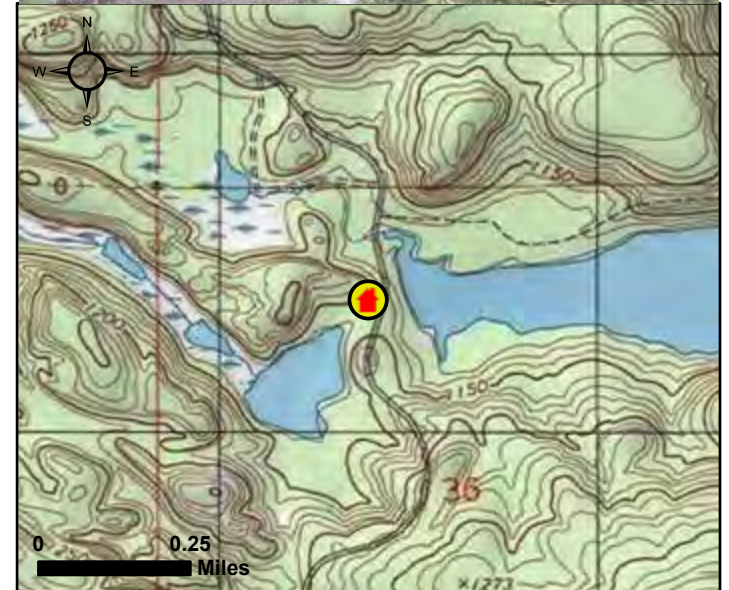
**Rating:** High  
**ProtectionLevel:** Full,  
**Resources of Concern:** Unknown  
**Occupied:** No  
**In Community:** No,  
**Revisit Interval:** yrs  
**Map Label:** 98

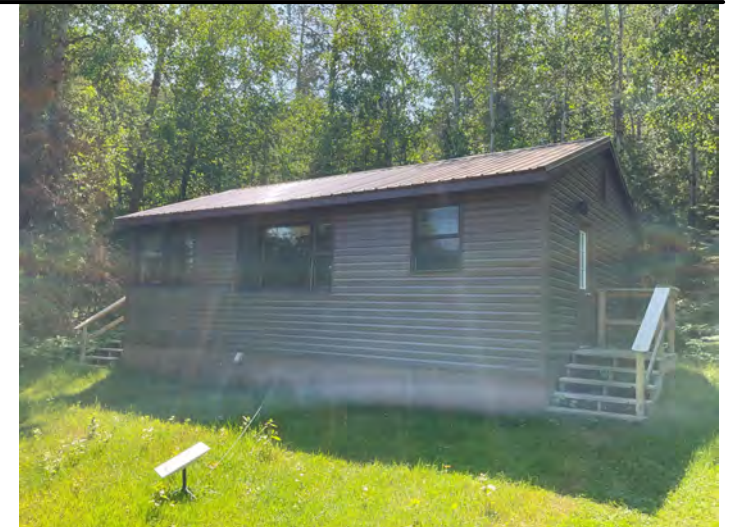
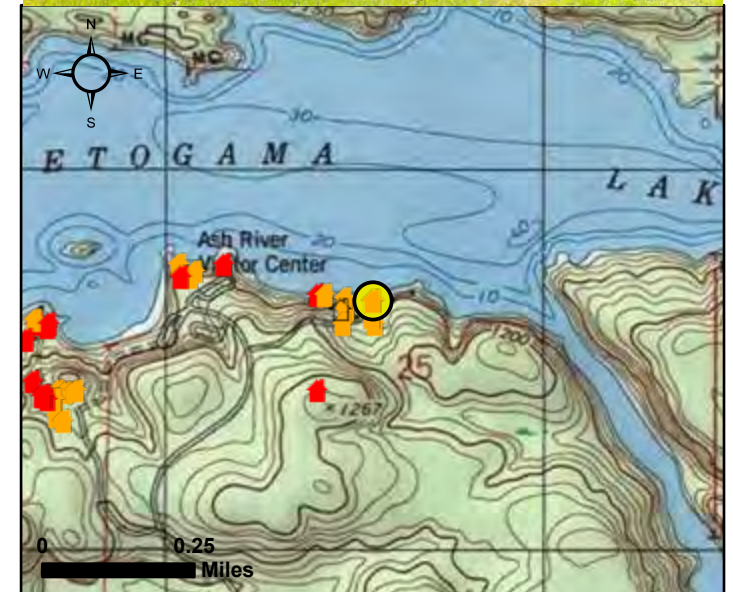
**Rating:** Moderate  
**ProtectionLevel:** Full,  
**Resources of Concern:** Unknown  
**Occupied:** Yes  
**In Community:** Yes, Ash River Quarters  
**Revisit Interval:** 5 yrs  
**Map Label:** 112

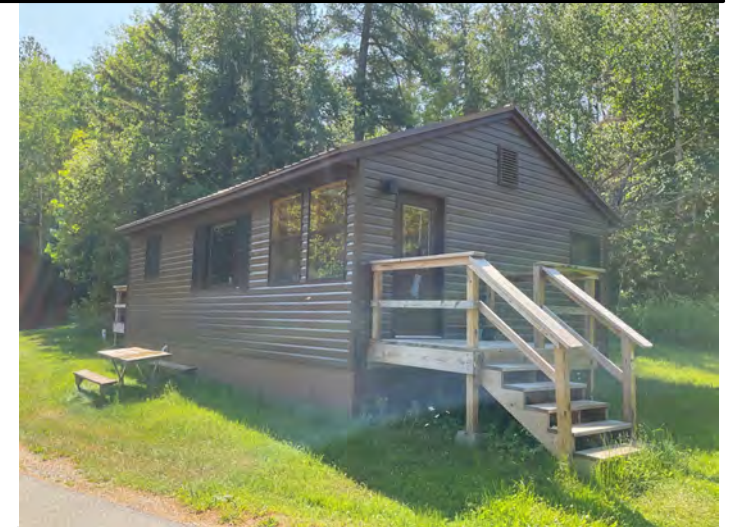
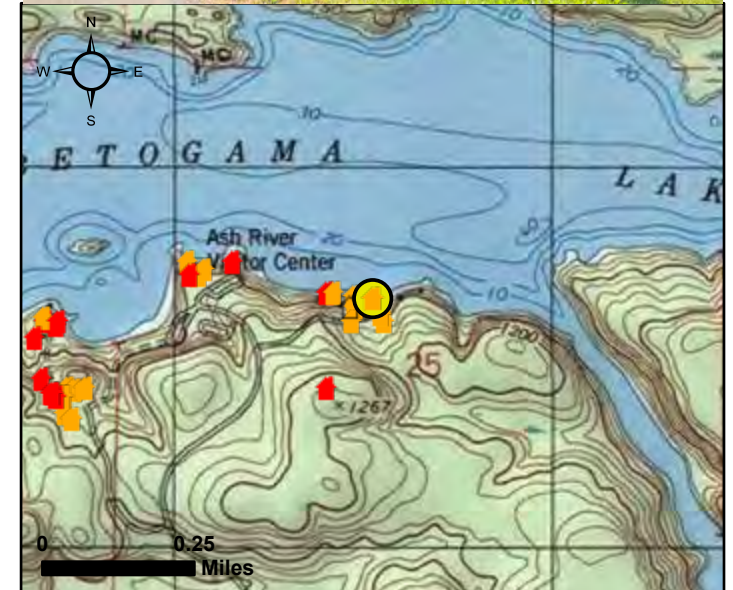
**Rating:** Moderate  
**Protection Level:** Full,  
**Resources of Concern:** Unknown  
**Occupied:** Yes  
**In Community:** Yes, Ash River Quarters  
**Revisit Interval:** 5 yrs  
**Map Label:** 105

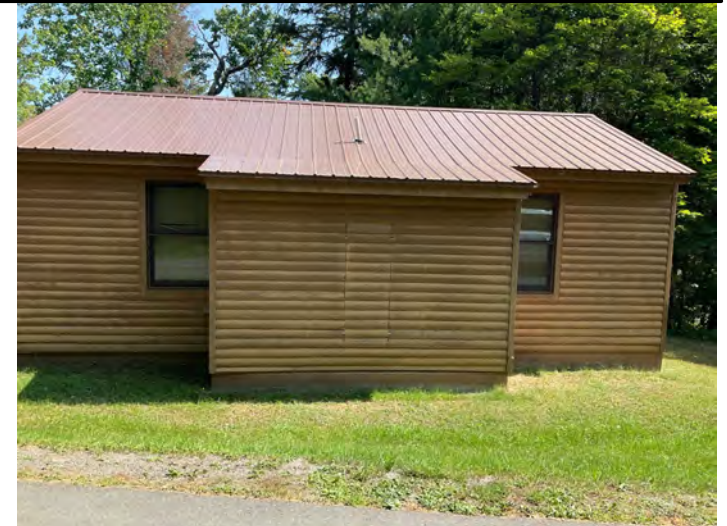
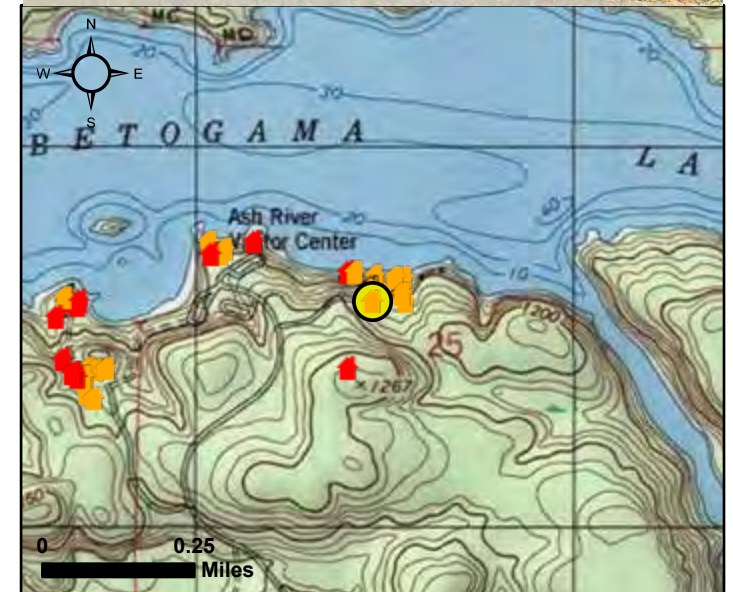
**Rating:** Moderate  
**Protection Level:** Full,  
**Resources of Concern:** Unknown  
**Occupied:** Yes  
**In Community:** Yes, Ash River Quarters  
**Revisit Interval:** 5 yrs  
**Map Label:** 102

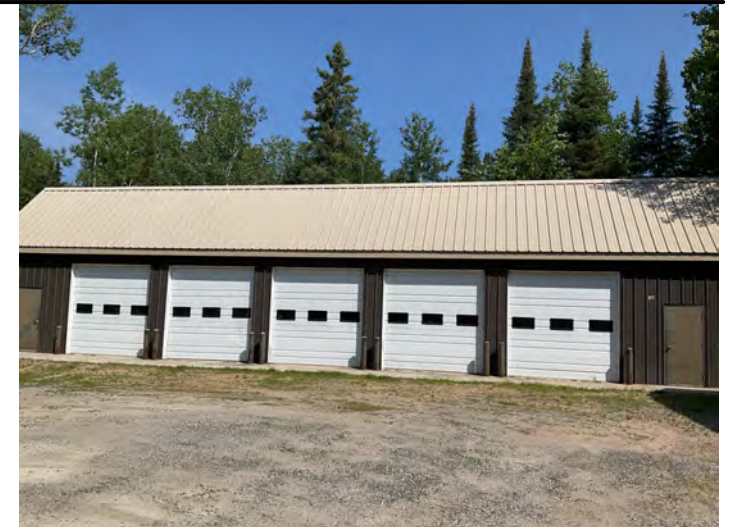
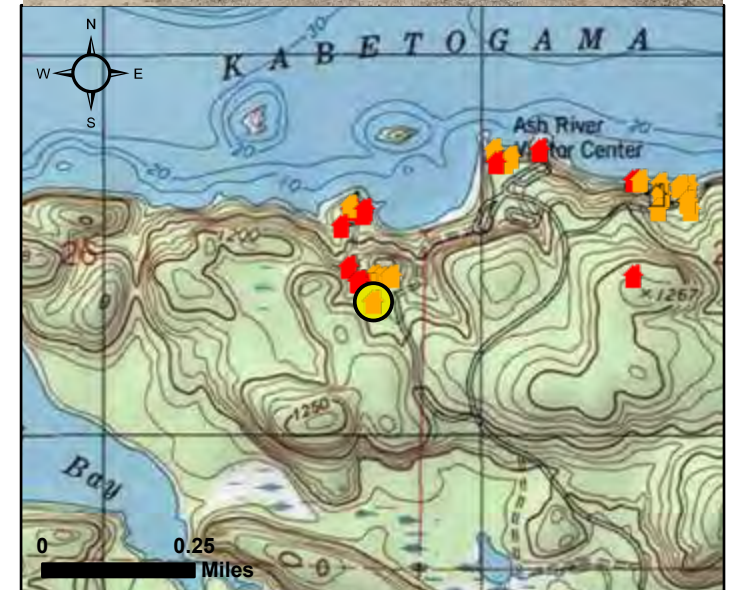
**Rating:** Moderate  
**Protection Level:** Full,  
**Resources of Concern:** Unknown  
**Occupied:** Yes  
**In Community:** Yes, Ash River Maintenance  
**Revisit Interval:** 5 yrs  
**Map Label:** 87

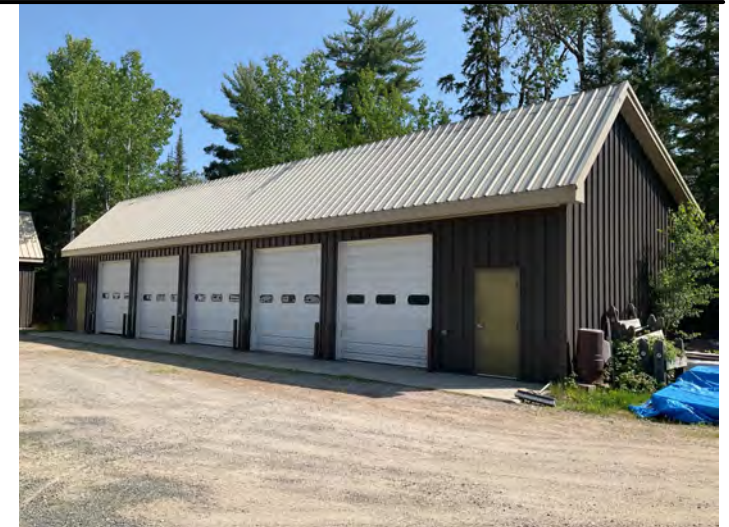
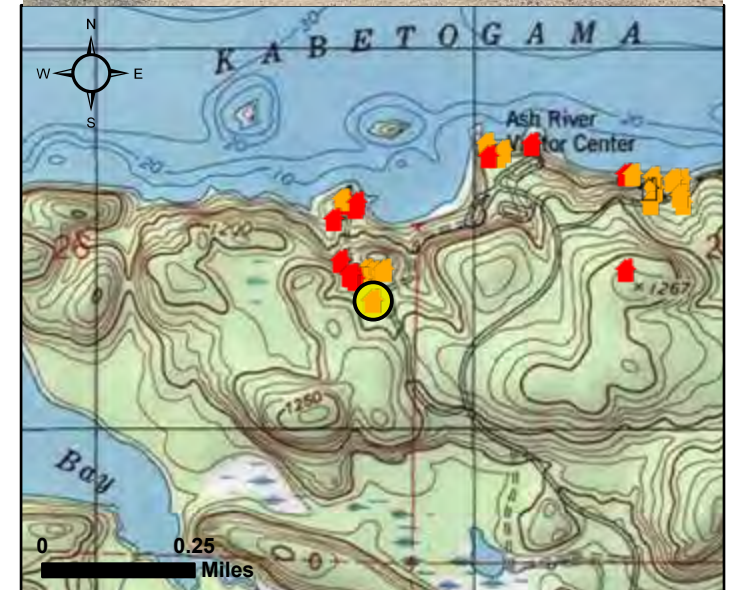
**Rating:** Moderate  
**Protection Level:** Full,  
**Resources of Concern:** Unknown  
**Occupied:** Yes  
**In Community:** Yes, Ash River Maintenance  
**Revisit Interval:** 5 yrs  
**Map Label:** 90

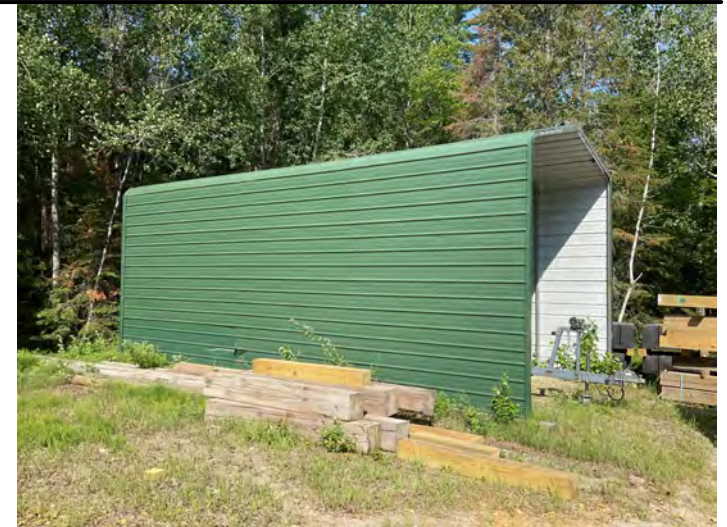
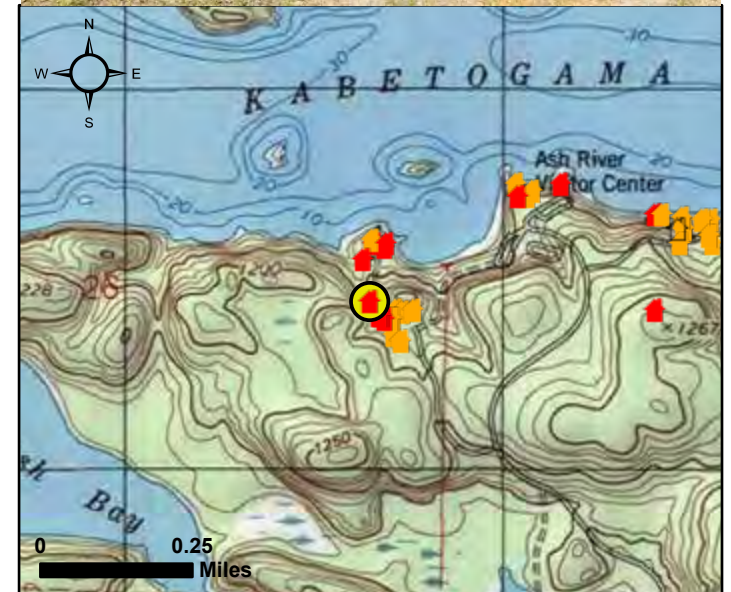
**Rating:** High  
**Protection Level:** Full,  
**Resources of Concern:** Unknown  
**Occupied:** No  
**In Community:** Yes, Ash River Maintenance  
**Revisit Interval:** 5 yrs  
**Map Label:** 78
