# NPS Wildfire Risk Assessments Assessment Locations

## Isle Royale National Park Overview

# NPS Wildland Fire Risk Assessment - Facility Assessment

**Facility Name:** Baggage Building, Houghton, B00603

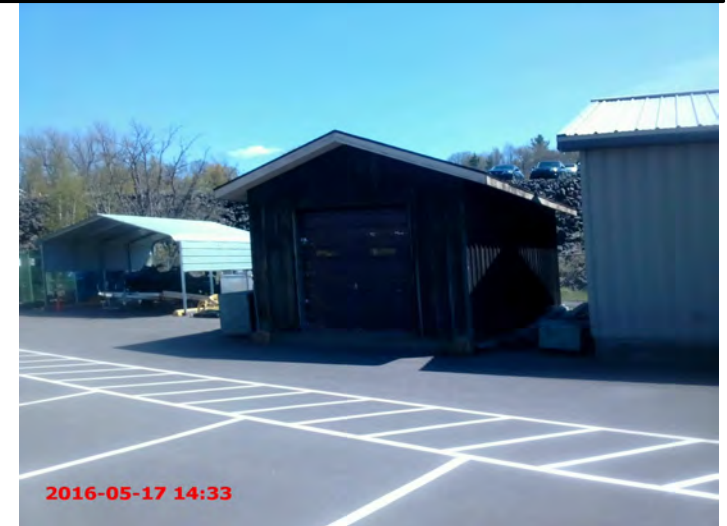
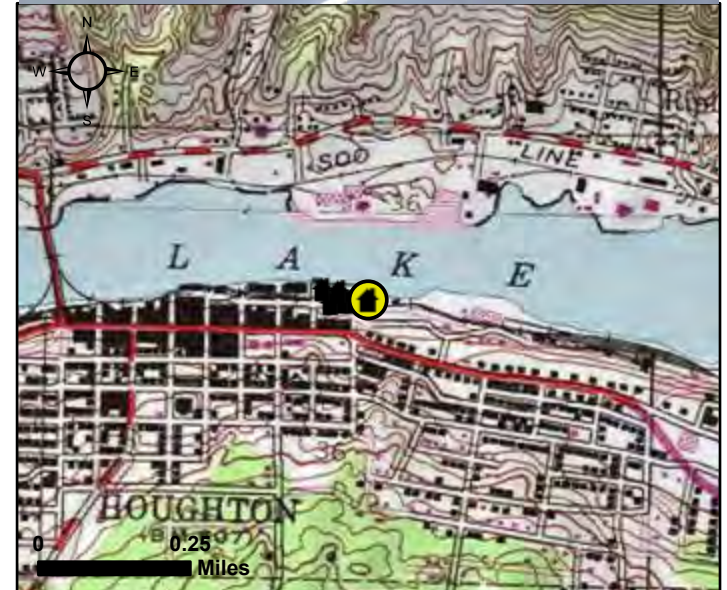
**Rating:** No Wildland Risk

**Fuel Type:** No wildland fuel

**Defensible Space:** Greater than 100ft treated

**Roof Material:** Fire resistant- tar,rubberized

**Siding Material:** Wood or open sided

**Foundation:** Closed, Less than 6in masonry exposed

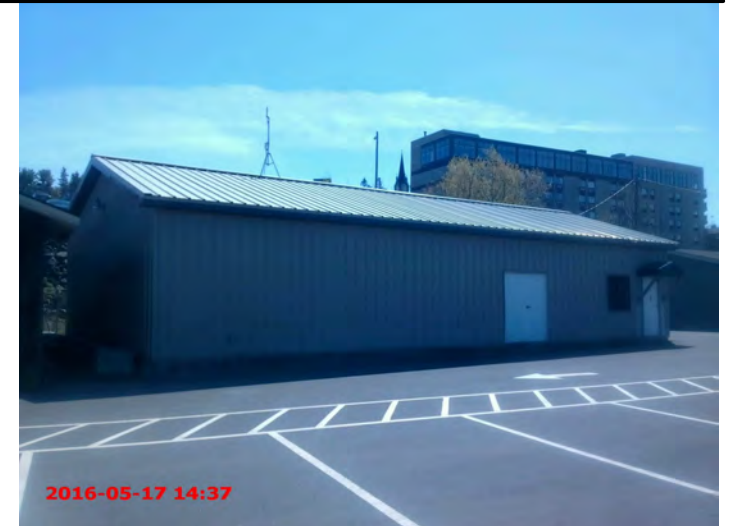
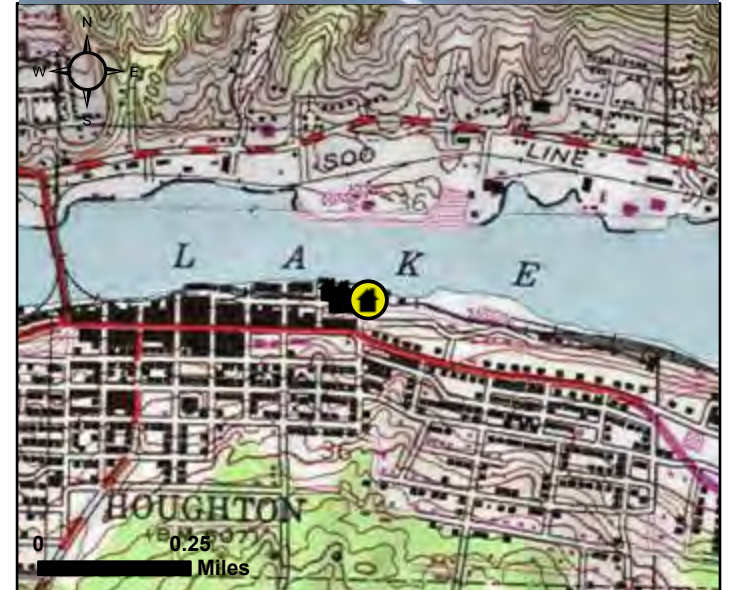
**Rating:** No Wildland Risk

**Roof Material:** Noncombustible or not applicable

**Siding Material:** Rock, concrete, metal

**Foundation:** Closed, 6in to 30in masonry exposed

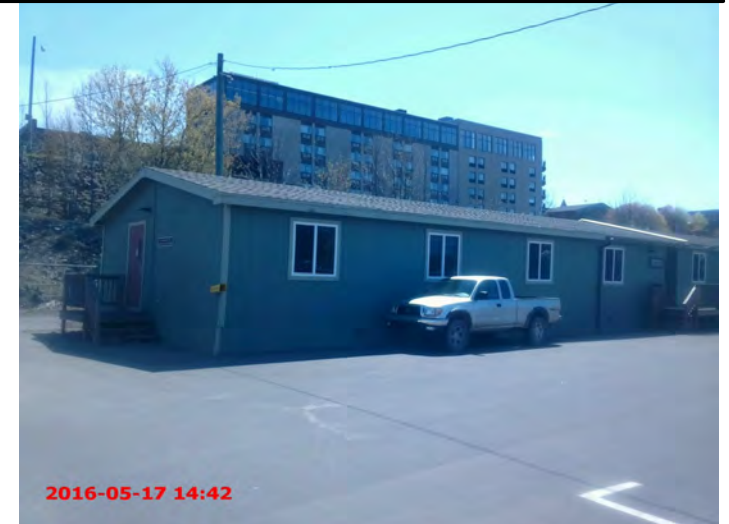
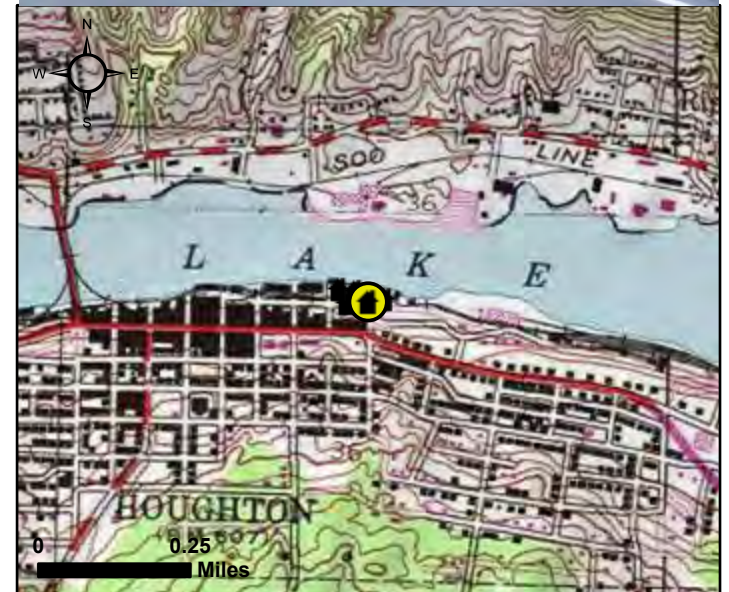
**Rating:** No Wildland Risk

**Roof Material:** Fire resistant- tar,rubberized

**Siding Material:** Wood or open sided

**Foundation:** Open or deck

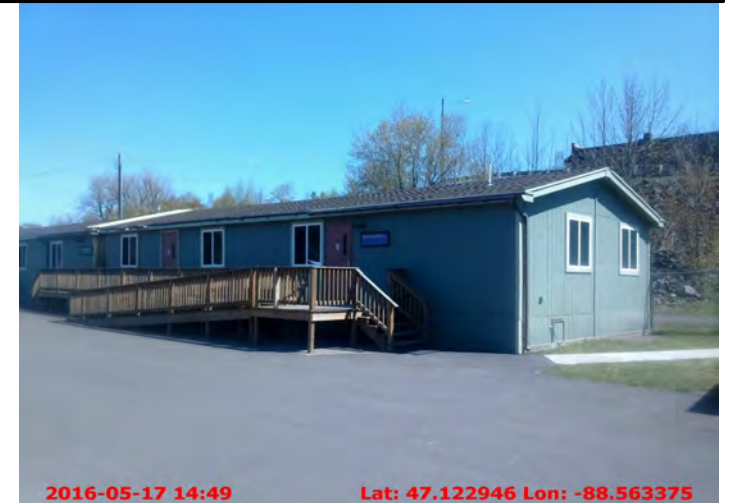
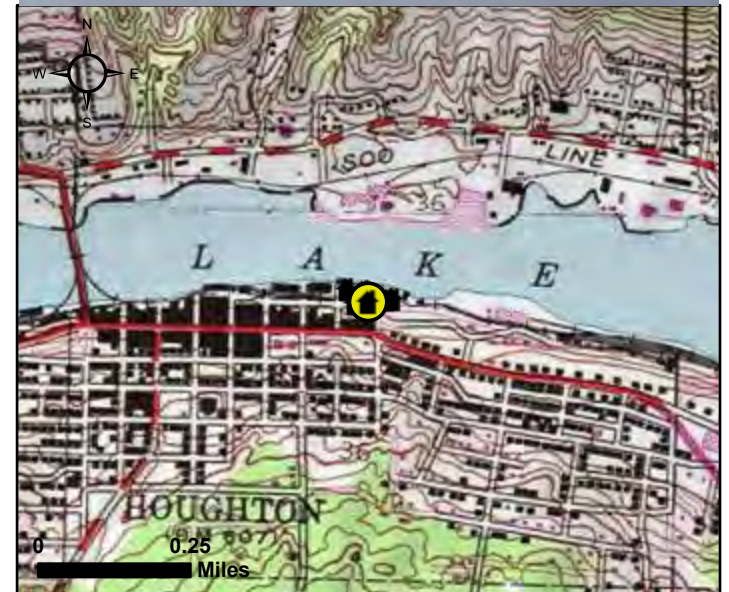
**Rating:** No Wildland Risk

**Roof Material:** Fire resistant- tar,rubberized

**Siding Material:** Wood or open sided

**Foundation:** Open or deck

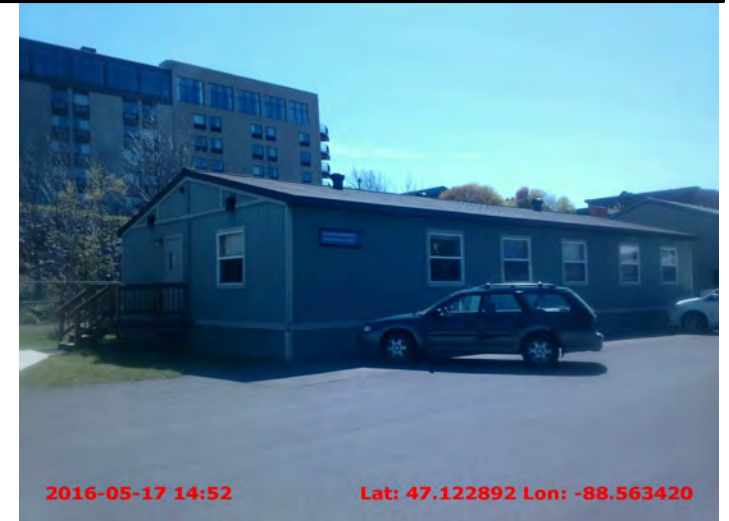
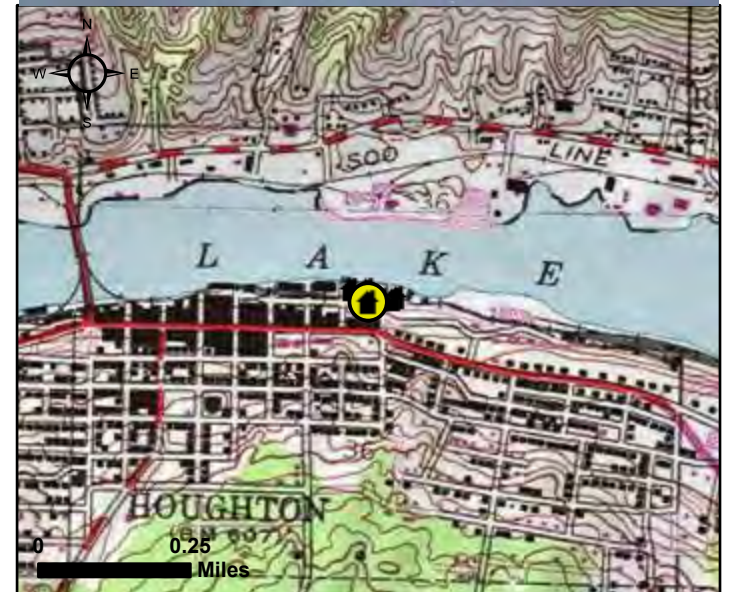
**Rating:** No Wildland Risk

**Roof Material:** Fire resistant- tar,rubberized

**Siding Material:** Wood or open sided

**Foundation:** Open or deck

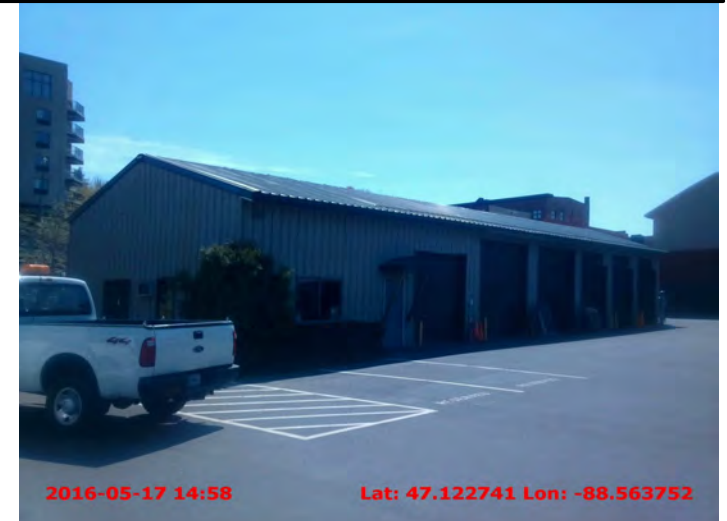
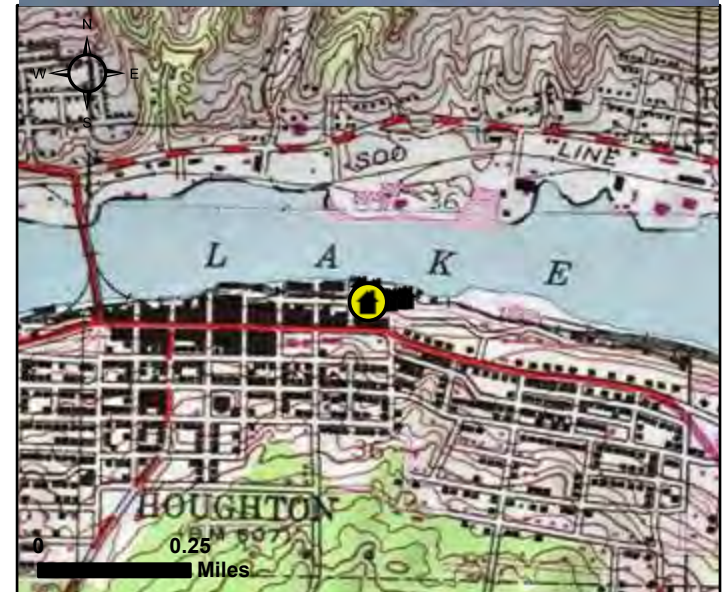
**Rating:** No Wildland Risk

**Roof Material:** Noncombustible or not applicable

**Siding Material:** Rock, concrete, metal

**Foundation:** Closed, Less than 6in masonry exposed

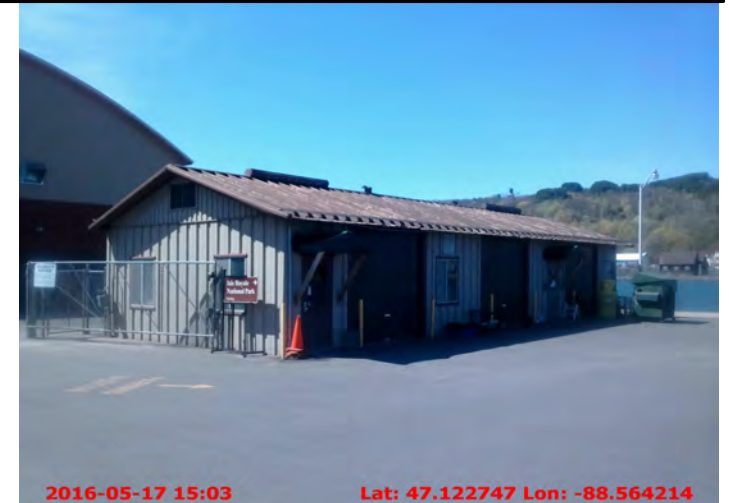
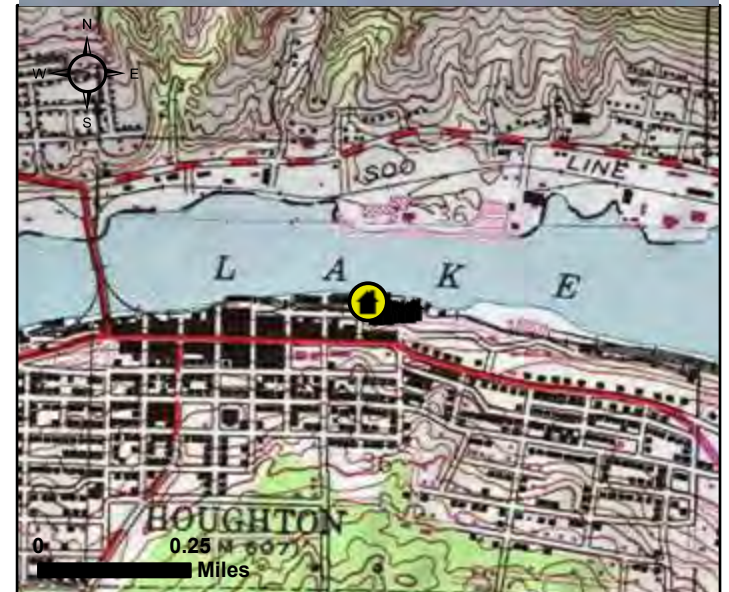
**Rating:** No Wildland Risk

**Roof Material:** Noncombustible or not applicable

**Siding Material:** Rock, concrete, metal

**Foundation:** Closed, Less than 6in masonry exposed

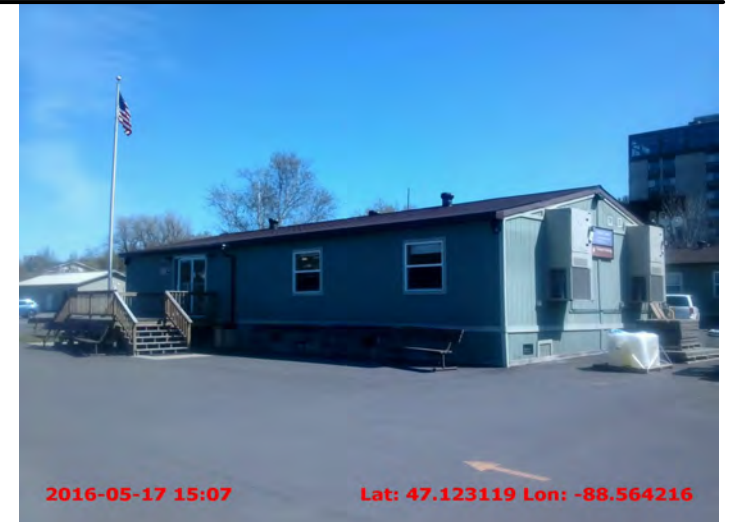
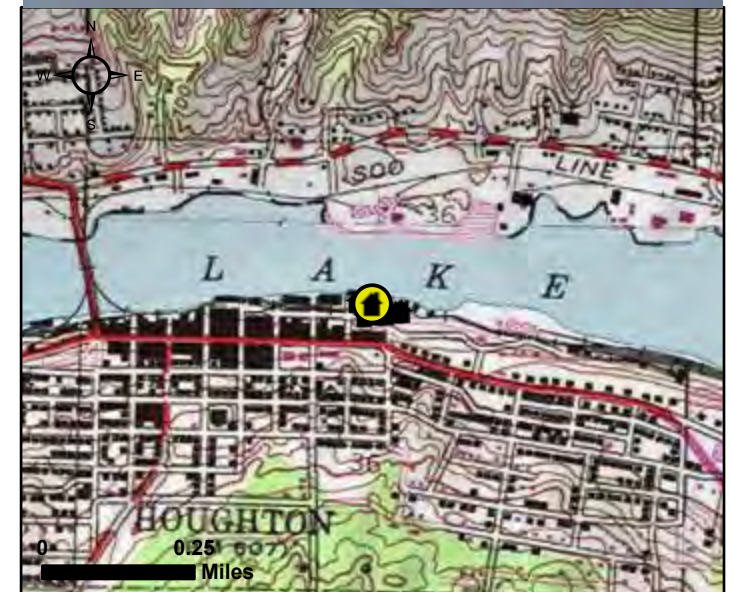
**Rating:** No Wildland Risk

**Roof Material:** Fire resistant- tar,rubberized

**Siding Material:** Wood or open sided

**Foundation:** Open or deck
