# NPS Wildfire Risk Assessments

### Grand Portage National Monument

# NPS Wildland Fire Risk Assessment - Facility Assessment

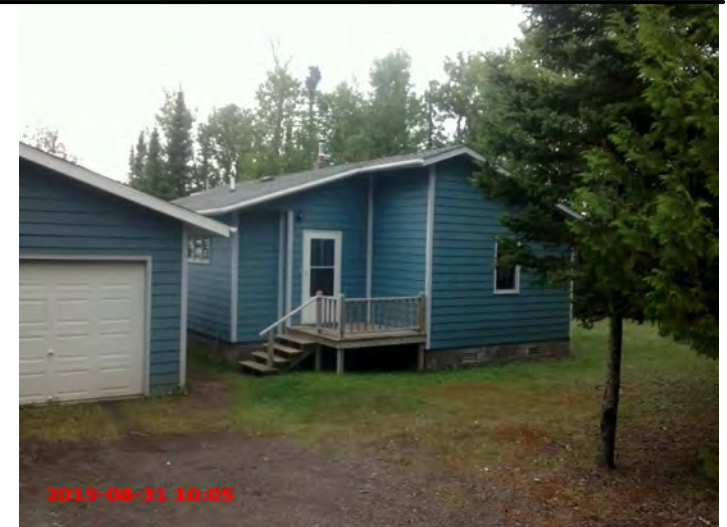
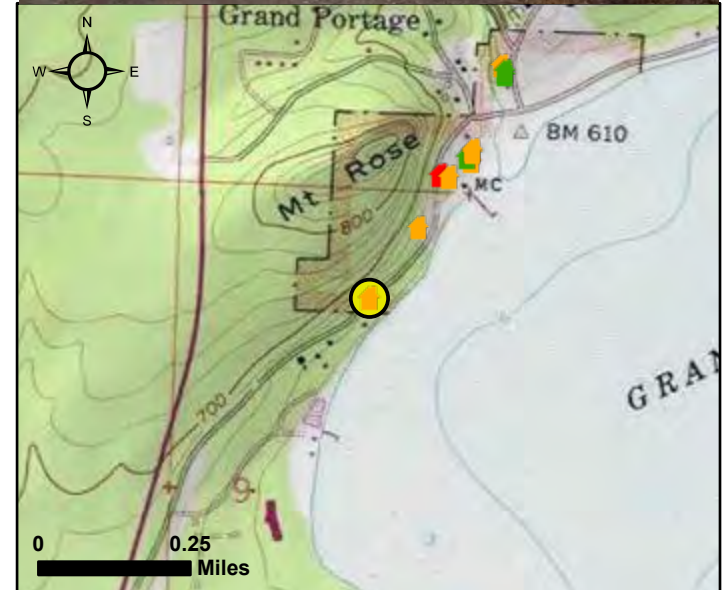
**Map Label:** 6

**Rating:** Moderate

**Defensible Space:** Less than 30 ft treated

**Firewood:** 5ft to 30ft from facility

**Propane:** Present and little to no fuels clearance

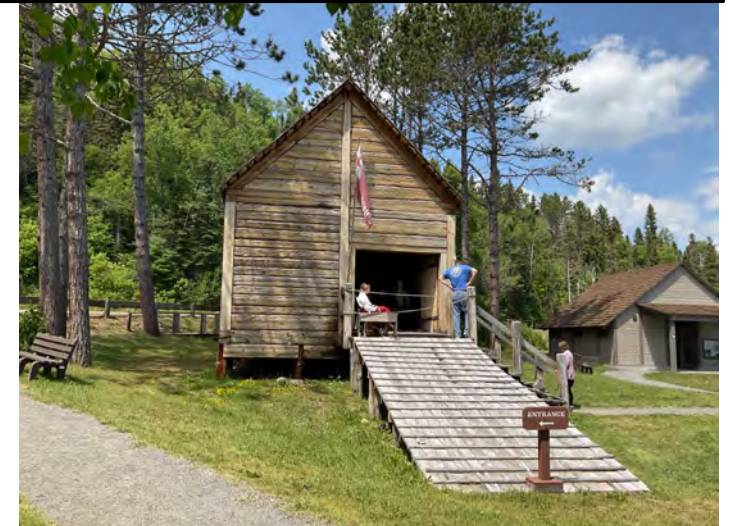
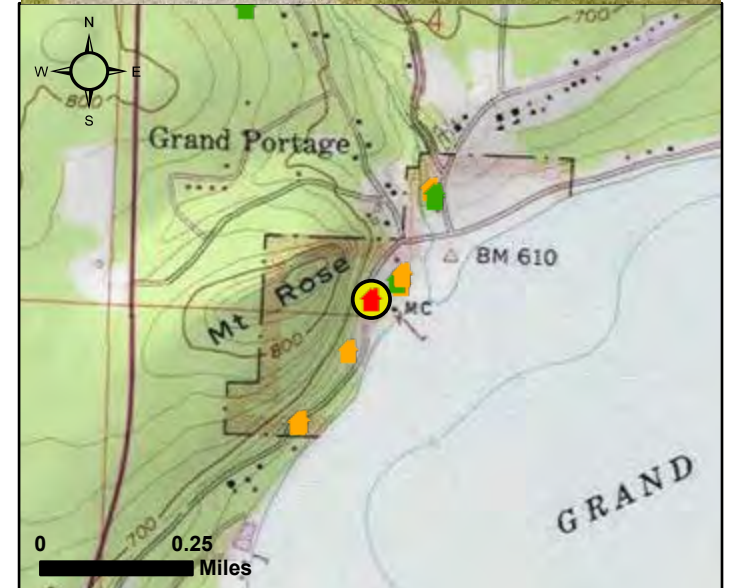
**Map Label:** 8

**Rating:** High

**Roof Material:** Combustible or no roof

**Foundation:** Open or deck

**Firewood:** Adjacent to/under deck of facility

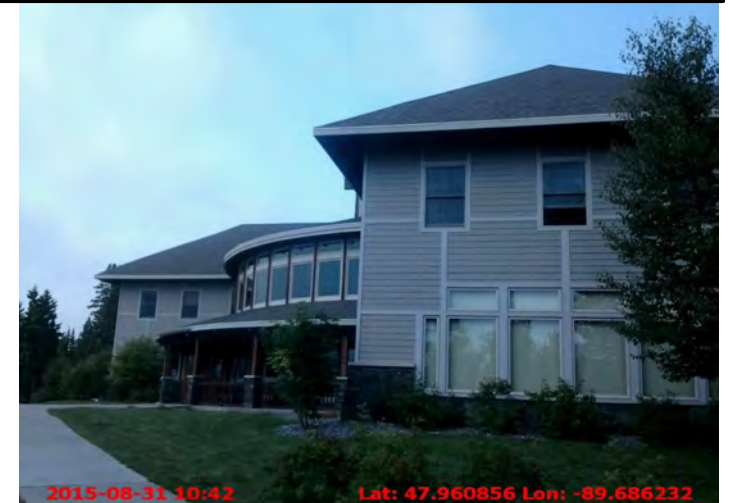
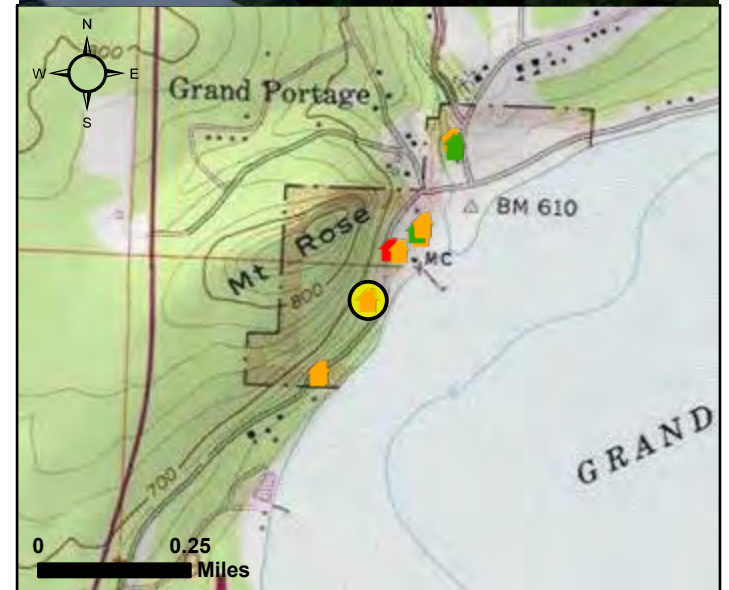
**Map Label:** 7

**Rating:** Moderate

**Defensible Space:** Less than 30 ft treated

**Propane:** Present and little to no fuels clearance

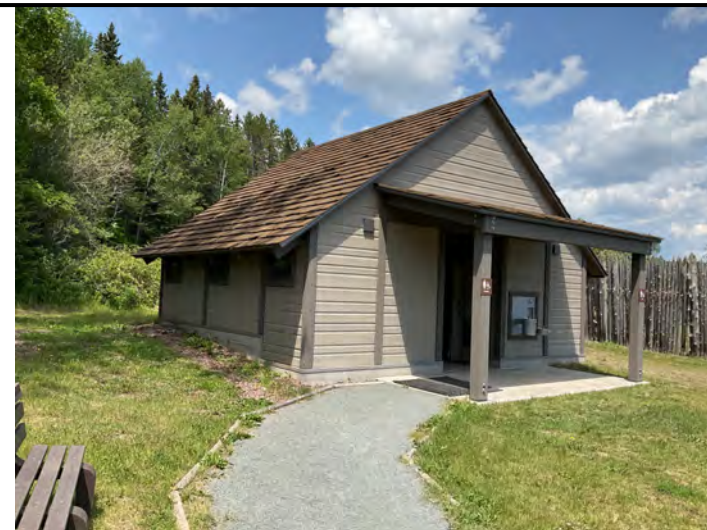
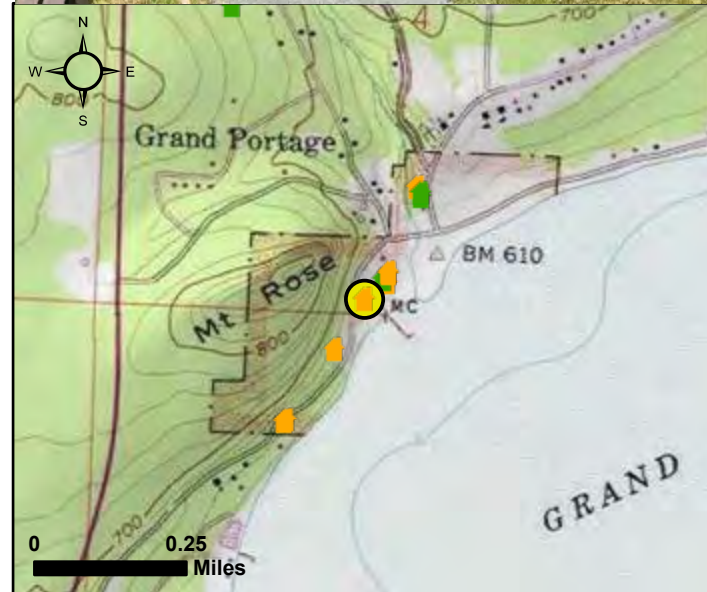
**Map Label:** 9

**Rating:** Moderate

**Roof Material:** Combustible or no roof

**Siding Material:** Wood or open sided

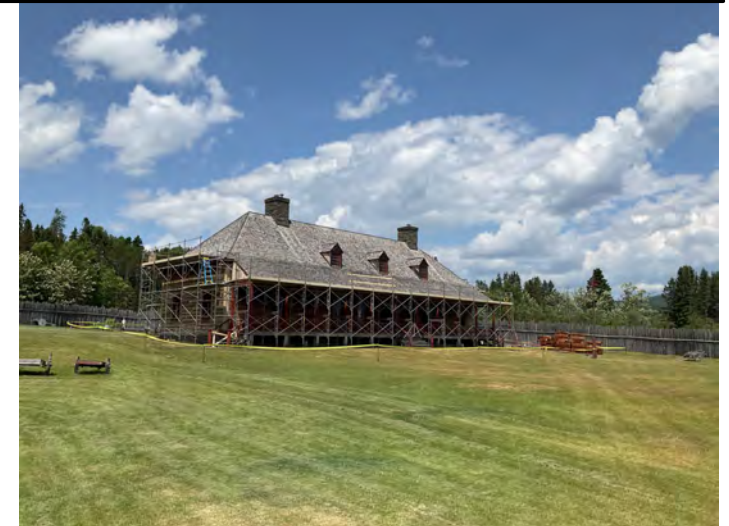
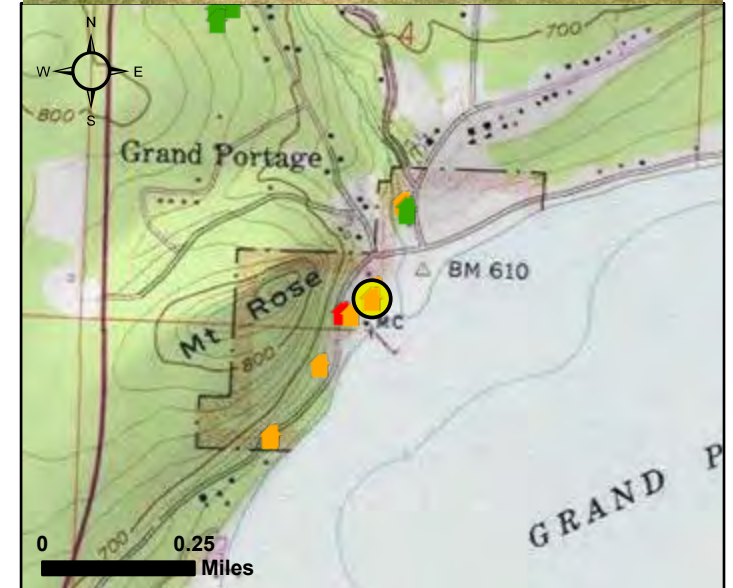
**Rating:** Moderate  
**Protection Level:** Undesignated,  
**Resources of Concern:** Unknown  
**Occupied:** Yes  
**In Community:** Yes, Stockade and Great Hall  
**Revisit Interval:** 5 yrs  
**Map Label:** 11

**Primary Access:** Road  
**Ingress Egress:** 2 or more roads in/out  
**Access Width:** 2 lanes (Greater than 24')  
**Access Condition:** Surfaced-paved, grade Less than 5%  
**Bridge Condition:** Less than 300 ft with turnaround  
**Access and Turnarounds:** Less than 300 ft with turnaround  
**Facility Number or Sign:** Marked and clearly visible  
**Fuel Type:** Shrub or timber  
**Fuel Load:** Moderate  
**Defensible Space:** 100 ft treated  
**Topography:** Slope Less than 5%  
**Roof Material:** Combination of fire resisitant and combustible  
**Siding Material:** Log construction  
**Foundation:** Open or deck  
**Firewood:** 5ft to 30ft from facility  
**Water Supply:** Pressurized hydrant(s) or fixed sprinkler system  
**Propane:** None  
**Overhead Hazards:** No overhead hazards  
**Comments:** Under construction

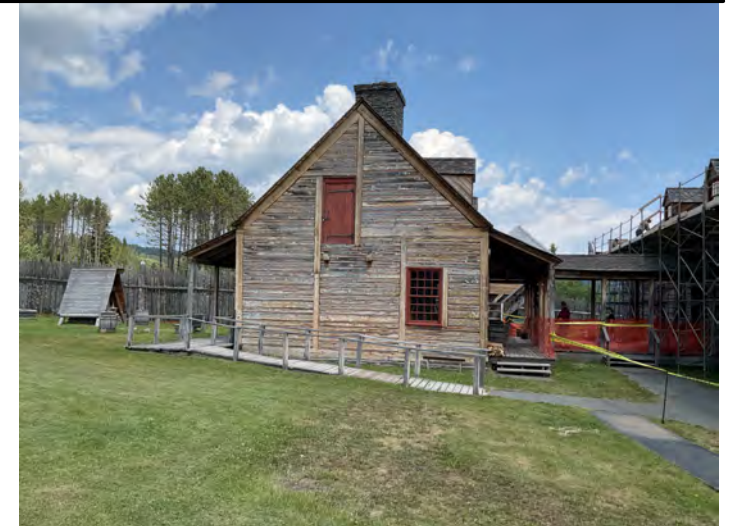
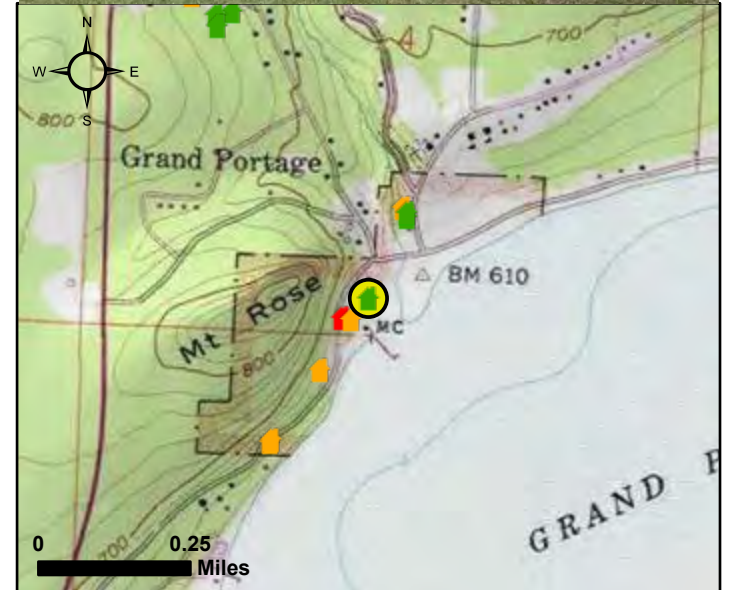
**Map Label:** 10

**Rating:** Low

**Siding Material:** Log construction

**Firewood:** Adjacent to/under deck of facility

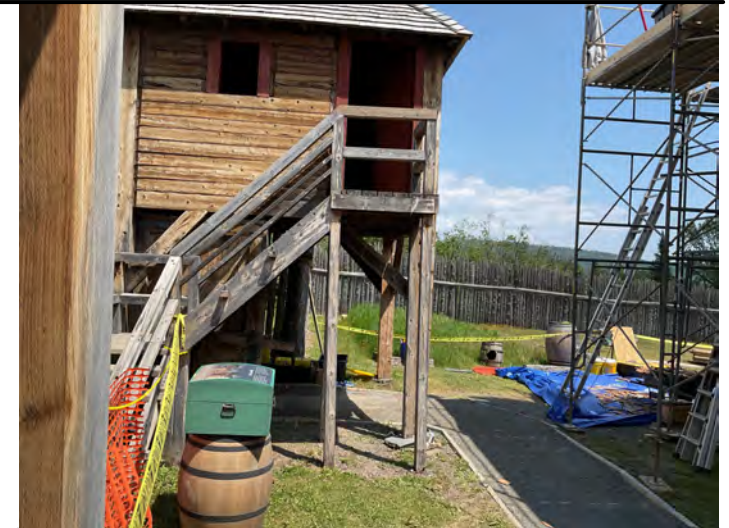
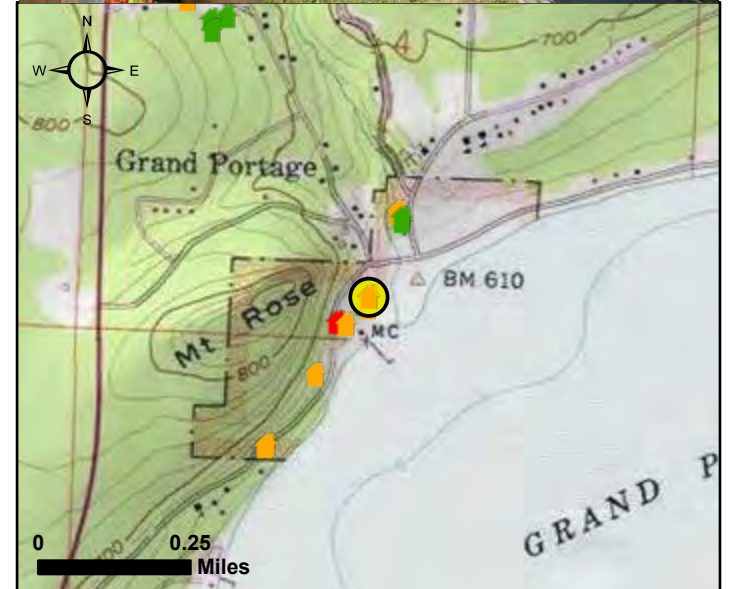
**Map Label:** 12

**Rating:** Moderate

**Roof Material:** Combustible or no roof

**Siding Material:** Wood or open sided

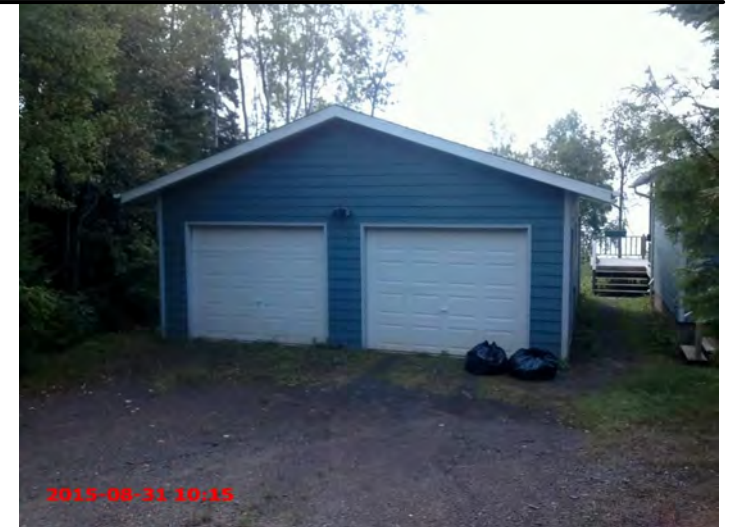
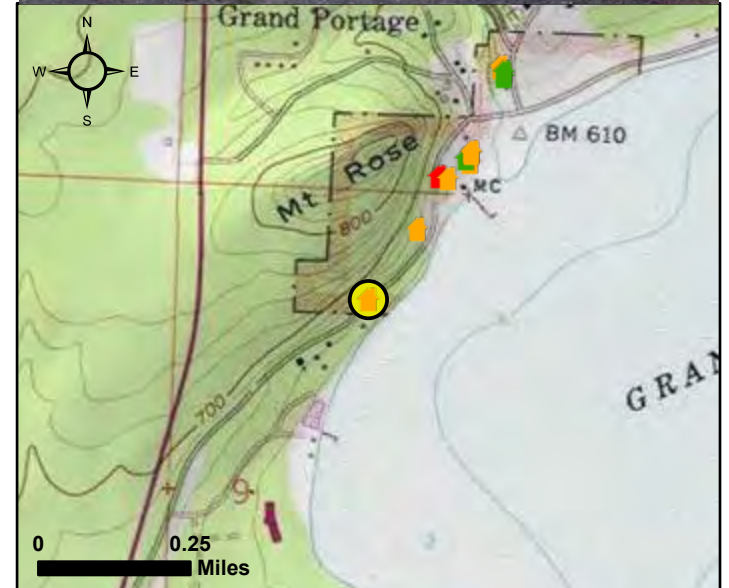
**Map Label:** 13

**Rating:** Moderate

**Defensible Space:** Less than 30 ft treated

**Firewood:** 5ft to 30ft from facility

**Propane:** Present and little to no fuels clearance

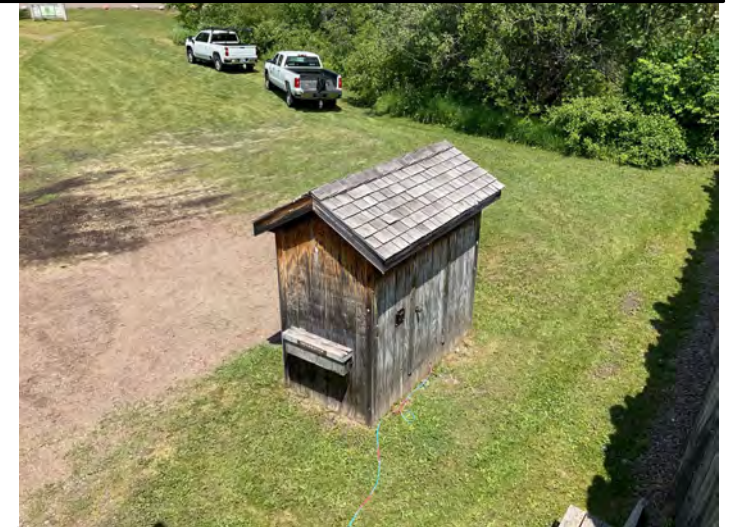
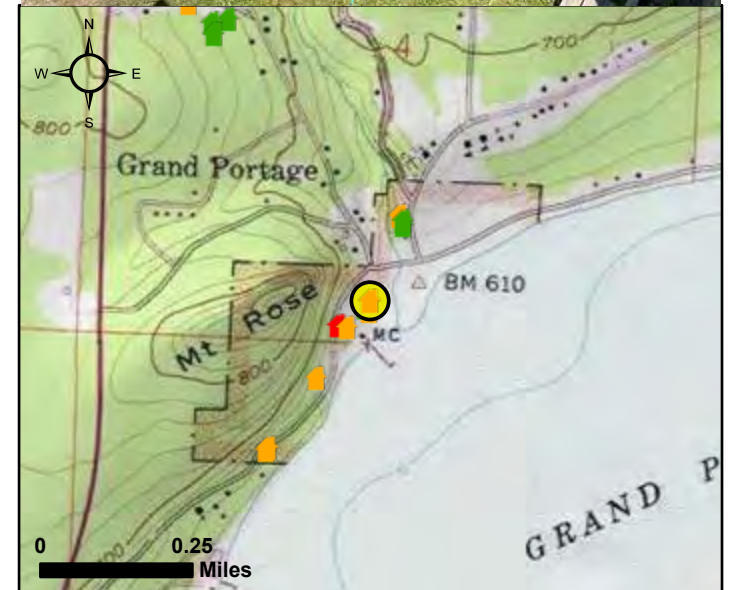
**Map Label:** 14

**Rating:** Moderate

**Roof Material:** Combustible or no roof

**Siding Material:** Wood or open sided

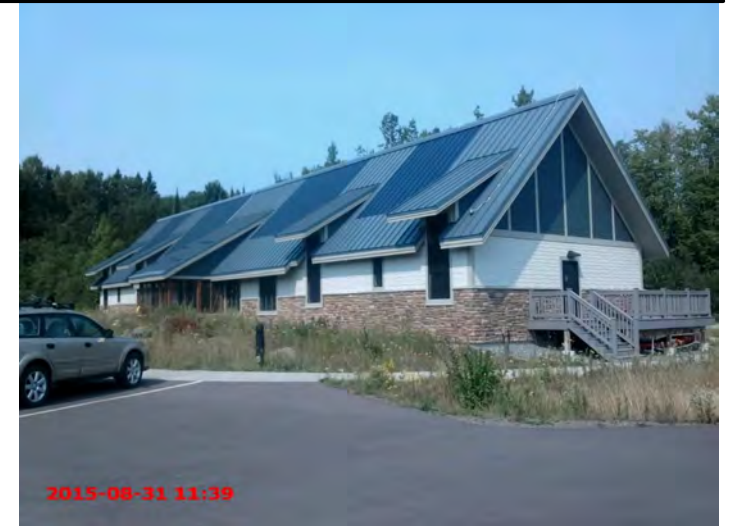
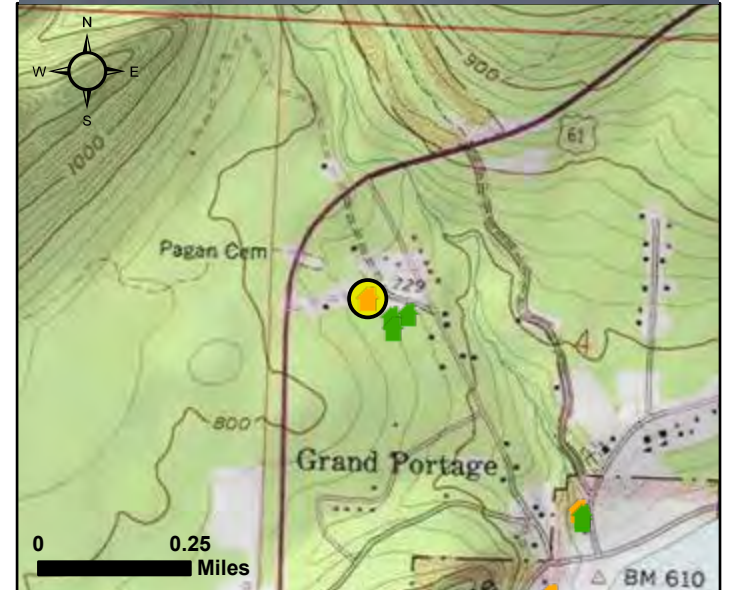
**Map Label:** 2

**Rating:** Moderate

**Defensible Space:** Less than 30 ft treated

**Foundation:** Open or deck
