# NPS Wildfire Risk Assessments

### Theodore Roosevelt National Park

Theodore Roosevelt National Park-North Unit

# NPS Wildland Fire Risk Assessment - Facility Assessment

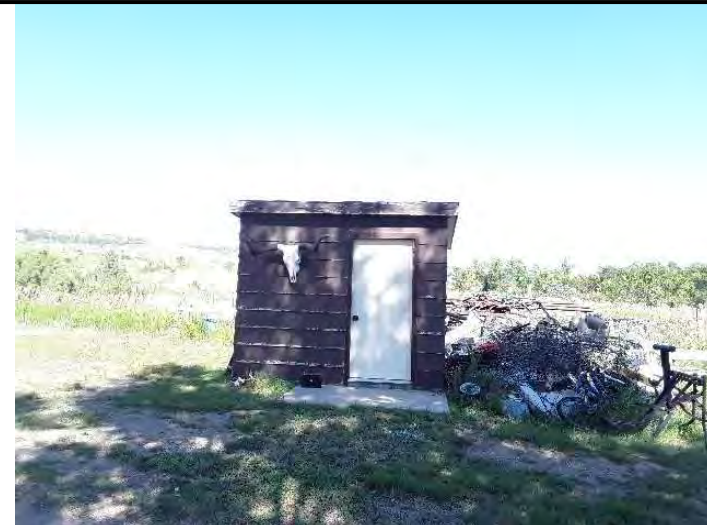
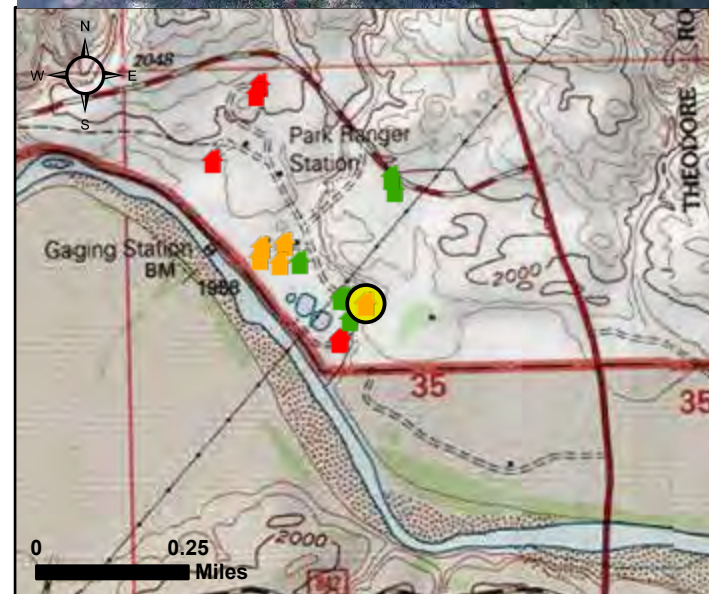
**Facility Name:** NU - Custodial Storage Building 238

**Rating:** Moderate

**Defensible Space:** Less than 30 ft treated

**Siding Material:** Wood or open sided

**Overhead Hazards:** Overhead hazards will limit aircraft

**Comments:** River bank 25 ft behind structure.

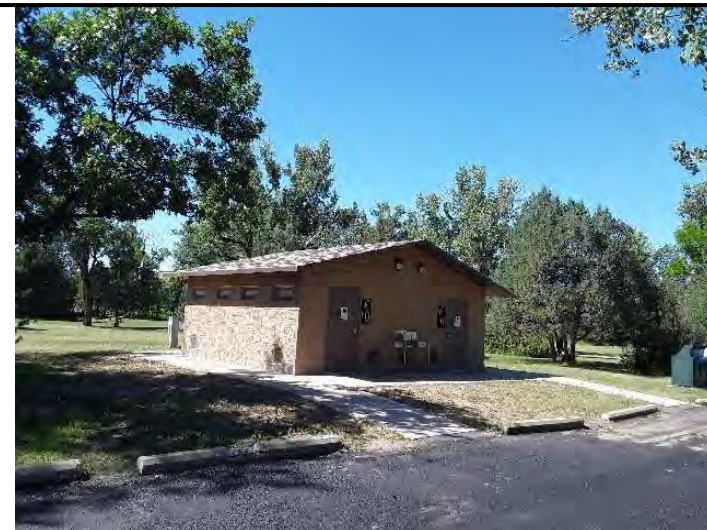
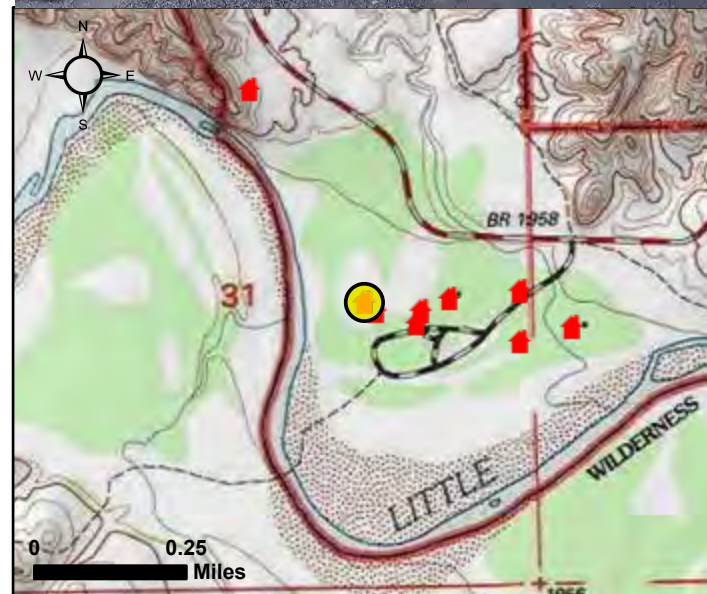
**Facility Name:** NU-Restroom 68, Campgrounds

**Rating:** Moderate

**Roof Material:** Combustible or no roof

**Water Supply:** No reliable water source nearby

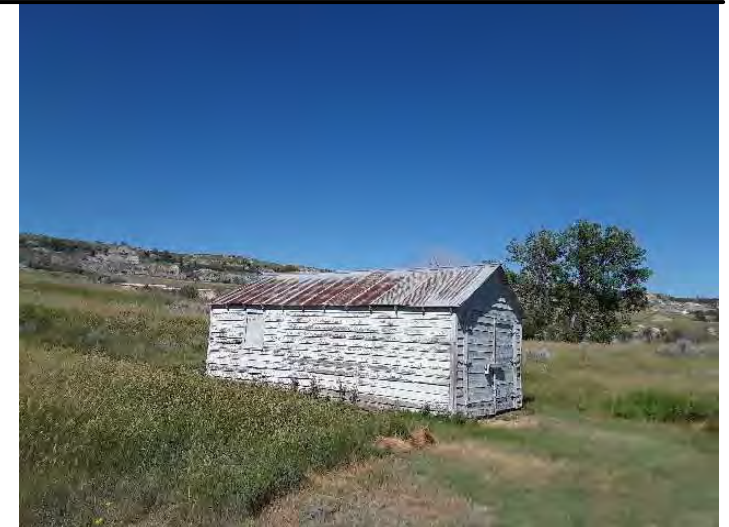
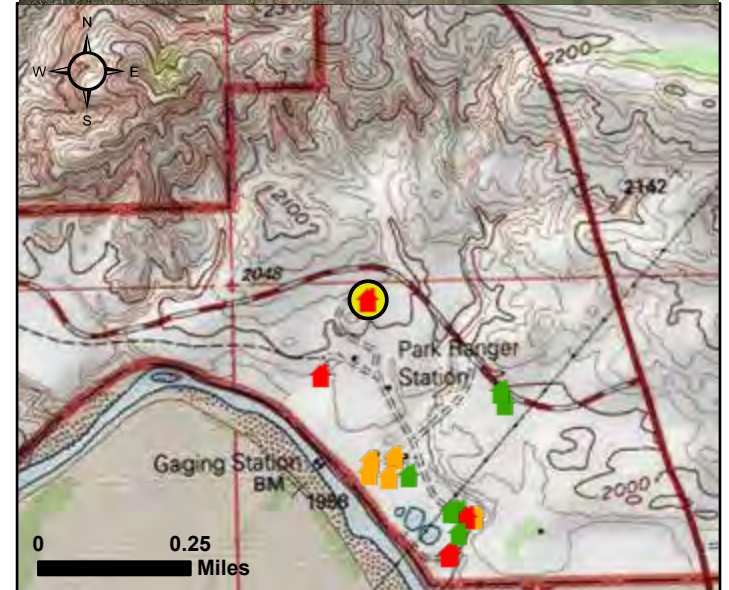
**Facility Name:** NU-Gray House Garage 211

**Rating:** High

**Defensible Space:** Less than 30 ft treated

**Roof Material:** Combination of fire resisitant and combustible

**Siding Material:** Wood or open sided

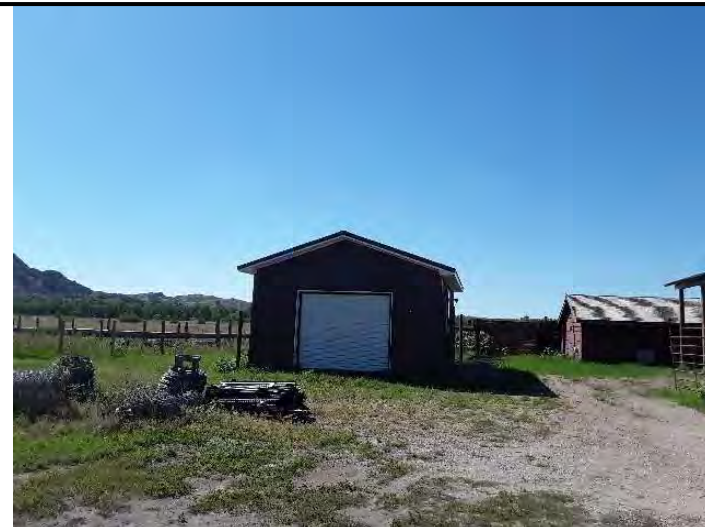
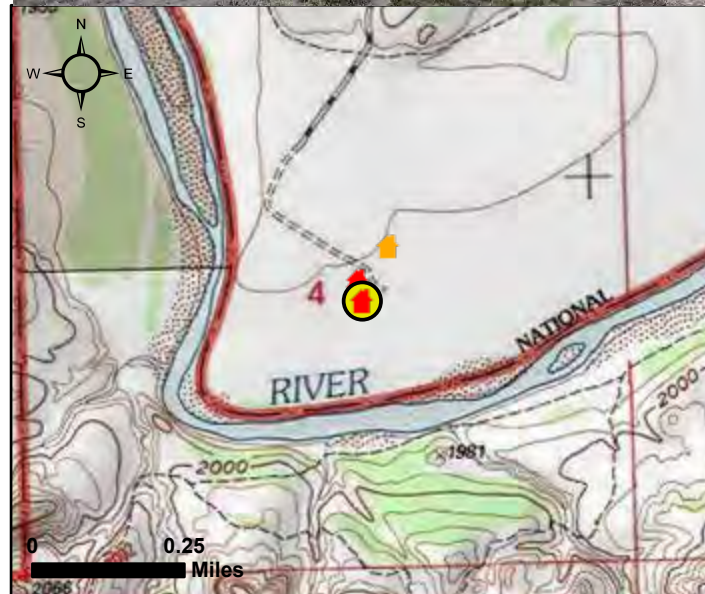
**Facility Name:** NU-WHF Pit Toilet 241

**Rating:** High

**Defensible Space:** No defensible space

**Siding Material:** Wood or open sided

**Water Supply:** No reliable water source nearby

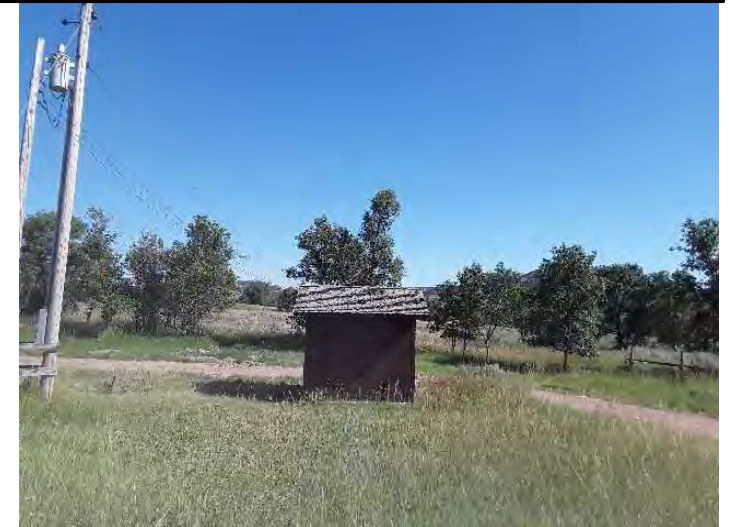
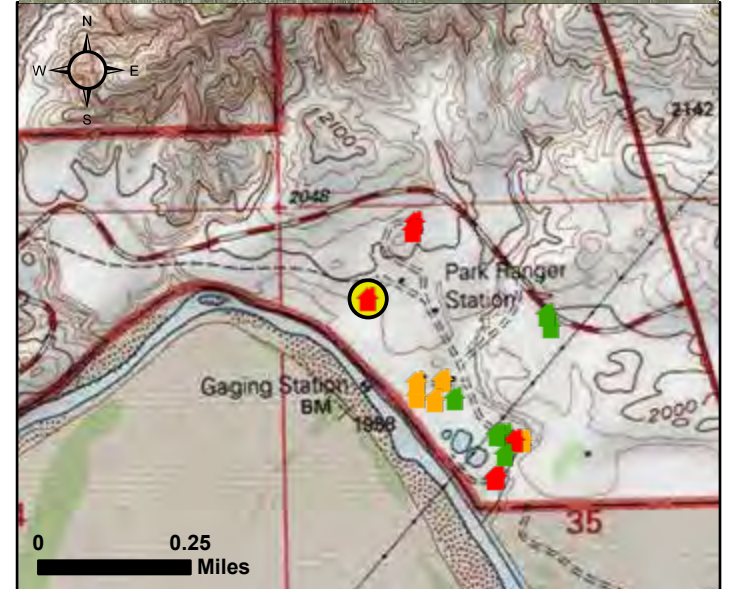
**Facility Name:** NU-Headquarters-Wellhouse 212

**Rating:** High

**Defensible Space:** Less than 30 ft treated

**Roof Material:** Combustible or no roof

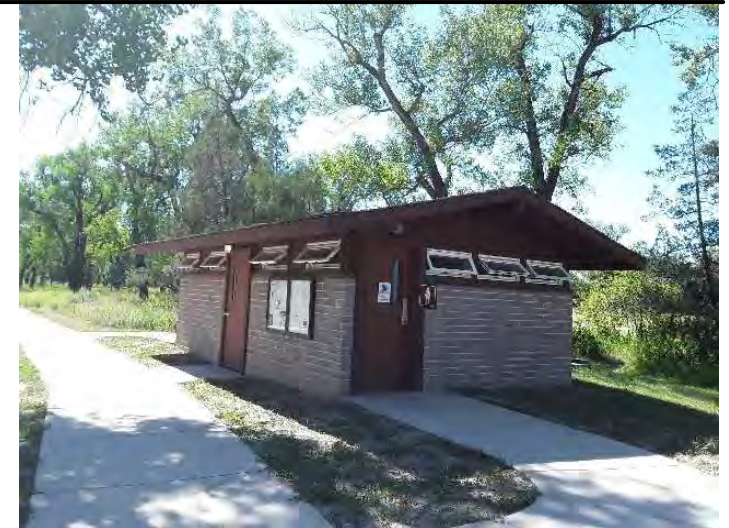
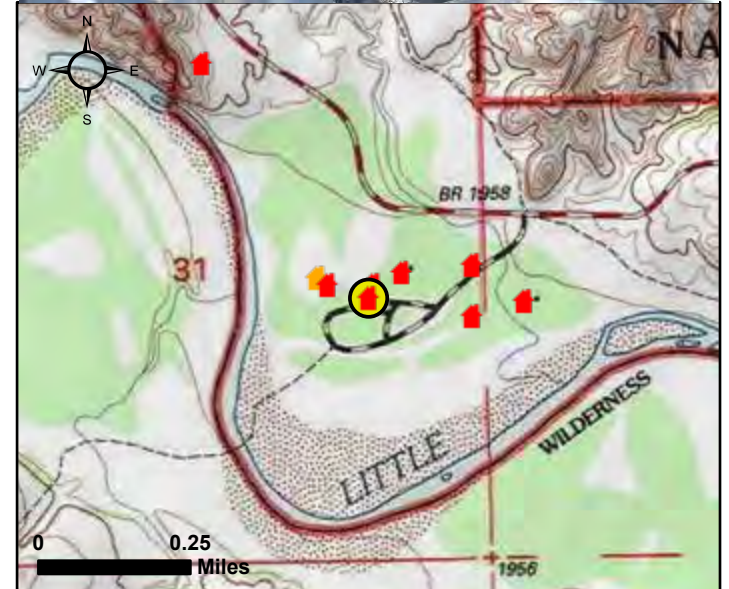
**Facility Name:** NU-Restroom 67, Picnic Area

**Rating:** High

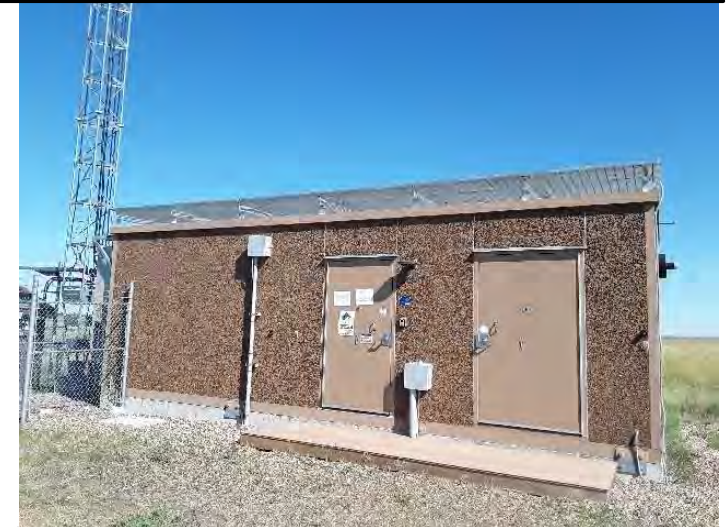
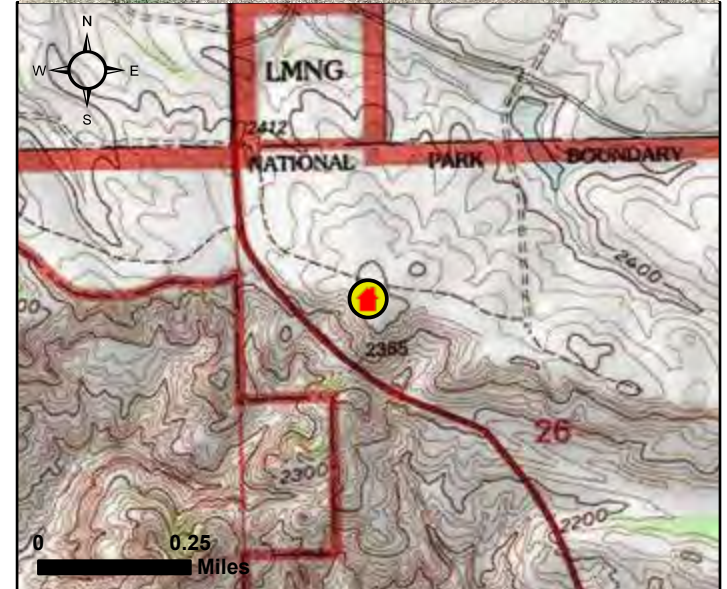
**Overhead Hazards:** Overhead hazards will limit aircraft

**Comments:** Accessed by non maintained one lane road.  
Radio Tower may be hazard to aircraft.

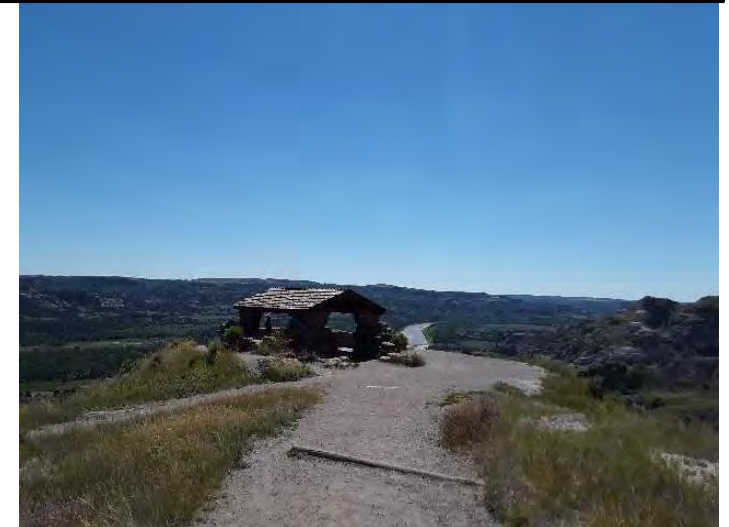
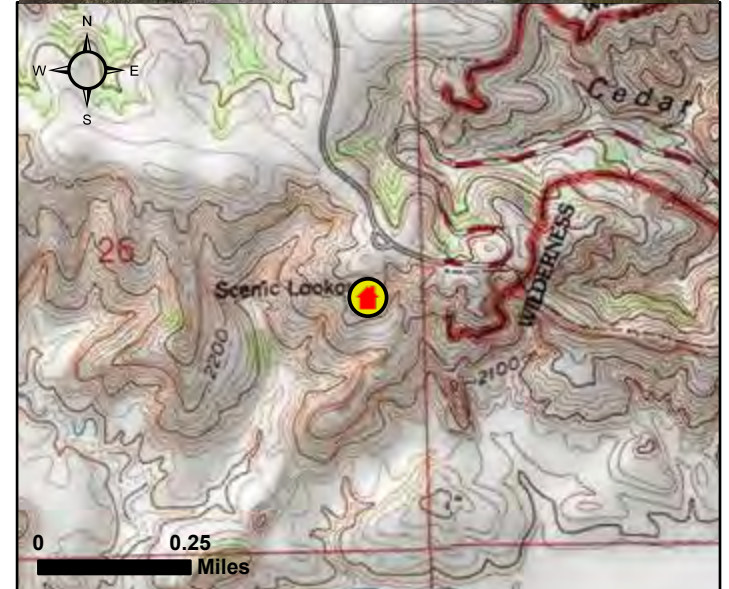
**Comments:** Historic Structure

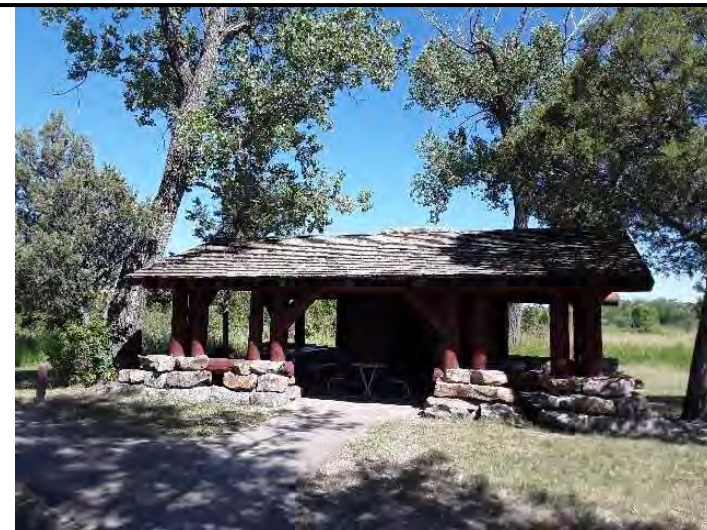
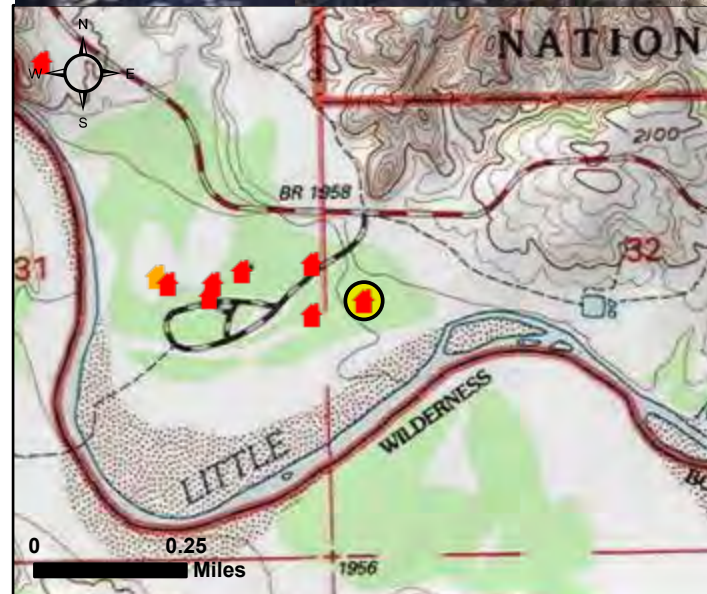
**Comments:** Accessed by walking over small wooden bridge from group campground.

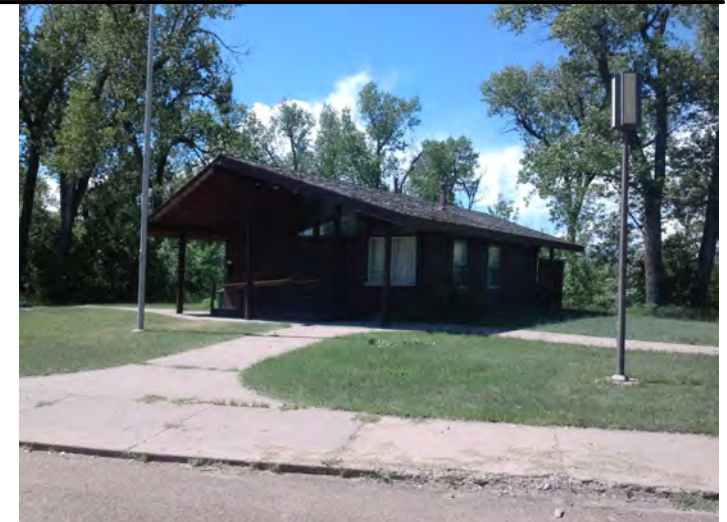
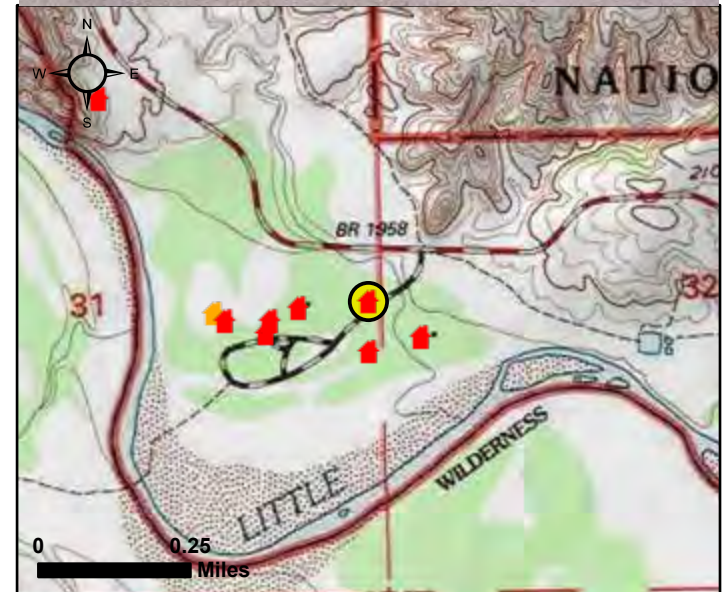
**Comments:** May not be occupied but has potential to be.

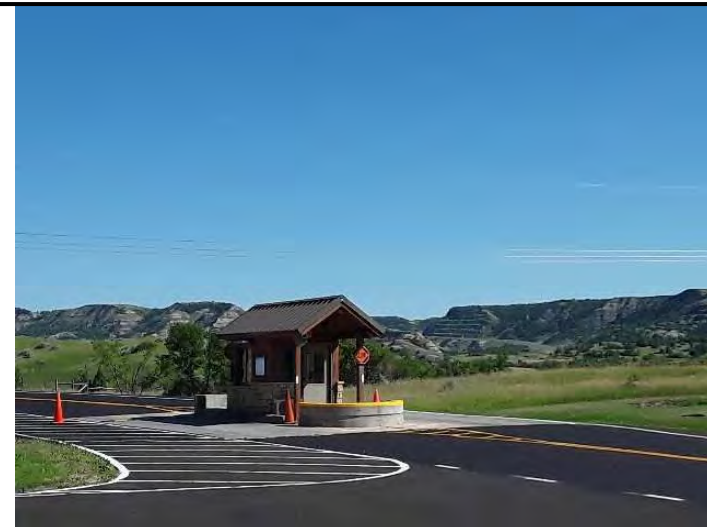
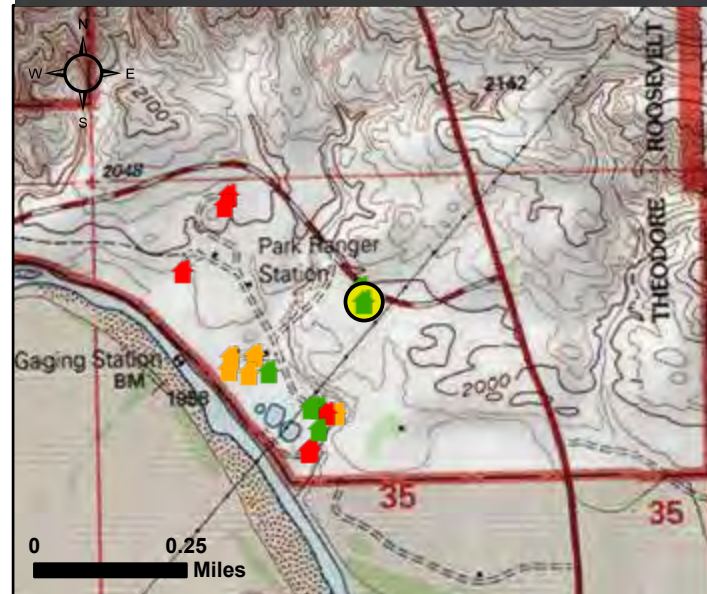
**Overhead Hazards:** Overhead hazards will limit aircraft

**Comments:** High voltage powerlines east of structure could limit aircraft.

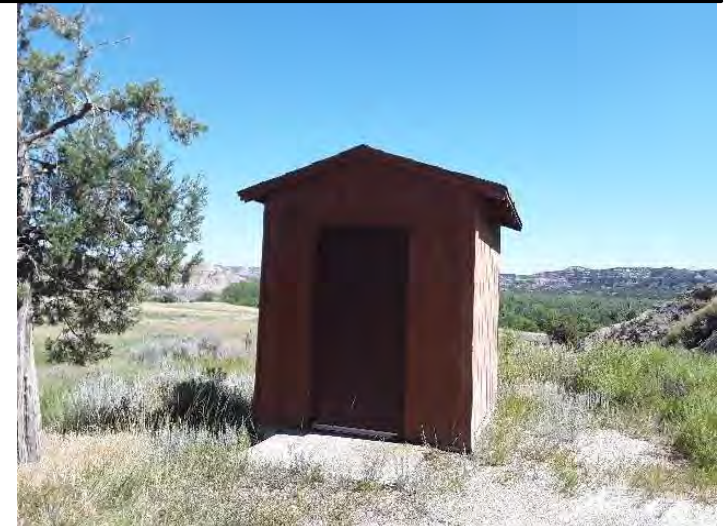
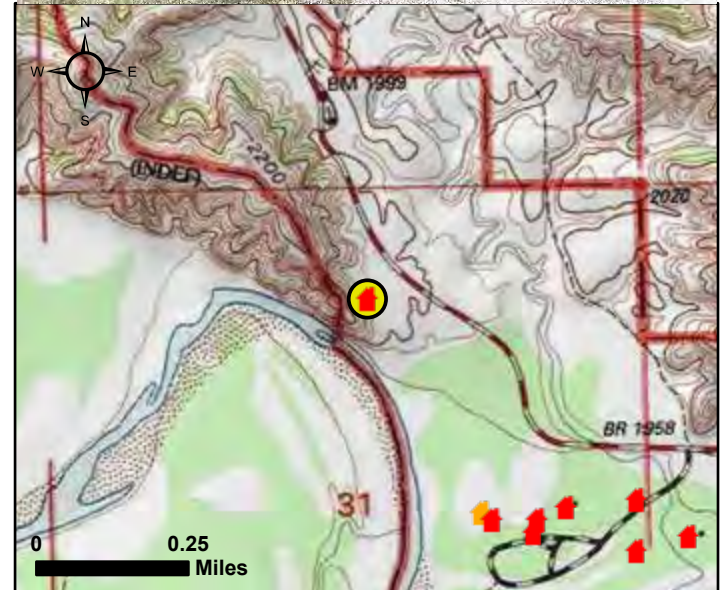
**Comments:** Sets at the bse of a steep slope.

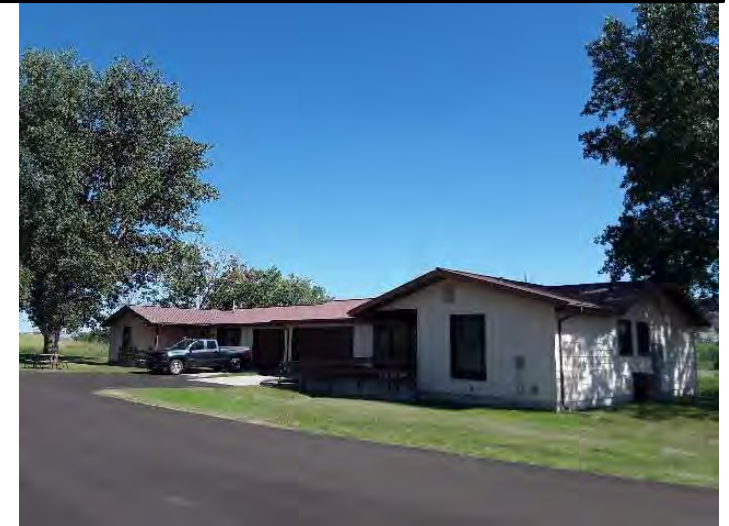
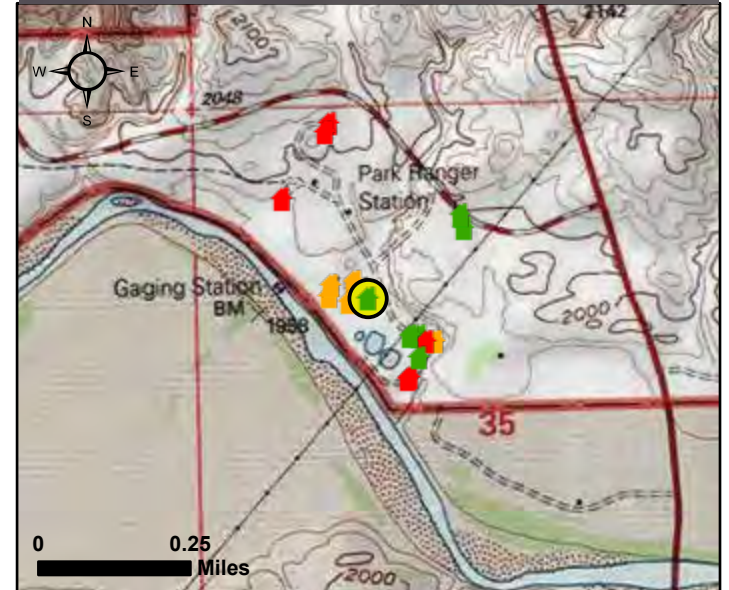
**Overhead Hazards:** Overhead hazards will limit aircraft

**Comments:** Facility attached to 205B

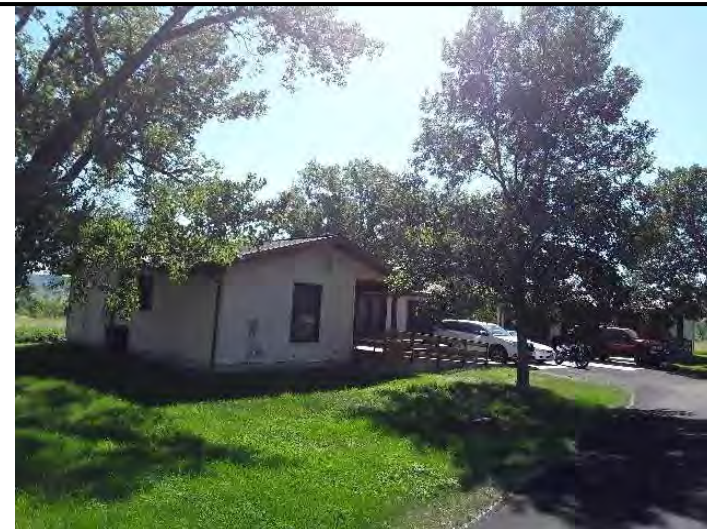
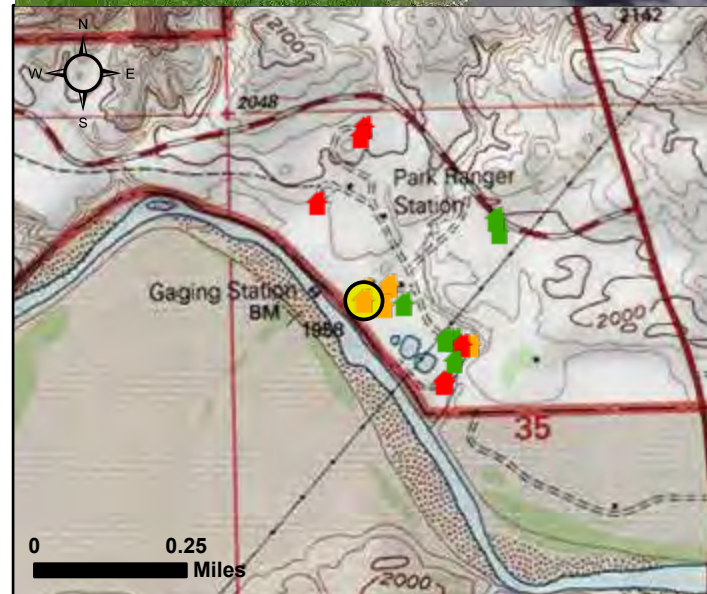
**Overhead Hazards:** Overhead hazards will limit aircraft

**Comments:** Facility attached to 204

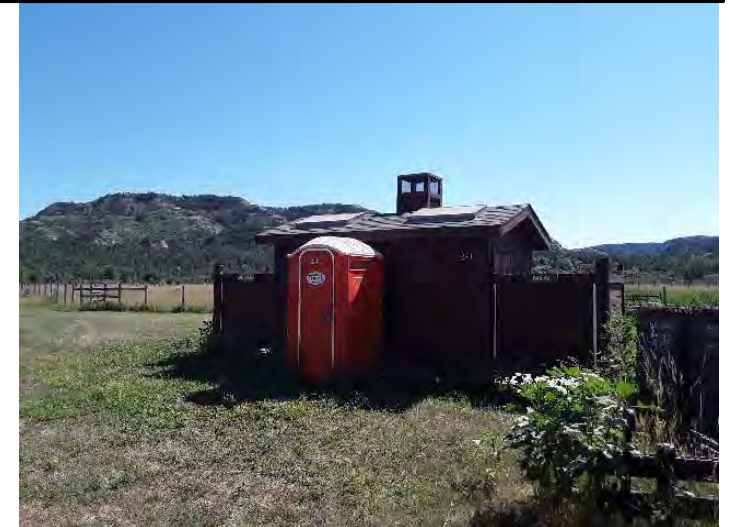
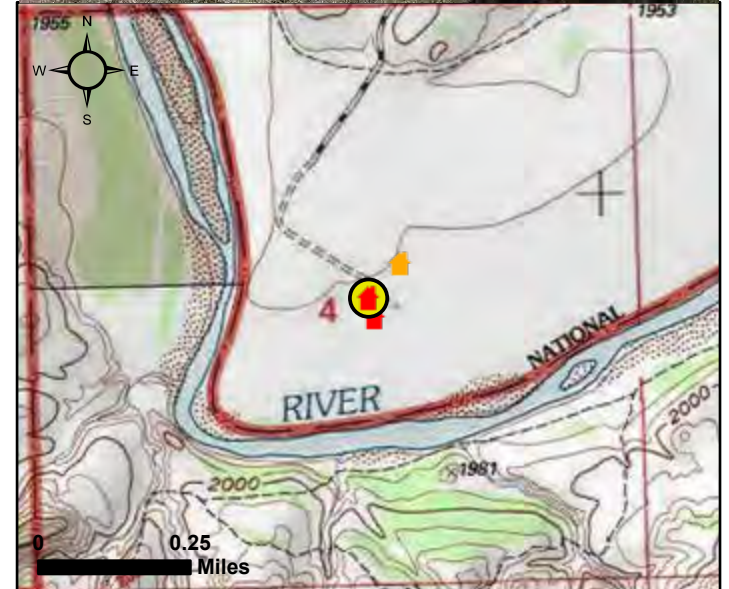
**Comments:** Shade structure surrounded by wooden corrals.

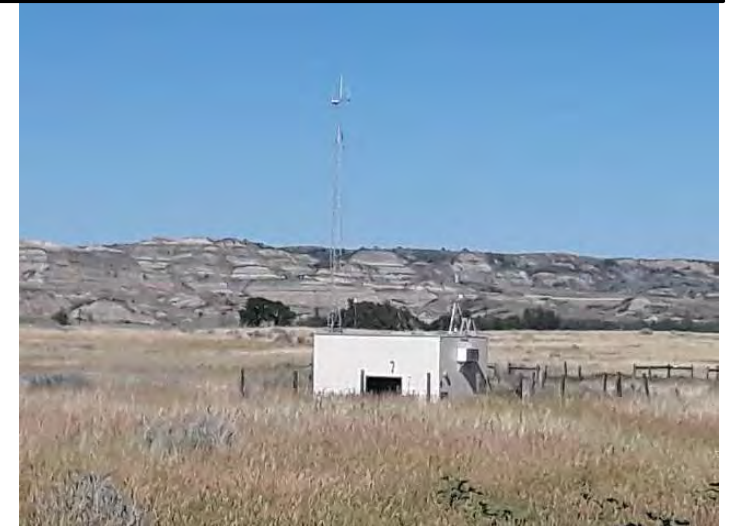
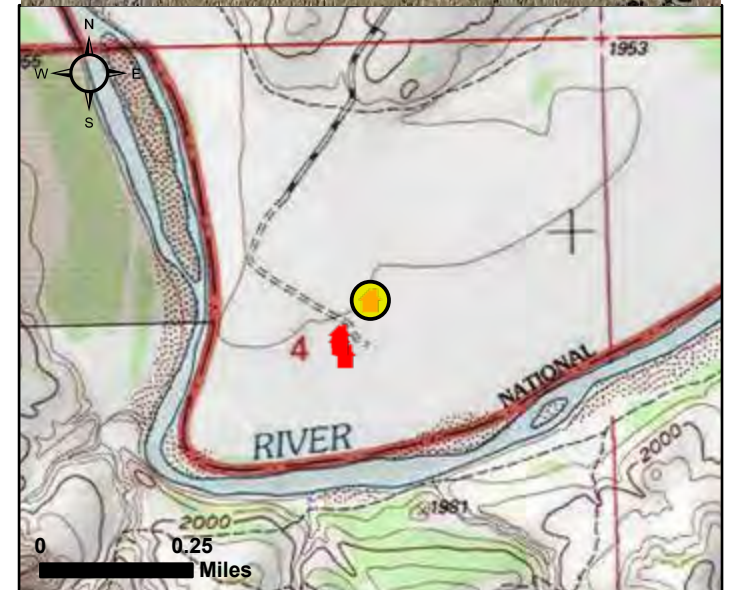
**Comments:** Believed to,be air monitoring station.

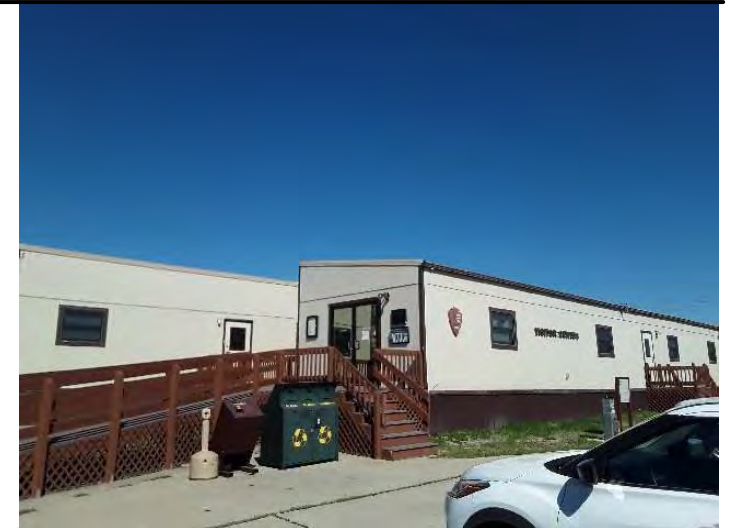
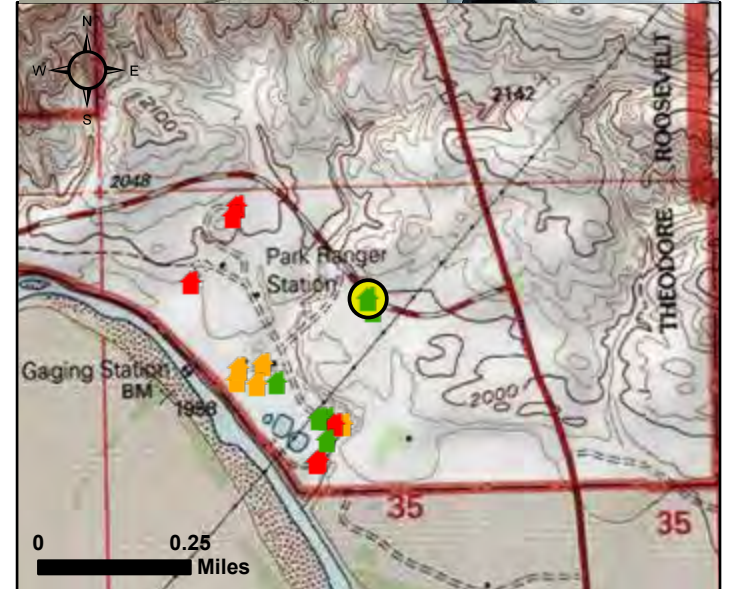
**Overhead Hazards:** Overhead hazards will limit aircraft

**Comments:** High voltage powerlines east of structure could limit aircraft.
