# NPS Wildfire Risk Assessments

# Bonita Canyon Dr

# NPS Wildand Fire Risk Assessment - Facility Wildfire Risk Assessment Summary

**Unit - Location: CHIR - Bonita Canyon Dr.**

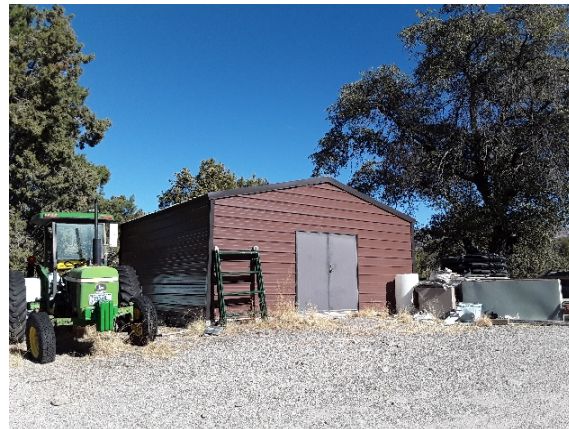
2021\_CHIR\_CHIR\_UNK002\_Bldg 000-Resource Management\_Front.jpg

Defensible Space: <30 ft treated

Fuel Load (w/in 300 ft): Moderate

Fuel Type (w/in 300ft): Grass,shrub,hardwood litter

| Label # | Facility/Community Name | Assessment Scale | Site Visit Type | Firewise Zone | Treatment | Treatment Description | Person Hours |
|---|---|---|---|---|---|---|---|
| 1 | Bldg 000-Resource Management | Individual Facility | Initial | 1 | Clear adjacent and overhanging fuels to create 10 feet spacing between canopy and structure or chimney openings | | 6.0 |
| | | Individual Facility | Initial | 1 | Mow dead/dying grass to less than 4 inches | | 1.0 |

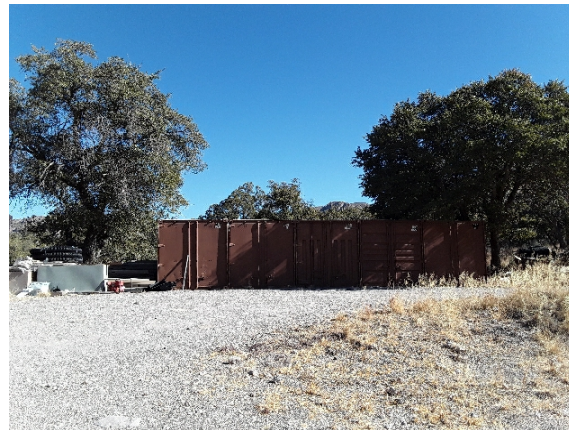
2021\_CHIR\_77543\_Front.jpg

Defensible Space: <30 ft treated

Fuel Load (w/in 300 ft): Moderate

Fuel Type (w/in 300ft): Grass,shrub,hardwood litter

| Label # | Facility/Community Name | Assessment Scale | Site Visit Type | Firewise Zone | Treatment | Treatment Description | Person Hours |
|---|---|---|---|---|---|---|---|
| 2 | BLDG-046 Storage-Electrical Supplies | Individual Facility | Initial | 1 | Limb trees 6 to 15 feet above ground | | 2.0 |
| | | Individual Facility | Initial | 1 | Mow dead/dying grass to less than 4 inches | | 1.0 |

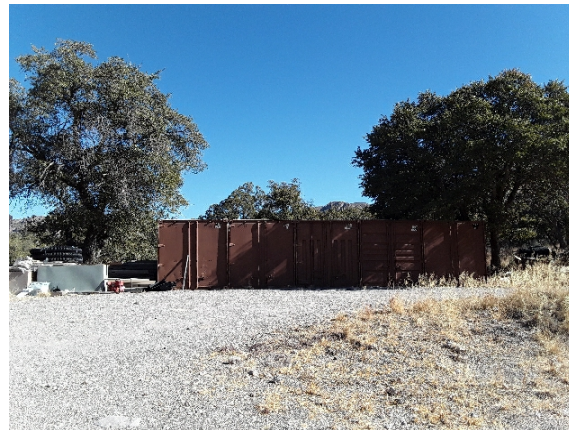
2021\_CHIR\_77533\_BLDG-047 Storage- Power Tools and Equipment\_Front.jpg

**Defensible Space:** <30 ft treated

**Fuel Load (w/in 300 ft):** Moderate

**Assessment Comments:** 046,047,048,049,051 are conex boxes side by side same applies to all

| Label # | Facility/Community Name | Assessment Scale | Site Visit Type | Firewise Zone | Treatment | Treatment Description | Person Hours |
|---|---|---|---|---|---|---|---|
| 3 | BLDG-047 Storage- Power Tools and Equipment | Individual Facility | Initial | 1 | Clear adjacent and overhanging fuels to create 10 feet spacing between canopy and structure or chimney openings | | 2.0 |
| | | Individual Facility | Initial | 1 | Mow dead/dying grass to less than 4 inches | | 1.0 |

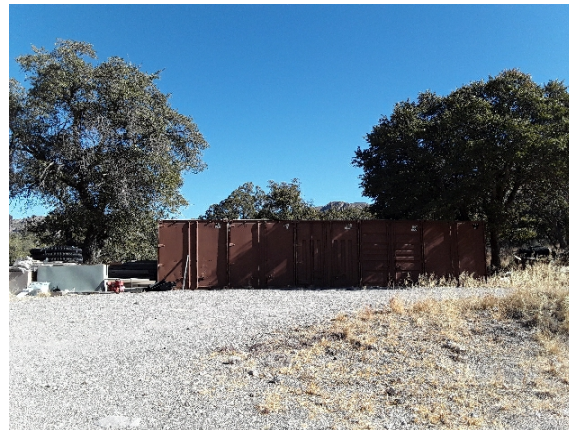
2021\_CHIR\_77519\_Front.jpg

Defensible Space: <30 ft treated

Fuel Load (w/in 300 ft): Moderate

Fuel Type (w/in 300ft): Grass,shrub,hardwood litter

| Label # | Facility/Community Name | Assessment Scale | Site Visit Type | Firewise Zone | Treatment | Treatment Description | Person Hours |
|---|---|---|---|---|---|---|---|
| 4 | BLDG-048 Storage-Housing furniture | Individual Facility | Initial | 1 | Mow dead/dying grass to less than 4 inches | | 1.0 |
| | | Individual Facility | Initial | 2 | Limb trees 6 to 15 feet above ground | | 3.0 |

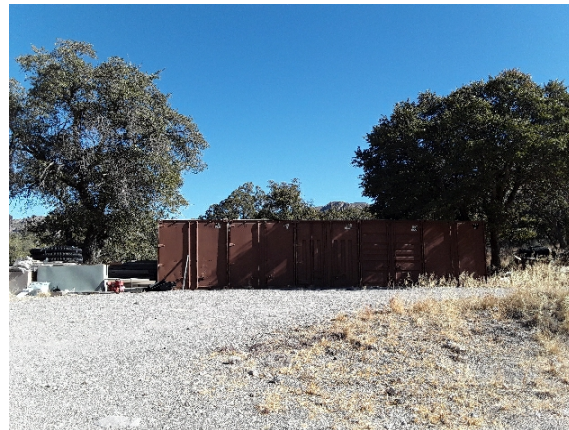
2021\_CHIR\_77511\_Front.jpg

**Defensible Space:** <30 ft treated

**Fuel Load (w/in 300 ft):** Moderate

**Fuel Type (w/in 300ft):** Grass,shrub,hardwood litter

| 5 | BLDG-049 Storage- Trails storage. | Individual Facility | Initial | 1 | Clear adjacent and overhanging fuels to create 10 feet spacing between canopy and structure or chimney openings | | 2.0 |
| | | Individual Facility | Initial | 1 | Mow dead/dying grass to less than 4 inches | | 1.0 |

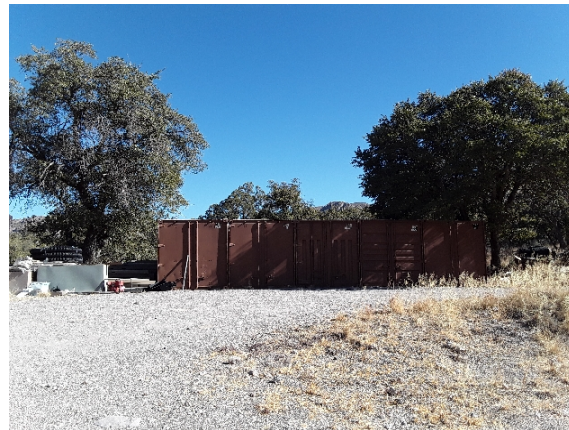
2021\_CHIR\_77507\_Front.jpg

**Access & Turnarounds:** Access is <300 ft from facility w/turnaround  
**Facility Number/Sign:** Marked and clearly visible  
**Defensible Space:** <30 ft treated

**Fuel Load (w/in 300 ft):** Moderate  
**Fuel Type (w/in 300ft):** Grass,shrub,hardwood litter  
**Topography (w/in 300ft):** Slope <5%  
**Roof Material:** Noncombustible or not applicable

| 6 | BLDG-051 Storage- Fire Management Storage. | Individual Facility | Initial | 1 | Mow dead/dying grass to less than 4 inches | | 1.0 |

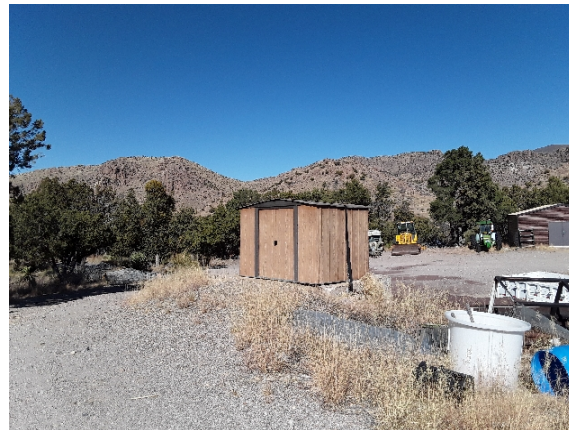
Photo 1.jpg

**Access & Turnarounds:** Access is <300 ft from facility w/turnaround  
**Facility Number/Sign:** None or not clearly visible  
**Defensible Space:** 100 ft treated

**Fuel Load (w/in 300 ft):** Light  
**Fuel Type (w/in 300ft):** Grass,shrub,hardwood litter  
**Topography (w/in 300ft):** Slope <5%  
**Roof Material:** Noncombustible or not applicable

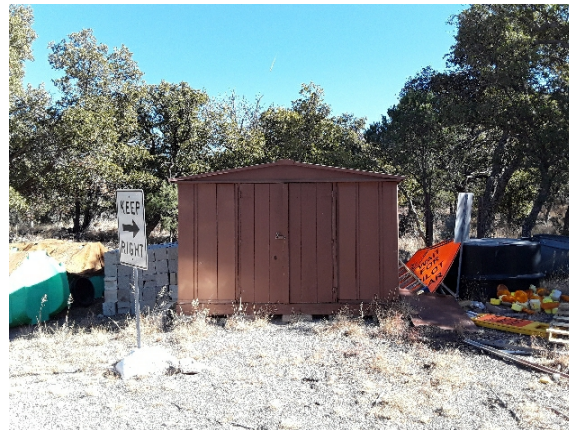
2021\_CHIR\_CHIR\_UNK001\_SignShed\_Front.jpg

**Access & Turnarounds:** Access is <300 ft from facility w/turnaround  
**Facility Number/Sign:** None or not clearly visible  
**Defensible Space:** <30 ft treated

**Fuel Load (w/in 300 ft):** Moderate  
**Fuel Type (w/in 300ft):** Grass,shrub,hardwood litter  
**Topography (w/in 300ft):** Slope <5%  
**Roof Material:** Noncombustible or not applicable

**Siding Material:** Rock, concrete, metal  
**Foundation:** Open or deck  
**Fences/Decks:** Combustible, adjacent, clear of veg/debris  
**Firewood:** None

| 8 | Sign Shed | Individual Facility | Initial | 1 | Mow dead/dying grass to less than 4 inches | | 1.0 |
| | | Individual Facility | SiteVisit | 1 | Limb trees 6 to 15 feet above ground | | 2.0 |
