# NPS Wildfire Risk Assessments Assessment Locations

## CORO - Coronado National Memorial Overview

# NPS Wildand Fire Risk Assessment - Facility Assessment

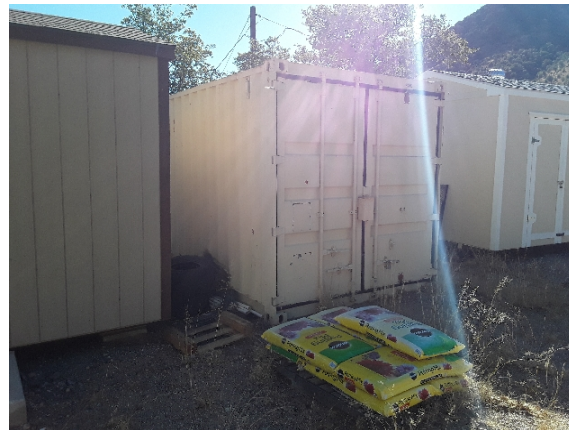
2021\_CORO\_not found \_conex box\_Front.jpg

**Score: 50**  
**Rating: Moderate**

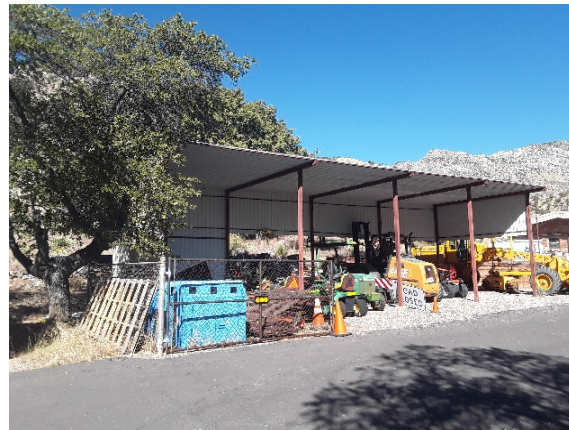
2021\_CORO\_79207\_Equipment Shed\_Front.jpg

**Additional Obstacles:** Hazmat, UXO,etc. , PLEASE COMMENT  
**Triage Category:**  
**Hazmat:** gas tanks nearby  
**Assessment Comments:**

**Score: 65**  
**Rating: High**

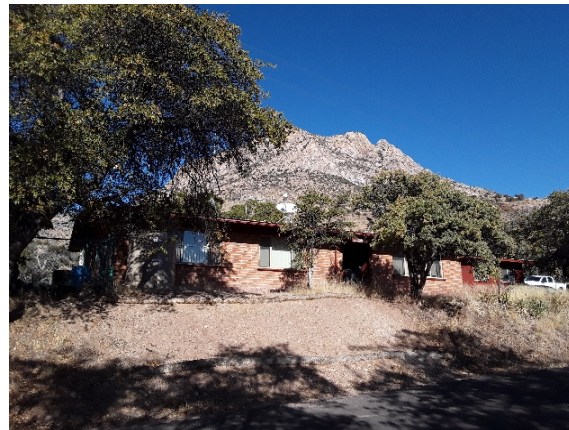
2021\_CORO\_79203\_Headquarters Building\_Front.jpg

**Score: 52**  
**Rating: Moderate**

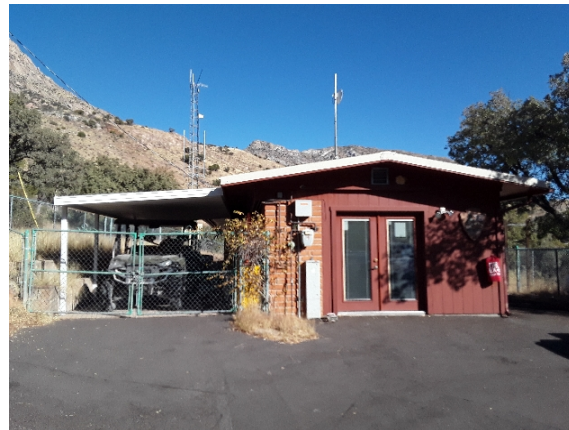
2021\_CORO\_79196\_L.E. Office\_Front.jpg

**Score: 38**  
**Rating: Low**

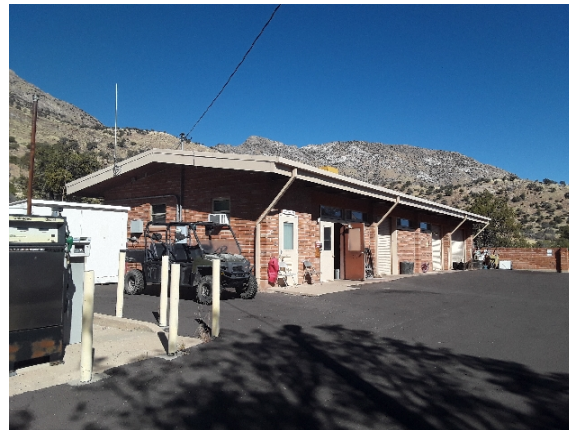
2021\_CORO\_79205\_MAINTENANCE SHOP\_Front.jpg

**Additional Obstacles:** Hazmat, UXO,etc. , PLEASE COMMENT  
**Triage Category:**  
**Hazmat:** fuel locker on B side, gas and diesel pump on B side  
**Assessment Comments:**

**Score: 51**  
**Rating: Moderate**

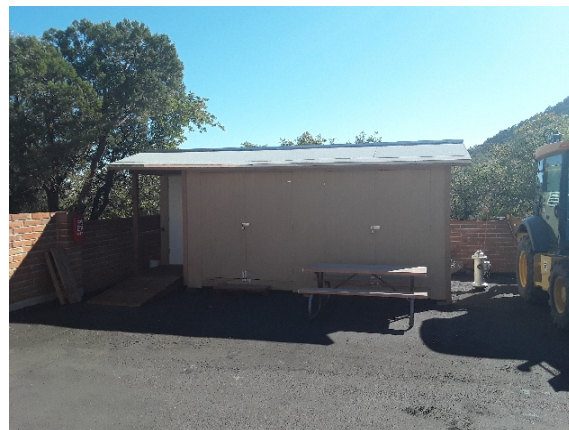
2021\_CORO\_79206\_Maintenance Storage Shed\_Front.jpg

**Additional Obstacles:** Hazmat, UXO,etc. , PLEASE COMMENT  
**Triage Category:**  
**Hazmat:** gas pumps are nearby  
**Assessment Comments:**

**Score: 71**  
**Rating: High**

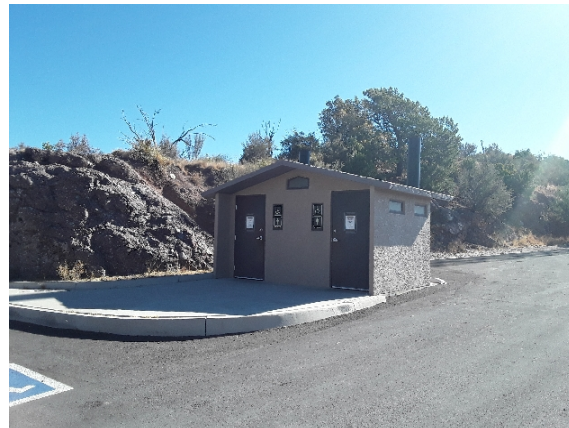
2021\_CORO\_79202\_MONTEFrontUMA PASS COMFORT STATION\_Front.jpg

**Score: 48** **Asset Priority Index (API): 36**  
**Rating: Moderate**

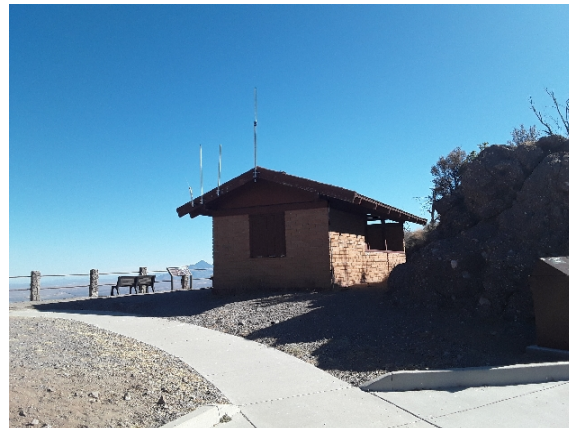
2021\_CORO\_79201\_Montezuma Pass Contact Station\_Front.jpg

**Score: 70**  
**Rating: High**

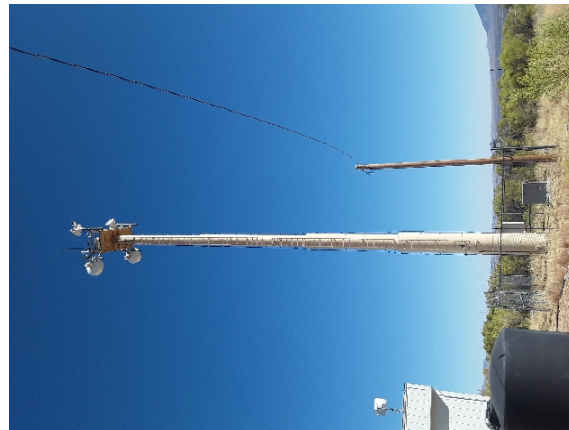
2021\_CORO\_not found \_NPS Mobile Repeater\_Front.jpg

**Assessment Comments:** according to park staff, nearby structure is portable and will be moved

**Score: 41**  
**Rating: Low**

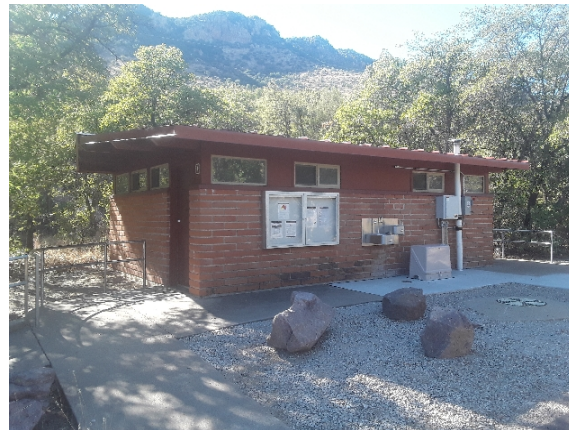
2021\_CORO\_79222\_PICNIC AREA COMFORT STATION\_Front.jpg

**Score: 55**  
**Rating: Moderate**

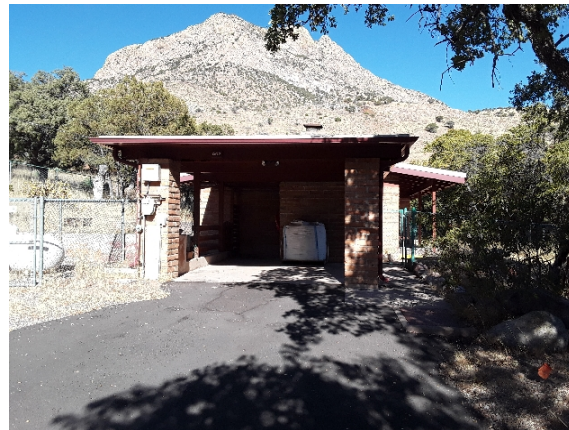
2021\_CORO\_79195\_QUARTERS #2\_Front.jpg

**Assessment Comments:** other photos not accessible due to fence

**Score: 52**  
**Rating: Moderate**

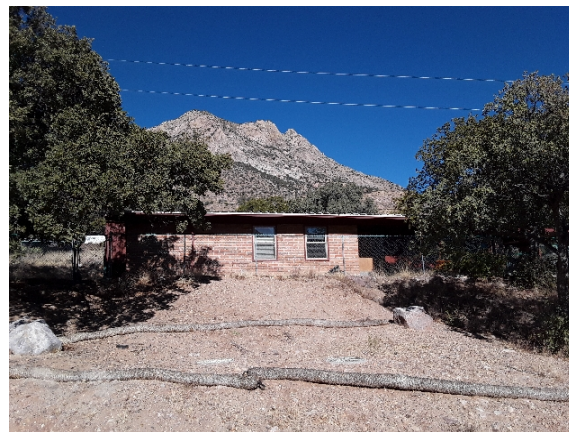
2021\_CORO\_79193\_Quarters 1\_Front.jpg

**Safety Zones:** Potential safety zone(s) in area  
**Additional Obstacles:** None  
**Triage Category:**  
**Hazmat:**  
**Assessment Comments:** other photos not accessible due to fence

**Score: 52**  
**Rating: Moderate**  
**Asset Priority Index (API): 42**

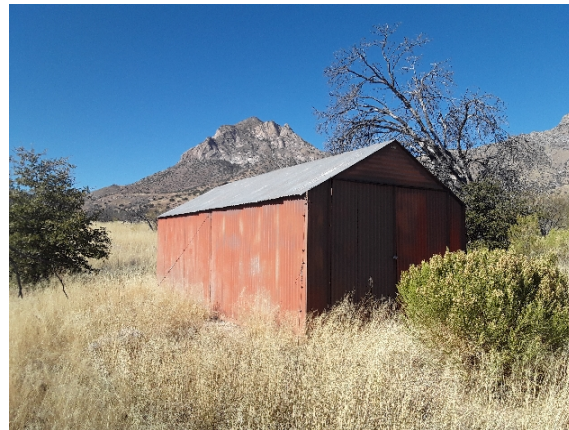
2021\_CORO\_not found \_Storage Shed\_Front.jpg

**Score: 64**  
**Rating: High**

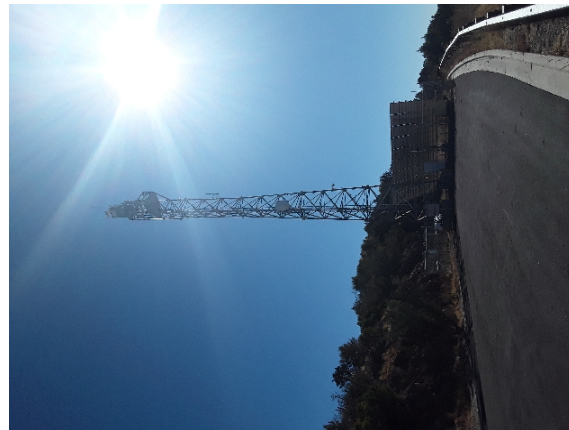
2021\_CORO\_not found \_USBP Observation Tower\_Front.jpg

**Score: 66**  
**Rating: High**

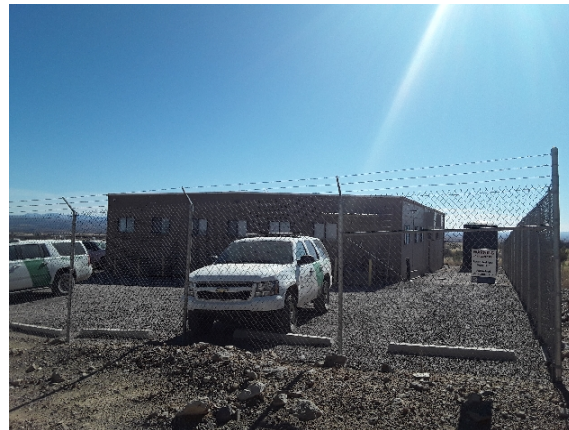
2021\_CORO\_not found \_USBP Ops Office\_Front.jpg

**Score: 29**  
**Rating: Low**

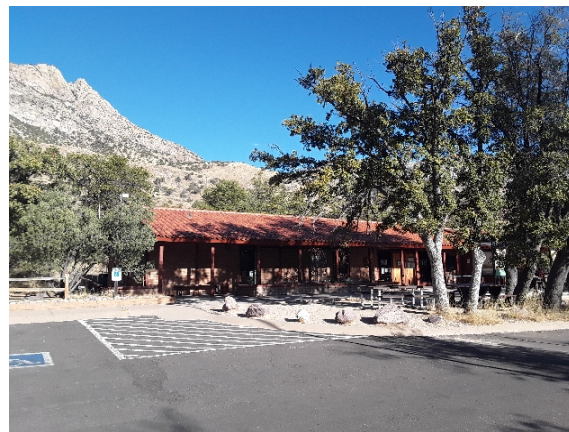
2021\_CORO\_79199\_Visitor Center\_Front.jpg

**Score: 51**  
**Rating: Moderate**

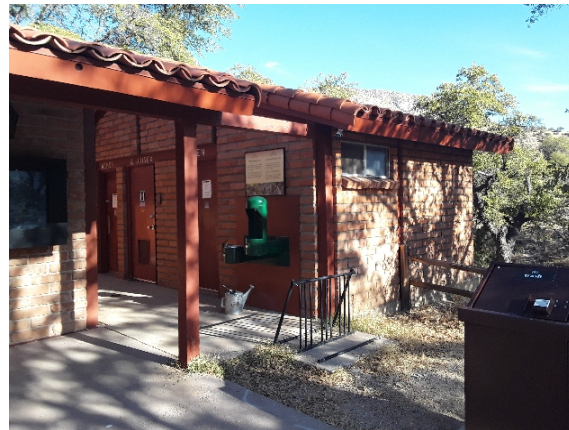
2021\_CORO\_79200\_Visitor Center Comfort Station\_Front.jpg

**Score: 49**  
**Rating: Moderate**
