# NPS Wildfire Risk Assessments

### Saguaro National Park

# Rincon Mountain-Backcountry

# NPS Wildand Fire Risk Assessment - Facility Wildfire Risk Assessment Summary

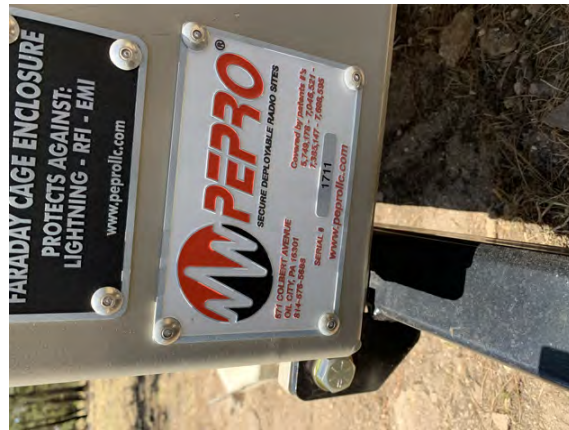
2021\_SAGU\_\_Mica Repeater\_P.jpg

**Assessment Comments:**

**Score: 82**  
**Rating: High**

| Label # | Facility/Community Name | Assessment Scale | Site Visit Type | Firewise Zone | Treatment | Treatment Description | Person Hours |
|---|---|---|---|---|---|---|---|
| 4 | Mica Repeater | Individual Facility | | | | | |

| Facility/Community Name | Assessment Scale | Triage Category | Tactic Description | Person Hours | Equipment Description | Equip. Qty |
|---|---|---|---|---|---|---|
| Mica Repeater | Individual Facility | PrepLeave | - | | - | |

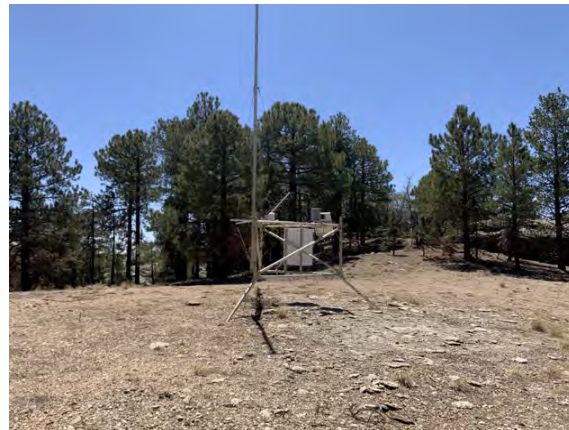
2021\_SAGU\_\_Rincon RAWS\_P.jpg

**Assessment Comments:** QHVA3. WIMS ID 21207

**Score: 70**  
**Rating: High**

| Label # | Facility/Community Name | Assessment Scale | Site Visit Type | Firewise Zone | Treatment | Treatment Description | Person Hours |
|---|---|---|---|---|---|---|---|
| 5 | Rincon RAWS | Individual Facility | | | | | |

| Facility/Community Name | Assessment Scale | Triage Category | Tactic Description | Person Hours | Equipment Description | Equip. Qty |
|---|---|---|---|---|---|---|
| Rincon RAWS | Individual Facility | PrepLeave | - | | - | |

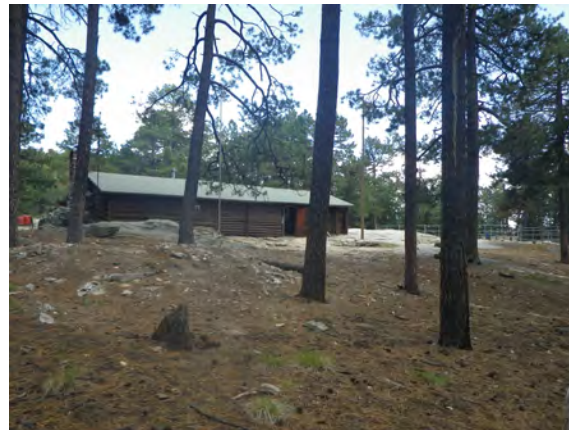
2013\_SAGU\_79293\_RM Manning Cabin\_Front.jpg

**Firewood:** Adjacent to/under deck of facility  
**Propane Tanks:** Present and fuels clearance  
**Water Supply:** No reliable water source nearby  
**Overhead Hazards:** No overhead hazards

**Safety Zones:** No safety zone(s) in area  
**Additional Obstacles:** Hazmat, UXO, etc. , PLEASE COMMENT  
**Triage Category:**  
**Hazmat:** Propane, flammable materials in Flam locker.

**Assessment Comments:** Facility only accessible by foot or air.

**Score: 72**  
**Rating: High**

| Label # | Facility/Community Name | Assessment Scale | Site Visit Type | Firewise Zone | Treatment | Treatment Description | Person Hours |
|---|---|---|---|---|---|---|---|
| 6 | RM Manning Cabin | Individual Facility | Initial | 1 | Clear adjacent and overhanging fuels to create 10 feet spacing between canopy and structure or chimney openings | | 6.0 |

| 6 | RM Manning Cabin | Individual Facility | Initial | 1 | Firewood should be moved at least 50 ft from the facility and 15 horizontal feet from tree canopies | | 6.0 |
| | | Individual Facility | Initial | 1 | Remove dead or dying component of shrubs and trees | | 6.0 |
| | | Individual Facility | Initial | 2 | Limb trees 6 to 15 feet above ground | | 12.0 |
| | | Individual Facility | Initial | 2 | Open crown spacing 10 to 30 feet depending on slope | | 18.0 |
| | | Individual Facility | Initial | 3 | Remove heavy ground fuels such as logs and stumps | | 12.0 |

| Facility/Community Name | Assessment Scale | Triage Category | Tactic Description | Person Hours | Equipment Description | Equip. Qty |
|---|---|---|---|---|---|---|
| RM Manning Cabin | Individual Facility | PrepHold | Fuels reduction - | 18.0 | - | |
| | | | Remove flammable materials - | 6.0 | - | |
| | | | Structure wrap - Wrap is staged and located in rafters of dog run. Other supplies (tape, staples stapler) will be needed, ladder on site. | 48.0 | - | |

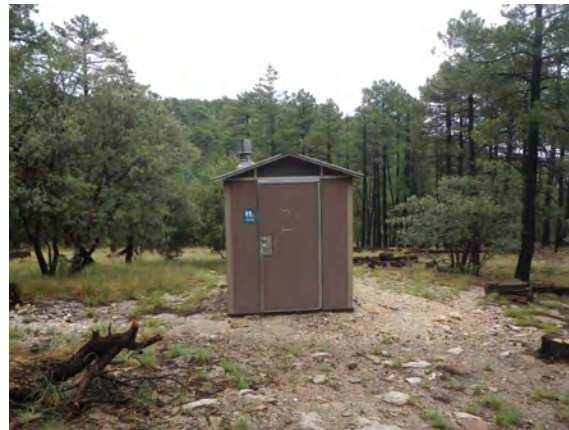
2013\_SAGU\_97712\_RM Manning Camp Comfort Station\_Front.jpg

Assessment Comments: Facility is only accessible by Foot or Air.

Score: 89  
Rating: High

| 7 | RM Manning Camp Comfort Station | Individual Facility | Initial | 1 | Flammable ground cover such as leaf litter, woody debris or highly flammable vegetation should be removed | | 6.0 |
| | | Individual Facility | Initial | 2 | Flammable ground cover should be removed or isolated | | 12.0 |
| | | Individual Facility | Initial | 2 | Limb trees 6 to 15 feet above ground | | 12.0 |
| | | Individual Facility | Initial | 3 | Remove heavy ground fuels such as logs and stumps | | 18.0 |

| Facility/Community Name | Assessment Scale | Triage Category | Tactic Description | Person Hours | Equipment Description | Equip. Qty |
|---|---|---|---|---|---|---|
| RM Manning Camp Comfort Station | Individual Facility | PrepHold | Burnout, no line construction necessary - | 6.0 | - | |
| | | | Fuels reduction - | 30.0 | - | |

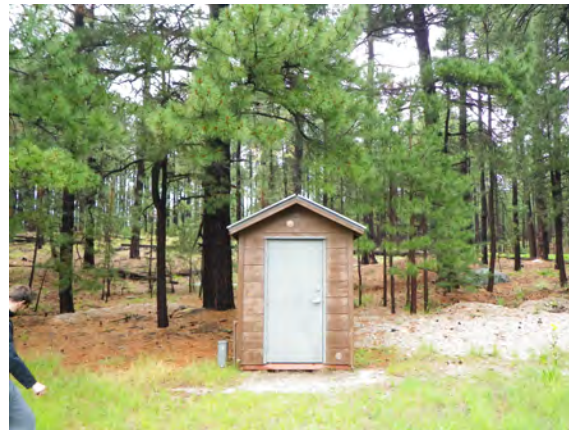
2013\_SAGU\_0000001\_RM Manning Pump House\_Front.jpg

Hazmat: Sodium Hypochlorite,spray paint , spray adhesive, PVC cement and Primer.

Assessment Comments: Facility only accessible by foot or Air.

Score: 95  
Rating: High

| 8 | RM Manning Pump House | Individual Facility | Initial | 1 | Clear adjacent and overhanging fuels to create 10 feet spacing between canopy and structure or chimney openings | | 0.0 |
| | | Individual Facility | Initial | 1 | Flammable ground cover such as leaf litter, woody debris or highly flammable vegetation should be removed | | 6.0 |
| | | Individual Facility | Initial | 2 | Flammable ground cover should be removed or isolated | | 6.0 |
| | | Individual Facility | Initial | 2 | Open crown spacing 10 to 30 feet depending on slope | | 6.0 |
| | | Individual Facility | Initial | 3 | Remove heavy ground fuels such as logs and stumps | | 6.0 |

| Facility/Community Name | Assessment Scale | Triage Category | Tactic Description | Person Hours | Equipment Description | Equip. Qty |
|---|---|---|---|---|---|---|
| RM Manning Pump House | Individual Facility | PrepHold | Structure wrap - | 12.0 | - | |
| | | | Fuels reduction - | 6.0 | - | |

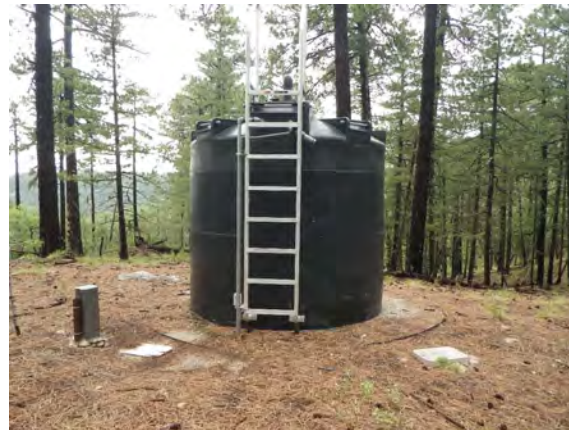
2013\_SAGU\_0000002\_RM Manning Water Tank\_Front.jpg

Assessment Comments: Facility is only accessible by foot or Air

Score: 119  
Rating: High

| 9 | RM Manning Water Tank | Individual Facility | Initial | 1 | Flammable ground cover such as leaf litter, woody debris or highly flammable vegetation should be removed | Remove adjacent heavy dead and down, rake needles and disperse. | 3.0 |
| | | Individual Facility | Initial | 2 | Flammable ground cover should be removed or isolated | | 6.0 |
| | | Individual Facility | Initial | 2 | Limb trees 6 to 15 feet above ground | | 6.0 |
| | | Individual Facility | Initial | 2 | Open crown spacing 10 to 30 feet depending on slope | | 30.0 |

| 9 | RM Manning Water Tank | Individual Facility | Initial | 3 | Remove heavy ground fuels such as logs and stumps | Area to be treated approx 2 Acres | 12.0 |
| | | Individual Facility | Initial | 3 | Remove standing dead or dying trees or limb 6 to 15 feet above ground | | 6.0 |

| Facility/Community Name | Assessment Scale | Triage Category | Tactic Description | Person Hours | Equipment Description | Equip. Qty |
|---|---|---|---|---|---|---|
| RM Manning Water Tank | Individual Facility | PrepHold | Handline - Install HL and fire off of HL at appropriate time. | 6.0 | - | |
| | | | Fuels reduction - | 42.0 | - | |

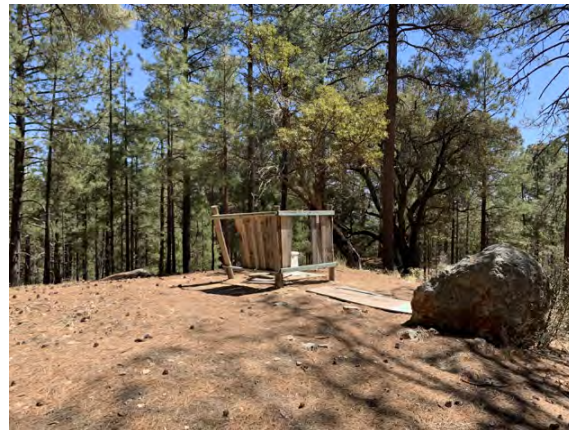
2013\_SAGU\_0000004\_RM Spud Rock Campground Toilet\_P.jpg

Assessment Comments: Facility is an open toilet, Only Accessable by Foot or Air.

Score: 96  
Rating: High

| Facility/Community Name | Assessment Scale | Triage Category | Tactic Description | Person Hours | Equipment Description | Equip. Qty |
|---|---|---|---|---|---|---|
| RM Spud Rock Campground Toilet | Individual Facility | | Structure wrap - | 6.0 | - | |
| | | | Handline - Handling and burnout.. best option.<br>Structure wrap it light it and go | 6.0 | - | |
