# NPS Wildfire Risk Assessments

### Tumacacori National Historic Monument

# Calabazas

# NPS Wildand Fire Risk Assessment - Facility Assessment

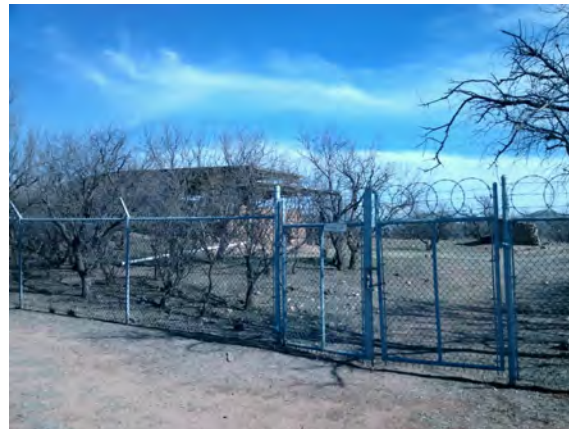
2018\_TUMA\_\_Ruins and Shelter\_Front.jpg

**Defensible Space:** 30 ft treated

**Water Supply:** No reliable water source nearby

**Assessment Comments:** Not surveyed in 2021 - spoke to park staff and was told that the ruins/shelter are not made of flammable materials and 30ft defensible space is maintained.

**Score:** 56  
**Rating:** Moderate
