# NPS Wildfire Risk Assessments Assessment Locations

## LIRI - Little River Canyon National Preserve

# NPS Wildand Fire Risk Assessment - Facility Assessment

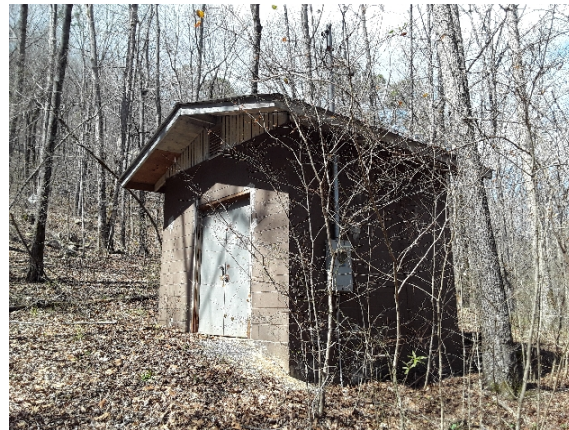
2022\_LIRI\_not found\_Cinder Block Utility Building\_Front.jpg

Rating: High

Defensible Space: No defensible space

Topography (w/in 300ft): Slope 21% to 30%

Water Supply: No reliable water source nearby

Score: 69  
Rating: High

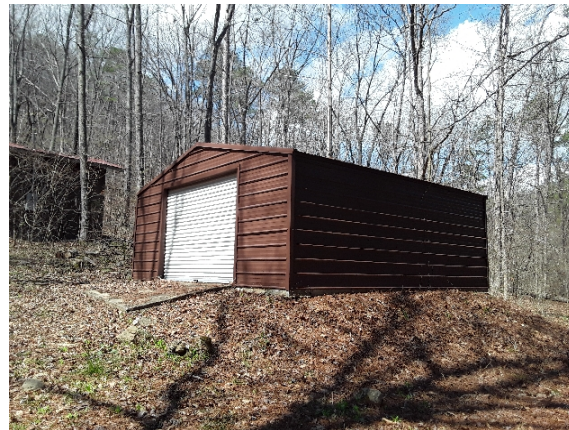
2022\_LIRI\_227444\_CMP Storage Building\_Front.jpg

Rating: Moderate

Defensible Space: 30 ft treated

Topography (w/in 300ft): Slope 21% to 30%

Water Supply: No reliable water source nearby

Score: 56  
Rating: Moderate

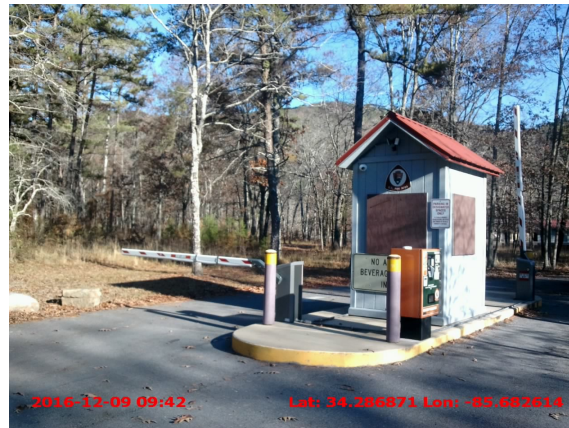
2016 LIRI\_111682\_CMDUA Fee Booth\_Front.jpg

Bridge Condition: Flammable, load limit will limit response

Siding Material: Wood or open sided

Fences/Decks: Combustible but separated from facility

Score: 48  
Rating: Moderate

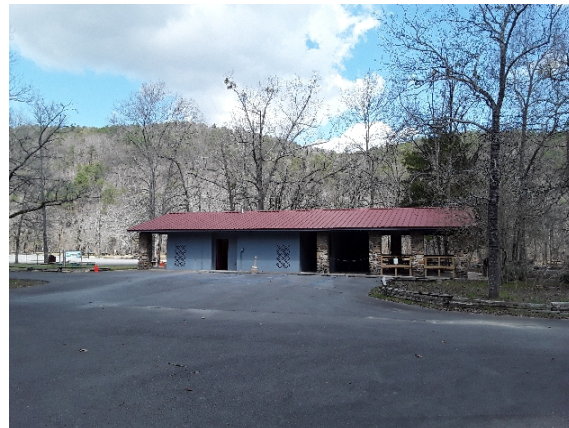
2022\_LIRI\_66396\_CMP Multi-Use Facility\_Front.jpg

Defensible Space: <30 ft treated

Water Supply: Limited or dependent on electricity

Score: 45  
Rating: Moderate

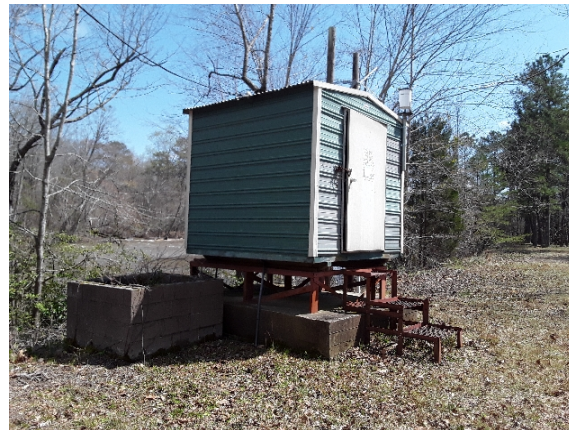
2022\_LIRI\_not found\_USGS Stream Gaging Station\_Front.jpg

**Rating:** High

**Defensible Space:** <30 ft treated

**Foundation:** Open or deck

**Water Supply:** No reliable water source nearby

**Score: 63**  
**Rating: High**

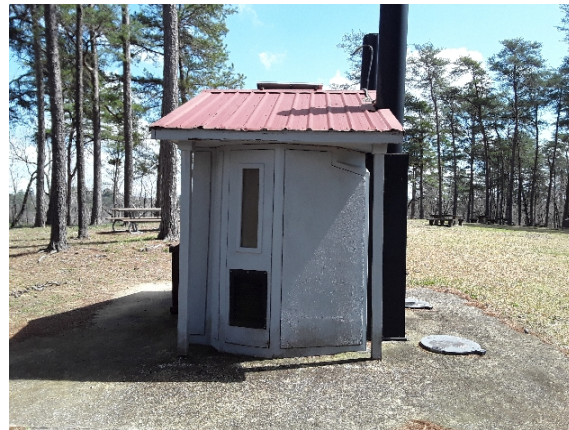
2022\_LIRI\_66417\_Eberhart Comfort Station\_Front.jpg

Score: 37  
Rating: Low

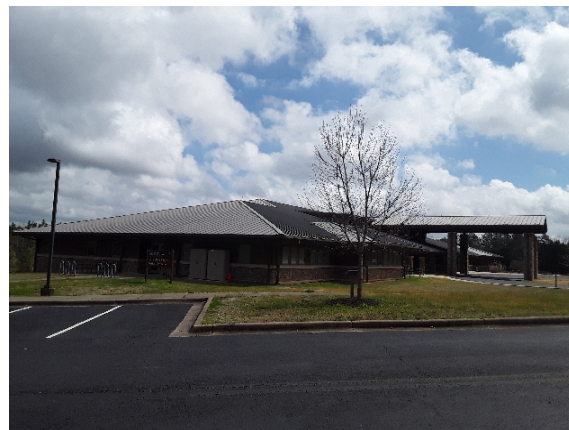
2022\_LIRI\_115757\_LIRI Visitor Center\_Front.jpg

Firewood: Adjacent to/under deck of facility

Hazmat: Hazmat Storage

Score: 26  
Rating: Low

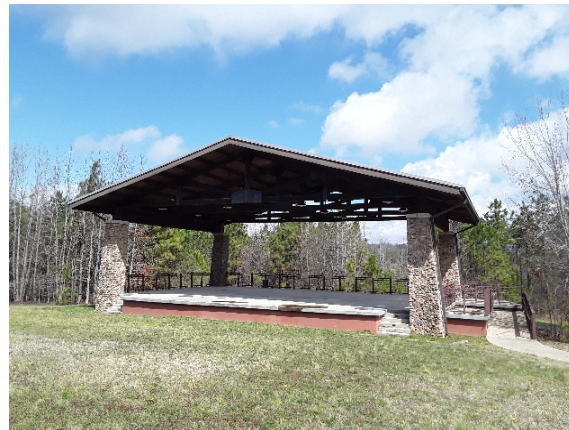
2022\_LIRI\_not found\_LIRI Amphitheatre\_Front.jpg

Assessment Comments: Please assess. Not owned by NPS. JMS 3/3/2022

Score: 27  
Rating: Low

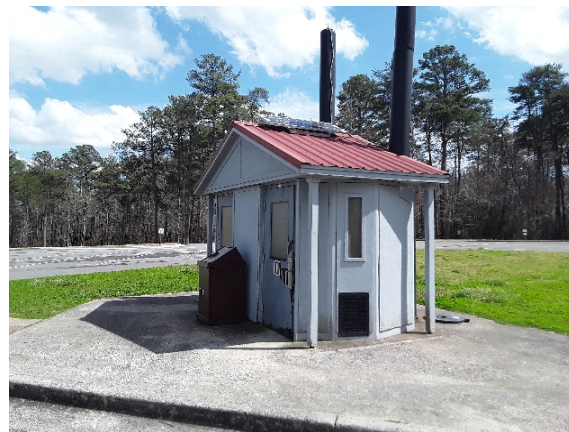
2022\_LIRI\_66404\_Falls Comfort Station\_Front.jpg

Score: 25  
Rating: Low

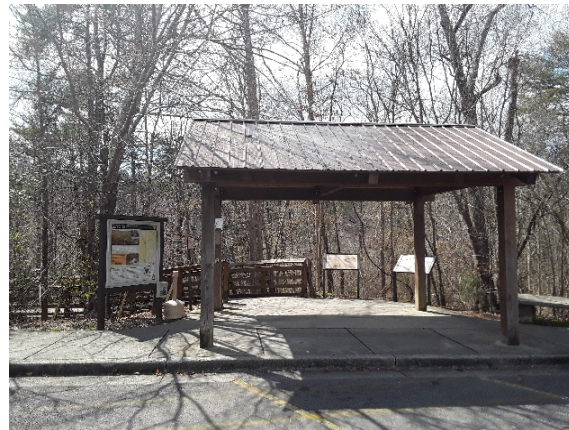
2022\_LIRI\_not found\_Little River Canyon Shade Structure\_Front.jpg

Score: 52  
Rating: Moderate

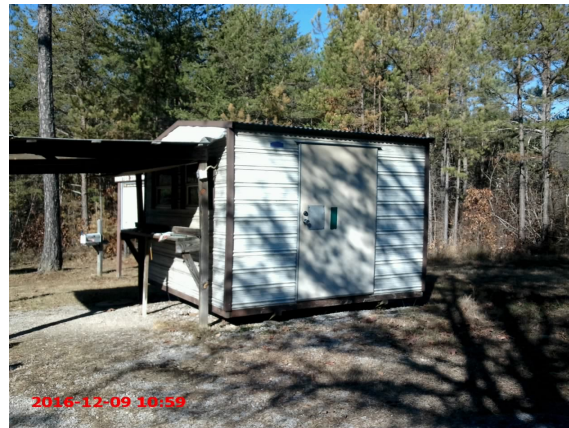
2016 LIRI\_\_Deer Check Station\_Front.jpg

Foundation: Open or deck

Assessment Comments: Owned and operated by Alabama Dept of NR. No survey necessary. (JMS 3/2/2022)

Score: 53  
Rating:  
SRVNotRequired

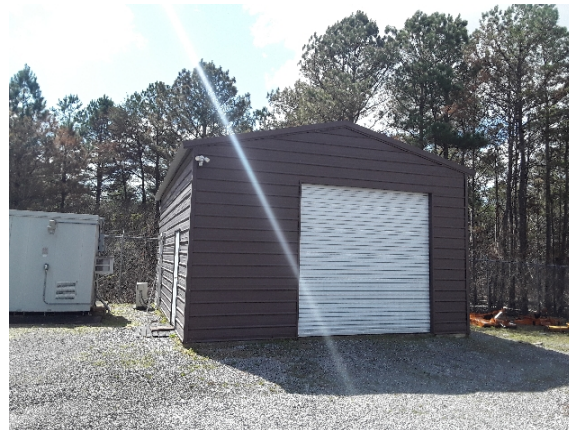
2022\_LIRI\_104050\_LIRI Fire Building & Gym\_Front.jpg

Score: 30  
Rating: Low

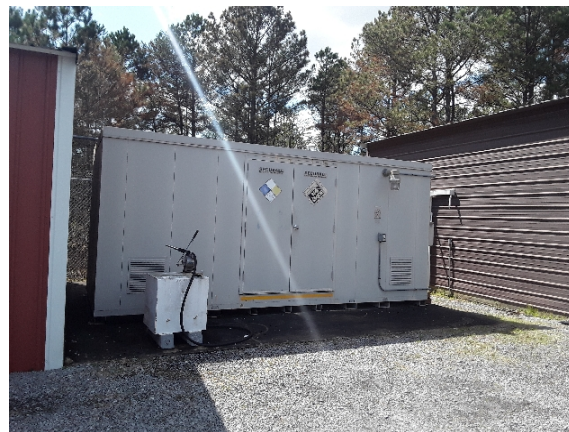
2022\_LIRI\_97579\_Maint Flammable Storage Building\_Front.jpg

Hazmat: Flammables storage and propane

Score: 28  
Rating: Low

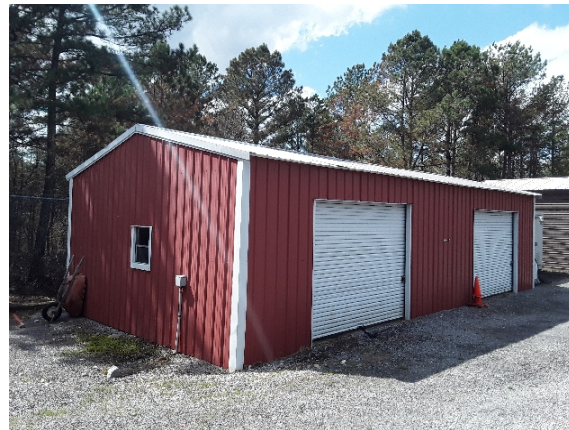
2022\_LIRI\_97577\_RT and Fire Building\_Front.jpg

**Hazmat:** Hazmat Storage

**Score: 30**  
**Rating: Low**

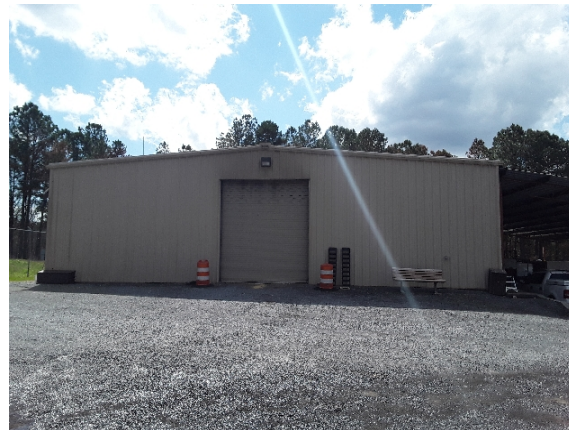
2022\_LIRI\_66409\_Maintenance Building\_Front.jpg

Hazmat: Flammables storage

Score: 30  
Rating: Low

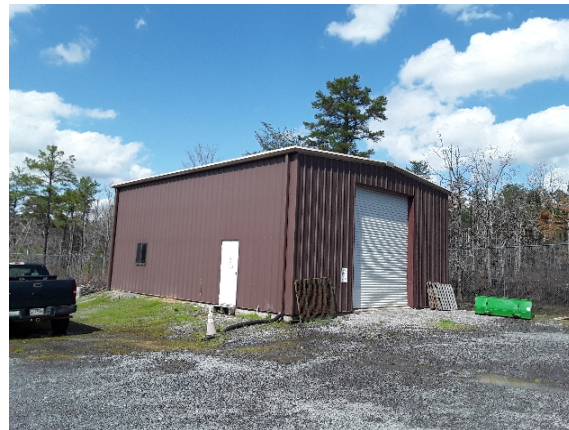
2022\_LIRI\_00000\_State Wildlife Building\_Front.jpg

Hazmat: Hazmat Storage

Score: 26  
Rating: Low
