# NPS Wildfire Risk Assessments Assessment Locations

## DEVA - Death Valley National Park - Overview

DEVA - Eureka Valley - Overview

# NPS Wildland Fire Risk Assessment - Facility Assessment

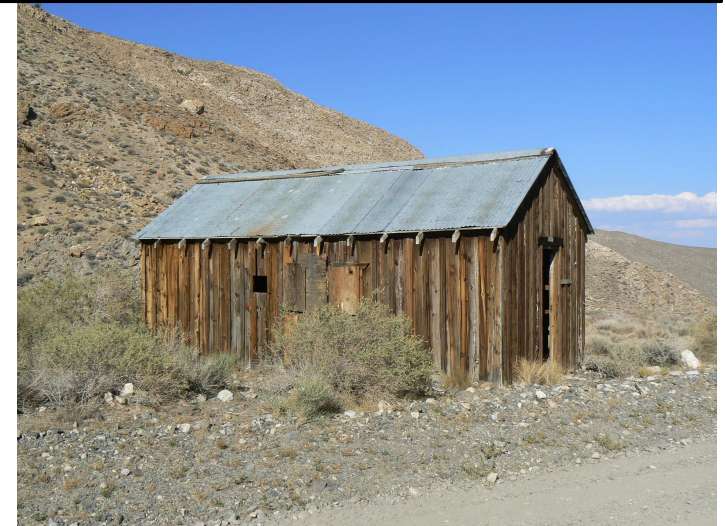
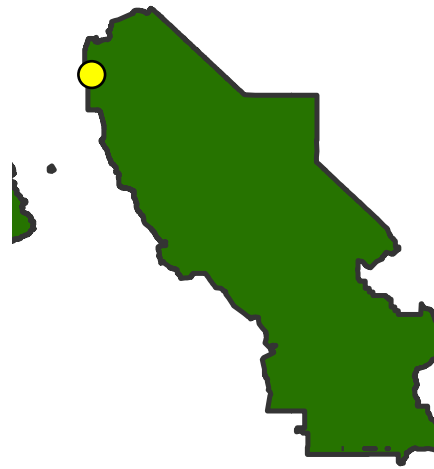
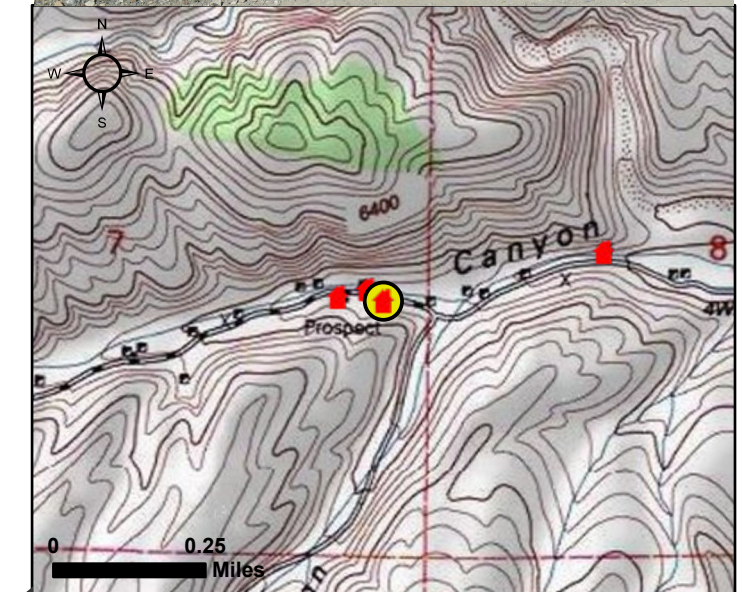
**Facility Name:** Marble Canyon Cabin 2

**Rating:** High

**Fuel Type:** Shrub or timber

**Fuel Load:** Light or no wildland fuels

**Defensible Space:** Less than 30 ft treated

**Roof Material:** Noncombustible or not applicable

**Siding Material:** Wood or open sided

**Comments:** Backcountry cultural resource

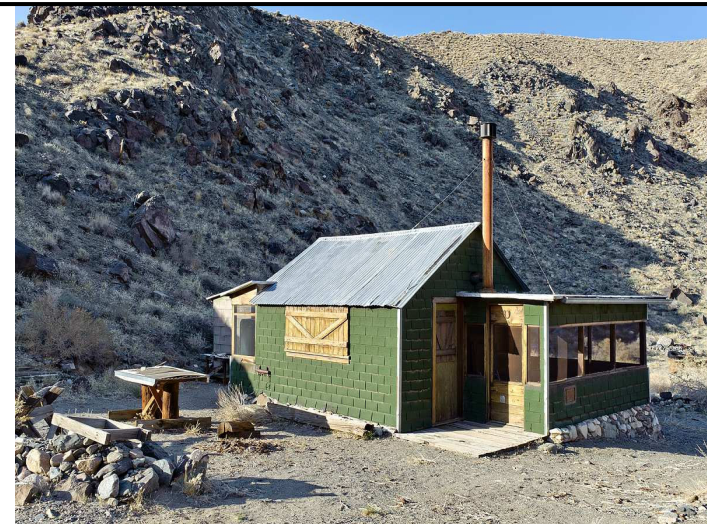
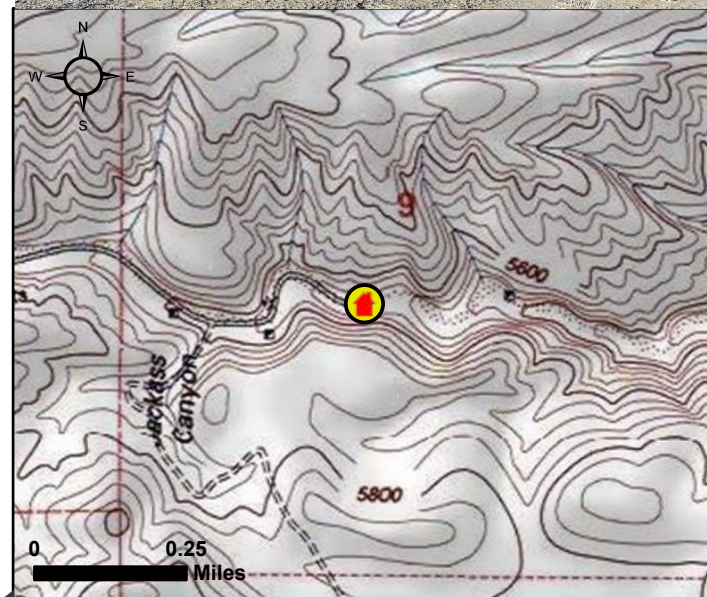
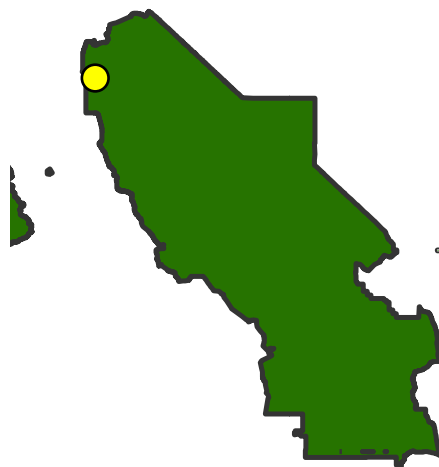
**Facility Name:** Easy Pickings Cabin

**Rating:** High

**Fuel Type:** Shrub or timber

**Fuel Load:** Light or no wildland fuels

**Defensible Space:** Less than 30 ft treated

**Roof Material:** Noncombustible or not applicable

**Siding Material:** Wood or open sided

**Comments:** Backcountry cultural resource

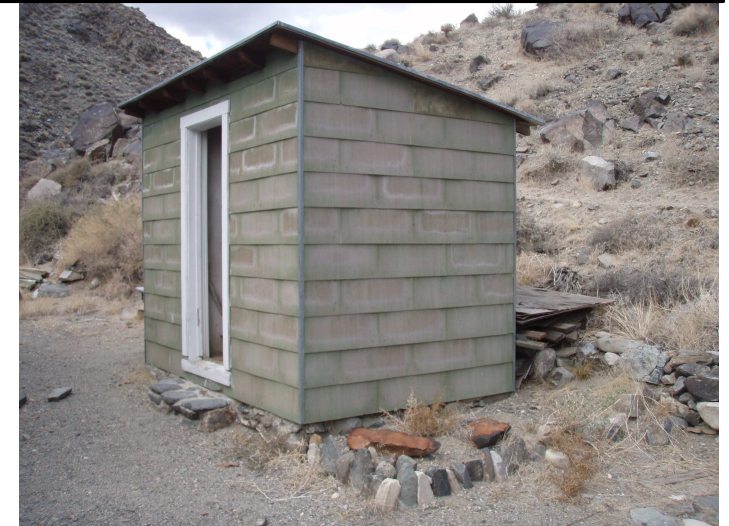
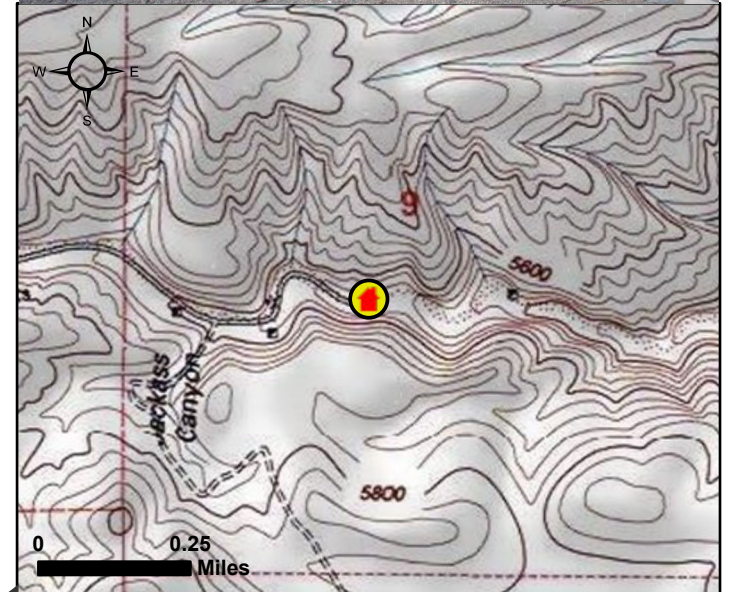
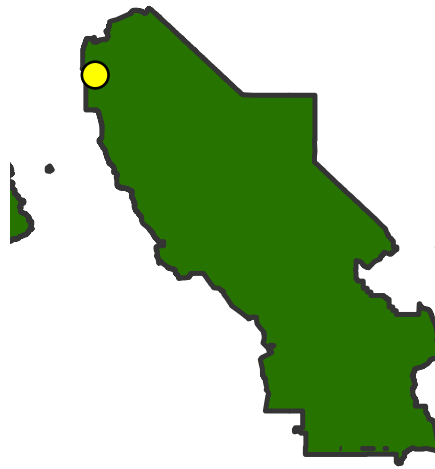
**Facility Name:** Easy Pickings Shed

**Rating:** High

**Fuel Type:** Shrub or timber

**Fuel Load:** Light or no wildland fuels

**Defensible Space:** Less than 30 ft treated

**Roof Material:** Combination of fire resitant and combustible

**Siding Material:** Wood or open sided

**Comments:** Backcountry cultural resource

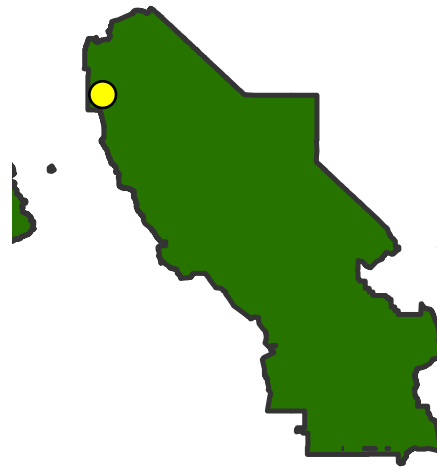
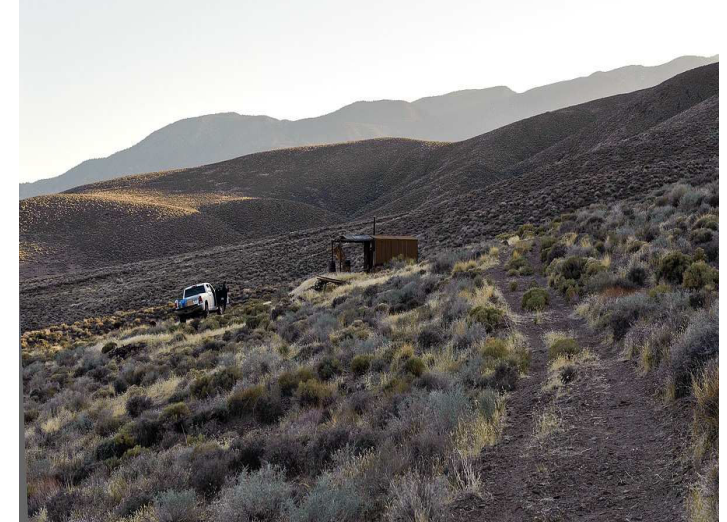
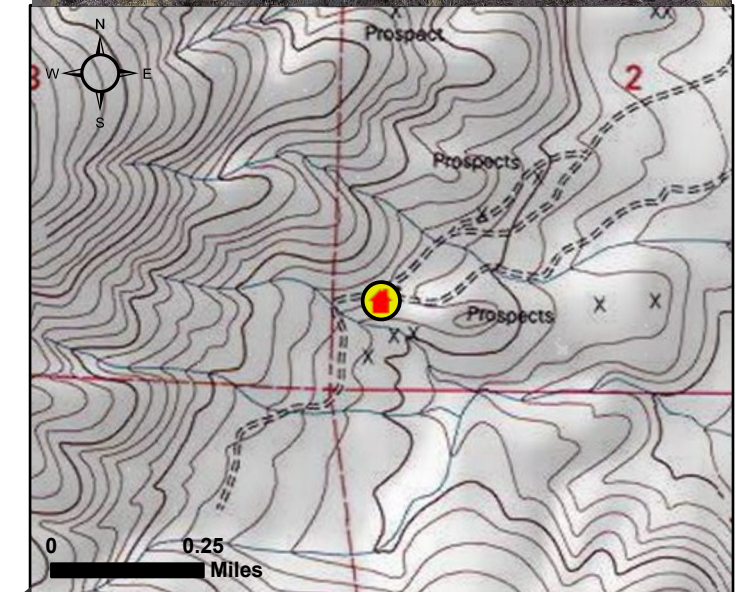
**Facility Name:** Jackass Flats Tarpaper Cabin

**Rating:** High

**Fuel Type:** Shrub or timber

**Fuel Load:** Light or no wildland fuels

**Defensible Space:** Less than 30 ft treated

**Roof Material:** Combination of fire resitant and combustible

**Siding Material:** Wood or open sided

**Comments:** Backcountry cultural resource

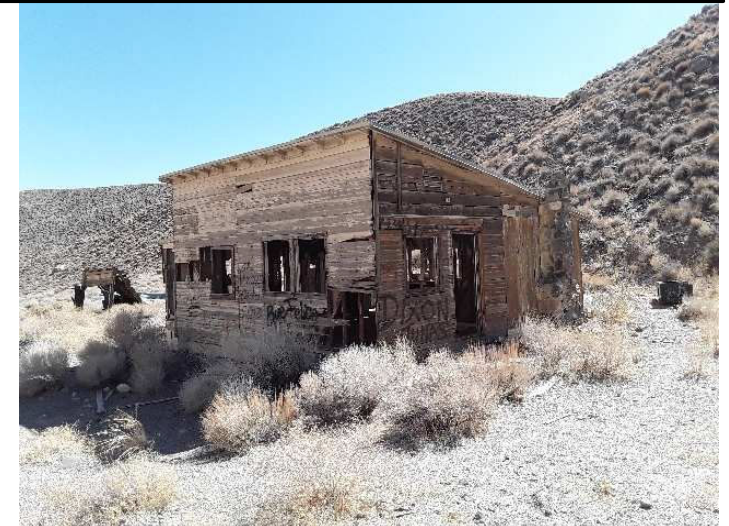
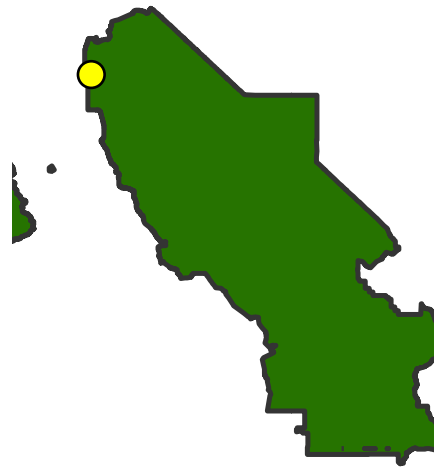
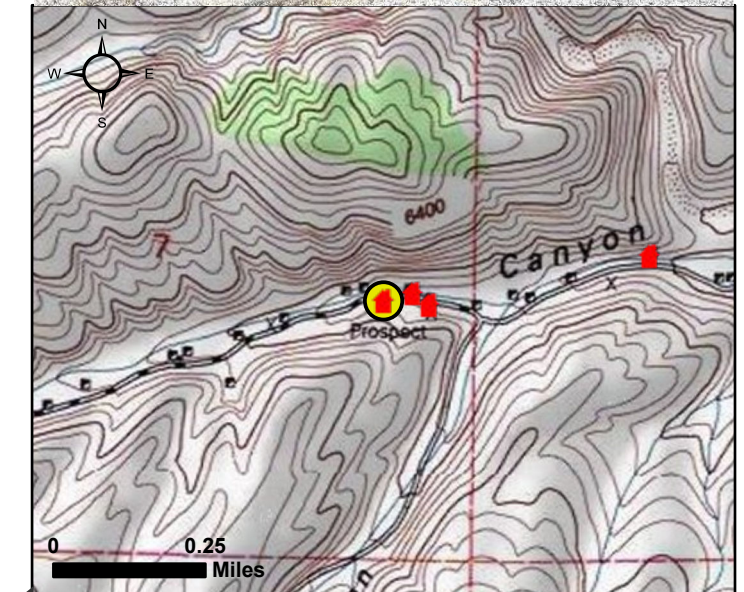
**Facility Name:** Marble Canyon Cabin 1

**Rating:** High

**Fuel Type:** Grass and shrub, hardwood litter

**Fuel Load:** Light or no wildland fuels

**Defensible Space:** Less than 30 ft treated

**Roof Material:** Noncombustible or not applicable

**Siding Material:** Wood or open sided

**Comments:** Backcountry cultural resource

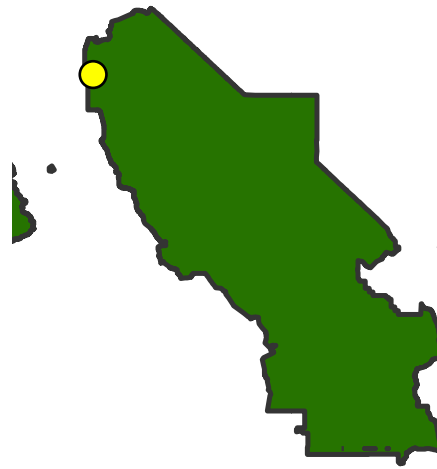
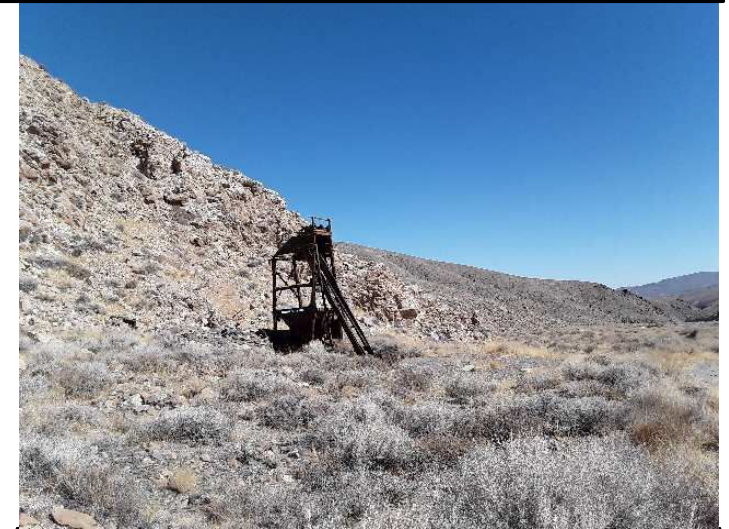
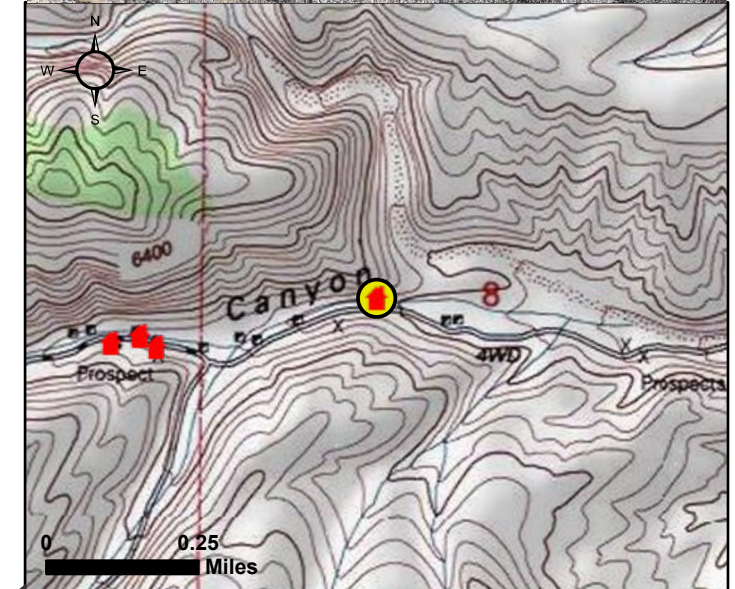
**Facility Name:** Marble Canyon Headframe 1

**Rating:** High

**Fuel Type:** Grass and shrub, hardwood litter

**Fuel Load:** Moderate

**Defensible Space:** Less than 30 ft treated

**Siding Material:** Wood or open sided

**Comments:** Backcountry cultural resource. 4x4 and high clearance necessary for access

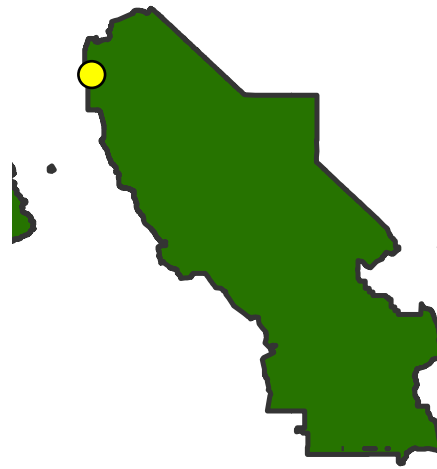
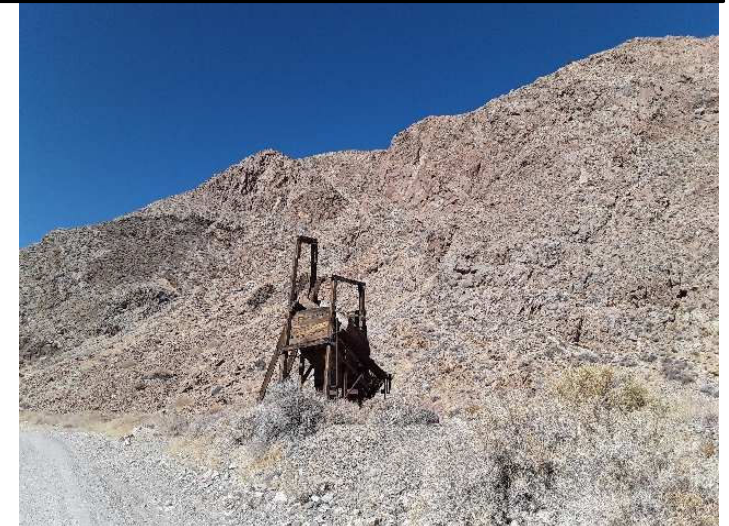
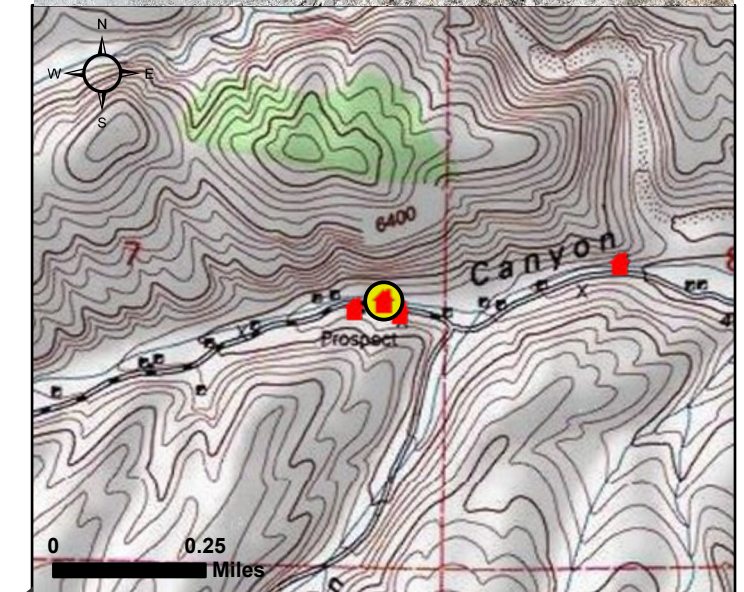
**Facility Name:** Marble Canyon Headframe 2

**Rating:** High

**Fuel Type:** Grass and shrub, hardwood litter

**Fuel Load:** Moderate

**Defensible Space:** Less than 30 ft treated

**Siding Material:** Wood or open sided

**Comments:** Backcountry cultural resource

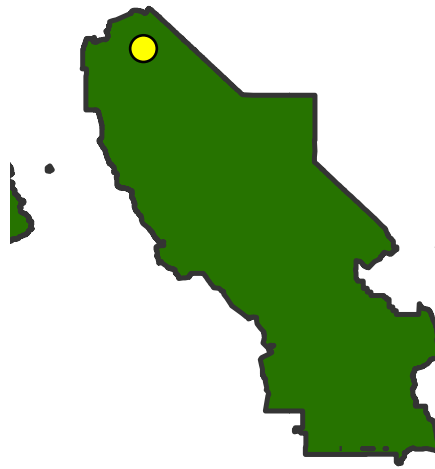
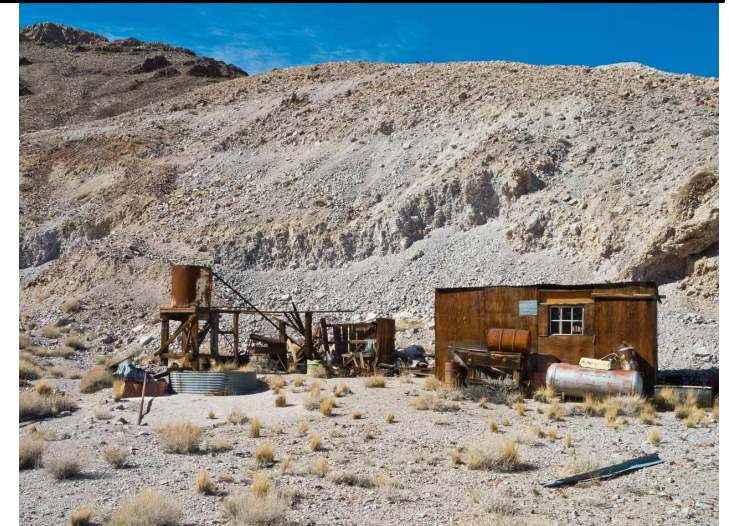
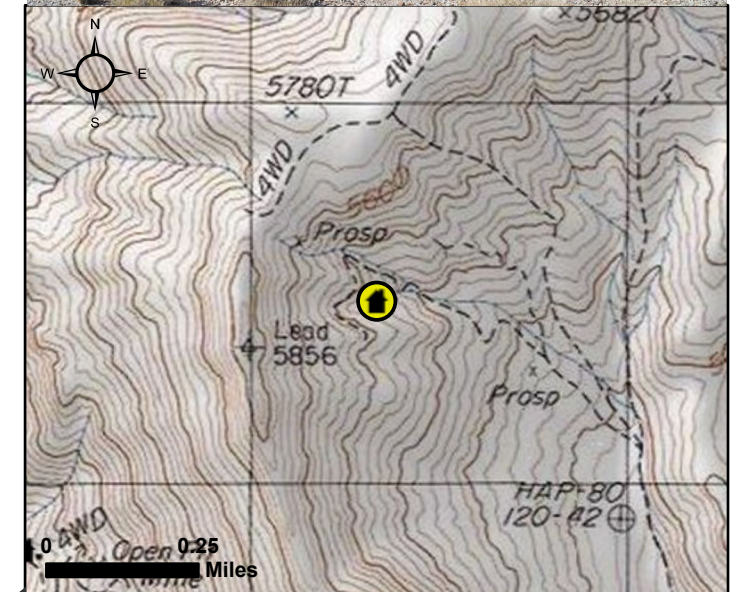
**Facility Name:** Rebecca Mine Cabin

**Rating:** No Wildland Risk

**Fuel Type:** No wildland fuel

**Defensible Space:** 30 ft treated

**Siding Material:** Wood or open sided

**Comments:** Backcountry cultural resource. 4x4 and high clearance necessary to access

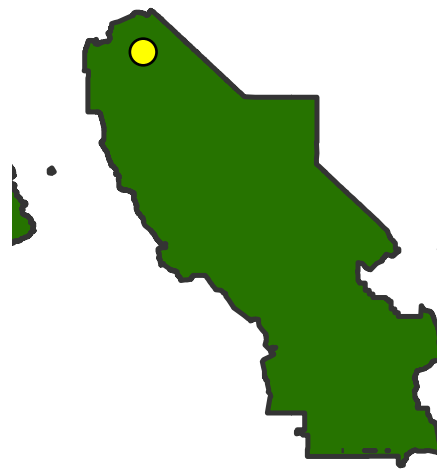
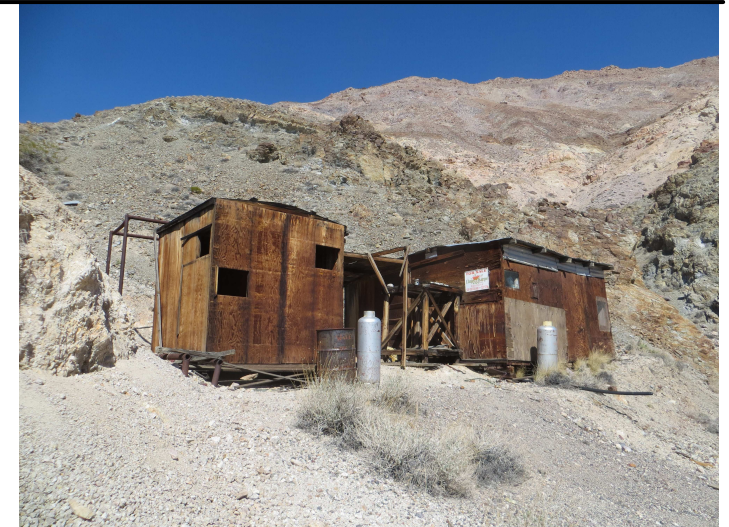
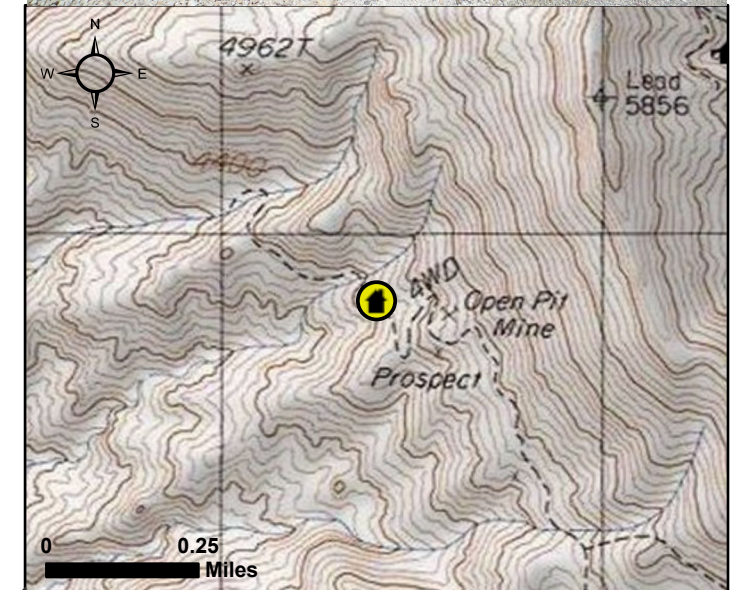
**Facility Name:** Up and Down Mine Cabin

**Rating:** No Wildland Risk

**Fuel Type:** No wildland fuel

**Defensible Space:** 30 ft treated

**Roof Material:** Combustible or no roof

**Siding Material:** Wood or open sided

**Comments:** Backcountry cultural resource. 4x4 and high clearance necessary to access

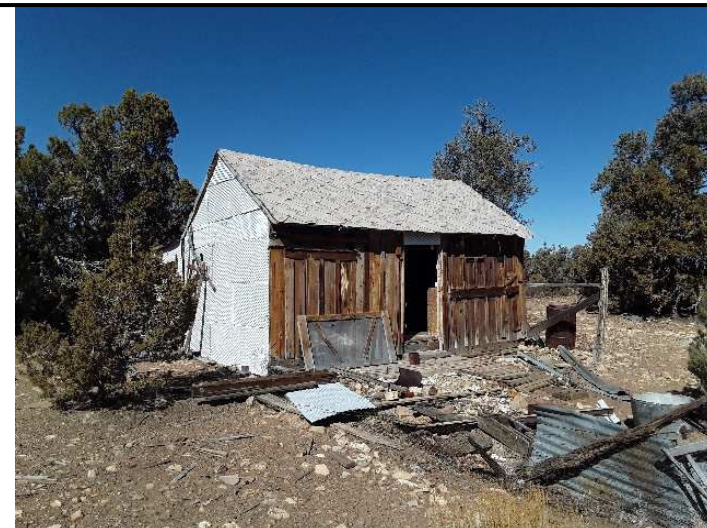
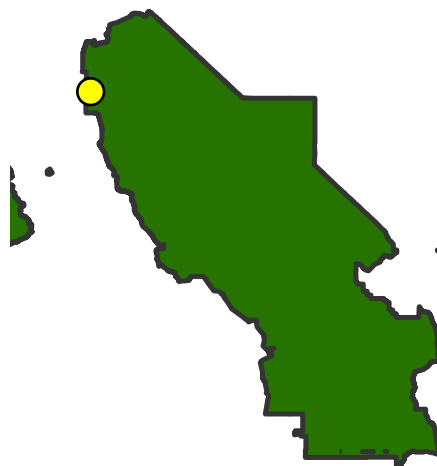
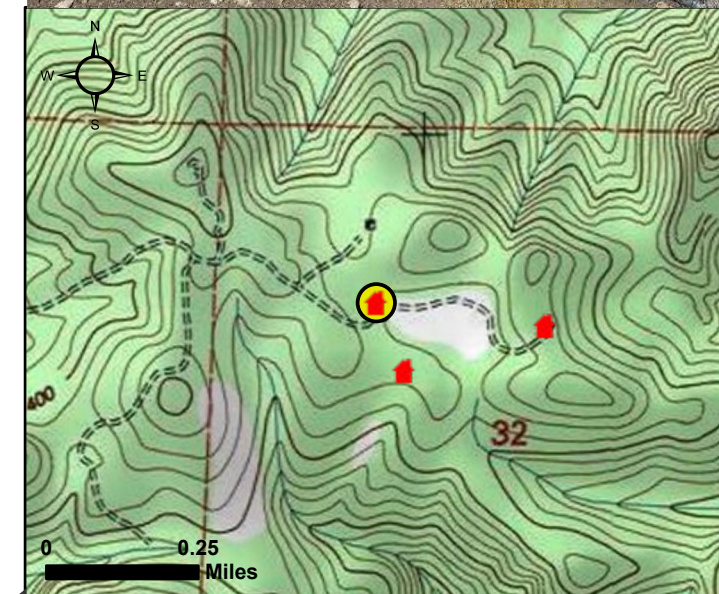
**Facility Name:** Whippoorwill Cabin 1

**Rating:** High

**Fuel Type:** Shrub or timber

**Fuel Load:** Moderate

**Defensible Space:** Less than 30 ft treated

**Roof Material:** Fire resistant- tar, rubberized

**Siding Material:** Wood or open sided

**Comments:** Backcountry cultural resource. 4x4 and high clearance necessary to access

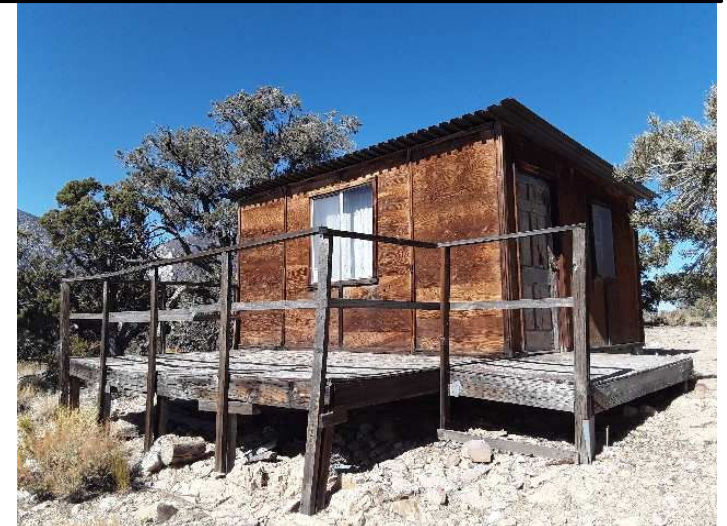
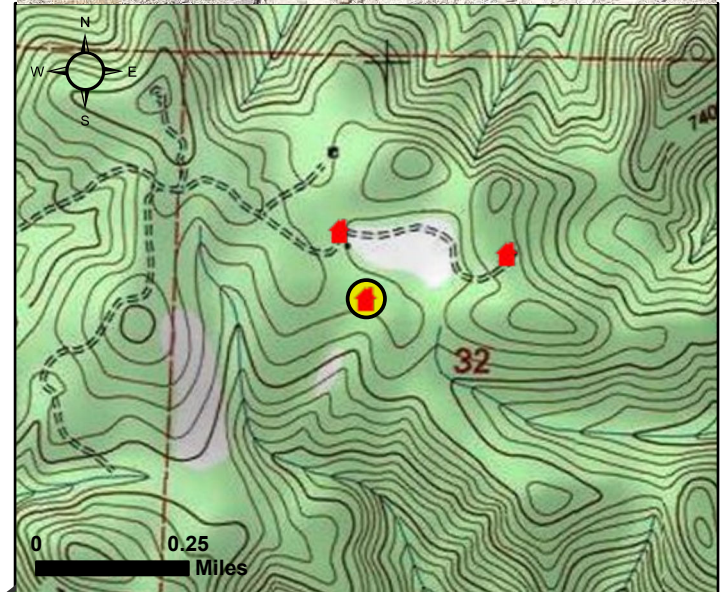
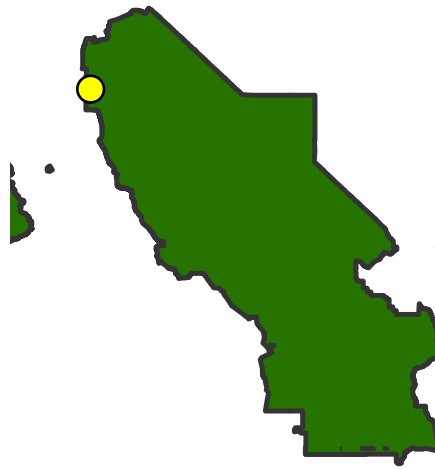
**Facility Name:** Whippoorwill Cabin 2

**Rating:** High

**Fuel Type:** Shrub or timber

**Fuel Load:** Moderate

**Defensible Space:** Less than 30 ft treated

**Siding Material:** Wood or open sided

**Comments:** Backcountry cultural resource. 4x4 and high clearance necessary for access

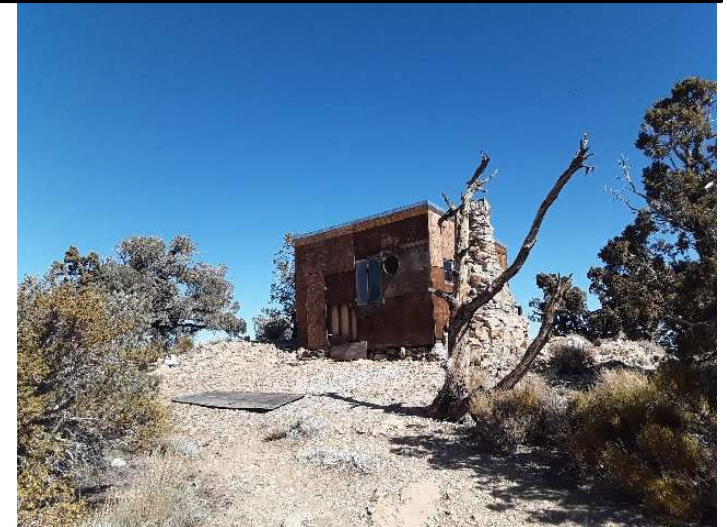
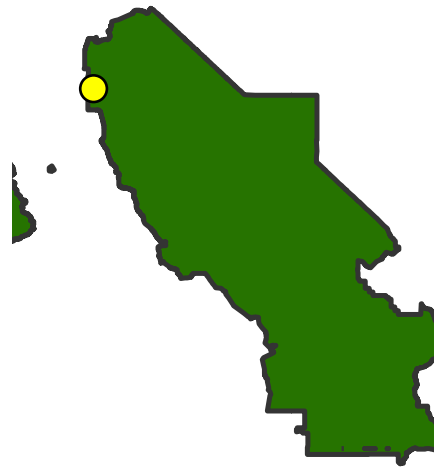
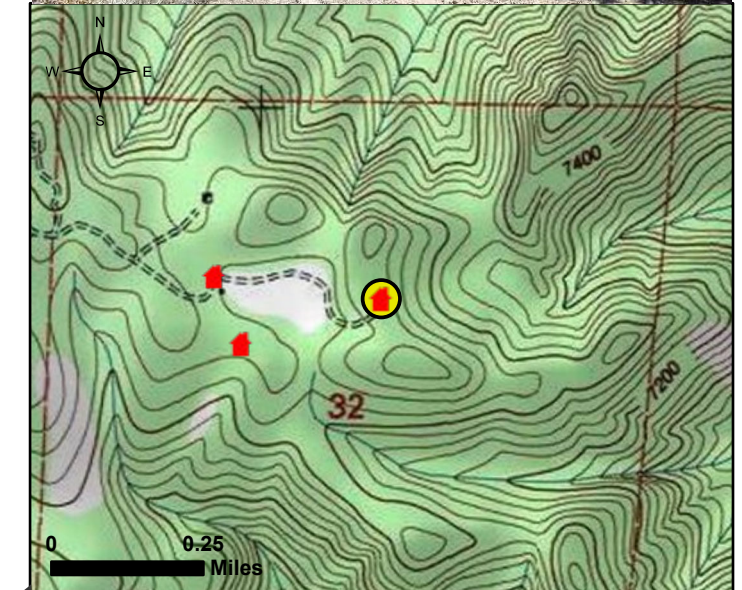
**Facility Name:** Whippoorwill Cabin 3

**Rating:** High

**Fuel Type:** Shrub or timber

**Fuel Load:** Moderate

**Defensible Space:** Less than 30 ft treated

**Siding Material:** Wood or open sided

**Comments:** Backcountry cultural resource. 4x4 and high clearance necessary to access
