# NPS Wildfire Risk Assessments Assessment Locations

## Mojave National Preserve - Overview

# NPS Wildland Fire Risk Assessment - Facility Assessment

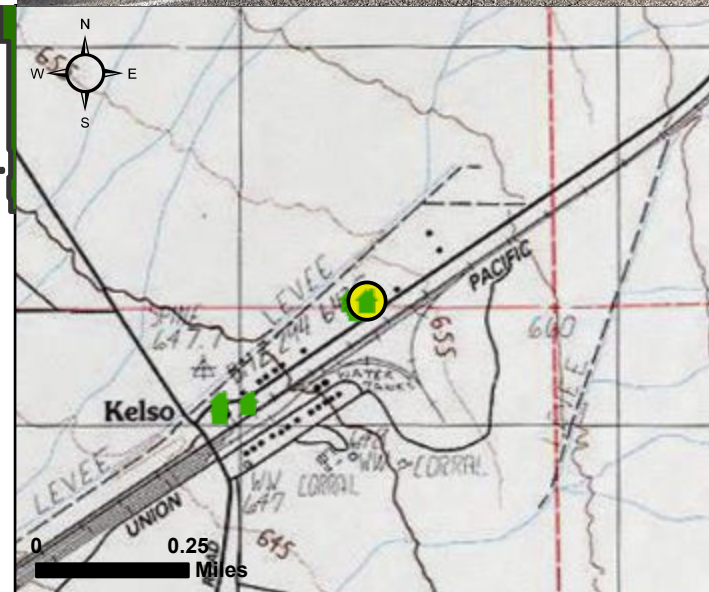
**Comments:** building behind locked fence, limited view

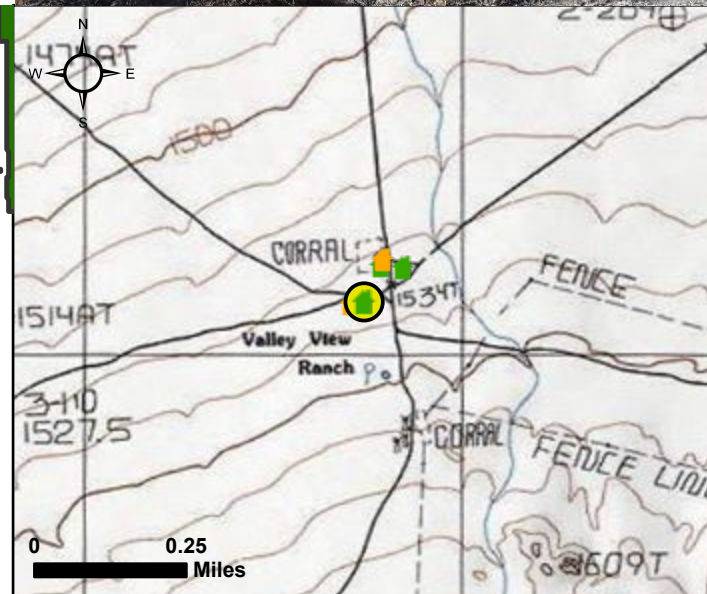
**Comments:** in 2020 Dome fire area

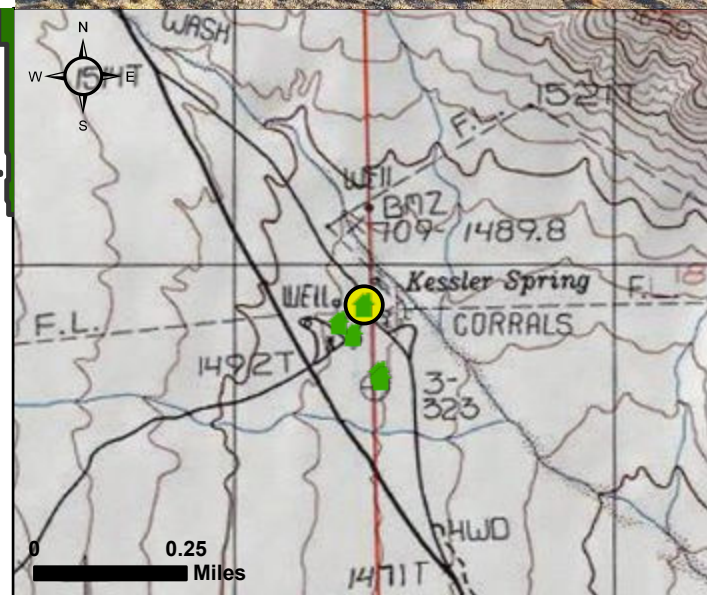
**Comments:** in the 2020 Dome fire area

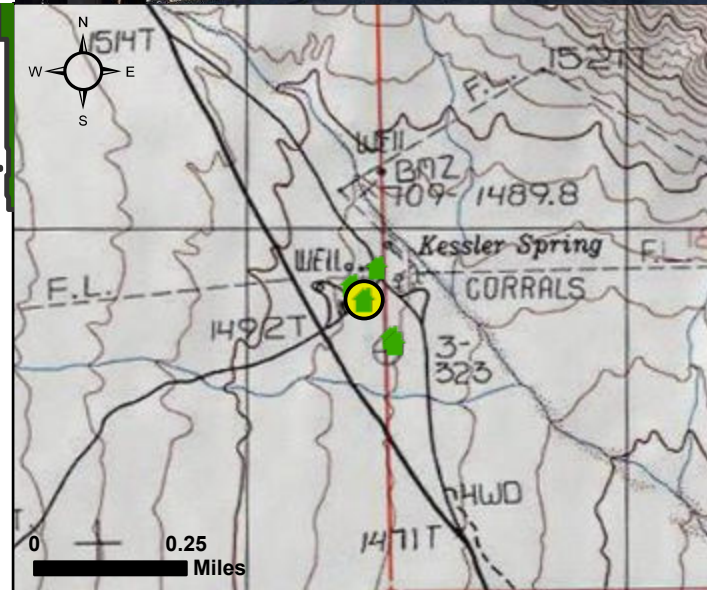
**Comments:** being rebuilt/repaired following 2020 Dome fire damage

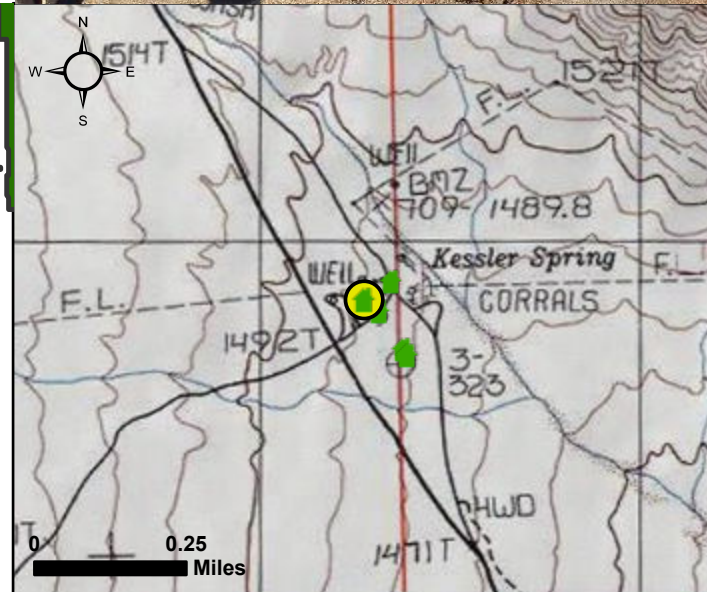
**Comments:** in 2020 Dome fire area

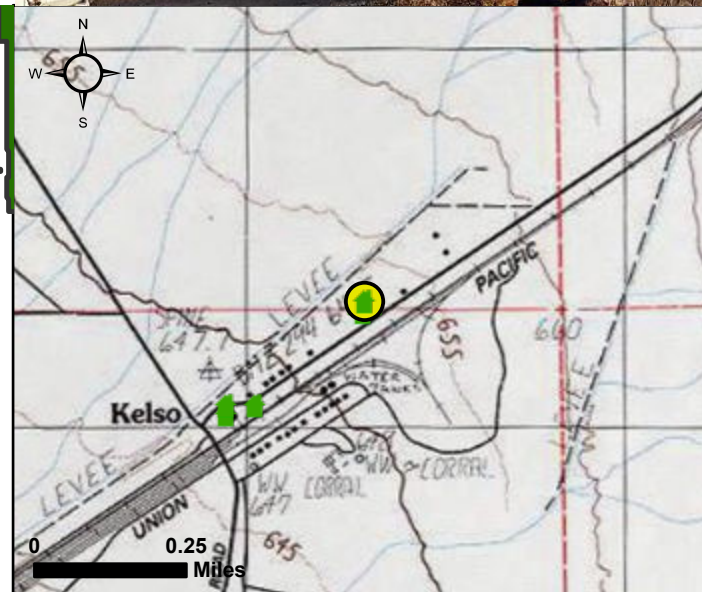
**Comments:** buildings behind locked fence, limited view

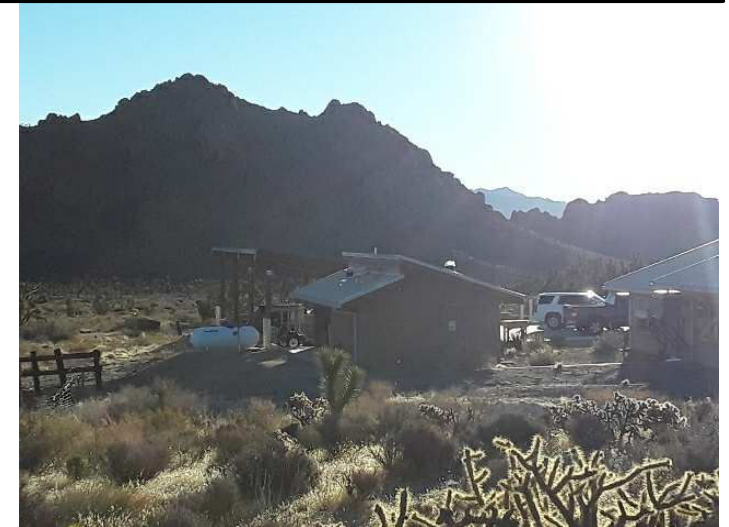
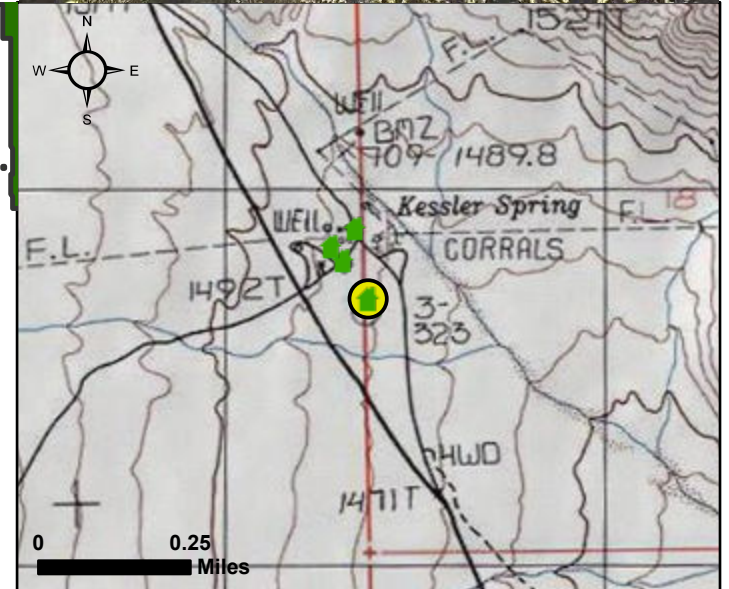
**Comments:** building is on edge of 2020 Dome fire area.  
other photos not taken due to dog

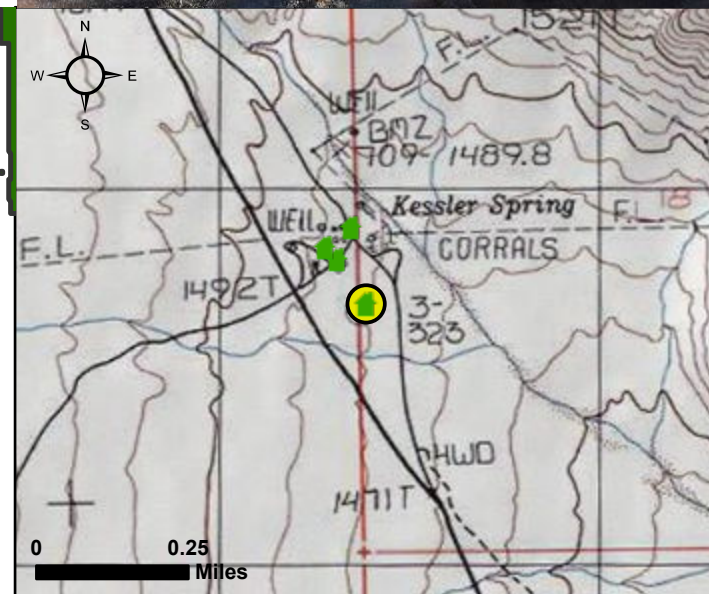
**Comments:** building is on edge of 2020 Dome fire area.  
other photos not taken due to dog

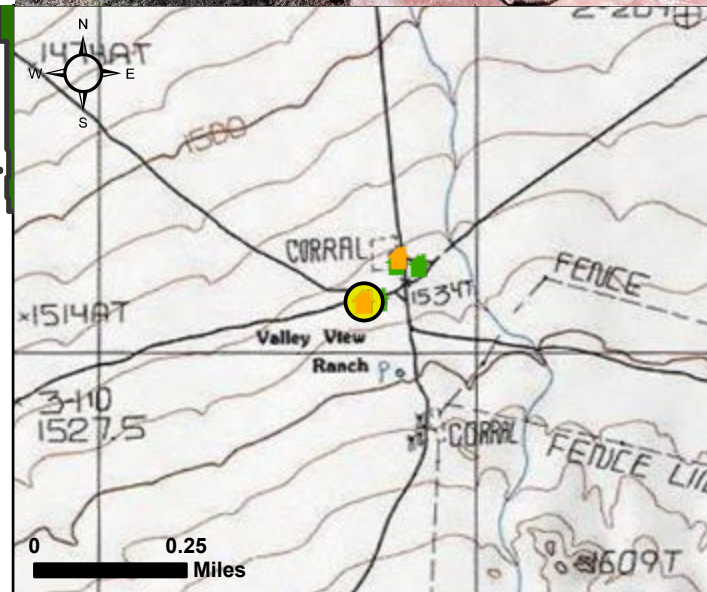
**Comments:** building damaged in 2020 Dome fire

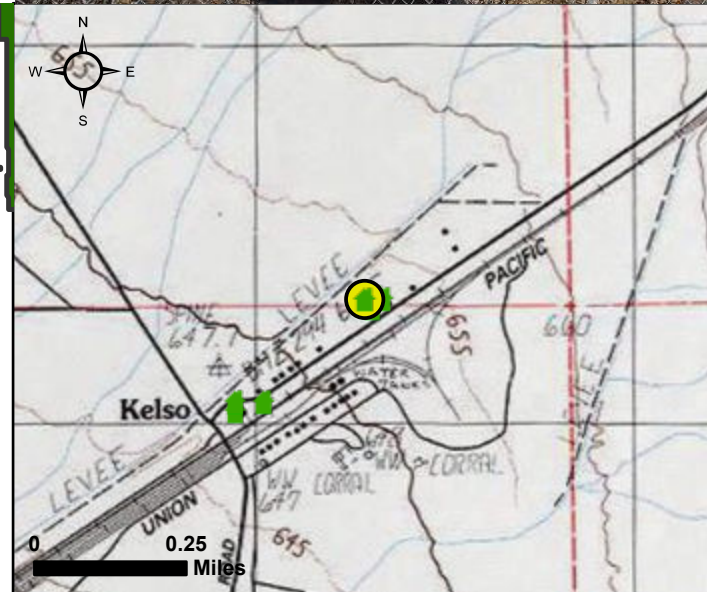
**Comments:** building behind locked fence, limited view

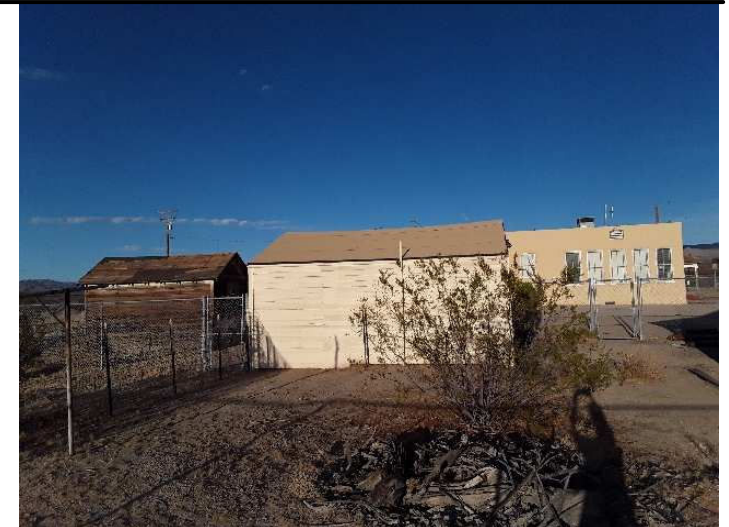
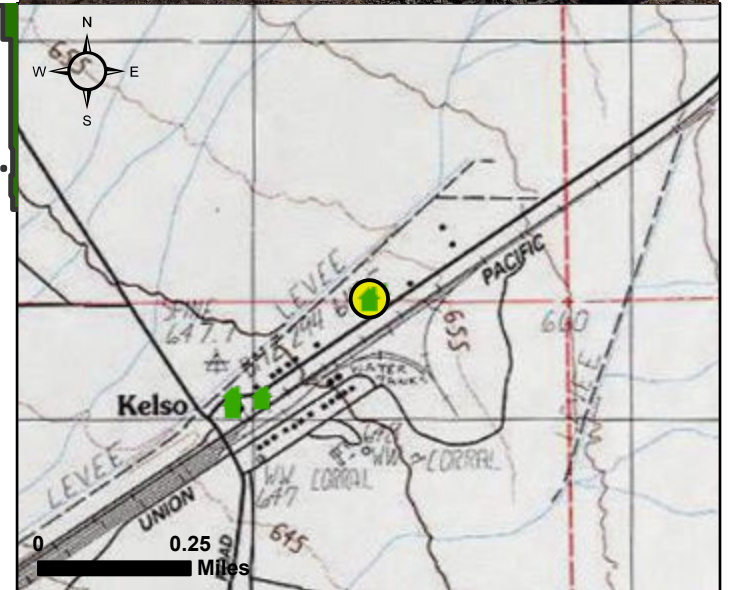
**Comments:** buildings behind locked fence- only one view visible

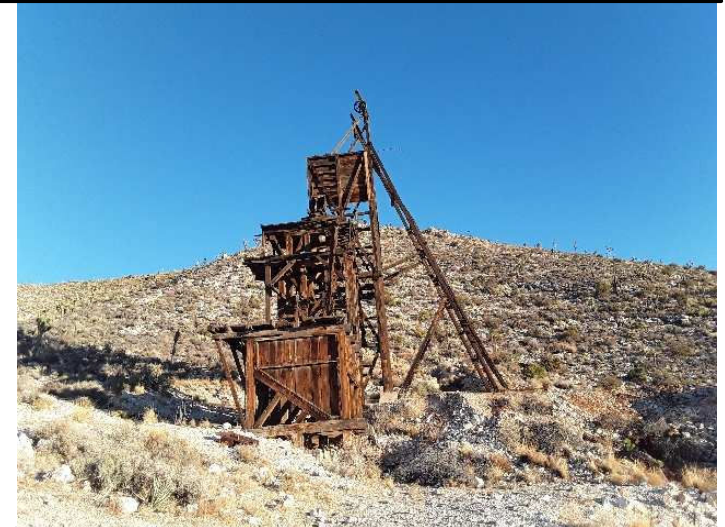
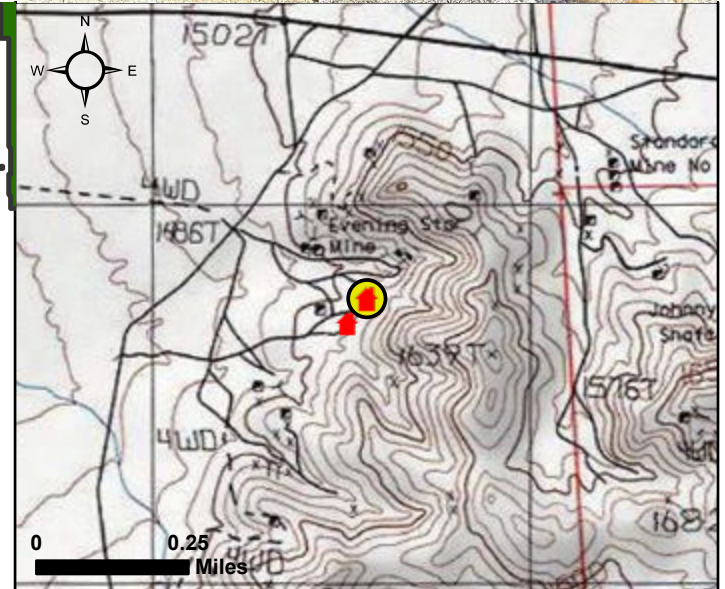
**Comments:** high clearance and 4x4 recommended

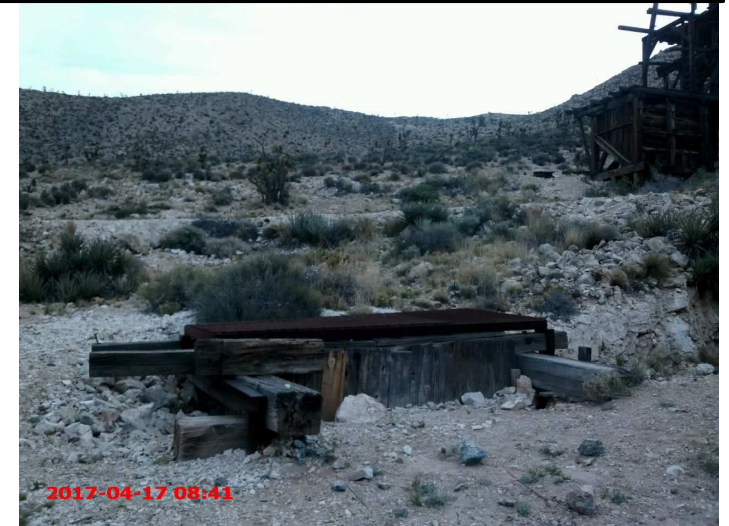
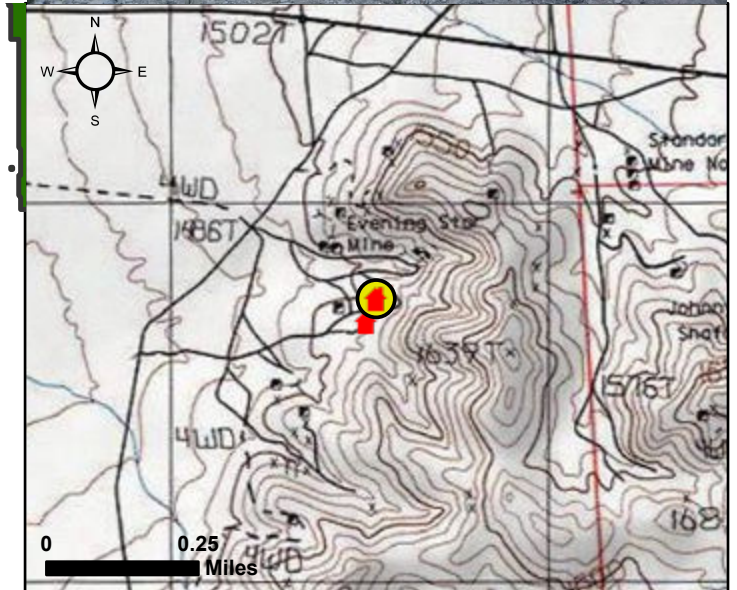
**Comments:** high clearance and 4x4 recommended

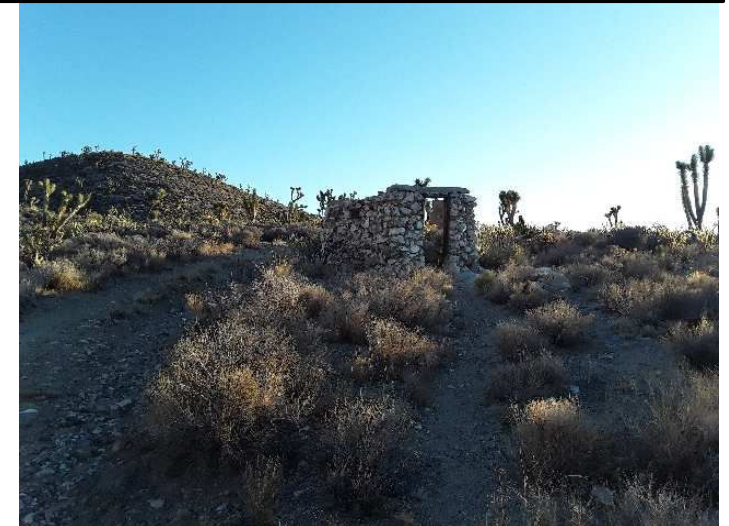
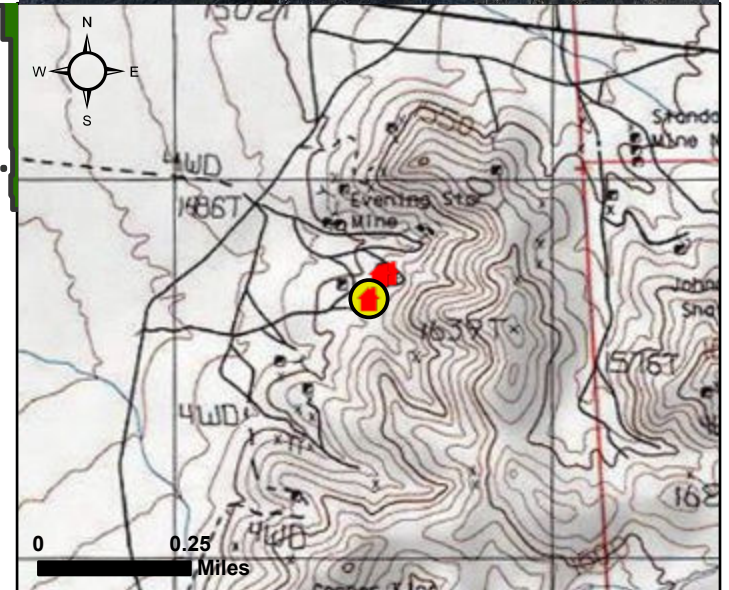
**Comments:** high clearance and 4x4 recommended

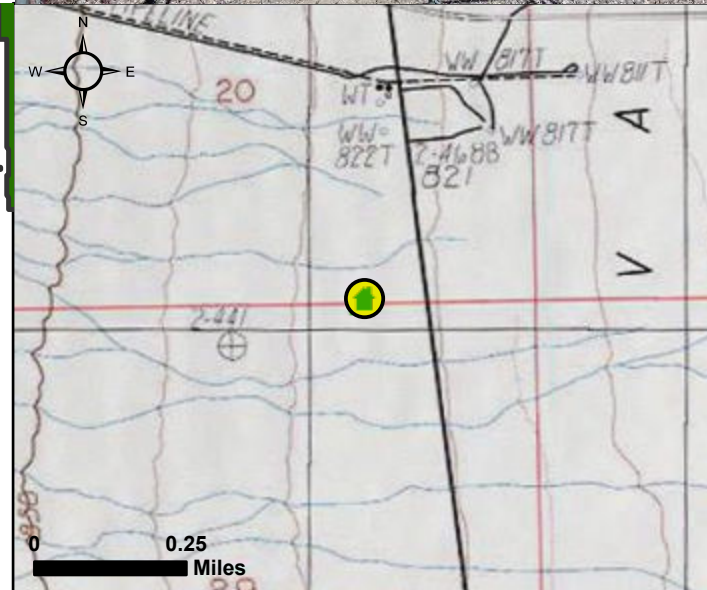
**Comments:** Desert tortoise research facility with creosote. facility enclosed in fence with locked gate
