# NPS Wildfire Risk Assessments Assessment Locations

## Organ Pipe Cactus National Monument - Overview

# Puerto Blanco Drive

## ORPI - Organ Pipe Cactus National Monument

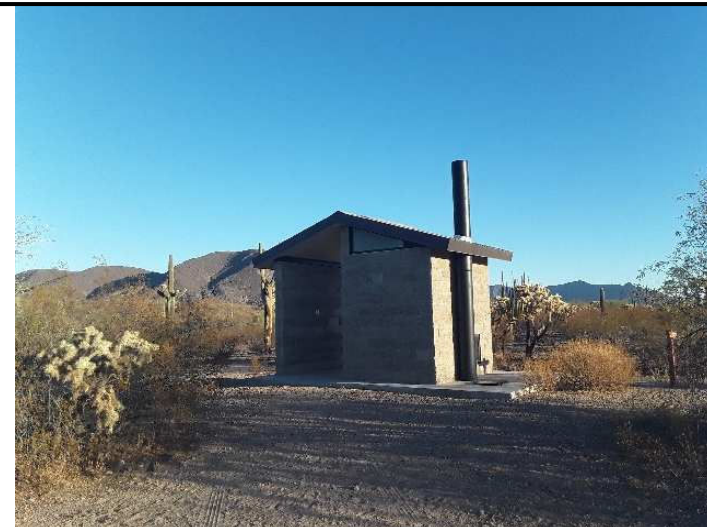
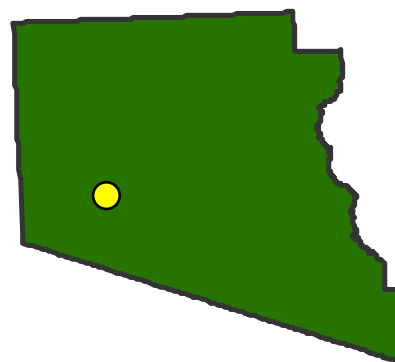
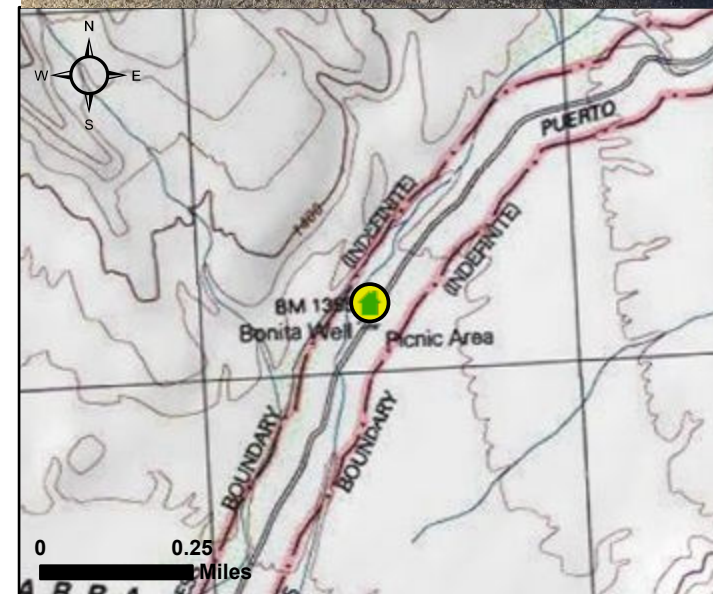
**Facility Name:** Bonita Well Restroom

**Rating:** Low

**Facility Number or Sign:** None or not clearly visible

**Water Supply:** No reliable water source nearby

**Comments:** Drug smuggling presence in the area.

| Label # | Facility Name | Owner | FMSS ID<br>(if NPS<br>owned) | Facility<br>Type | Facility<br>Use | Occupied | Last Site<br>Visit<br>Date* | Resource<br>Of<br>Concern | Score | Rating | Protection<br>Level | Assessment<br>Comments | Restriction |
|---|---|---|---|---|---|---|---|---|---|---|---|---|---|
| 88 | Bonita Well<br>Restroom | NPS | 74398 | Building | Public | N | 1/14/21 | Unknown | 35 | Low | Not<br>Designated | Drug<br>smuggling<br>presence in<br>the area. | UNR |

| Label # | Facility/Community Name | Assessment Scale | Site Visit Type | Firewise Zone | Treatment | Treatment Description | Person Hours |
|---|---|---|---|---|---|---|---|
| 88 | Bonita Well Restroom | Individual Facility | SiteVisit | 1 | Clear adjacent and overhanging fuels to create 10 feet spacing between canopy and structure or chimney openings | | 3.0 |

| Facility/Community Name | Assessment Scale | Triage Category | Tactic Description | Person Hours | Equipment Description | Equip. Qty |
|---|---|---|---|---|---|---|
| Bonita Well Restroom | Individual Facility | Standalone | Other, please describe. - none necessary. sparse fuel load and flat terrain | | - | |

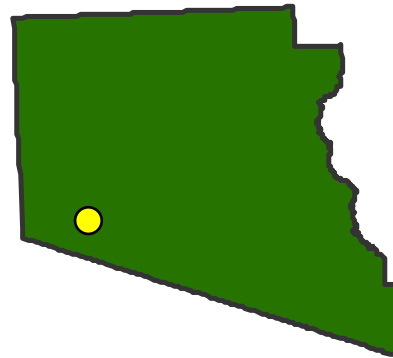
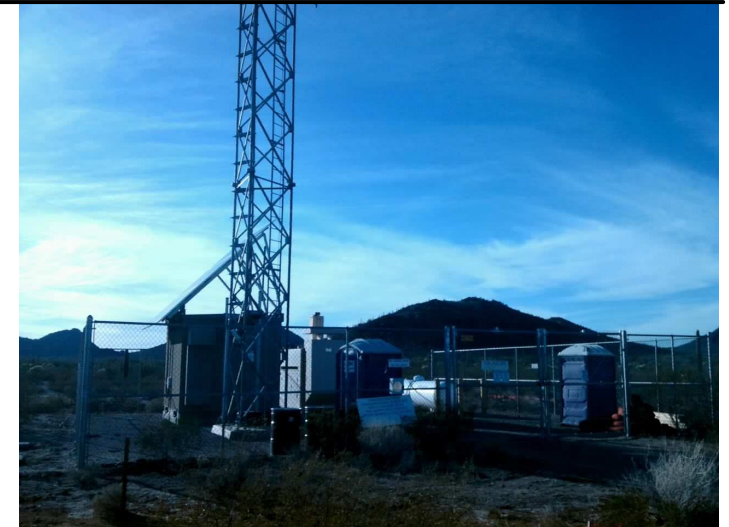
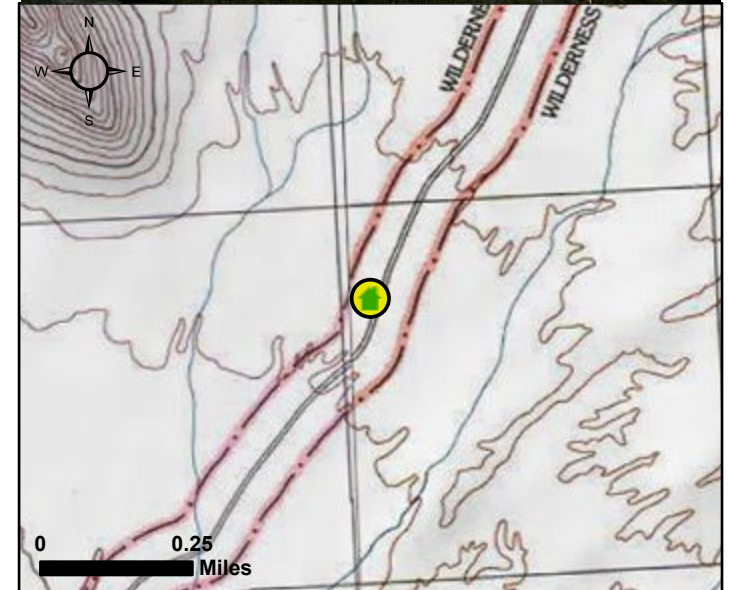
**Rating:** Low  
**ProtectionLevel:** Not Designated,  
**Resources of Concern:** Unknown  
**Occupied:** No  
**In Community:** No,  
**Revisit Interval:** 5 yrs  
**Map Label:** 89

**Firewood:** None  
**Water Supply:** No reliable water source nearby  
**Propane:** Present and fuels clearance  
**Overhead Hazards:** No overhead hazards

**Comments:** drug smuggling in area

| Label # | Facility Name | Owner | FMSS ID<br>(if NPS<br>owned) | Facility<br>Type | Facility<br>Use | Occupied | Last Site<br>Visit<br>Date* | Resource<br>Of<br>Concern | Score | Rating | Protection<br>Level | Assessment<br>Comments | Restriction |
|---|---|---|---|---|---|---|---|---|---|---|---|---|---|
| 89 | CBP Observation<br>Tower | OtherFedGov | not found | CommSite | Admin | N | 1/14/21 | Unknown | 29 | Low | Not<br>Designated | drug<br>smuggling in<br>area | UNR |

| Label # | Facility/Community Name | Assessment Scale | Site Visit Type | Firewise Zone | Treatment | Treatment Description | Person Hours |
|---|---|---|---|---|---|---|---|
| 89 | CBP Observation Tower | Individual Facility | Initial | 1 | Flammable ground cover such as leaf litter, woody debris or highly flammable vegetation should be removed | | 3.0 |

| Facility/Community Name | Assessment Scale | Triage Category | Tactic Description | Person Hours | Equipment Description | Equip. Qty |
|---|---|---|---|---|---|---|
| CBP Observation Tower | Individual Facility | Standalone | Other, please describe. - none necessary. sparse fuels and flat terrain | | - | |
