# NPS Wildfire Risk Assessments Assessment Locations

## Cane River Creole National Historic Park - Overview

# Magnolia Plantation

## CARI - Cane River Creole National Historical Park

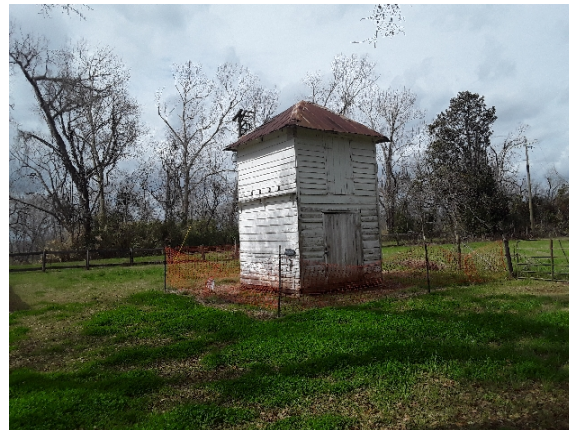
2021\_CARI\_74410\_Magnolia Pigeonnier\_Front.jpg

**Roof Material:** Noncombustible or not applicable  
**Siding Material:** Wood or open sided  
**Foundation:** Open or deck  
**Fences/Decks:** None or noncombustible

**Score: 24**  
**Rating: Low**

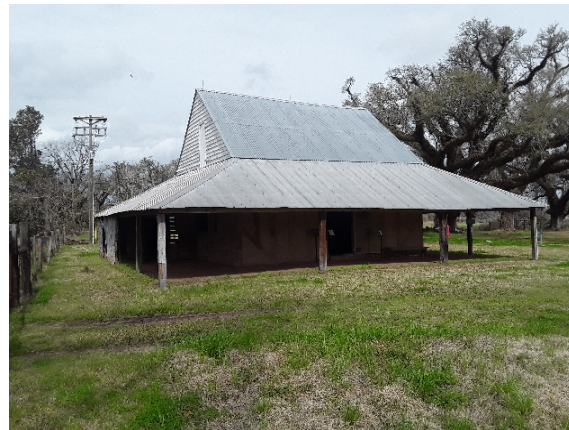
2021\_CARI\_74409\_Blacksmith Shop\_Front.jpg

Siding Material: Wood or open sided

Fences/Decks: Combustible, adjacent, clear of veg/debris

Score: 27  
Rating: Low

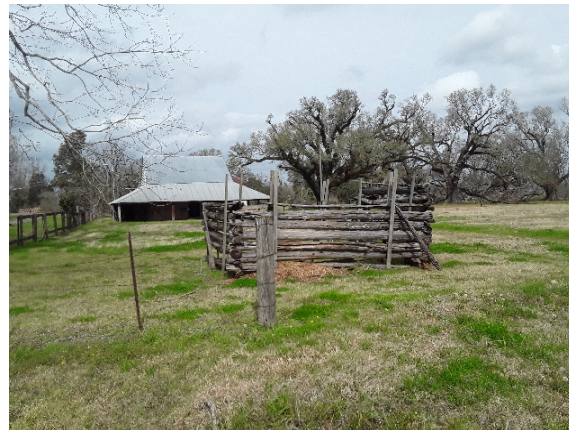
2021\_CARI\_74425\_Corn Crib, Magnolia Plantation\_Front.jpg

Facility Number/Sign: None or not clearly visible

Roof Material: Combustible or no roof

Siding Material: Wood or open sided

Fences/Decks: Combustible but separated from facility

Score: 48  
Rating: Moderate

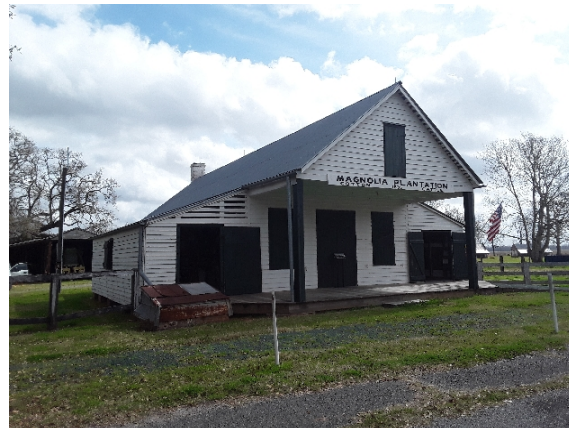
2021\_CARI\_74407\_Store (Magnolia)\_Front.jpg

**Roof Material:** Noncombustible or not applicable  
**Siding Material:** Wood or open sided  
**Foundation:** Open or deck  
**Fences/Decks:** Combustible, adjacent, clear of veg/debris

**Score: 20**  
**Rating: Low**

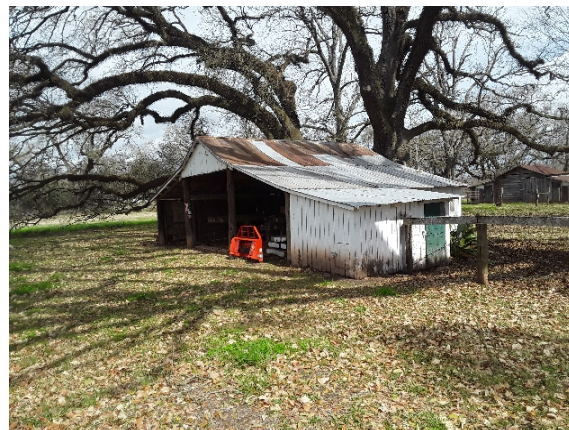
2021\_CARI\_74414\_Carriage Shed (Magnolia)\_Front.jpg

**Facility Number/Sign:** None or not clearly visible

**Siding Material:** Wood or open sided

**Score: 21**  
**Rating: Low**

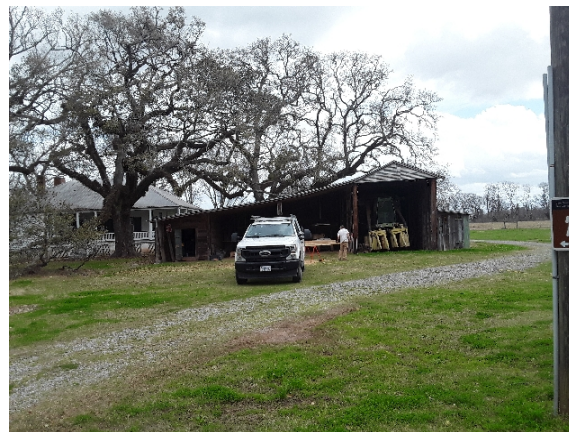
2021\_CARI\_78736\_Cotton Picker Shed  
(Magnolia)\_Front.jpg

Fences/Decks: Combustible, adjacent, clear of veg/debris

Firewood: Adjacent to/under deck of facility

Additional Obstacles: Hazmat, UXO,etc. , PLEASE COMMENT

Hazmat: misc. maintenance materials, possibly flammable

Score: 26  
Rating: Low

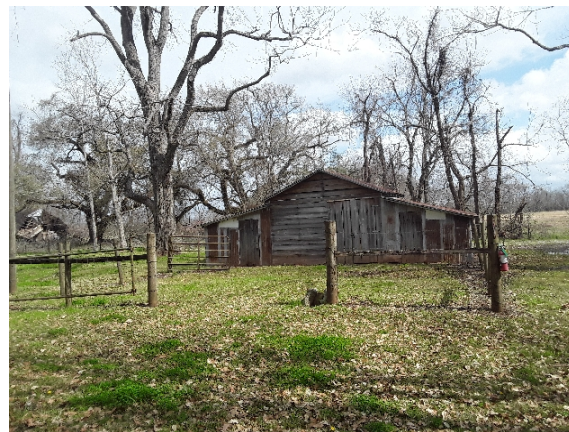
2021\_CARI\_74417\_Stable\_Front.jpg

**Bridge Condition:** None/nonflammable,load limit will not limit response  
**Access & Turnarounds:** Access is <300 ft from facility w/turnaround  
**Facility Number/Sign:** None or not clearly visible

**Roof Material:** Noncombustible or not applicable  
**Siding Material:** Wood or open sided  
**Foundation:** Open or deck  
**Fences/Decks:** Combustible but separated from facility

**Score: 30**  
**Rating: Low**

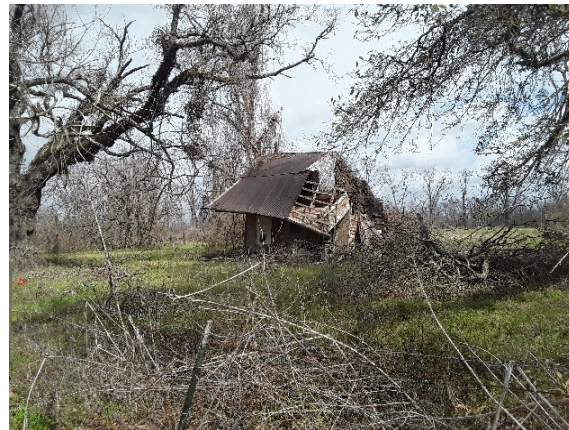
2021\_CARI\_not found \_"Cooks" Cabin\_Front.jpg

**Assessment Comments:** Not on Park Property, NPS does not maintain.

**Score:**  
**Rating:**  
PVTNotSurveyed

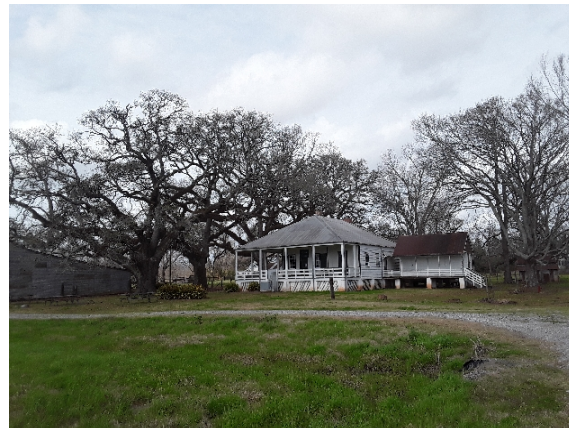
2021\_CARI\_74404\_Overseers House - Slave Hospital (Magnolia)\_Front.jpg

**Score: 20**  
**Rating: Low**

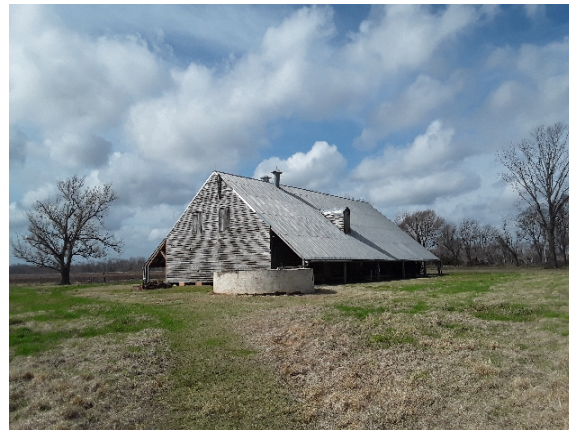
2021\_CARI\_74427\_Cotton Gin\_Front.jpg

**Score: 18**  
**Rating: Low**

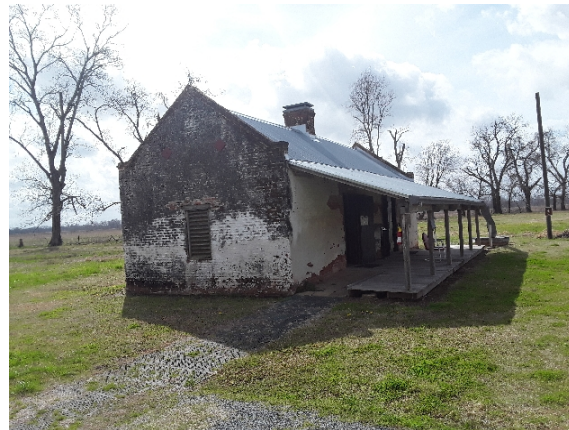
2021\_CARI\_74438\_Slave Quarters 1\_Front.jpg

**Roof Material:** Combustible or no roof  
**Siding Material:** Rock, concrete, metal  
**Foundation:** Closed, >30in masonry exposed or N/A  
**Fences/Decks:** Combustible, adjacent, clear of veg/debris

**Score: 36**  
**Rating: Low**

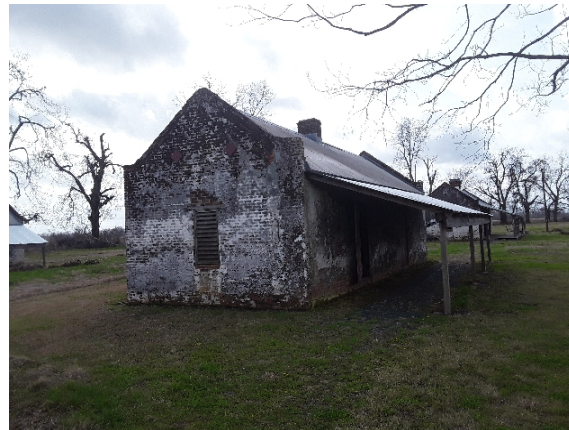
2021\_CARI\_74445\_Slave Quarters 2\_Front.jpg

**Bridge Condition:** None/nonflammable,load limit will not limit response  
**Access & Turnarounds:** Access is <300 ft from facility w/turnaround  
**Facility Number/Sign:** None or not clearly visible

**Score: 15**  
**Rating: Low**

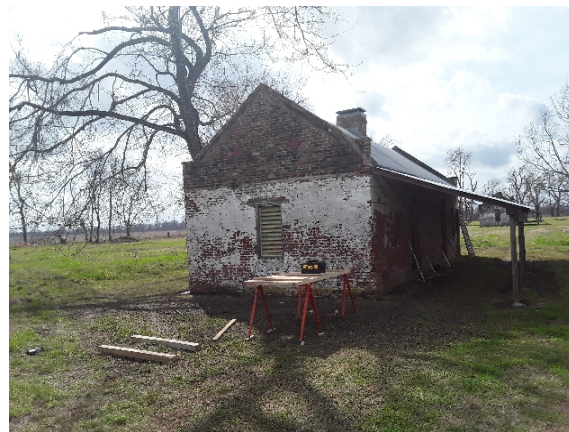
2021\_CARI\_74447\_Slave Quarters 3\_Front.jpg

**Bridge Condition:** None/nonflammable,load limit will not limit response  
**Access & Turnarounds:** Access is <300 ft from facility w/turnaround  
**Facility Number/Sign:** None or not clearly visible

**Score: 15**  
**Rating: Low**

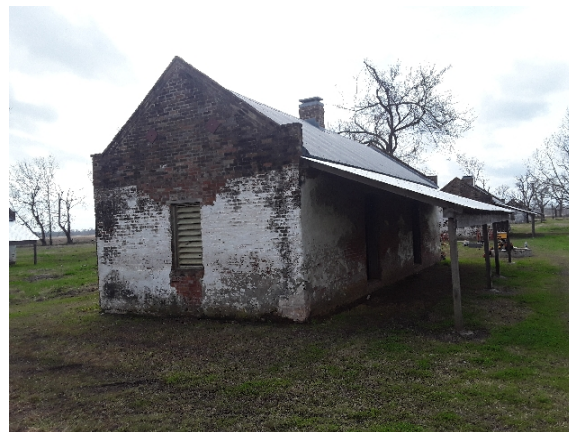
2021\_CARI\_74449\_Slave Quarters 4\_Front.jpg

**Bridge Condition:** None/nonflammable,load limit will not limit response  
**Access & Turnarounds:** Access is <300 ft from facility w/turnaround  
**Facility Number/Sign:** None or not clearly visible

**Score: 15**  
**Rating: Low**

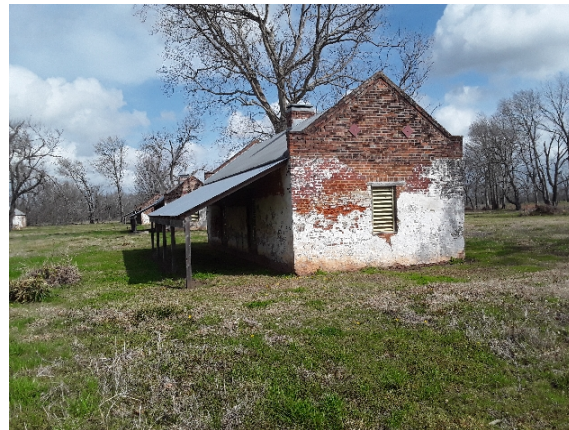
2021\_CARI\_74453\_Slave Quarters 8\_Front.jpg

**Score: 15**  
**Rating: Low**

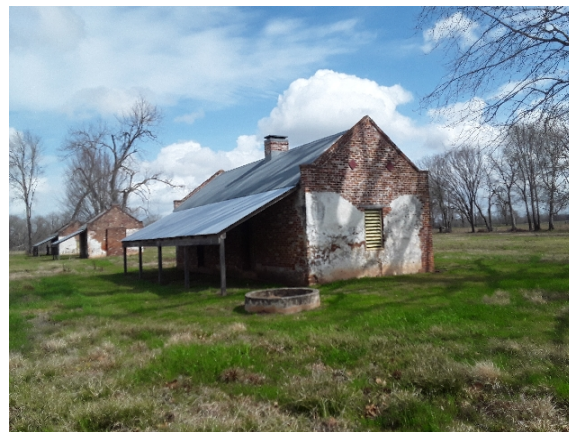
2021\_CARI\_74452\_Slave Quarters 7\_Front.jpg

**Bridge Condition:** None/nonflammable,load limit will not limit response  
**Access & Turnarounds:** Access is <300 ft from facility w/turnaround  
**Facility Number/Sign:** None or not clearly visible

**Score: 15**  
**Rating: Low**

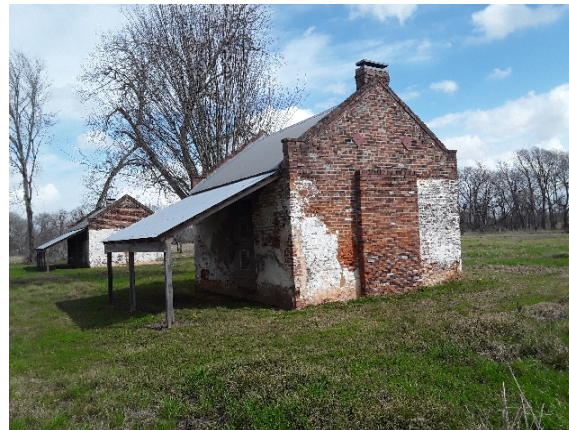
2021\_CARI\_74451\_Slave Quarters 6\_Front.jpg

**Bridge Condition:** None/nonflammable,load limit will not limit response  
**Access & Turnarounds:** Access is <300 ft from facility w/turnaround  
**Facility Number/Sign:** None or not clearly visible

**Score: 15**  
**Rating: Low**

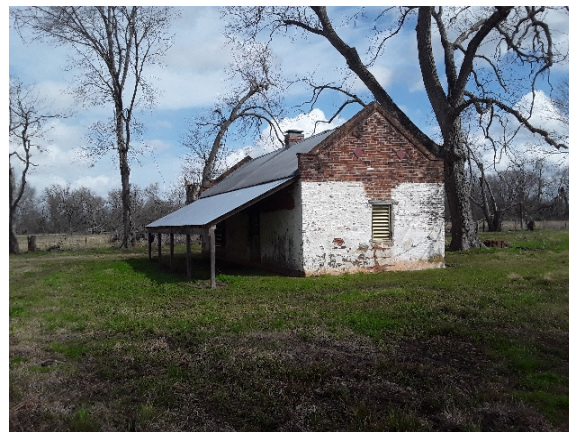
2021\_CARI\_74450\_Slave Quarters 5\_Front.jpg

**Bridge Condition:** None/nonflammable,load limit will not limit response  
**Access & Turnarounds:** Access is <300 ft from facility w/turnaround  
**Facility Number/Sign:** None or not clearly visible

**Score: 15**  
**Rating: Low**
