# Dog Canyon

## NPS Wildfire Risk Assessments

# NPS Wildand Fire Risk Assessment - Facility Wildfire Risk Assessment Summary

## Unit - Location: GUMO - Dog Canyon

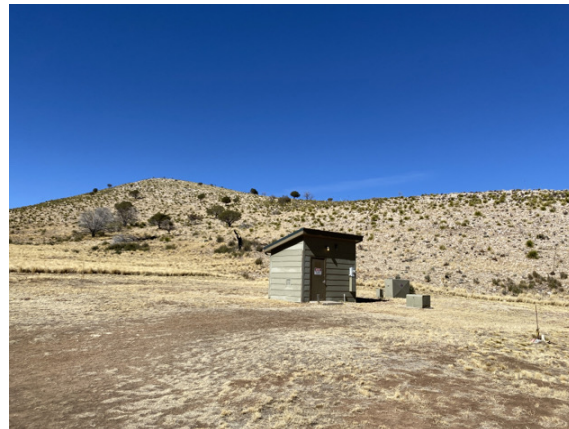
2021\_GUMO\_72264\_DC BLDG263 PUMP CONTROLS CHLORINE STORAGE\_Front.jpg

Firewood: Adjacent to/under deck of facility

Score: 57  
Rating: Moderate

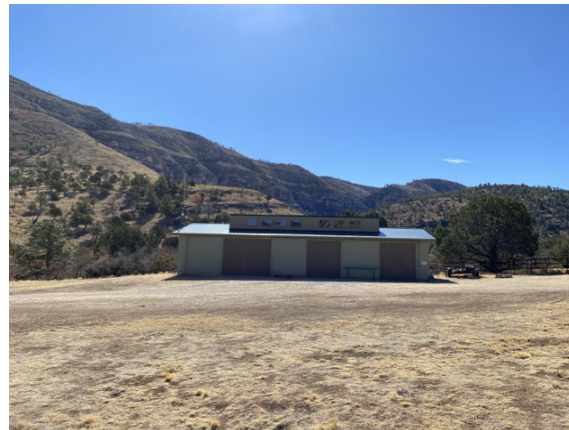
2021\_GUMO\_72261\_DC BLDG261 BARN\_Front.jpg

Firewood: Adjacent to/under deck of facility

Hazmat: FUEL TANKS WITHIN 50 FEET

Score: 57  
Rating: Moderate

| Label # | Facility/Community Name | Assessment Scale | Site Visit Type | Firewise Zone | Treatment | Treatment Description | Person Hours |
|---|---|---|---|---|---|---|---|
| 5 | DC BLDG261 BARN | Individual Facility | Initial | 1 | Firewood should be moved at least 50 ft from the facility and 15 horizontal feet from tree canopies | | 1.0 |
| | | Individual Facility | Initial | 1 | Open crown spacing 10 to 30 feet depending on slope | | 1.0 |
| | | Individual Facility | Initial | 1 | Remove dead or dying component of shrubs and trees | | 1.0 |

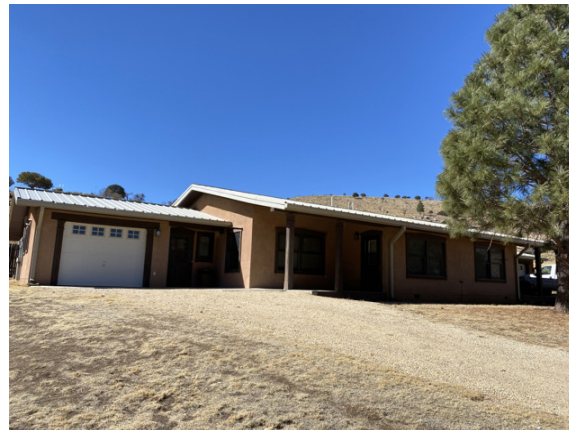
2021\_GUMO\_72246\_Q-361 DC APARTMENT  
BLDG\_Front.jpg

Score: 34  
Rating: Low

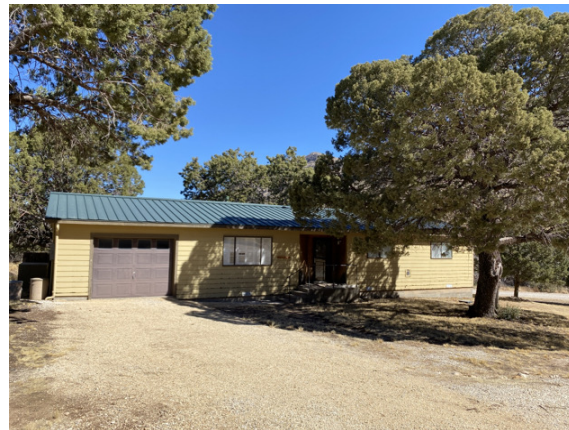
2021\_GUMO\_72241\_Q-361 DC RESIDENCE\_Front.jpg

Score: 40  
Rating: Low

| Label # | Facility/Community Name | Assessment Scale | Site Visit Type | Firewise Zone | Treatment | Treatment Description | Person Hours |
|---|---|---|---|---|---|---|---|
| 7 | Q-361 DC RESIDENCE | Individual Facility | Initial | 1 | Clear adjacent and overhanging fuels to create 10 feet spacing between canopy and structure or chimney openings | | 1.0 |

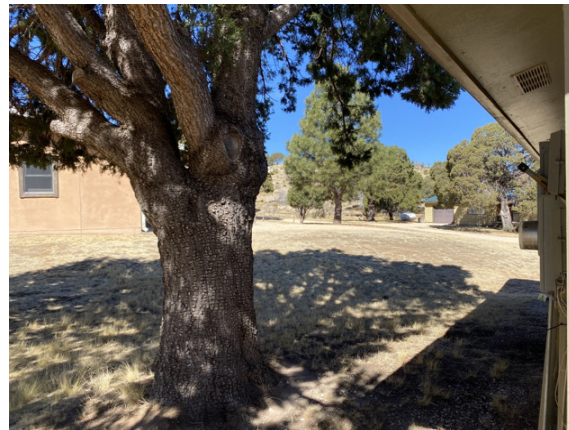
2021\_GUMO\_72251\_DC Building 161 Contact Station\_Front.jpg

Defensible Space: 30 ft treated

Score: 59  
Rating: Moderate

| Label # | Facility/Community Name | Assessment Scale | Site Visit Type | Firewise Zone | Treatment | Treatment Description | Person Hours |
|---|---|---|---|---|---|---|---|
| 8 | DC Building 161 Contact Station | Individual Facility | Initial | 1 | Clear adjacent and overhanging fuels to create 10 feet spacing between canopy and structure or chimney openings | | 1.0 |

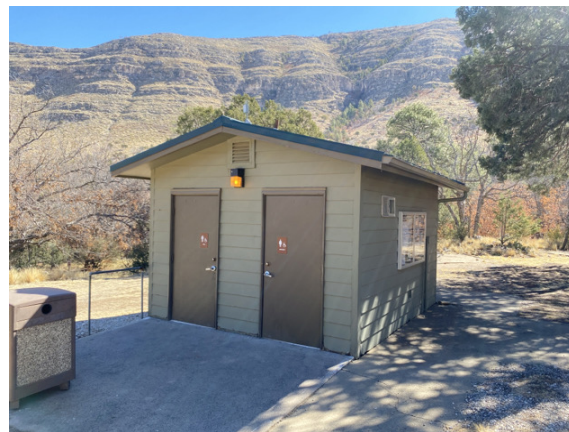
2021\_GUMO\_72256\_B-162 DC Comfort Station\_Front.jpg

Defensible Space: 30 ft treated

Fuel Load (w/in 300 ft): Moderate

Score: 63  
Rating: High

| 9 | B-162 DC Comfort Station | Individual Facility | Initial | 1 | Remove dead or dying component of shrubs and trees | SNAGS | 1.0 |
