# Gila Cliff Dwellings National Monument

## NPS Wildfire Risk Assessments

# NPS Wildand Fire Risk Assessment - Facility Wildfire Risk Assessment Summary

## Unit - Location: GICL - Gila Cliff Dwellings

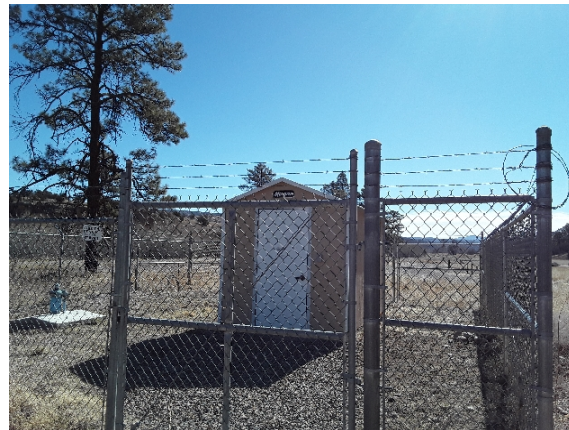
2021\_GICL\_246251\_well house woody's \_Front.jpg

**Roof Material:** Noncombustible or not applicable  
**Siding Material:** Vinyl  
**Foundation:** Closed, >30in masonry exposed or N/A  
**Fences/Decks:** None or noncombustible

**Firewood:** None  
**Propane Tanks:** None  
**Water Supply:** Pressurized hydrant(s) or fixed sprinkler system  
**Overhead Hazards:** No overhead hazards

**Score: 29**  
**Rating: Low**

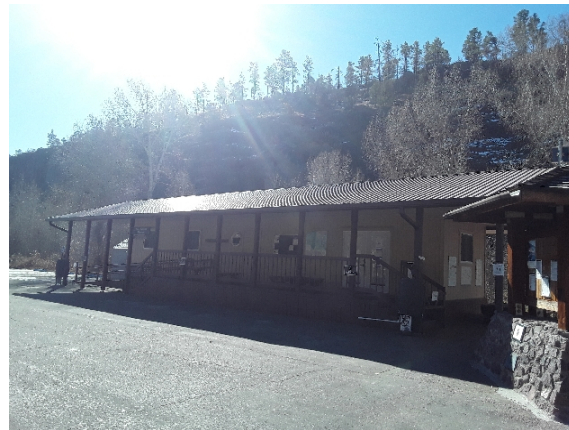
2021\_GICL\_90747\_Visitor Contact Station\_Front.jpg

**Foundation:** Closed, < 6in masonry exposed

**Score: 61**  
**Rating: Moderate**

| 3 | Visitor Contact Station | Individual Facility | Initial | 1 | Flammable ground cover such as leaf litter, woody debris or highly flammable vegetation should be removed | | 8.0 |
| | | Individual Facility | Initial | 2 | Flammable ground cover should be removed or isolated | | 40.0 |

| 3 | Visitor Contact Station | Individual Facility | Initial | 2 | Limb trees 6 to 15 feet above ground | | 8.0 |

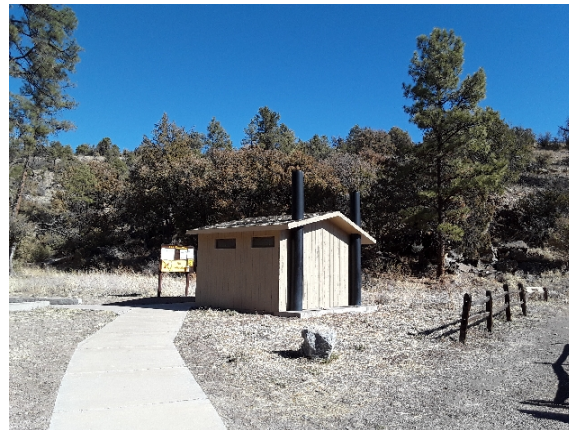
2021\_GICL\_23324?\_Vault Toilet\_Front.jpg

**Score: 36**  
**Rating: Low**

| 7 | Vault Toilet | Individual Facility | SiteVisit | 2 | Limb trees 6 to 15 feet above ground | | 15.0 |
| | | Individual Facility | SiteVisit | 2 | Open crown spacing 10 to 30 feet depending on slope | | 25.0 |

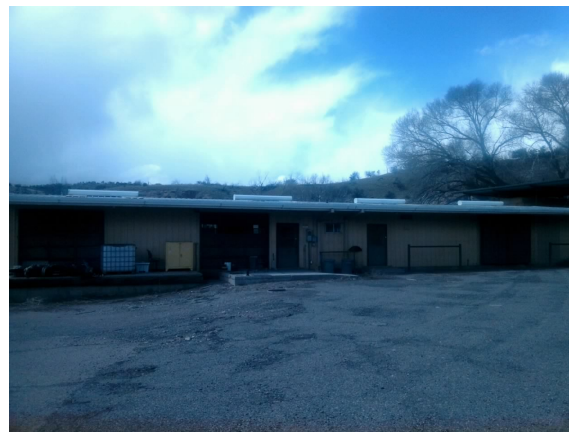
2017\_GICL\_\_Wilderness Barn\_Front.jpg

**Foundation:** Closed, < 6in masonry exposed

**Score: 60**  
**Rating: Moderate**

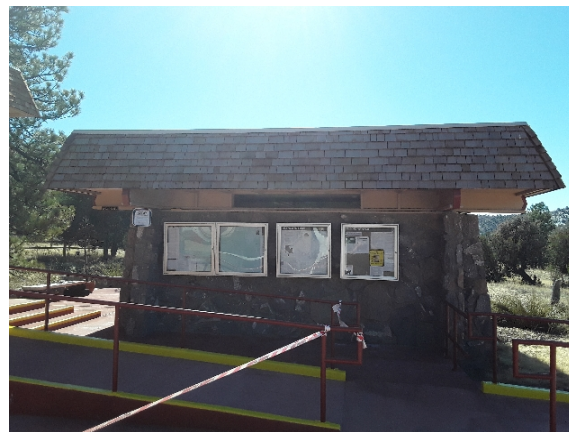
2021\_GICL\_90735\_Comfort Station\_Front.jpg

**Siding Material:** Wood or open sided  
**Foundation:** Closed, >30in masonry exposed or N/A  
**Fences/Decks:** None or noncombustible  
**Firewood:** None

**Additional Obstacles:** None  
**Triage Category:**  
**Hazmat:**  
**Assessment Comments:** Tactics included in adjacent structure.

**Score: 40**  
**Rating: Low**

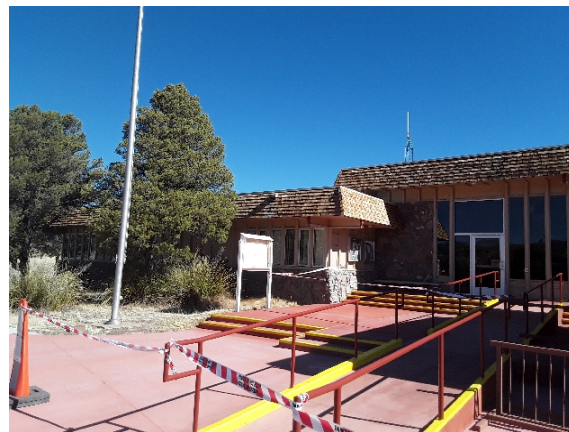
2021\_GICL\_90734\_Visitors Center /  
Administration\_Front.jpg

**Score: 46**  
**Rating: Moderate**

| Label # | Facility/Community Name | Assessment Scale | Site Visit Type | Firewise Zone | Treatment | Treatment Description | Person Hours |
|---|---|---|---|---|---|---|---|
| 13 | Visitors Center / Administration | Individual Facility | Initial | 1 | Clear adjacent and overhanging fuels to create 10 feet spacing between canopy and structure or chimney openings | | 2.0 |
| | | Individual Facility | Initial | 1 | Flammable ground cover such as leaf litter, woody debris or highly flammable vegetation should be removed | | 4.0 |
| | | Individual Facility | Initial | 1 | Limb trees 6 to 15 feet above ground | | 4.0 |
| | | Individual Facility | Initial | 1 | Mow dead/dying grass to less than 4 inches | | 3.0 |

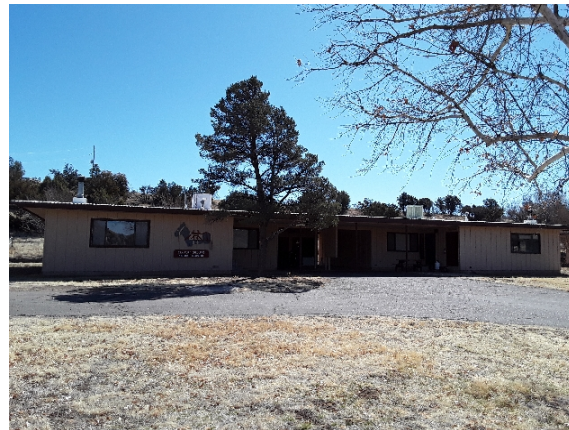
2021\_GICL\_907??\_Bunkhouse\_Front.jpg

**Siding Material:** Wood or open sided  
**Foundation:** Closed, < 6in masonry exposed  
**Fences/Decks:** Combustible, adjacent, clear of veg/debris  
**Firewood:** Adjacent to/under deck of facility

**Score: 48**  
**Rating: Moderate**
