# NPS Wildfire Risk Assessments Assessment Locations

## El Malpais National Monument

# NPS Wildand Fire Risk Assessment - Facility Wildfire Risk Assessment Summary

## Unit - Location: ELMA - El Malpais West

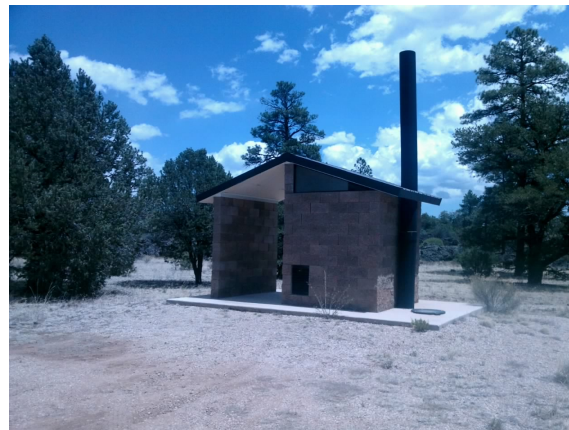
2018\_ELMA\_40561\_Big Tubes Bathroom  
Campground\_Front.jpg

Defensible Space: <30 ft treated

Water Supply: No reliable water source nearby

Score: 70  
Rating: High

| Label # | Facility/Community Name | Assessment Scale | Site Visit Type | Firewise Zone | Treatment | Treatment Description | Person Hours | Date |
|---|---|---|---|---|---|---|---|---|
| 1 | Big Tubes Bathroom/Campground | Individual Facility | SiteVisit | 1 | Limb trees 6 to 15 feet above ground | | 4.0 | 5/21/18 |
| | | Individual Facility | SiteVisit | 2 | Limb trees 6 to 15 feet above ground | | 6.0 | 5/21/18 |

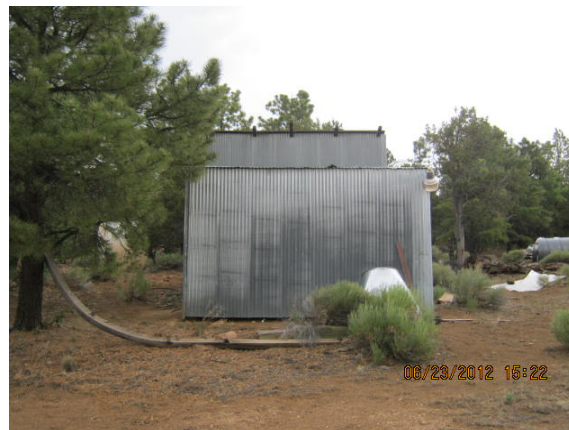
ELMA\_Bone Yard Metal Storage\_D.jpg

Defensible Space: No defensible space

Firewood: 5ft to 30ft from facility

Score: 76  
Rating: High

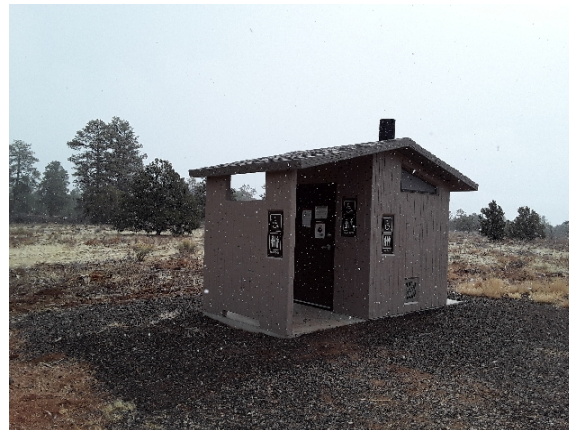
2021\_ELMA\_238191\_El Calderon Bathroom\_Front.jpg

Assessment Comments: recent fuels reduction apparent

Score: 50  
Rating: Moderate

| 4 | El Calderon Bathroom | Individual Facility | SiteVisit | 1 | Clear adjacent and overhanging fuels to create 10 feet spacing between canopy and structure or chimney openings | | 4.0 | 5/21/18 |
| | | Individual Facility | SiteVisit | 1 | Flammable ground cover such as leaf litter, woody debris or highly flammable vegetation should be removed | | 2.0 | 5/21/18 |
| | | Individual Facility | SiteVisit | 1 | Limb trees 6 to 15 feet above ground | | 2.0 | 5/21/18 |

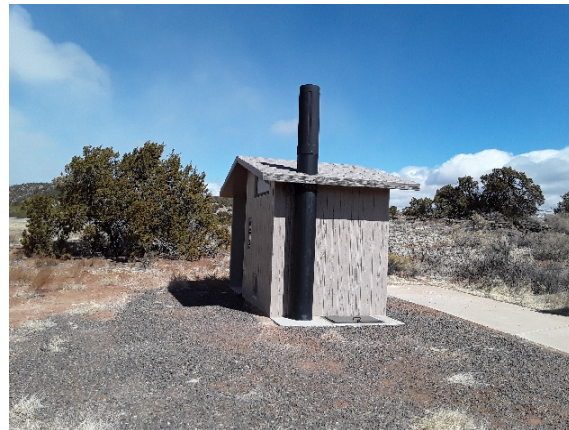
2021\_ELMA\_238186\_FrontAT Vaulted Toilet\_Front.jpg

**Score: 40**  
**Rating: Low**

| 5 | ZAT Vaulted Toilet | Individual Facility | SiteVisit | 1 | Flammable ground cover such as leaf litter, woody debris or highly flammable vegetation should be removed | | 2.0 | 5/21/18 |
| | | Individual Facility | SiteVisit | 1 | Mow dead/dying grass to less than 4 inches | | 2.0 | 5/21/18 |

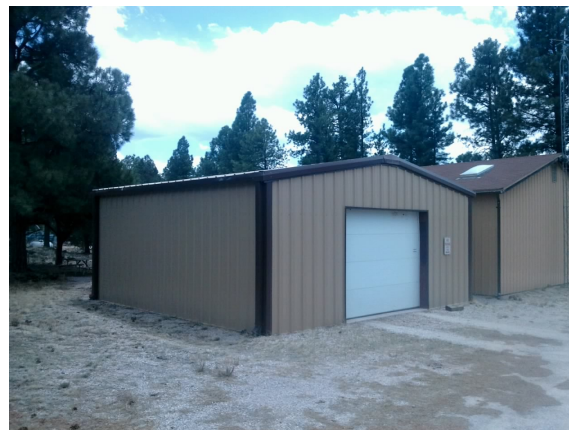
2018\_ELMA\_\_Fire Cache Bay 1\_Front.jpg

**Score: 71**  
**Rating: High**

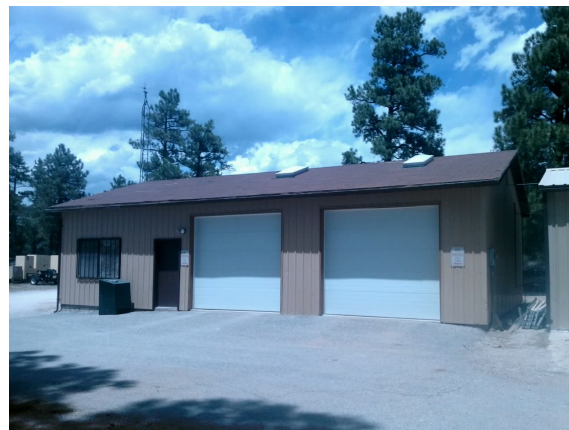
2018\_ELMA\_\_Old IC Bldg King House\_Front.jpg

**Assessment Comments:** Safety Zone: Powerline present but not charged live wire.

**Score: 74**  
**Rating: High**

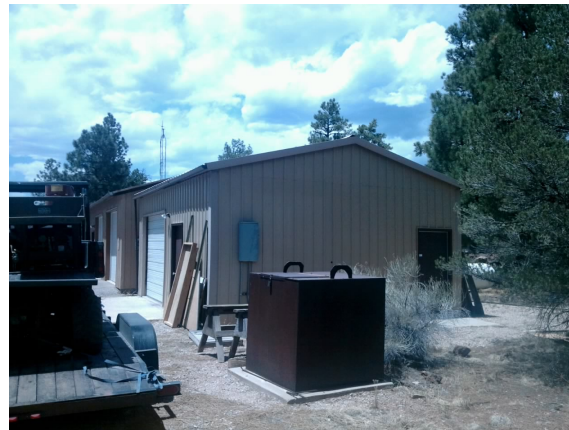
2018\_ELMA\_40672\_Pump Hose Fire Cache\_Front.jpg

Score: 67  
Rating: High

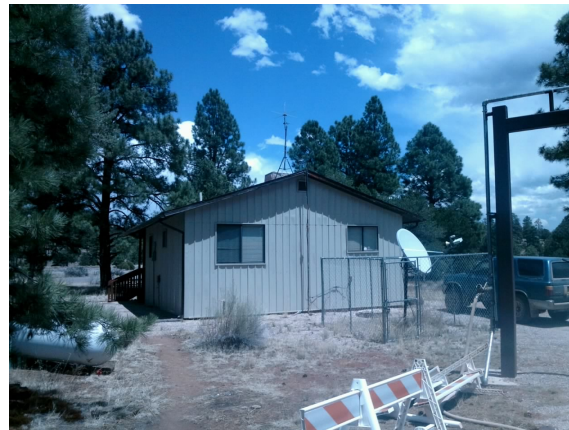
2018\_ELMA\_45803\_Fire Operations Center\_Front.jpg

Score: 75  
Rating: High

| Label # | Facility/Community Name | Assessment Scale | Site Visit Type | Firewise Zone | Treatment | Treatment Description | Person Hours | Date |
|---|---|---|---|---|---|---|---|---|
| 10 | Fire Operations Center | Facility In Community (ELMA Fire Operations Center) | SiteVisit | 1 | Mow dead/dying grass to less than 4 inches | | 2.0 | 5/21/18 |
| | | Facility In Community (ELMA Fire Operations Center) | SiteVisit | 2 | Flammable ground cover should be removed or isolated | | 4.0 | 5/21/18 |
| | | Facility In Community (ELMA Fire Operations Center) | SiteVisit | 2 | Limb trees 6 to 15 feet above ground | | 8.0 | 5/21/18 |

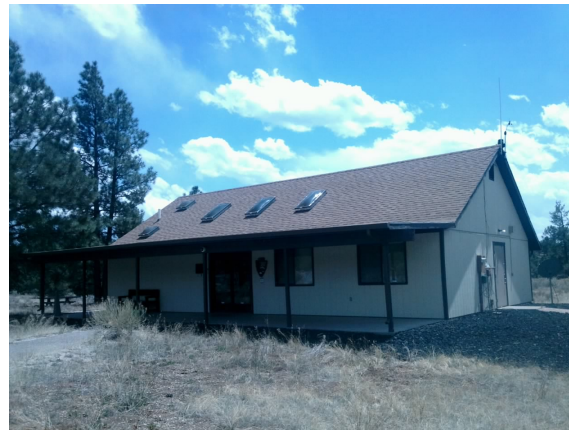
2018\_ELMA\_40674\_EL Malpais Information Center\_Front.jpg

**Assessment Comments:** Bridge Const. Material: No. Bridge Load Limits: No.

Ignition Potential: Vents needs screening. Obstacles: Leech line south of structure.

**Score: 70**  
**Rating: High**

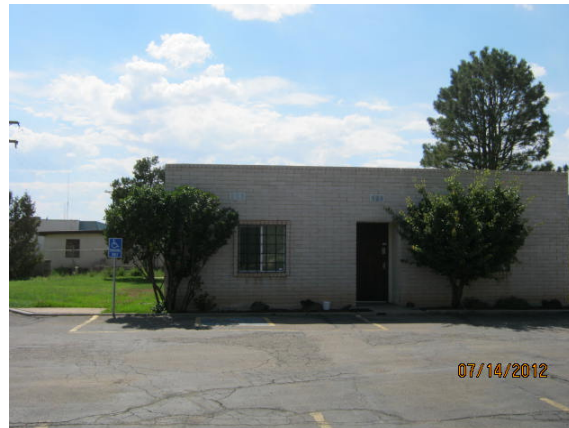
2018\_ELMA\_\_ELMA Headquarters\_D.jpg

Overhead Hazards: Overhead hazards will limit aircraft

Score: 15  
Rating: Low

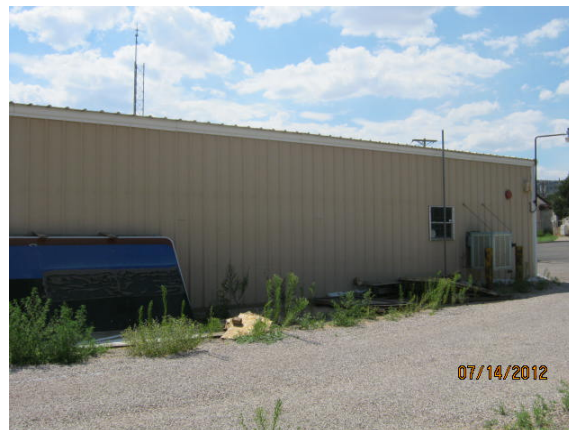
2018\_ELMA\_\_Elma HQ Maintenance Shop\_D.jpg

**Score: 10**  
**Rating: Low**

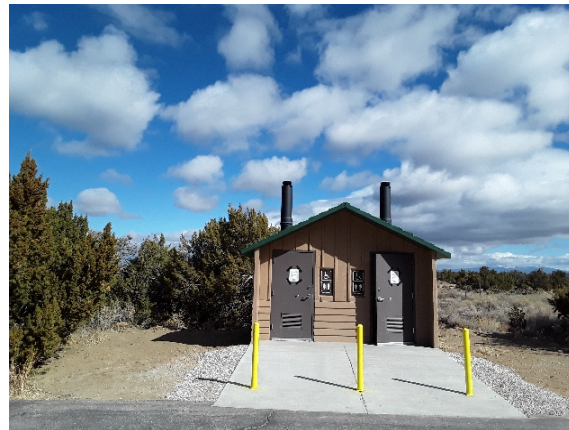
2021\_ELMA\_not found \_vault toilet \_Front.jpg

Score: 47  
Rating: Moderate

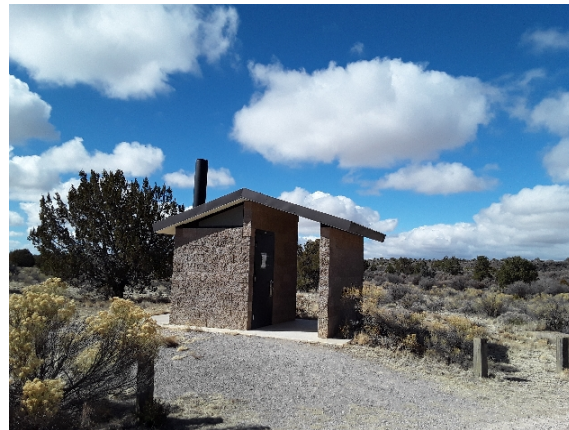
2021\_ELMA\_44379\_Lava Falls\_Front.jpg

Score: 50  
Rating: Moderate

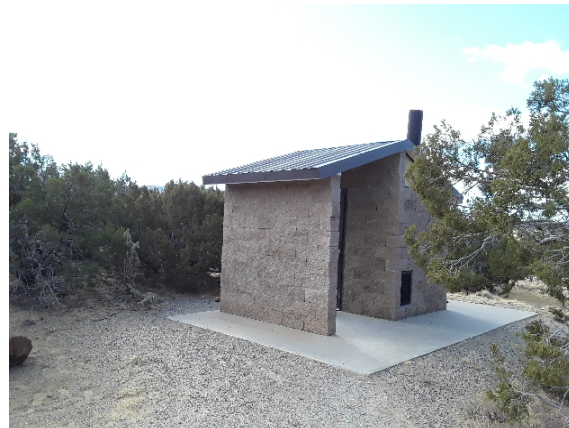
2021\_ELMA\_40562\_Sandstone Bluff Vault Toilet\_Front.jpg

Score: 69  
Rating: High
