# NPS Wildfire Risk Assessments Assessment Locations

## El Morro National Monument

# NPS Wildland Fire Risk Assessment - Facility Wildfire Risk Assessment Summary

## Unit - Location: ELMO - El Morro

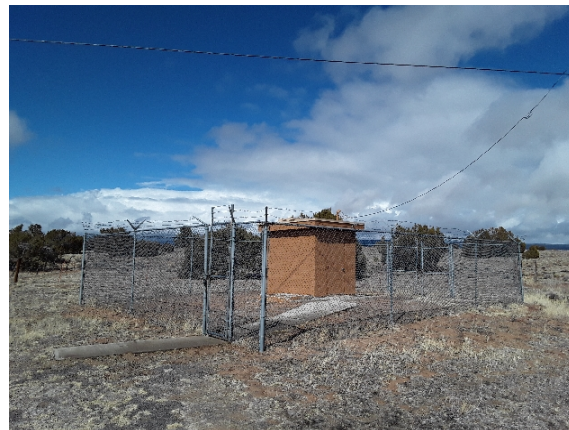
2021\_ELMO\_91760\_El Morro Pump House\_Front.jpg

**Fences/Decks:** None or noncombustible  
**Firewood:** None  
**Propane Tanks:** None  
**Water Supply:** No reliable water source nearby  
**Overhead Hazards:** Overhead hazards will limit aircraft

**Safety Zones:** Potential safety zone(s) in area  
**Additional Obstacles:** None  
**Triage Category:**  
**Hazmat:**  
**Assessment Comments:** Overhead Hazard: Powerline and poles above pump house.

**Score: 46**  
**Rating: Moderate**  
**Asset Priority Index (API):**  
N/A

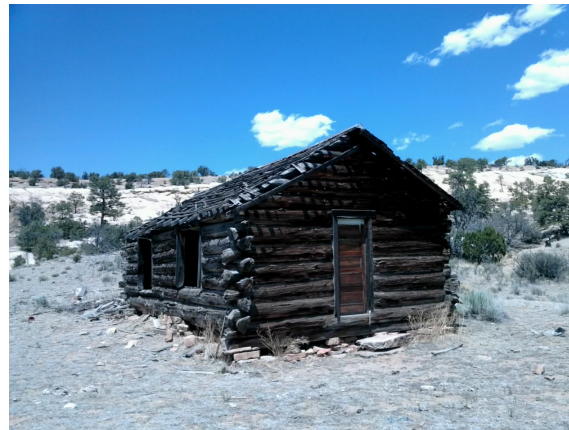
2018\_ELMO\_\_Historic Cabin\_Front.jpg

Score: 107  
Rating: High

| 2 | Historic Cabin | Individual Facility | SiteVisit | 1 | Flammable ground cover such as leaf litter, woody debris or highly flammable vegetation should be removed | | 2.0 |

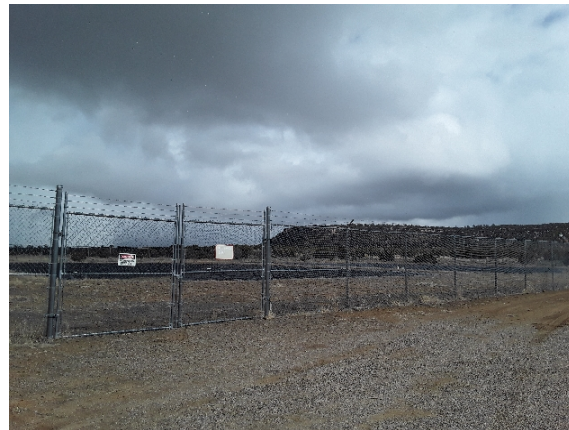
2021\_ELMO\_67090\_Sewage Lagoon\_Front.jpg

Score: 47  
Rating: Moderate

| Label # | Facility/Community Name | Assessment Scale | Triage Category | Tactic Description | Person Hours | Equipment Description | Equip. Qty |
|---|---|---|---|---|---|---|---|
| 3 | Sewage Lagoon | Individual Facility | Standalone | Burnout, no line construction necessary - | 8.0 | - | |

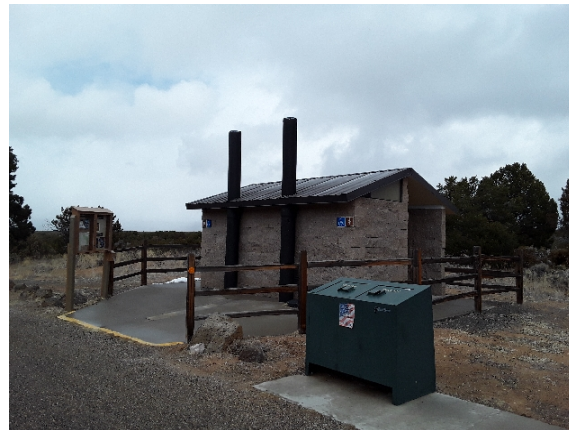
2021\_ELMO\_66962\_El Morro Campground Vault Toilet\_Front.jpg

Score: 57  
Rating: Moderate

| 4 | El Morro Campground Vault Toilet | Individual Facility | SiteVisit | 1 | Mow dead/dying grass to less than 4 inches | | 1.0 |
| | | Individual Facility | SiteVisit | 2 | Limb trees 6 to 15 feet above ground | | 4.0 |

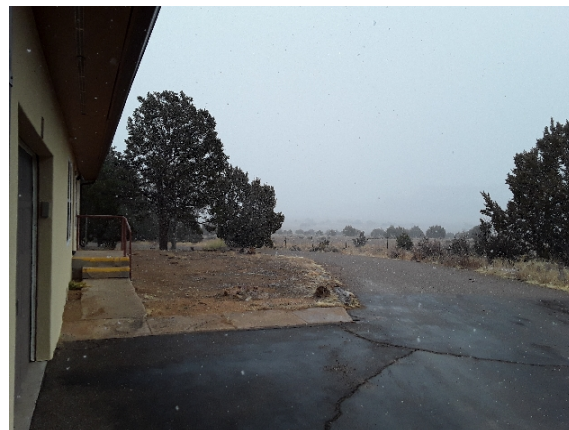
2021\_ELMO\_67081\_House #8\_.jpg

**Siding Material:** Rock, concrete, metal  
**Foundation:** Closed, >30in masonry exposed or N/A  
**Fences/Decks:** Combustible, adjacent, clear of veg/debris

**Score: 51**  
**Rating: Moderate**

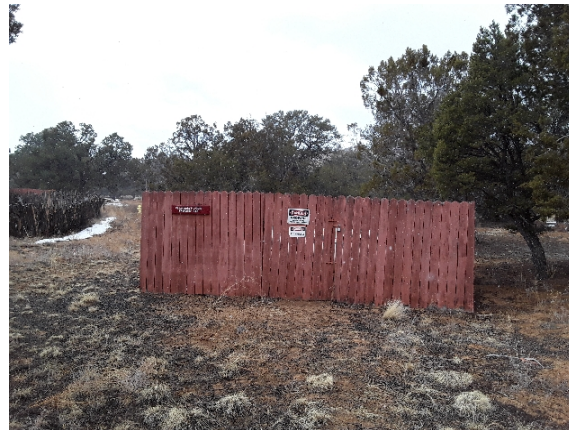
2021\_ELMO\_not found \_Propane Tank #2\_Front.jpg

**Safety Zones:** Potential safety zone(s) in area  
**Additional Obstacles:** None  
**Triage Category:**  
**Hazmat:**  
**Assessment Comments:** Firewood: Wooden fence.

**Score: 48**  
**Rating: Moderate**

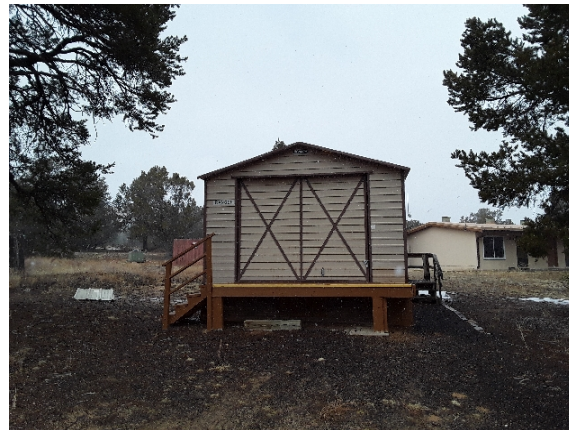
2021\_ELMO\_67086\_Ranger Storage\_Front.jpg

**Score: 57**  
**Rating: Moderate**

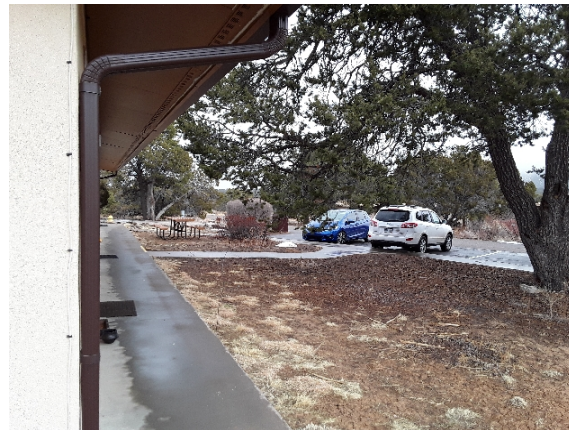
2021\_ELMO\_67082\_El Morro Apartment 1-3\_.jpg

Score: 45  
Rating: Moderate

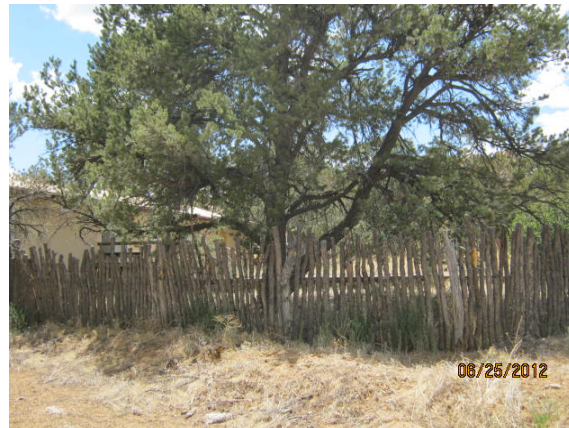
2018\_ELMO\_\_El Morro Residence Storage Shed\_x.jpg

**Score: 62**  
**Rating: None**

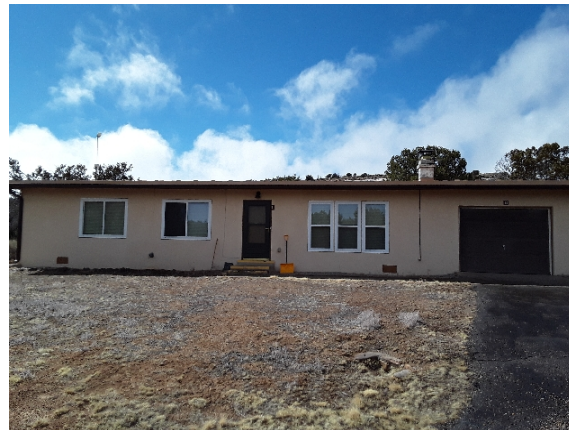
2021\_ELMO\_67078\_House #7\_Front.jpg

**Safety Zones:** Potential safety zone(s) in area  
**Additional Obstacles:** None  
**Triage Category:**  
**Hazmat:**  
**Assessment Comments:** Maintenance: Grass/shrub.

**Score: 62**  
**Rating: Moderate**  
**Asset Priority Index (API): 52**

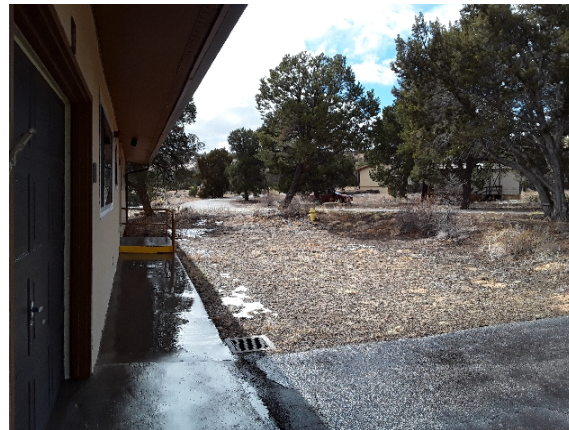
2021\_ELMO\_67077\_House #6\_.jpg

**Score: 62**  
**Rating: Moderate**  
**Asset Priority Index (API): 52**

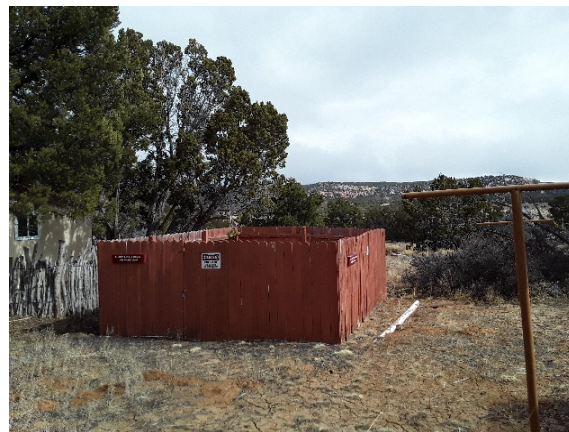
2021\_ELMO\_not found \_Propane Tank #1\_Front.jpg

**Score: 58**  
**Rating: Moderate**

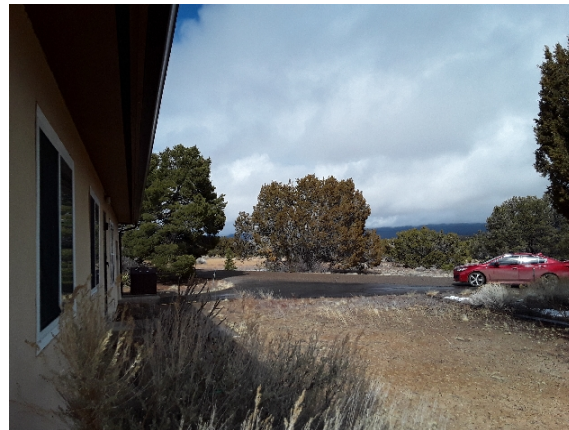
2021\_ELMO\_67076\_House #5\_.jpg

**Siding Material:** Rock, concrete, metal  
**Foundation:** Closed, >30in masonry exposed or N/A  
**Fences/Decks:** Combustible,adjacent,no veg/debris clearance

**Score: 54**  
**Rating: Moderate**

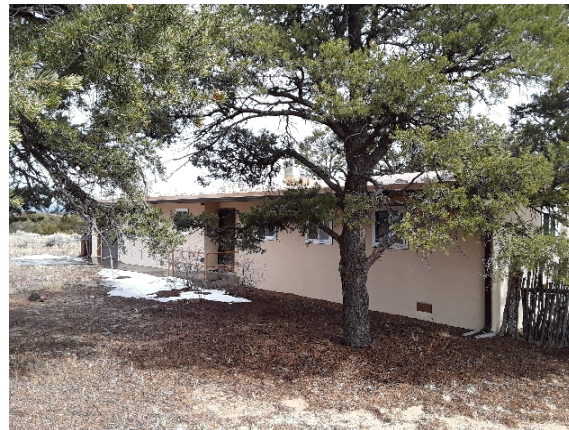
2021\_ELMO\_67065\_House #4\_Front.jpg

**Siding Material:** Rock, concrete, metal  
**Foundation:** Closed, >30in masonry exposed or N/A  
**Fences/Decks:** Combustible,adjacent,no veg/debris clearance

**Score: 54**  
**Rating: Moderate**  
**Asset Priority Index (API): 52**

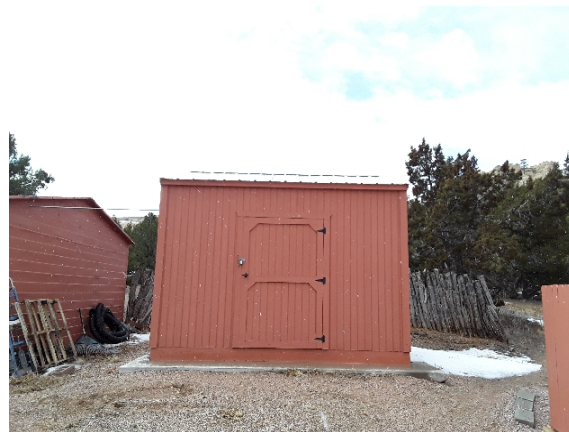
2021\_ELMO\_67060\_Book Storage Shed\_Front.jpg

**Siding Material:** Wood or open sided  
**Foundation:** Closed, < 6in masonry exposed  
**Fences/Decks:** Combustible,adjacent,no veg/debris clearance

**Safety Zones:** No safety zone(s) in area  
**Additional Obstacles:** None  
**Triage Category:**  
**Hazmat:**  
**Assessment Comments:**

**Score: 59**  
**Rating: Moderate**  
**Asset Priority Index (API): 23**

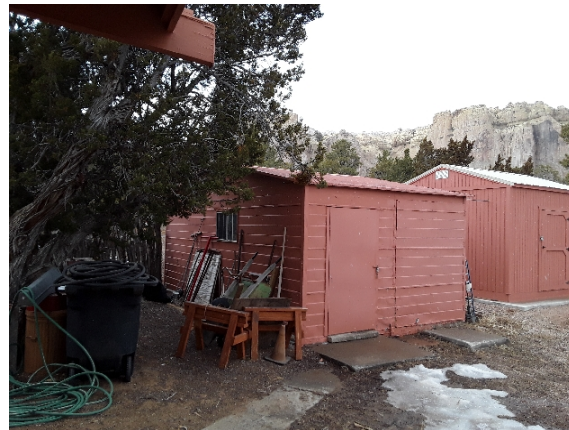
2021\_ELMO\_67057\_ELMO Lumber Storage\_Front.jpg

**Foundation:** Closed, < 6in masonry exposed

**Score: 65**  
**Rating: High**

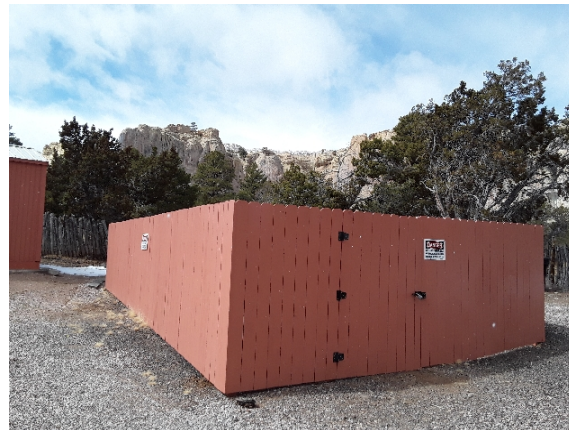
2021\_ELMO\_67349\_ELMO Propane Tank\_Front.jpg

**Score: 46**  
**Rating: Moderate**  
**Asset Priority Index (API):**  
N/A

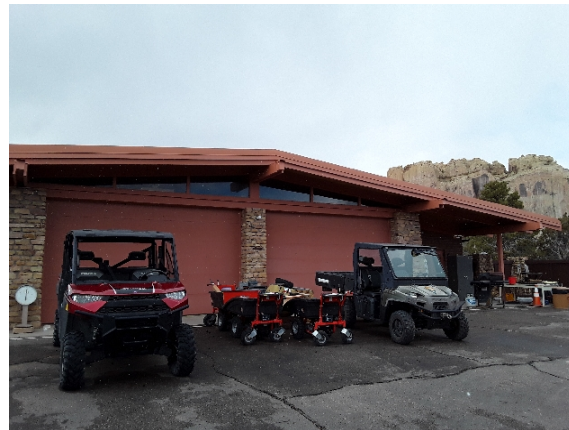
2021\_ELMO\_67054\_El Morro Maintenance\_Front.jpg

Score: 48  
Rating: Moderate

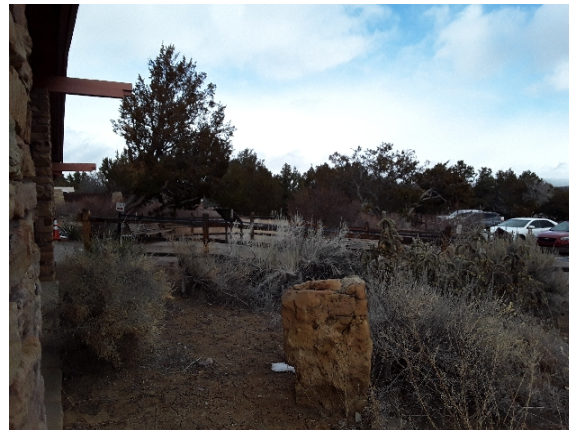
2021\_ELMO\_67003\_El Morro VC\_.jpg

**Siding Material:** Rock, concrete, metal  
**Foundation:** Closed, >30in masonry exposed or N/A  
**Fences/Decks:** Combustible,adjacent,no veg/debris clearance

**Score: 52**  
**Rating: Moderate**  
**Asset Priority Index (API): 100**

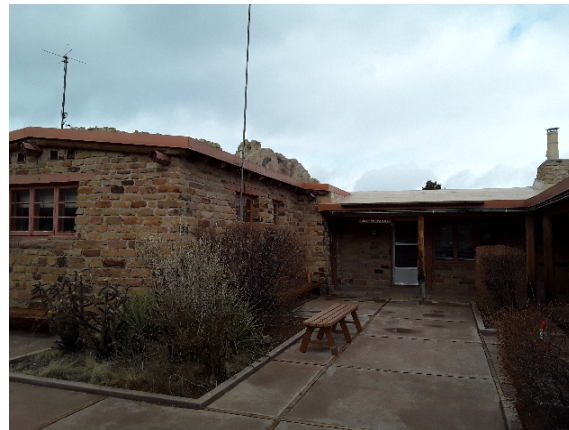
2021\_ELMO\_67045\_El Morro Administration Bldg.\_Front.jpg

Score: 54  
Rating: Moderate

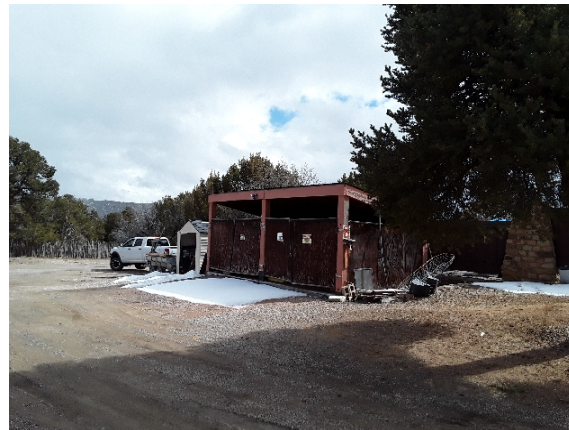
2021\_ELMO\_67064\_ELMO Fuel Storage Shed\_Front.jpg

Hazmat: Hazmat stored in structure.

Score: 55  
Rating: Moderate
