# Rainbow Bridge

# NPS Wildand Fire Risk Assessment - Facility Assessment

## Facility: RB (Rainbow Bridge) B001 Comfort Station (Floating)

## Facility: RB (Rainbow Bridge) Shade Structure #1

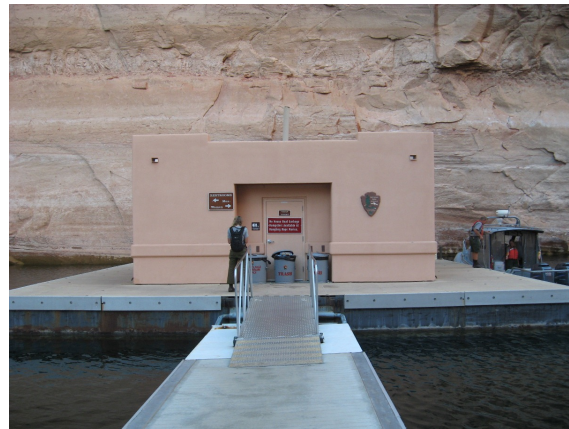
2012\_RABR\_44461\_RB (Rainbow Bridge) B001 Comfort Station (Floating)\_Front.jpg

Rating: NoWildlandRisk

Assessment Comments: N/A: Building is floating in a canyon on the water

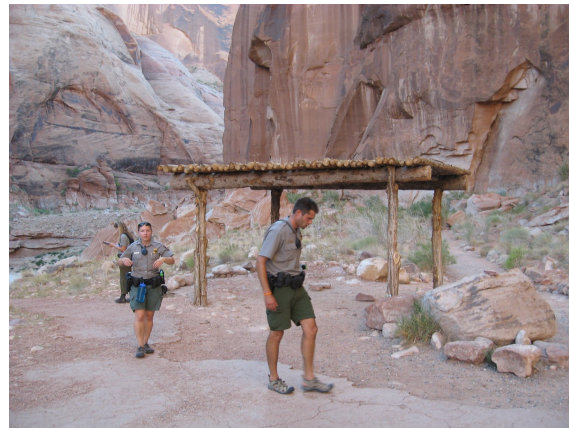
2012\_RABR\_GLCA RB Shade Sturcuture #1\_RB (Rainbow Bridge) Shade Structure #1\_Front.jpg

**Additional Obstacles:** None  
**Triage Category:**  
**Hazmat:**  
**Assessment Comments:** Road Width: By Boat. Water Supply: Lake Powell.  
Treatment: None. Very sparse fuels. It is in a canyon only accessible by water.

**Score: 56**  
**Rating: Moderate**

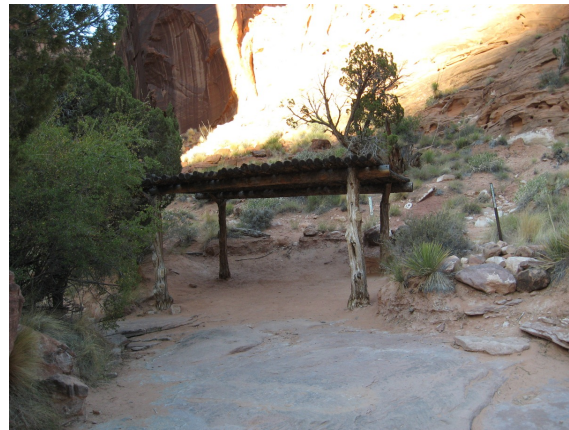
2012\_RABR\_GLCA RB Shade Sturcuture #2\_RB (Rainbow Bridge) Shade Structure #2\_Front.jpg

**Additional Obstacles:** None  
**Triage Category:**  
**Hazmat:**  
**Assessment Comments:** Road Width: By Boat. Water Supply: Lake Powell.  
Treatment: None. Wooden structure has some accumulation of fuels around it but it is remotely located and culturally sensitive to do any work to this area.

**Score: 59**  
**Rating: Moderate**
