# NPS Wildfire Risk Assessments Assessment Locations

National Park Service  
U.S. Department of the Interior

## Canyon De Chelly National Monument - Overview

# NPS Wildland Fire Risk Assessment - Facility Assessment

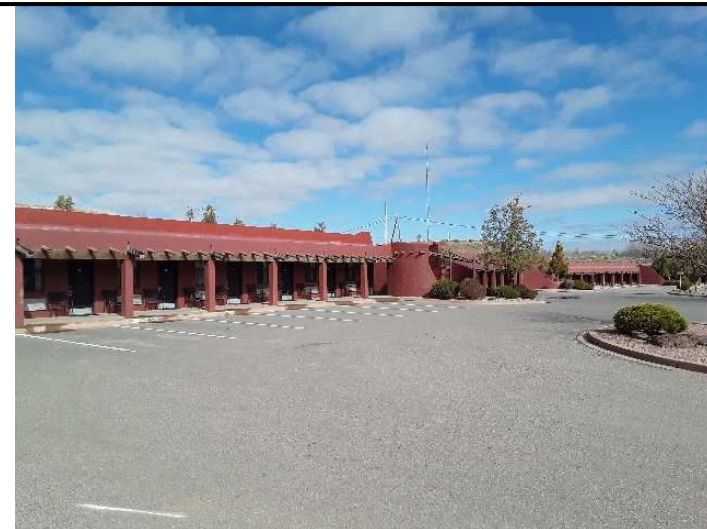
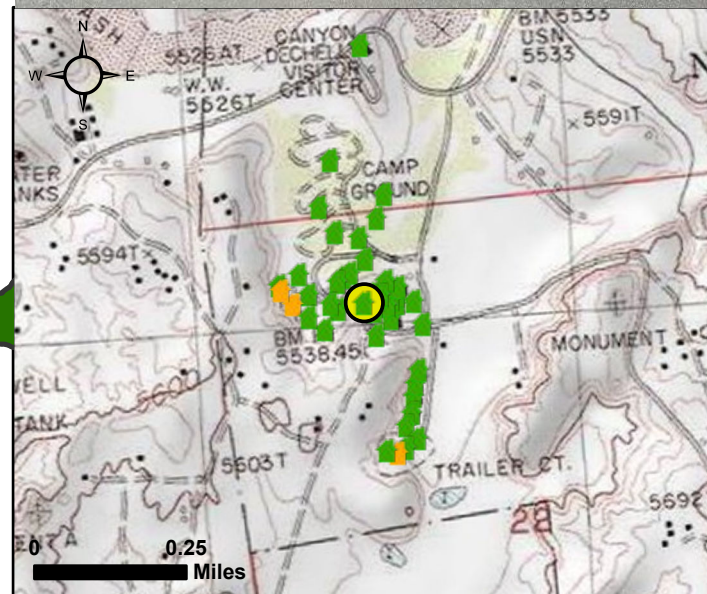
**Facility Name:** Concessions Motel Units (42 rooms)

**Comments:** motel built into hill. no photo b,c,d
