# NPS Wildfire Risk Assessments Assessment Locations

## Walnut Canyon National Monument- Overview

# NPS Wildand Fire Risk Assessment - Facility Wildfire Risk Assessment Summary

## Unit - Location: WACA - Walnut Canyon

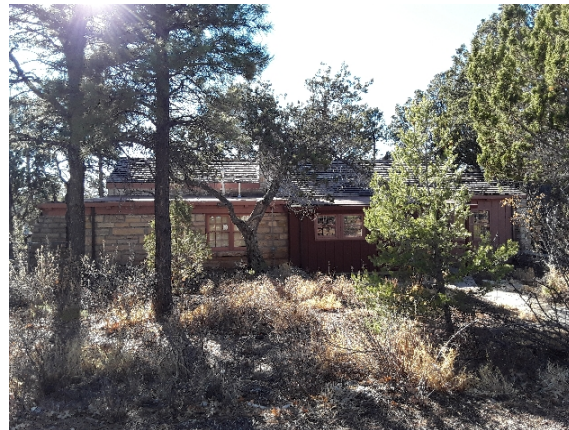
2020\_WACA\_48497\_Q-1 Housing\_Z.jpg

**Assessment Comments:** no B photo due to fence

**Score: 89**  
**Rating: High**

| Label # | Facility/Community Name | Assessment Scale | Site Visit Type | Firewise Zone | Treatment | Treatment Description | Person Hours |
|---|---|---|---|---|---|---|---|
| 2 | Q-1 Housing | Individual Facility | Initial | 1 | Flammable ground cover such as leaf litter, woody debris or highly flammable vegetation should be removed | | 4.0 |
| | | Individual Facility | Initial | 1 | Open crown spacing 10 to 30 feet depending on slope | | 4.0 |
| | | Individual Facility | Initial | 1 | Roof and gutters should be cleared of vegetative debris | | 1.0 |
| | | Individual Facility | Initial | 2 | Open crown spacing 10 to 30 feet depending on slope | | 16.0 |
| | | Individual Facility | Initial | 2 | Remove dead or dying component of shrubs and trees | | 5.0 |

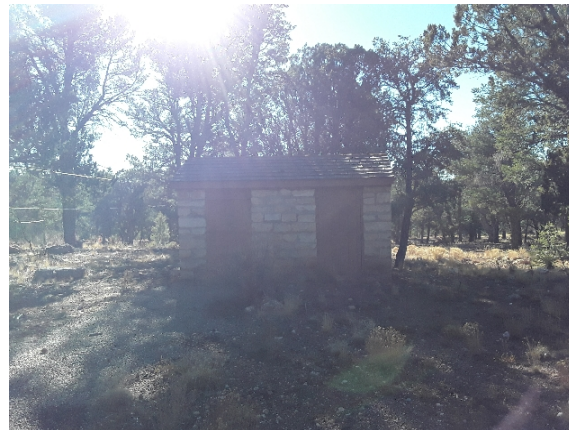
2020\_WACA\_search not found \_Q-1 Housing Garage\_Z.jpg

**Score: 72**  
**Rating: High**

| Label # | Facility/Community Name | Assessment Scale | Site Visit Type | Firewise Zone | Treatment | Treatment Description | Person Hours |
|---|---|---|---|---|---|---|---|
| 3 | Q-1 Housing Garage | Individual Facility | Initial | 1 | Clear adjacent and overhanging fuels to create 10 feet spacing between canopy and structure or chimney openings | | 2.0 |

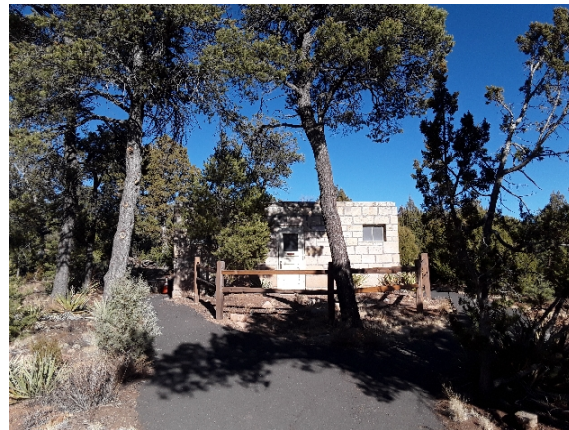
2020\_WACA\_search not found \_Visitors center picnic restrooms\_Front.jpg

Score: 57  
Rating: Moderate

| Label # | Facility/Community Name | Assessment Scale | Site Visit Type | Firewise Zone | Treatment | Treatment Description | Person Hours |
|---|---|---|---|---|---|---|---|
| 4 | Visitors center picnic restrooms | Individual Facility | Initial | 1 | Flammable ground cover such as leaf litter, woody debris or highly flammable vegetation should be removed | | 2.0 |
| | | Individual Facility | Initial | 2 | Limb trees 6 to 15 feet above ground | | 6.0 |

| 4 | Visitors center picnic restrooms | Individual Facility | Initial | 2 | Remove dead or dying component of shrubs and trees | | 8.0 |

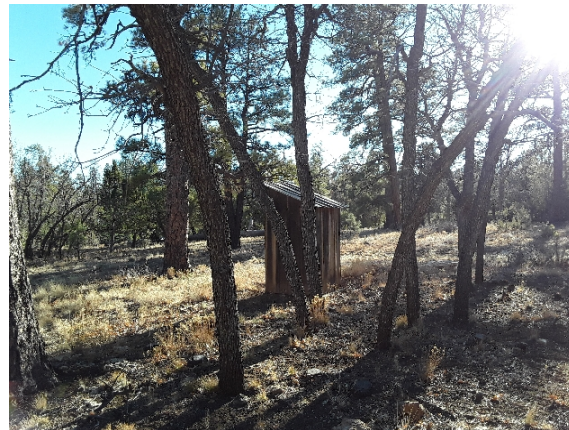
2020\_WACA\_46819\_WACA CCC Restroom\_Z.jpg

Score: 111  
Rating: High

| 5 | WACA CCC Restroom | Individual Facility | Initial | 1 | Open crown spacing 10 to 30 feet depending on slope | | 1.0 |
| | | Individual Facility | Initial | 1 | Remove dead or dying component of shrubs and trees | | 1.0 |
| | | Individual Facility | Initial | 2 | Remove dead or dying component of shrubs and trees | | 2.0 |

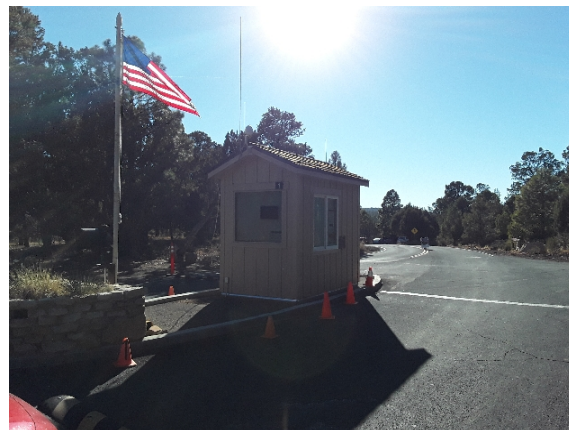
2020\_WACA\_51280\_WACA Entrance Station\_P\_.jpg

Score: 58  
Rating: Moderate

| 6 | WACA Entrance Station | Individual Facility | Initial | 2 | Limb trees 6 to 15 feet above ground | | 6.0 |
| | | Individual Facility | Initial | 2 | Open crown spacing 10 to 30 feet depending on slope | | 8.0 |

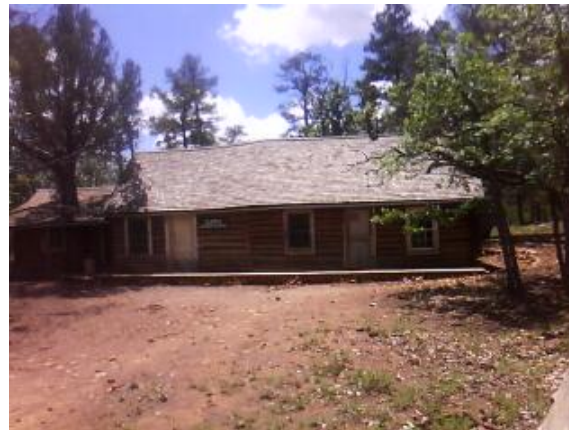
WACA-46810-WACA Historic Ranger Cabin (107)-Front.jpg

Score: 102  
Rating: High

| 7 | WACA Historic Ranger Cabin (107) | Individual Facility | Initial | 1 | Mow dead/dying grass to less than 4 inches | | 2.0 |
| | | Individual Facility | Initial | 1 | Roof and gutters should be cleared of vegetative debris | | 2.0 |
| | | Individual Facility | Initial | 2 | Limb trees 6 to 15 feet above ground | | 6.0 |
| | | Individual Facility | Initial | 2 | Remove dead or dying component of shrubs and trees | | 6.0 |

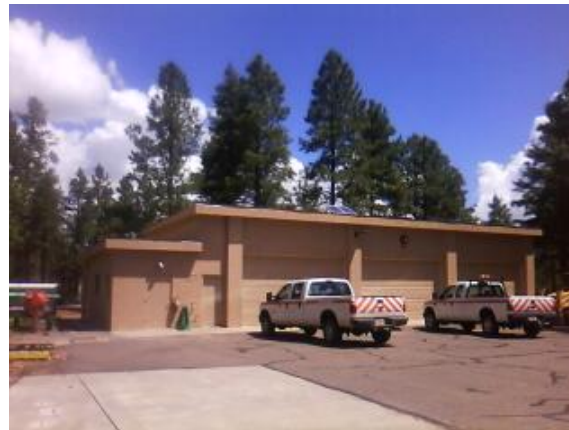
WACA-46811-WACA Maintenance Shop-Front.jpg

**Score: 50**  
**Rating: Moderate**

| 8 | WACA Maintenance Shop | Individual Facility | Initial | 2 | Remove dead or dying component of shrubs and trees | | 6.0 |

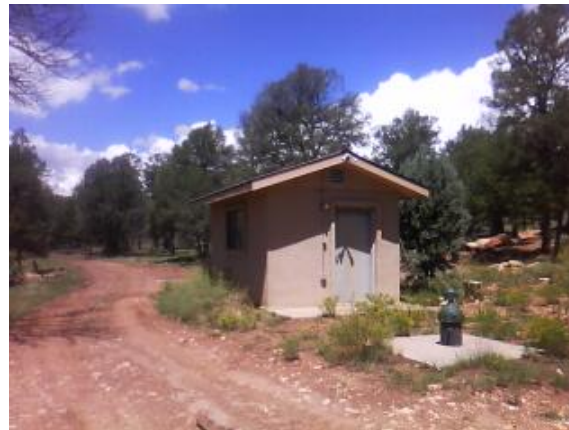
WACA-100371-WACA New Pumphouse (Constructed Fall 2005)-Front.jpg

Score: 72  
Rating: High

| 9 | WACA New Pumphouse<br>(Constructed Fall 2005) | Individual Facility | Initial | 1 | Flammable ground cover such as leaf litter, woody debris or highly flammable vegetation should be removed | | 2.0 |
| | | Individual Facility | Initial | 2 | Limb trees 6 to 15 feet above ground | | 6.0 |

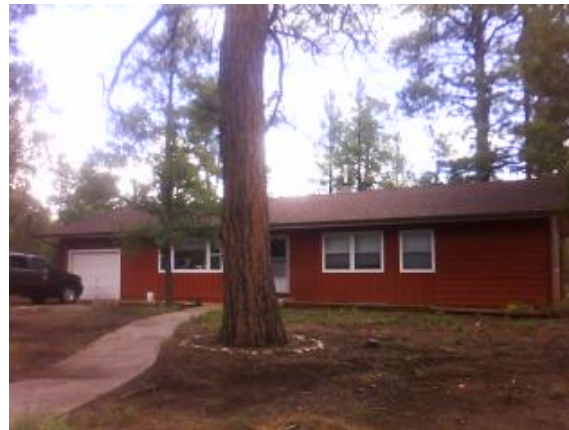
WACA-48483-WACA Pinyon Office (Formerly Res # 7)-  
Front.jpg

**Score: 53**  
**Rating: Moderate**

| 10 | WACA Pinyon Office<br>(Formerly Res # 7) | Individual Facility | Initial | 1 | Mow dead/dying grass to less than 4 inches | | 1.0 |
| | | Individual Facility | Initial | 1 | Roof and gutters should be cleared of vegetative debris | | 2.0 |
| | | Individual Facility | Initial | 2 | Remove dead or dying component of shrubs and trees | | 4.0 |

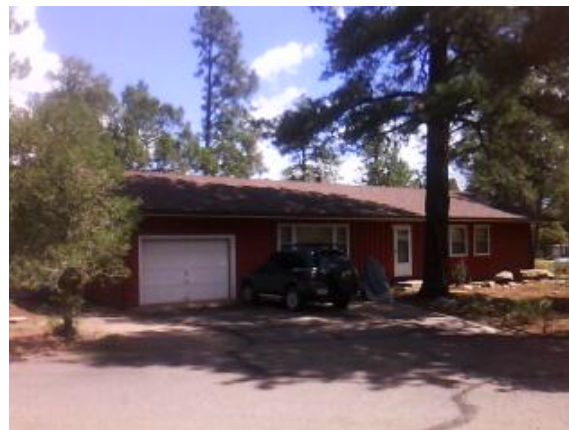
WACA-48482-WACA Ponderosa House (Res #6)-Front.jpg

**Score: 52**  
**Rating: Moderate**

| 11 | WACA Ponderosa House<br>(Res #6) | Individual Facility | Initial | 1 | Mow dead/dying grass to less than 4 inches | | 1.0 |
| | | Individual Facility | Initial | 1 | Roof and gutters should be cleared of vegetative debris | | 2.0 |
| | | Individual Facility | Initial | 2 | Remove dead or dying component of shrubs and trees | | 3.0 |

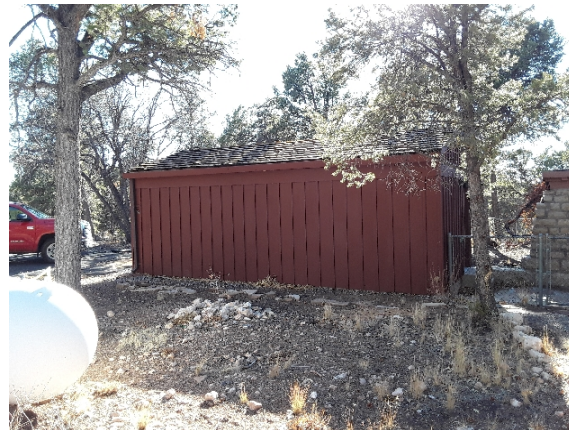
2020\_WACA\_113346\_WACA Residence # 1 Detached Garage\_Z.jpg

**Siding Material:** Wood or open sided  
**Foundation:** Closed, < 6in masonry exposed  
**Fences/Decks:** None or noncombustible  
**Firewood:** 5ft to 30ft from facility

**Propane Tanks:** Present and fuels clearance  
**Water Supply:** Pressurized hydrant(s) or fixed sprinkler system  
**Overhead Hazards:** No overhead hazards

**Score: 89**  
**Rating: High**

| 12 | WACA Residence # 1<br>Detached Garage | Individual Facility | Initial | 1 | Clear adjacent and overhanging fuels to create 10 feet spacing between canopy and structure or chimney openings | | 2.0 |
| | | Individual Facility | Initial | 1 | Limb trees 6 to 15 feet above ground | | 2.0 |

| 12 | WACA Residence # 1<br>Detached Garage | Individual<br>Facility | Initial | 2 | Remove dead or dying<br>component of shrubs and<br>trees | | 5.0 |

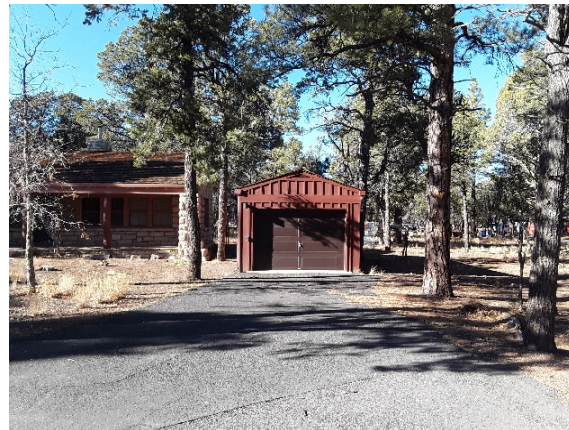
2020\_WACA\_48480\_WACA Residence # 2\_Z.jpg

**Score: 71**  
**Rating: High**

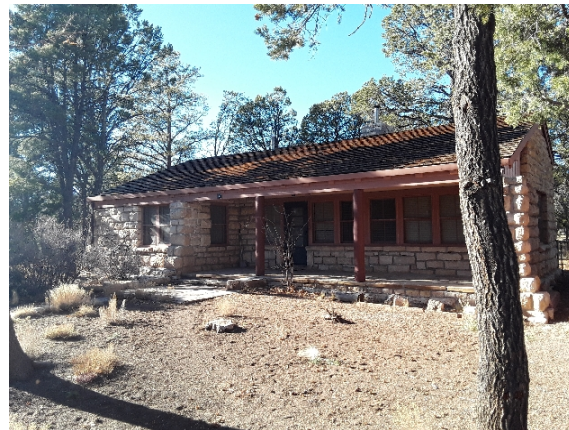
2020\_WACA\_48480\_WACA Residence # 2\_Z.jpg

Score: 71  
Rating: High

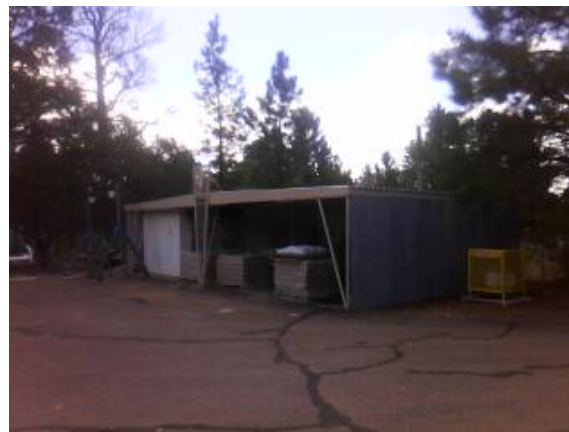
WACA-48480-WACA Residence # 2-Front.jpg

**Hazmat:** 5Gal LPG tanks adjacent, acetalline torch inside open bay.

**Score: 51**  
**Rating: Moderate**

| 15 | WACA Residence # 2 | Individual<br>Facility | Initial | 1 | Clear adjacent and<br>overhanging fuels to<br>create 10 feet spacing<br>between canopy and<br>structure or chimney<br>openings | | 2.0 |
| | | Individual<br>Facility | Initial | 1 | Roof and gutters should<br>be cleared of vegetative<br>debris | | 1.0 |
| | | Individual<br>Facility | Initial | 2 | Remove dead or dying<br>component of shrubs and<br>trees | | 3.0 |

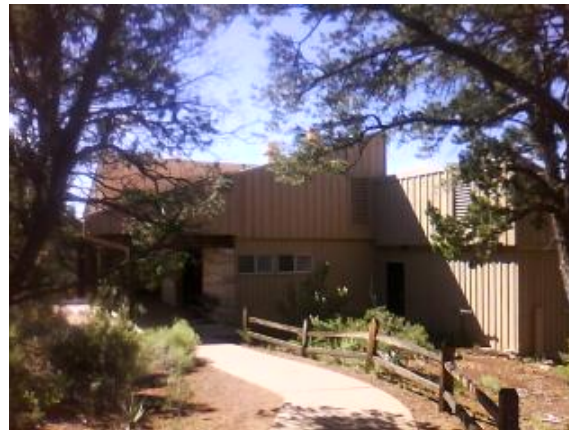
WACA-45499-WACA Visitor Center-Front.jpg

**Score: 60**  
**Rating: Moderate**

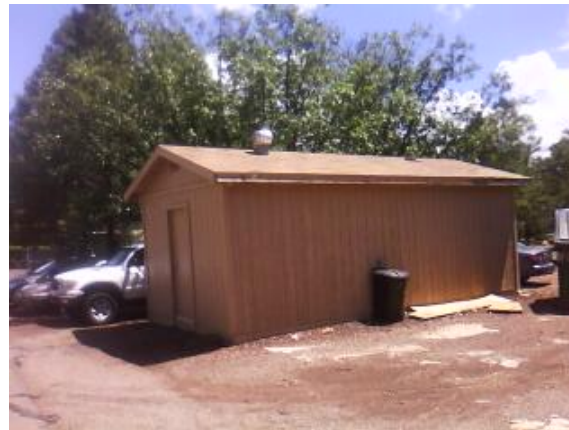
WACA-46816-WACA WNPA Shed-Front.jpg

**Score: 56**  
**Rating: Moderate**  
**Asset Priority Index (API):**  
**7**

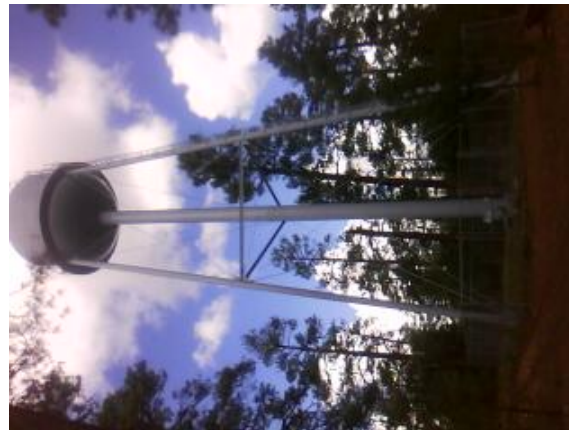
WACA--Water Tower-Front.jpg

**Score: 52**  
**Rating: Moderate**
