# NPS Wildfire Risk Assessments Assessment Locations

## Tuzigoot National Monument

# NPS Wildand Fire Risk Assessment - Facility Wildfire Risk Assessment Summary

## Unit - Location: TUZI - Tuzigoot National Monument

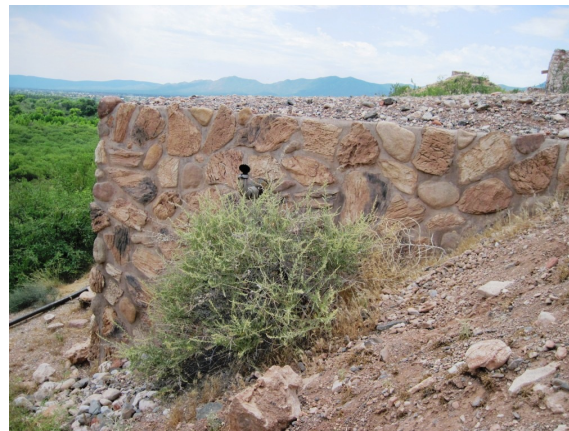
2018\_TUZI\_74442\_Fire Pump Building\_D.jpg

**Score: 40**  
**Rating: None**

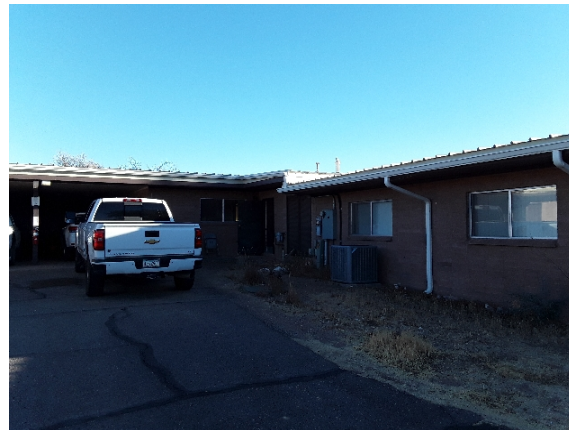
2020\_TUFrontL\_13713\_Quarters 5\_Front

**Score: 39**  
**Rating: Low**

| Label # | Facility/Community Name | Assessment Scale | Site Visit Type | Firewise Zone | Treatment | Treatment Description | Person Hours |
|---|---|---|---|---|---|---|---|
| 2 | Quarters 5 | Individual Facility | Initial | 1 | Remove dead or dying component of shrubs and trees | May need to mow grass around the building w/ weed eaters or a lawn mower. | 0.5 |
| | | Individual Facility | Initial | 2 | Flammable ground cover should be removed or isolated | Fuels need to be limbed, brushed, and mowed. The equipment needed to properly thin this zone would be chainsaws, brush cutters, and weed eaters. Would recommend clearing wood debris from outbuilding in the backyard. Would recommend clearing wood table and removing wood gate from alpha side of house. | 2.0 |
| | | Individual Facility | Initial | 3 | Remove standing dead or dying trees or limb 6 to 15 feet above ground | Fuels need to be limbed and cut with chainsaws and brush cutters. | 3.0 |

| Facility/Community Name | Assessment Scale | Triage Category | Tactic Description | Person Hours | Equipment Description | Equip. Qty |
|---|---|---|---|---|---|---|
| Quarters 5 | Individual Facility | PrepHold | Engine on scene - Engine should be on scene during fire event. Would recommend cutting grass and brush w/ a potential threat to the structure. Would recommend an engine on scene (A hydrant is on the Alpha side of the building, which is fed from a 50,000 gal. tank for drafting). Would recommend a sprinkler kit w/ pump to help protect the structure. | 6.0 | - | |
| | | | Fuels reduction - Fuels in zones 2 and 3 need treated to FireWise standards. Would recommend cutting grass and brush w/ a potential threat to the structure. Would recommend an engine on scene (A hydrant is on the Alpha side of the building, which is fed from a 50,000 gal. tank for drafting). Would recommend a sprinkler kit w/ pump to help protect the structure. | 12.0 | - | |

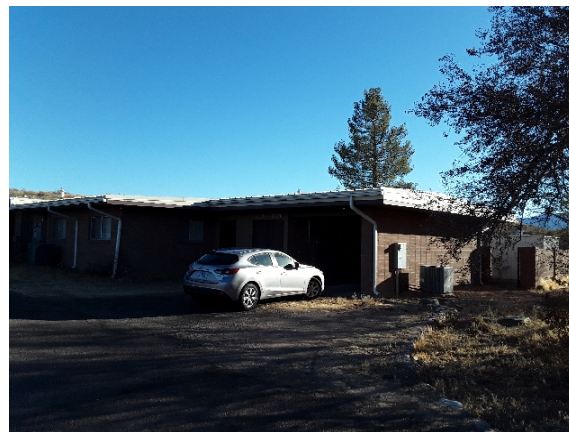
2020\_TUFrontL\_13716\_Quarters 7\_Front

**Score: 49**  
**Rating: Moderate**  
**Asset Priority Index (API): 20**

| Label # | Facility/Community Name | Assessment Scale | Site Visit Type | Firewise Zone | Treatment | Treatment Description | Person Hours |
|---|---|---|---|---|---|---|---|
| 3 | Quarters 7 | Individual Facility | Initial | 1 | Remove dead or dying component of shrubs and trees | May need to mow grass around the building w/ weed eaters or a lawn mower. | 0.5 |
| | | Individual Facility | Initial | 2 | Flammable ground cover should be removed or isolated | Fuels need to be limbed, brushed, and mowed. The equipment needed to properly thin this zone would be chainsaws, brush cutters, and weed eaters. Would recommend clearing wood debris from outbuilding in the backyard. Would recommend clearing wood table and removing wood gate from alpha side of house. | 2.0 |
| | | Individual Facility | Initial | 3 | Remove standing dead or dying trees or limb 6 to 15 feet above ground | Fuels need to be limbed and cut with chainsaws and brush cutters. | 3.0 |

| Facility/Community Name | Assessment Scale | Triage Category | Tactic Description | Person Hours | Equipment Description | Equip. Qty |
|---|---|---|---|---|---|---|
| Quarters 7 | Individual Facility | PrepHold | Fuels reduction - Fuels in zones 2 and 3 need treated to FireWise standards. Flammable materials should be moved away from outbuilding. Would recommend cutting grass and brush w/ a potential threat to the structure. Would recommend an engine on scene (A hydrant is on the Alpha side of the building, which is fed from a 50,000 gal. tank for drafting). Would recommend a sprinkler kit w/ pump to help protect the structure. | 12.0 | - | |
| | | | Engine on scene - Engine should be on scene during fire event. Would recommend cutting grass and brush w/ a potential threat to the structure. Would recommend an engine on scene (A hydrant is on the Alpha side of the building, which is fed from a 50,000 gal. tank for drafting). Would recommend a sprinkler kit w/ pump to help protect the structure. | 3.0 | - | |

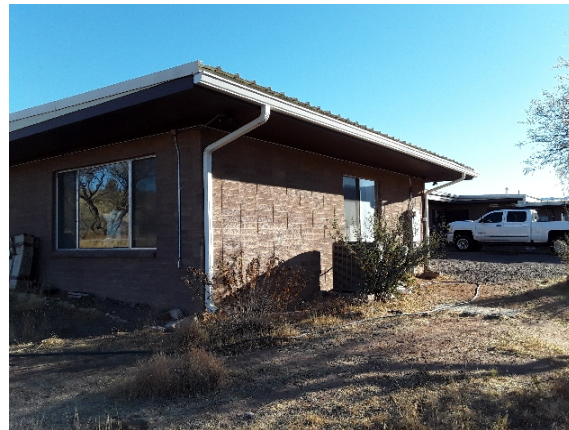
2020\_TUFrontI\_13711\_Resource Center\_Front

**Score: 39**  
**Rating: Low**

| Label # | Facility/Community Name | Assessment Scale | Site Visit Type | Firewise Zone | Treatment | Treatment Description | Person Hours |
|---|---|---|---|---|---|---|---|
| 4 | Resource Center | Individual Facility | Initial | 1 | Remove dead or dying component of shrubs and trees | May need to mow grass around the building w/ weed eaters or a lawn mower. | 0.5 |

| 4 | Resource Center | Individual Facility | Initial | 2 | Flammable ground cover should be removed or isolated | Fuels need to be limbed, brushed, and mowed. The equipment needed to properly thin this zone would be chainsaws, brush cutters, and weed eaters. Would recommend clearing wood debris from outbuilding in the backyard. Would recommend clearing wood table and removing wood gate from alpha side of house. | 2.0 |
| | | Individual Facility | Initial | 3 | Remove standing dead or dying trees or limb 6 to 15 feet above ground | Fuels need to be limbed and cut with chainsaws and brush cutters. | 3.0 |

| Facility/Community Name | Assessment Scale | Triage Category | Tactic Description | Person Hours | Equipment Description | Equip. Qty |
|---|---|---|---|---|---|---|
| Resource Center | Individual Facility | PrepHold | Engine on scene - (A hydrant is on the Alpha side of the building, which is fed from a 50,000 gal. tank for drafting). Would recommend a sprinkler kit w/ pump to help protect the structure. | 6.0 | - | |
| | | | Fuels reduction - Fuels in zones 2 and 3 need treated to FireWise standards. Would recommend cutting grass and brush w/ a potential threat to the structure. | 12.0 | - | |

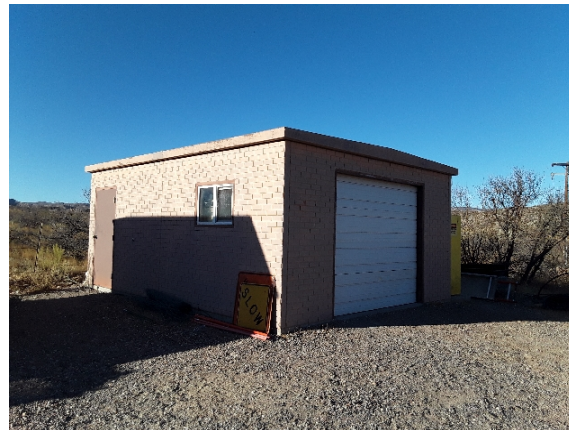
2020\_TUFrontI\_26621\_Storage Building\_Front

**Safety Zones:** Potential safety zone(s) in area  
**Additional Obstacles:** Hazmat, UXO,etc. , PLEASE COMMENT  
**Triage Category:**  
**Hazmat:** fuel storage locker on D side

**Score: 52**  
**Rating: Moderate**  
**Asset Priority Index (API): 32**

| 5 | Storage Building | Individual Facility | Initial | 1 | Open crown spacing 10 to 30 feet depending on slope | Create adequate crown spacing in brush. | 2.0 |
| | | Individual Facility | Initial | 2 | Open crown spacing 10 to 30 feet depending on slope | Create adequate crown spacing in brush. | 2.0 |
| | | Individual Facility | Initial | 2 | Remove dead or dying component of shrubs and trees | | 1.0 |

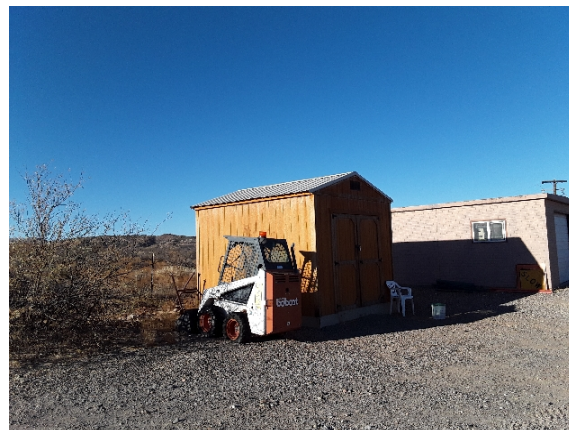
2020\_TUFrontI\_search not found \_Storage Shed\_Front

**Siding Material:** Vinyl  
**Foundation:** Closed, < 6in masonry exposed  
**Fences/Decks:** None or noncombustible  
**Firewood:** None  
**Propane Tanks:** Present and fuels clearance

**Score: 53**  
**Rating: Moderate**

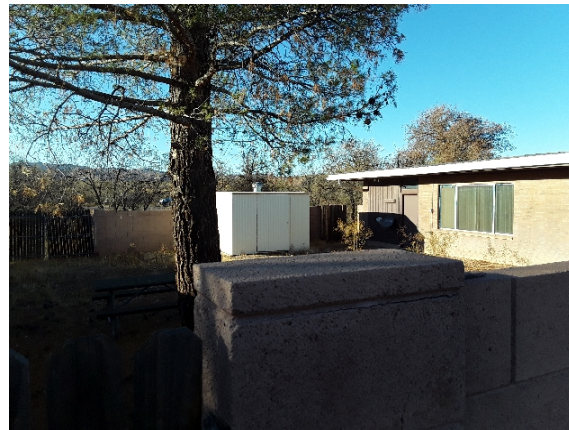
2020\_TUFrontI\_search not found \_Storage Shed\_Front

**Score: 37**  
**Rating: Low**

| 7 | Storage Shed | Individual Facility | Initial | 2 | Limb trees 6 to 15 feet above ground | | 1.0 |
| | | Individual Facility | Initial | 2 | Remove dead or dying component of shrubs and trees | | 1.0 |
| | | Individual Facility | Initial | 1 | Limb trees 6 to 15 feet above ground | | 1.0 |

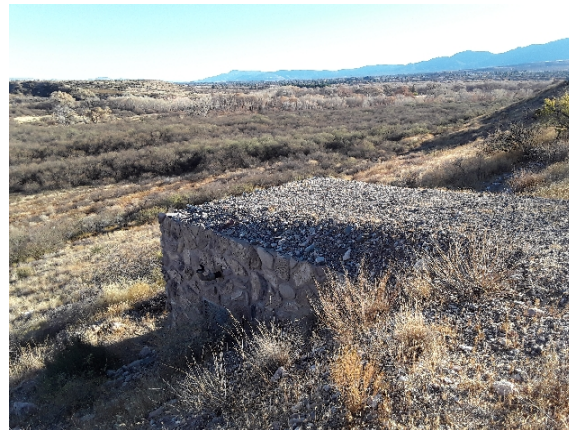
Photo 1.jpg

**Score: 55**  
**Rating: Moderate**

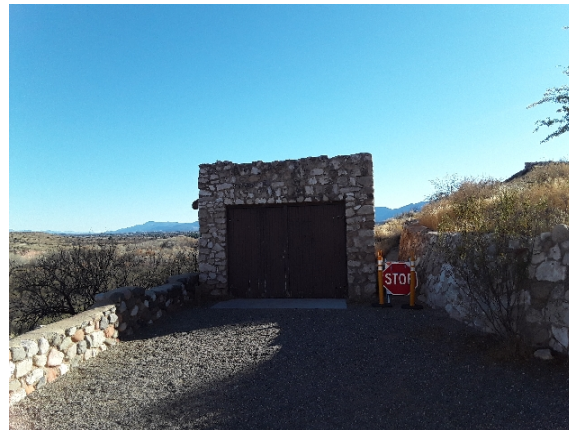
2020\_TUFrontL\_13719\_Old Shop Building HB\_Front

**Score: 59**  
**Rating: Moderate**  
**Asset Priority Index (API): 55**

| 9 | Old Shop Building HB | Facility In Community (Tuzigoot) | Initial | 1 | Flammable ground cover such as leaf litter, woody debris or highly flammable vegetation should be removed | Trim ground cover near structure. | 1.5 |
| | | Facility In Community (Tuzigoot) | Initial | 2 | Flammable ground cover should be removed or isolated | Trim dead/dying grass to less than 4 inches and flammable ground cover to less than 18 inches on bravo, charlie and delta sides. | 1.0 |
| | | Facility In Community (Tuzigoot) | Initial | 2 | Limb trees 6 to 15 feet above ground | Limb trees/shrubs 6 to 15 ft above vegetation. | 2.0 |
| | | Facility In Community (Tuzigoot) | Initial | 2 | Open crown spacing 10 to 30 feet depending on slope | Create adequate horizontal spacing taking into consideration height and slope on all sides of structures. | 1.5 |
| | | Facility In Community (Tuzigoot) | Initial | 3 | Remove standing dead or dying trees or limb 6 to 15 feet above ground | Limb dead/dying trees/branches 6 to 15 ft above ground fuels. | 1.5 |

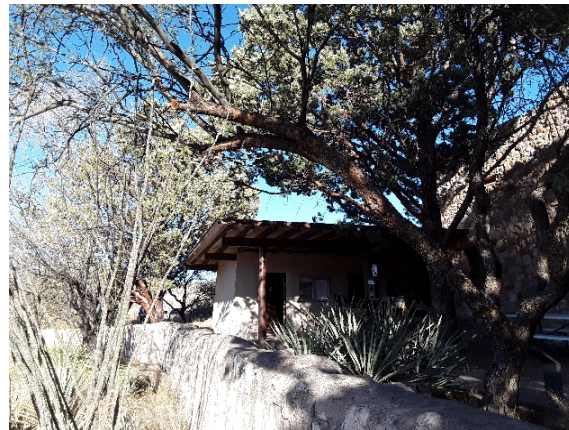
2020\_TUFrontL\_13704\_Restrooms\_Front

**Score: 35**  
**Rating: Low**

| | | Facility In Community (Tuzigoot) | | | | Clear roof and gutters of debris. | |
| | | Facility In Community (Tuzigoot) | | | | Trim dead or dying grass to less than 4 inches and flammable ground cover to less than 18 inches. | |

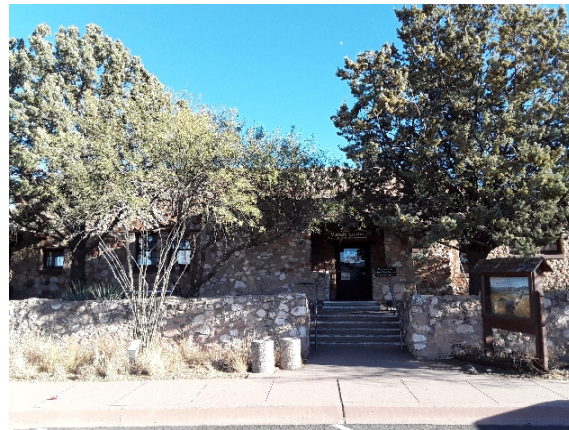
2020\_TUFrontL\_13702\_Visitor Center\_Front

**Score: 41**  
**Rating: Low**

| 11 | Visitor Center | Facility In Community (Tuzigoot) | Initial | 1 | Roof and gutters should be cleared of vegetative debris | Clear roof and gutters of debris. | 0.5 |
| | | Facility In Community (Tuzigoot) | Initial | 2 | Flammable ground cover should be removed or isolated | Trim dead or dying grass to less than 4 inches and flammable ground cover to less than 18 inches. | 1.0 |

| 11 | Visitor Center | Facility In Community (Tuzigoot) | Initial | 2 | Limb trees 6 to 15 feet above ground | Limb trees/shrubs 6 to 15 ft above vegetation. | 2.0 |
| | | Facility In Community (Tuzigoot) | Initial | 2 | Open crown spacing 10 to 30 feet depending on slope | Create adequate horizontal spacing taking into consideration height and slope on all sides of structures. | 1.5 |
| | | Facility In Community (Tuzigoot) | Initial | 3 | Remove standing dead or dying trees or limb 6 to 15 feet above ground | Limb dead or dying trees/limbs 6 to 15 ft above the ground. | 1.5 |

| Facility/Community Name | Assessment Scale | Triage Category | Tactic Description | Person Hours | Equipment Description | Equip. Qty |
|---|---|---|---|---|---|---|
| Visitor Center | Facility In Community (Tuzigoot) | PrepHold | Engine on scene - Recommend sprinklers be installed on C side, and engine on scene during fire event. | 6.0 | - | |
| | | | Install sprinkler system - Recommend sprinklers be installed on C side, and engine on scene during fire event. | 6.0 | - | |

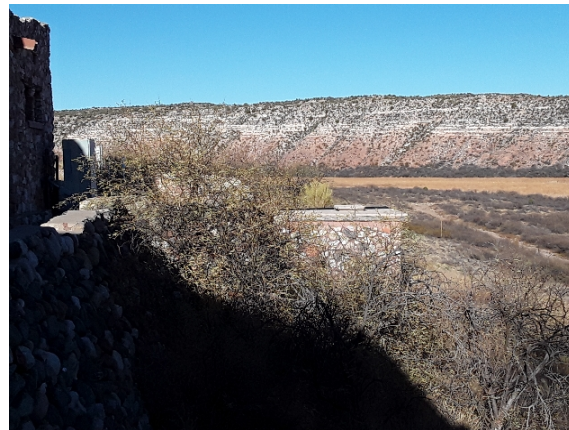
2020\_TUFrontI\_26620\_Well Pump House\_Front

**Score: 59**  
**Rating: Moderate**

| 12 | Well Pump House | Facility In Community (Tuzigoot) | Initial | 1 | Roof and gutters should be cleared of vegetative debris | Clear roof and gutters of debris. | 0.5 |
| | | Facility In Community (Tuzigoot) | Initial | 2 | Flammable ground cover should be removed or isolated | Trim dead or dying grass to less than 4 inches and flammable ground cover to less than 18 inches. | 1.0 |
| | | Facility In Community (Tuzigoot) | Initial | 2 | Limb trees 6 to 15 feet above ground | Limb trees/shrubs 6 to 15 ft above vegetation. | 2.0 |
| | | Facility In Community (Tuzigoot) | Initial | 2 | Open crown spacing 10 to 30 feet depending on slope | Create adequate horizontal spacing taking into consideration height and slope on all sides of structures. | 1.5 |
| | | Facility In Community (Tuzigoot) | Initial | 3 | Remove standing dead or dying trees or limb 6 to 15 feet above ground | Limb dead or dying trees/limbs 6 to 15 ft above the ground. | 1.5 |
