# NPS Wildfire Risk Assessments

### Sunset Crater Volcano National Monument

## SUCR - Sunset Crater Volcano National Monument

# NPS Wildand Fire Risk Assessment - Facility Wildfire Risk Assessment Summary

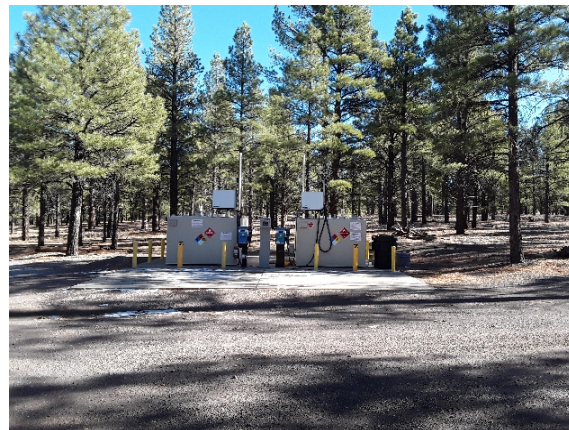
2020\_SUCR\_Not found\_Fuel Pumps / Tanks\_Front.jpg

**Score: 45**  
**Rating: Moderate**

| Label # | Facility/Community Name | Assessment Scale | Site Visit Type | Firewise Zone | Treatment | Treatment Description | Person Hours |
|---|---|---|---|---|---|---|---|
| | | Individual Facility | Initial | 1 | Flammable ground cover such as leaf litter, woody debris or highly flammable vegetation should be removed | clear pine needles. | 2.0 |

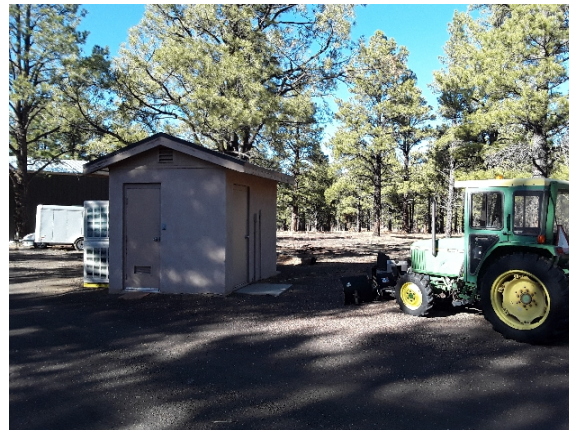
2020\_SUCR\_not found \_Shed\_Z.jpg

**Overhead Hazards:** Overhead hazards will limit aircraft

**Score: 52**  
**Rating: Moderate**

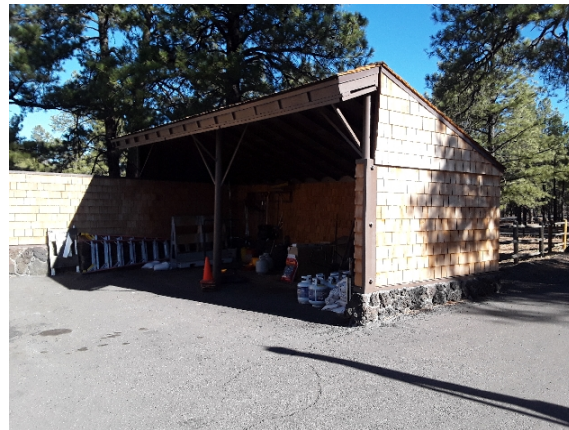
2020\_SUCR\_not found\_Shed\_Z.jpg

**Score: 48**  
**Rating: Moderate**

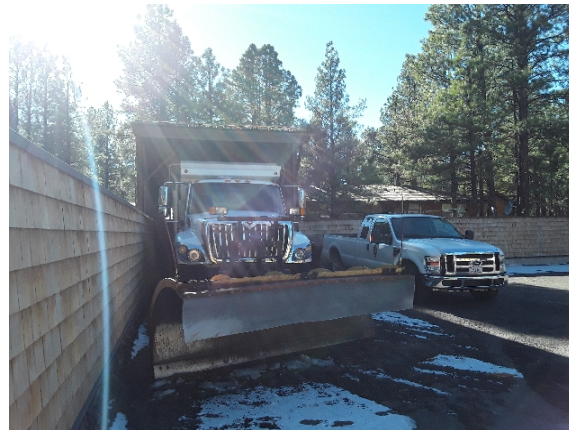
2020\_SUCR\_not found\_Shed\_Z.jpg

**Hazmat:** Diesel and gas in open bay.

**Score: 69**  
**Rating: High**

| Label # | Facility/Community Name | Assessment Scale | Site Visit Type | Firewise Zone | Treatment | Treatment Description | Person Hours |
|---|---|---|---|---|---|---|---|
| | | Individual Facility | Initial | 2 | Limb trees 6 to 15 feet above ground | | 2.0 |
| | | Individual Facility | Initial | 1 | Clear adjacent and overhanging fuels to create 10 feet spacing between canopy and structure or chimney openings | | 1.0 |

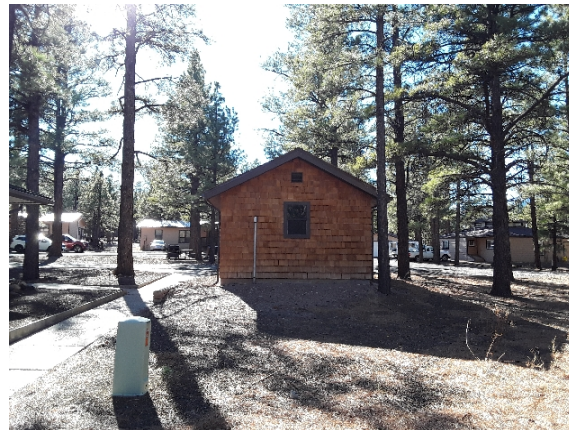
2020\_SUCR\_113344\_SUCR Apt 18A - Detached Garage\_Z.jpg

Score: 49  
Rating: Moderate

| 5 | SUCR Apt 18A - Detached Garage | Individual Facility | Initial | 1 | Clear adjacent and overhanging fuels to create 10 feet spacing between canopy and structure or chimney openings | | 2.0 |
| | | Individual Facility | Initial | 1 | Roof and gutters should be cleared of vegetative debris | | 1.0 |
| | | Individual Facility | Initial | 2 | Remove dead or dying component of shrubs and trees | | 1.0 |

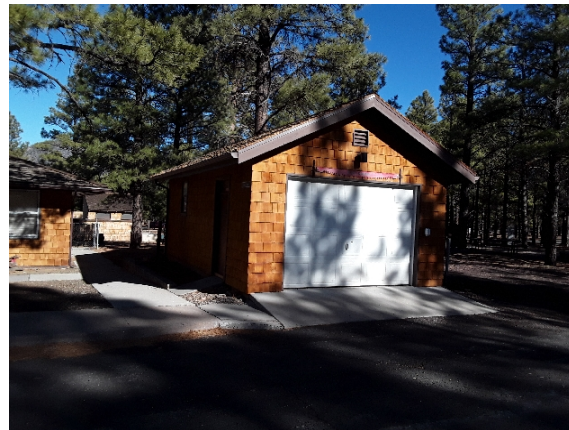
2020\_SUCR\_113348\_SUCR Apt 18B Detached Garage (being used as a Fire Cache)\_Z.jpg

**Score: 51**  
**Rating: Moderate**

| 6 | SUCR Apt 18B Detached Garage (being used as a Fire Cache) | Individual Facility | Initial | 1 | Clear adjacent and overhanging fuels to create 10 feet spacing between canopy and structure or chimney openings | | 3.0 |
| | | Individual Facility | Initial | 1 | Roof and gutters should be cleared of vegetative debris | | 1.0 |

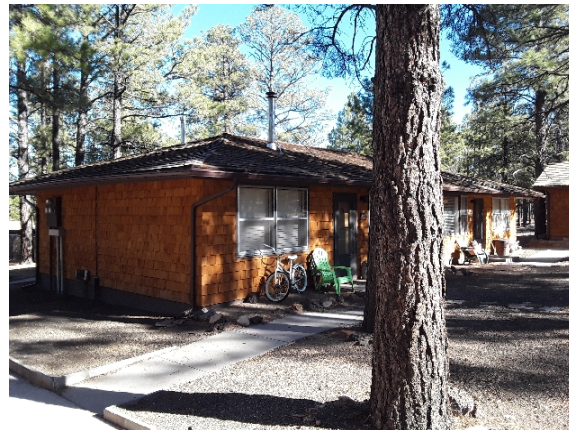
2020\_SUCR\_52742\_SUCR Apt Building\_Z.jpg

Score: 69  
Rating: High

| | | Individual Facility | Initial | 1 | Clear adjacent and overhanging fuels to create 10 feet spacing between canopy and structure or chimney openings | | 2.0 |
| | | Individual Facility | Initial | 1 | Roof and gutters should be cleared of vegetative debris | | 1.0 |

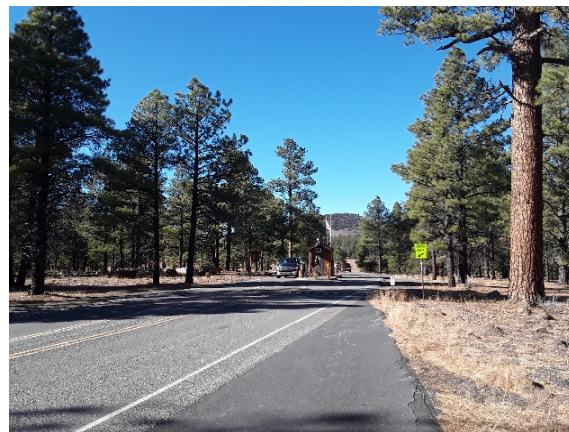
2020\_SUCR\_48425\_SUCR Entrance Station\_P.jpg

Score: 76  
Rating: High

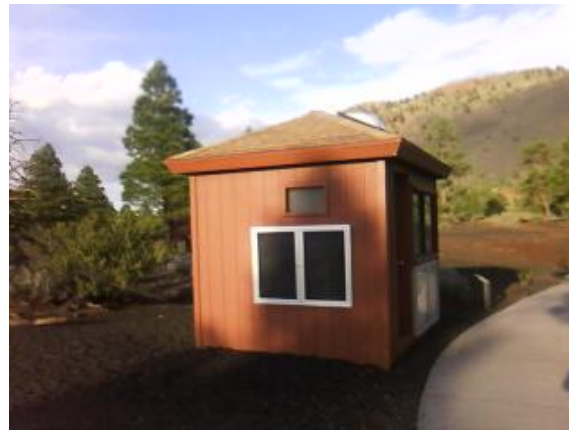
SUCR-48433-SUCR Lava Flow Interpretive Kiosk-Front.jpg

**Score: 48**  
**Rating: None**

| 9 | SUCR Lava Flow Interpretive Kiosk | Individual Facility | Initial | 1 | Remove dead or dying component of shrubs and trees | | 8.0 |

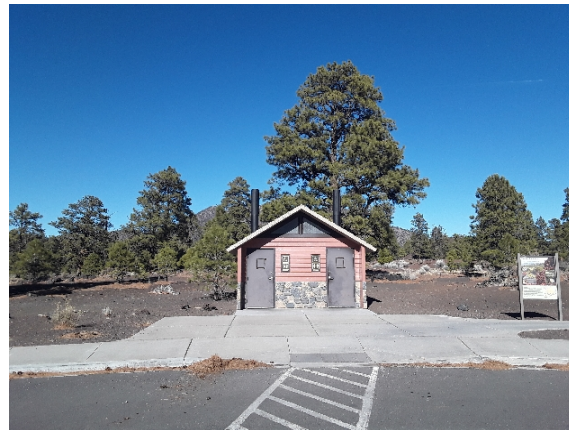
2020\_SUCR\_48429\_SUCR Lava Flow Rest Room\_Z.jpg

Score: 33  
Rating: Low

| | | Individual Facility | Initial | 1 | Clear adjacent and overhanging fuels to create 10 feet spacing between canopy and structure or chimney openings | | 0.5 |

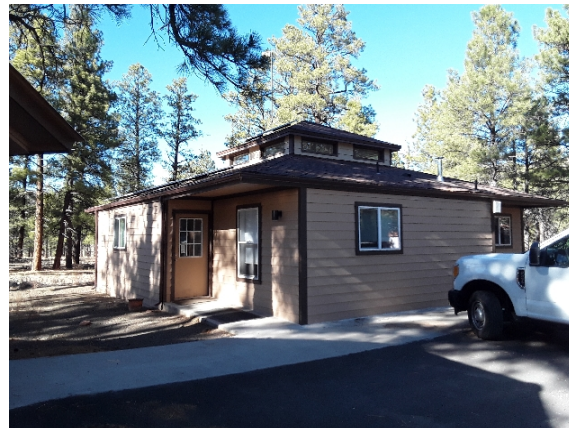
2020\_SUCR\_48441\_SUCR Maintenance Office (Formerly Mod # 12)\_Z.jpg

Score: 32  
Rating: Low

| 11 | SUCR Maintenance Office (Formerly Mod # 12) | Individual Facility | Initial | 1 | Roof and gutters should be cleared of vegetative debris | | 1.0 |
| | | Individual Facility | Initial | 2 | Remove dead or dying component of shrubs and trees | | 6.0 |

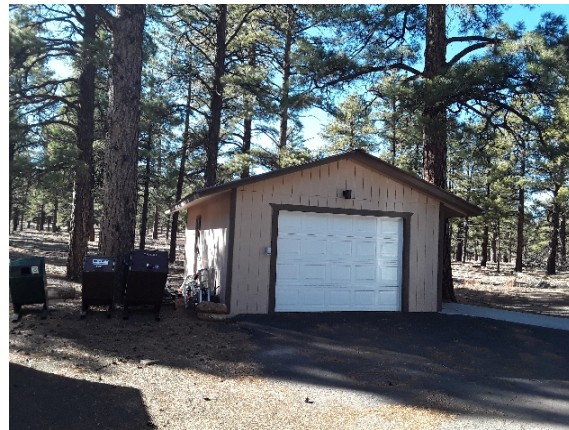
2020\_SUCR\_113349\_SUCR Mod # 12 Detached Garage\_Z.jpg

Score: 24  
Rating: Low

| 12 | SUCR Mod # 12 Detached Garage | Individual Facility | Initial | 1 | Clear adjacent and overhanging fuels to create 10 feet spacing between canopy and structure or chimney openings | | 2.0 |
| | | Individual Facility | Initial | 1 | Mow dead/dying grass to less than 4 inches | | 1.0 |
| | | Individual Facility | Initial | 1 | Roof and gutters should be cleared of vegetative debris | | 1.0 |

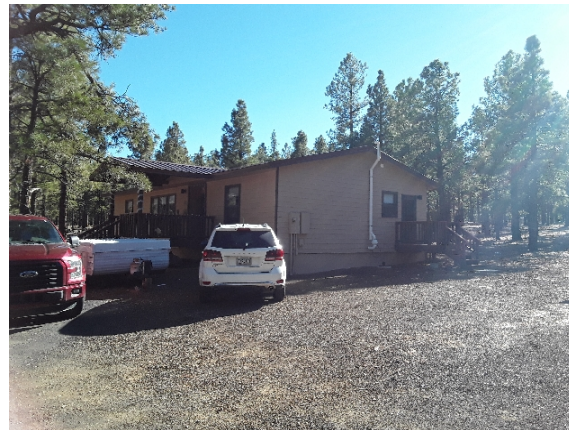
2020\_SUCR\_48526\_SUCR Mod # 2 (closest to gas pumps)\_Z.jpg

**Score: 36**  
**Rating: Low**

| | | Individual Facility | Initial | 1 | Mow dead/dying grass to less than 4 inches | | 1.0 |
| | | Individual Facility | Initial | 1 | Roof and gutters should be cleared of vegetative debris | | 1.0 |

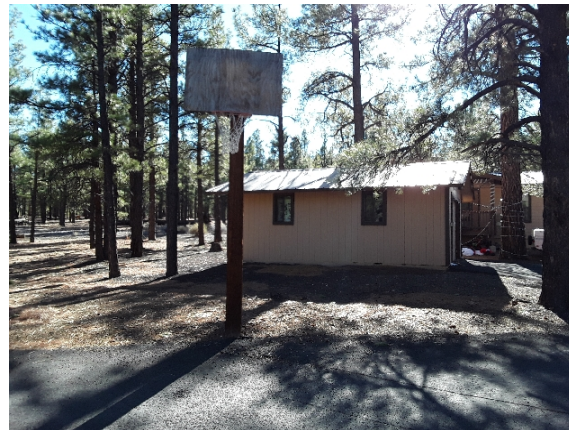
2020\_SUCR\_113350\_SUCR Mod # 2 Detached Garage\_Front.jpg

Score: 27  
Rating: Low

| 14 | SUCR Mod # 2 Detached Garage | Individual Facility | Initial | 1 | Roof and gutters should be cleared of vegetative debris | | 1.0 |
| | | Individual Facility | Initial | 2 | Remove dead or dying component of shrubs and trees | | 5.0 |

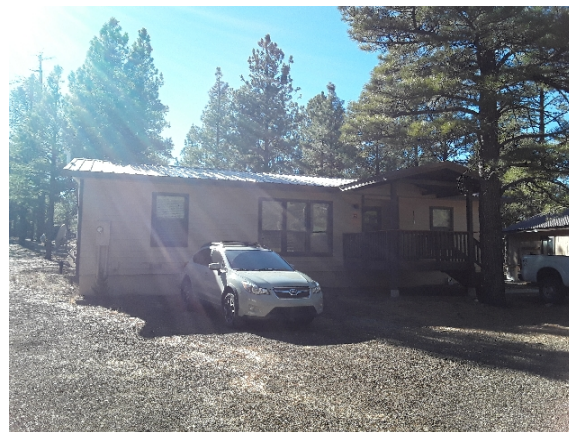
2020\_SUCR\_82933\_SUCR Mod # 7\_Z.jpg

Score: 30  
Rating: Low

| | | Individual Facility | Initial | 1 | Mow dead/dying grass to less than 4 inches | | 1.0 |
| | | Individual Facility | Initial | 1 | Roof and gutters should be cleared of vegetative debris | | 1.0 |

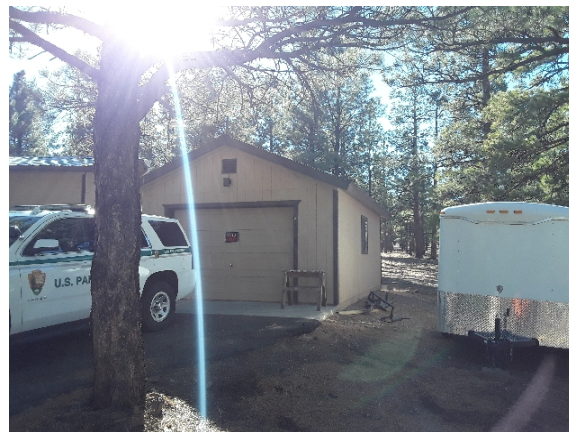
2020\_SUCR\_82933\_SUCR Mod # 7 Garage\_Z.jpg

Score: 21  
Rating: Low

| 16 | SUCR Mod # 7 Garage | Individual Facility | Initial | 1 | Limb trees 6 to 15 feet above ground | | 2.0 |
| | | Individual Facility | Initial | 1 | Mow dead/dying grass to less than 4 inches | | 1.0 |
| | | Individual Facility | Initial | 1 | Open crown spacing 10 to 30 feet depending on slope | | 8.0 |
| | | Individual Facility | Initial | 1 | Roof and gutters should be cleared of vegetative debris | | 1.0 |

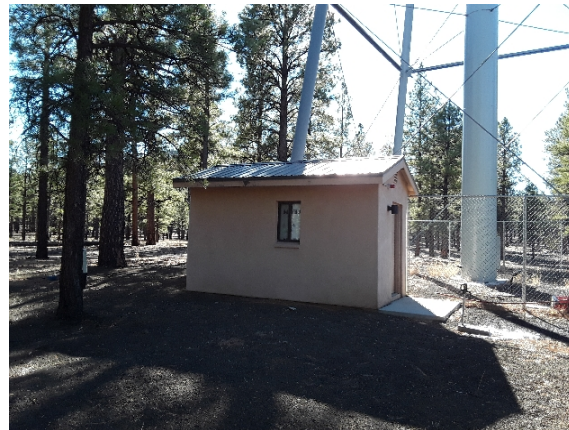
2020\_SUCR\_48439\_SUCR Pump House Building\_Z.jpg

Score: 50  
Rating: Moderate

| 17 | SUCR Pump House Building | Individual Facility | Initial | 1 | Limb trees 6 to 15 feet above ground | | 1.0 |

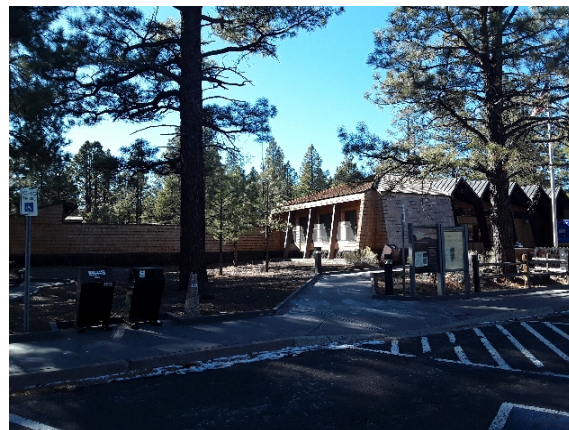
2020\_SUCR\_48424\_SUCR Visitor Center\_Front.jpg

Score: 66  
Rating: High

| 18 | SUCR Visitor Center | Individual Facility | Initial | 1 | Clear adjacent and overhanging fuels to create 10 feet spacing between canopy and structure or chimney openings | | 4.0 |
| | | Individual Facility | Initial | 1 | Mow dead/dying grass to less than 4 inches | | 1.0 |
| | | Individual Facility | Initial | 2 | Open crown spacing 10 to 30 feet depending on slope | | 24.0 |
