# Capulin Volcano

## CAVO - Capulin Volcano National Monument

# NPS Wildland Fire Risk Assessment - Facility Assessment

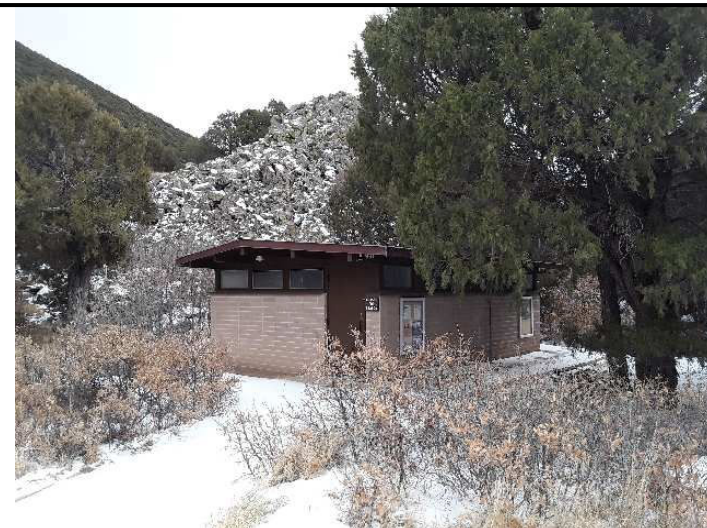
**Comments:** no water due to a burst in a water line

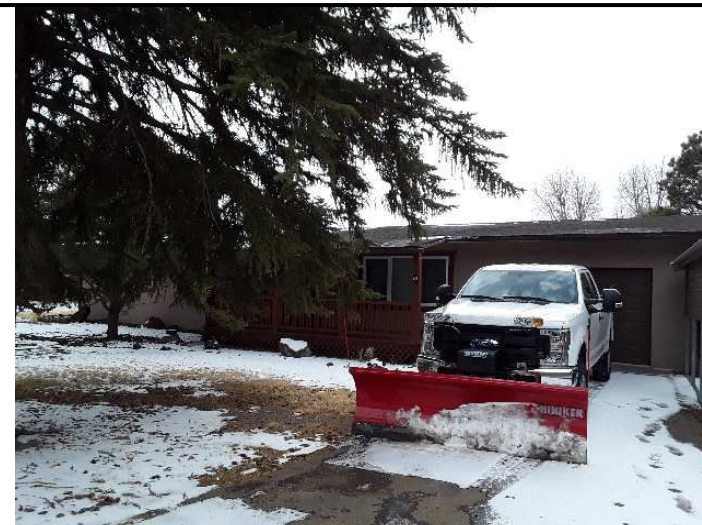
**Comments:** Hydrants are gravity fed, not fully pressurized.  
Propane tanks near south end of Visitor Center parking lot.  
no water due to water line leak

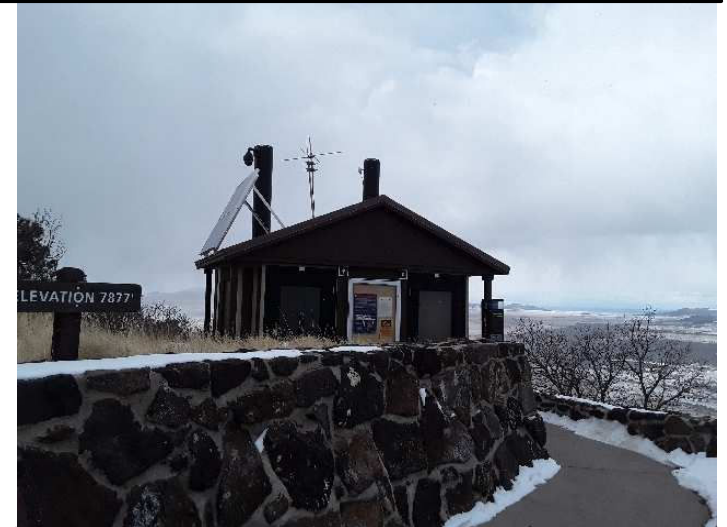
**Comments:** all water shut off due to pipe burst

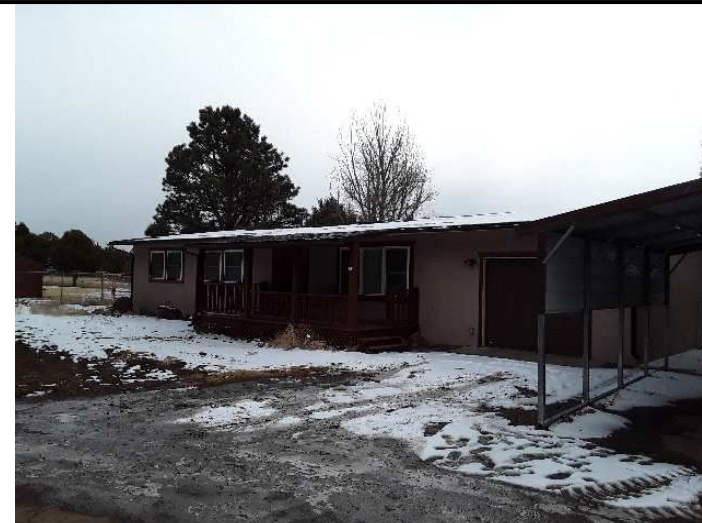
**Comments:** Hydrants are gravity fed, not fully pressurized.

no water due to water line leak

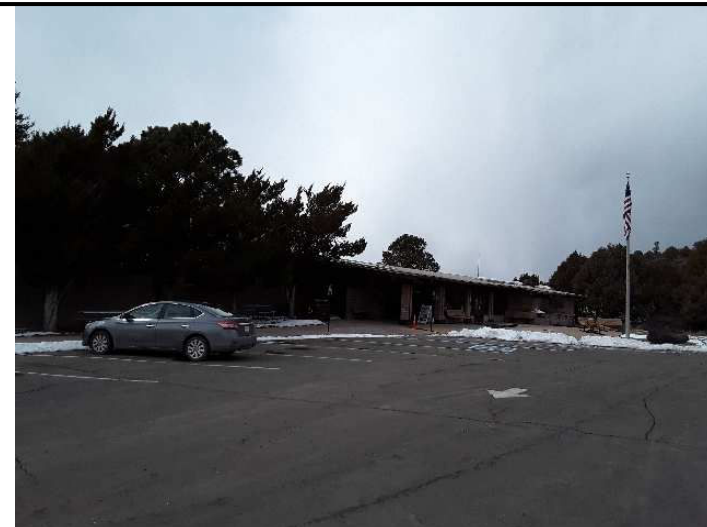
**Comments:** Hydrants are gravity fed, not fully pressurized.

water line leak no water

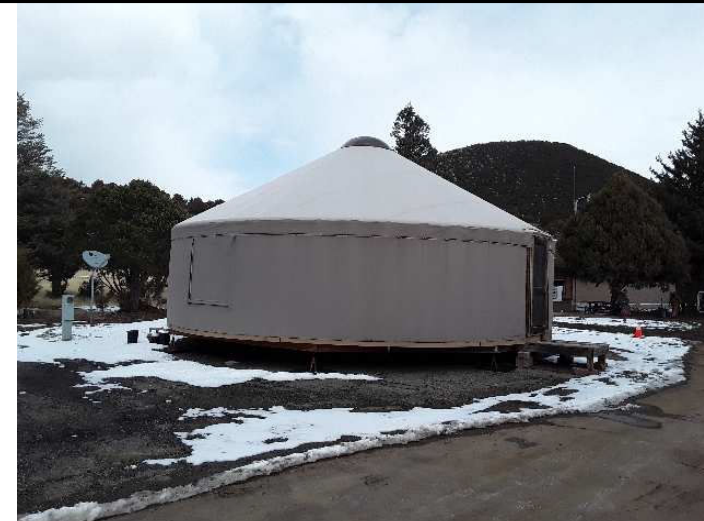
**Firewood:** None  
**Water Supply:** Limited or dependent on electricity  
**Propane:** None  
**Overhead Hazards:** No overhead hazards  
**Comments:** "Not Ready" per FMSS. Hydrants are gravity fed, not fully pressurized. Propane tanks near south end of Visitor Center parking lot.
