# NPS Wildfire Risk Assessments Assessment Locations

# Stevens Creek

## CURE - Curecanti National Recreation Area

# NPS Wildand Fire Risk Assessment - Facility Assessment

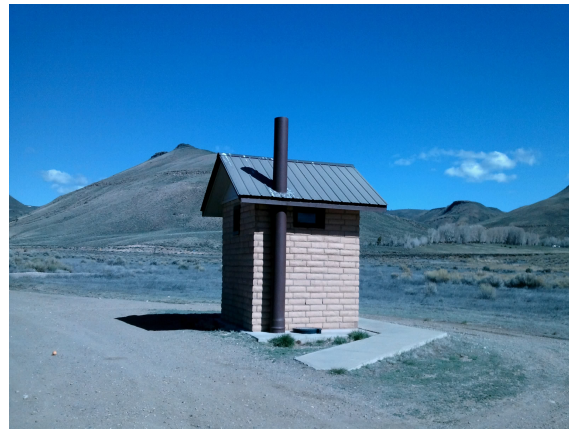
CURE\_75468\_North Willow Comfort Station\_Front.jpg

Rating: Low

Defensible Space: >100ft treated

Assessment Comments: Reliable water source near by is the lake.

Score: 22  
Rating: Low

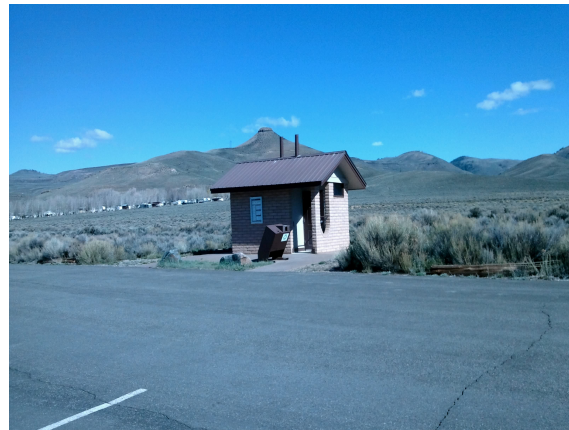
CURE\_75471\_Old Stevens Comfort Station\_Front.jpg

Rating: Low

Defensible Space: <30 ft treated

Score: 39  
Rating: Low

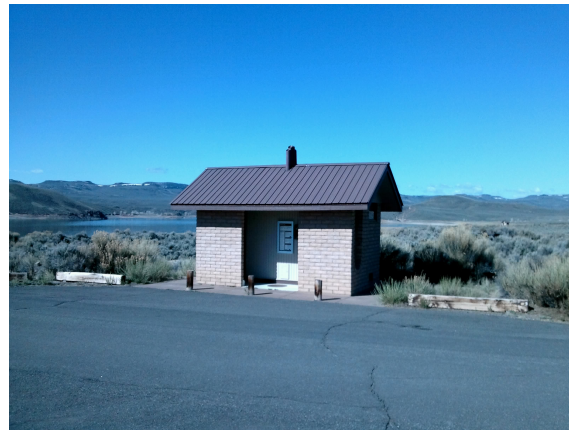
CURE\_75010\_Stevens Creek Loop C Comfort Station\_Front.jpg

**Rating:** Moderate

**Facility Number/Sign:** None or not clearly visible

**Defensible Space:** <30 ft treated

**Water Supply:** Limited or dependent on electricity

**Score: 46**  
**Rating: Moderate**

**Assessment Comments:** all treatments and tactics will be the same as water craft inspection facility

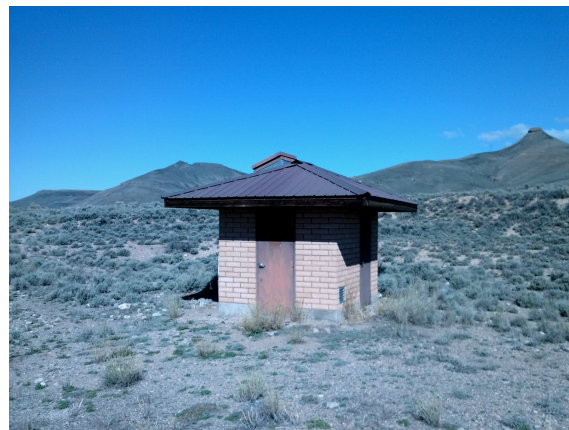
CURE\_75019\_Stevens Creek Pumphouse\_Front.jpg

**Rating:** Moderate

**Facility Number/Sign:** None or not clearly visible

**Defensible Space:** <30 ft treated

**Water Supply:** Limited or dependent on electricity

**Score: 45**  
**Rating: Moderate**

**Assessment Comments:** create community / all treatments and tactics will be the same as water craft inspection facility

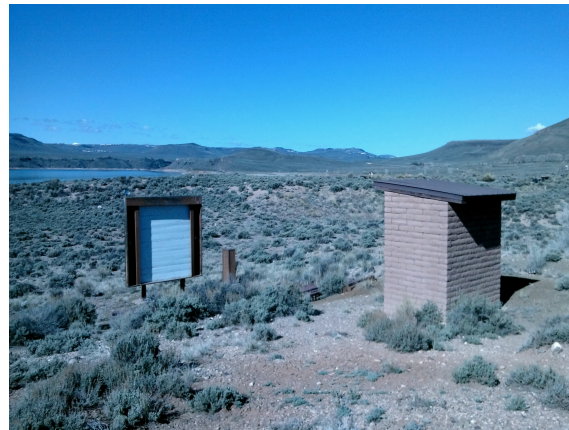
CURE\_\_Stevens Creek Ampitheatre\_Front.jpg

**Rating:** High

**Defensible Space:** No defensible space

**Roof Material:** Combination of fire resisitant and combustible

**Siding Material:** Wood or open sided

**Foundation:** Closed, < 6in masonry exposed

**Score: 72**  
**Rating: High**

**Assessment Comments:** create a community for this area. treatments and tactics at watercraft inspection station.

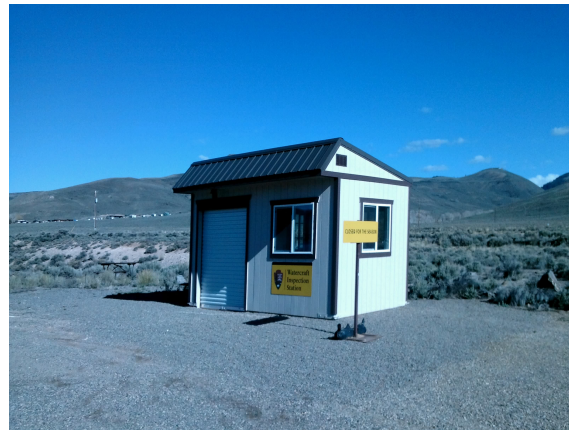
CURE\_Stevens Creek Watercraft Inspection Station\_Front.jpg

Rating: Low

Defensible Space: 30 ft treated

Siding Material: Wood or open sided

Water Supply: Limited or dependent on electricity

Score: 36  
Rating: Low

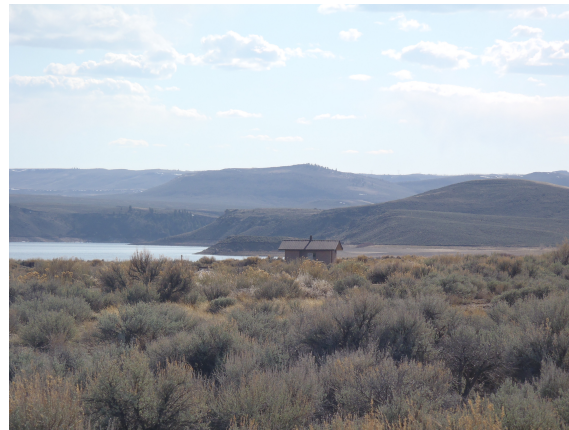
2015\_CURE\_75013\_Stevens Creek Fish Cleaning Station\_Z.jpg

**Rating:** Low

**Defensible Space:** <30 ft treated

**Score: 39**  
**Rating: Low**

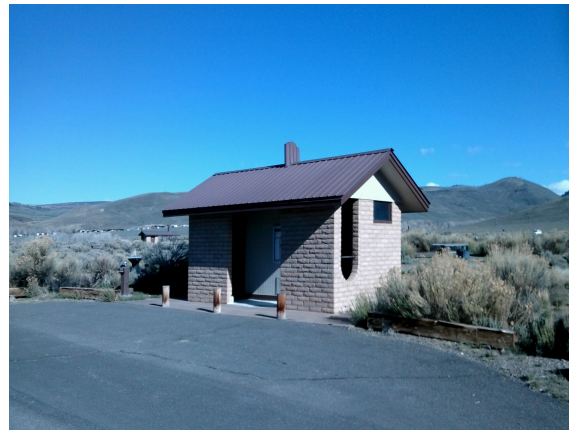
CURE\_75001\_Stevens Creek Loop B Comfort Station\_Front.jpg

**Rating:** Moderate

**Facility Number/Sign:** None or not clearly visible

**Defensible Space:** <30 ft treated

**Water Supply:** Limited or dependent on electricity

**Score: 46**  
**Rating: Moderate**

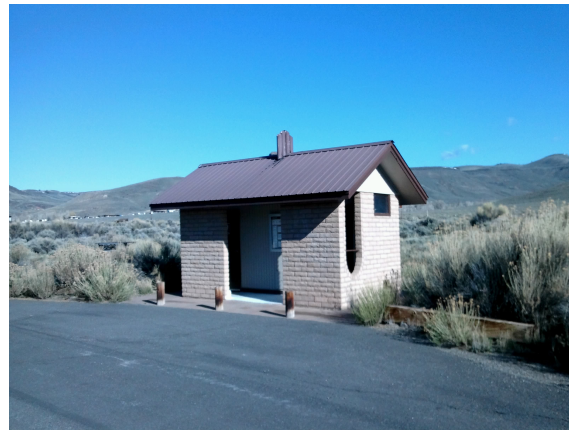
CURE\_74991\_Stevens Creek Loop A Comfort Station\_Front.jpg

**Rating:** Moderate

**Facility Number/Sign:** None or not clearly visible

**Defensible Space:** <30 ft treated

**Fuel Load (w/in 300 ft):** Moderate

**Water Supply:** Limited or dependent on electricity

**Score: 54**  
**Rating: Moderate**
