# NPS Wildfire Risk Assessments Assessment Locations

## Amistad National Recreation Area

# NPS Wildand Fire Risk Assessment - Facility Assessment

## Facility: Museum Storage Facility

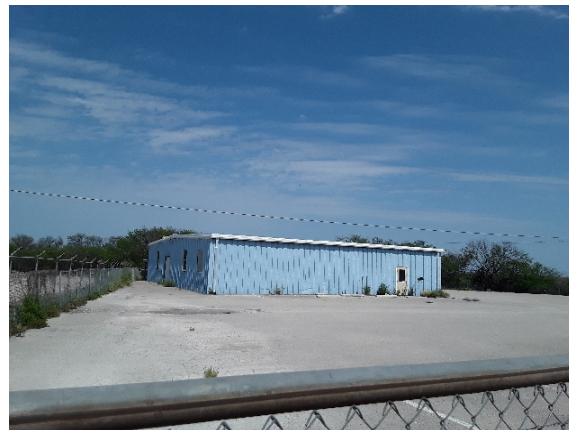
2021\_AMIS\_99070\_Museum Storage Facility\_Front.jpg

Defensible Space: 100 ft treated

Fuel Load (w/in 300 ft): Moderate

Fuel Type (w/in 300ft): Grass,shrub,hardwood litter

Score: 14  
Rating: Low
