NPS Wildfire Risk Assessment Project

# Arbuckle Dam

CHIC - Chickasaw National Recreation Area

# NPS Wildand Fire Risk Assessment - Facility Assessment

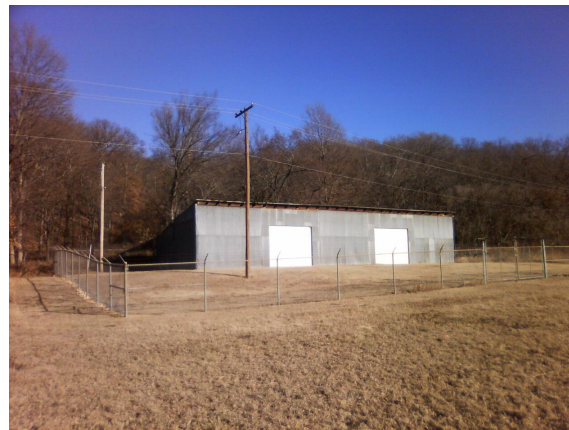
CHIC\_\_Equipment Storage\_Front.jpg

**Rating:** Moderate

**Defensible Space:** <30 ft treated

**Water Supply:** No reliable water source nearby

**Assessment Comments:** fenced off gated not pictures

**Score: 59**  
**Rating: Moderate**

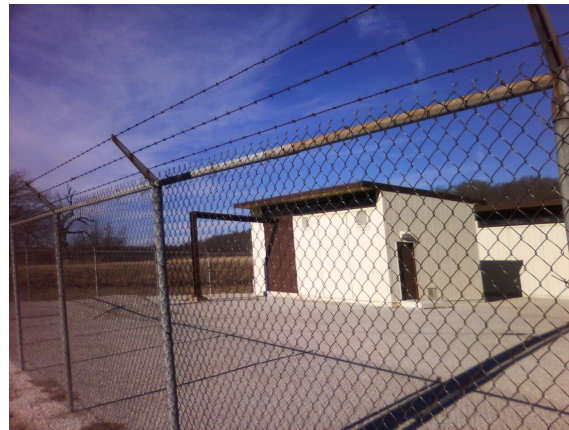
CHIC\_\_Dam Building\_Front.jpg

**Assessment Comments:** Treatments and tactics included in adjacent structure. fenced off no pictures

**Score: 39**  
**Rating: Low**

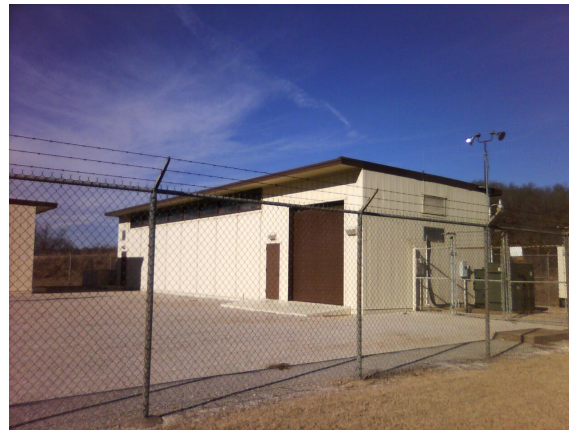
CHIC\_\_Dam Building\_Front.jpg

**Foundation:** Open or deck

**Assessment Comments:** fenced off no pictures

**Score: 40**  
**Rating: Low**

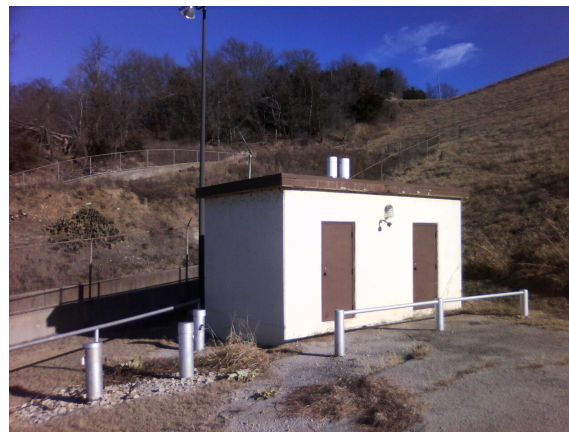
CHIC\_\_Dam Control Building\_Front.jpg

**Defensible Space:** <30 ft treated

**Assessment Comments:** fenced off no pictures

**Score: 48**  
**Rating: Moderate**

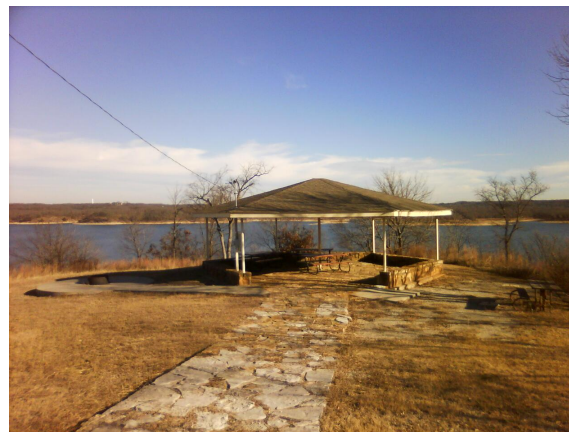
CHIC\_Picnic Shelter\_Front.jpg

**Rating:** High

**Defensible Space:** <30 ft treated

**Fuel Load (w/in 300 ft):** Moderate

**Topography (w/in 300ft):** Slope 31% to 40%

**Siding Material:** Wood or open sided

**Water Supply:** No reliable water source nearby

**Overhead Hazards:** Overhead hazards will limit aircraft

**Assessment Comments:** fenced off gated no pictures

**Score: 76**  
**Rating: High**
