# NPS Wildfire Risk Assessments Assessment Locations

## CHCU - Chaco Culture National Historical Park Overview

NPS Wildfire Risk Assessment Project

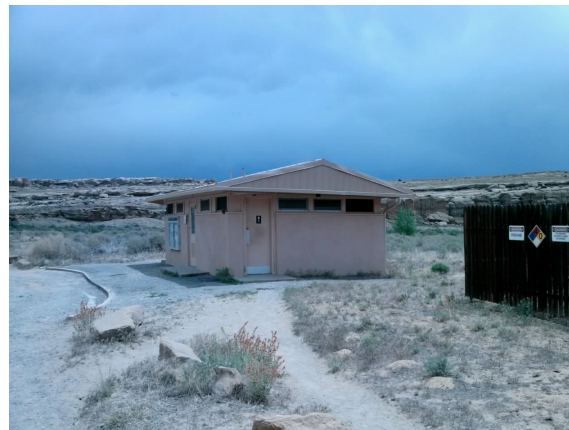
2018\_CHCU\_102023\_Comfort Station\_Front.jpg

**Primary Access:** Road  
**Ingress/Egress:** One roads in/out  
**Access Width:** 1 lane (<18ft)  
**Access Condition:** Non-surfaced- gravel,dirt,grade<5%

**Bridge Condition:** None/nonflammable,load limit will not limit response  
**Access & Turnarounds:** Access is >300 ft from facility w/turnaround  
**Facility Number/Sign:** None or not clearly visible

**Roof Material:** Noncombustible or not applicable  
**Siding Material:** Rock, concrete, metal  
**Foundation:** Closed, >30in masonry exposed or N/A

**Overhead Hazards:** No overhead hazards  
**Safety Zones:** Potential safety zone(s) in area  
**Additional Obstacles:** None  
**Triage Category:**  
**Hazmat:**

**Assessment Comments:** not accessible

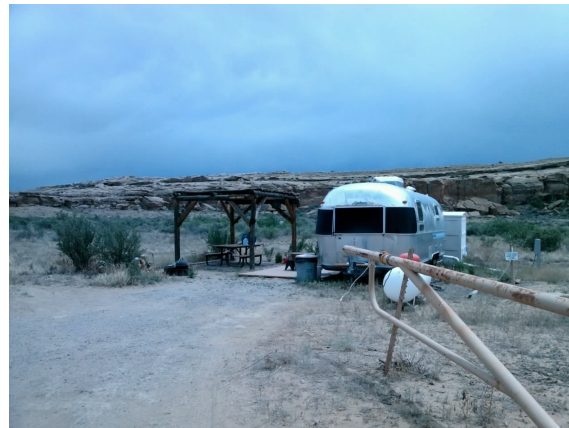
2018\_CHCU\_71895\_Campground Host Trailer\_Front.jpg

**Primary Access:** Road  
**Ingress/Egress:** One roads in/out  
**Access Width:** 1.5 lanes (>18ft)  
**Access Condition:** Non-surfaced- gravel,dirt,grade<5%

**Bridge Condition:** None/nonflammable,load limit will not limit response  
**Access & Turnarounds:** Access is <300 ft from facility w/o turnaround  
**Facility Number/Sign:** None or not clearly visible

**Roof Material:** Noncombustible or not applicable  
**Siding Material:** Rock, concrete, metal  
**Foundation:** Open or deck  
**Fences/Decks:** None or noncombustible

**Firewood:** None  
**Propane Tanks:** Present and fuels clearance  
**Water Supply:** Limited or dependent on electricity  
**Overhead Hazards:** No overhead hazards

**Safety Zones:** Potential safety zone(s) in area  
**Additional Obstacles:** None  
**Triage Category:**  
**Hazmat:**  
**Assessment Comments:** entry prohibited

**Score: 53**  
**Rating: Moderate**

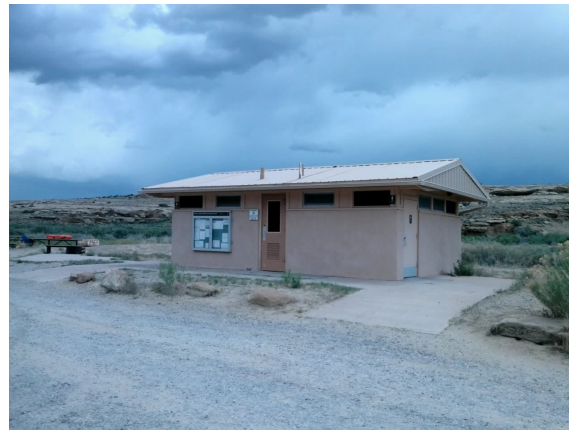
2018\_CHCU\_102022\_Gallo Campground RV Restrooms\_Front.jpg

**Primary Access:** Road  
**Ingress/Egress:** One roads in/out  
**Access Width:** 1 lane (<18ft)  
**Access Condition:** Non-surfaced- gravel,dirt,grade<5%

**Bridge Condition:** None/nonflammable,load limit will not limit response  
**Access & Turnarounds:** Access is >300 ft from facility w/turnaround  
**Facility Number/Sign:** None or not clearly visible

**Roof Material:** Noncombustible or not applicable  
**Siding Material:** Rock, concrete, metal  
**Foundation:** Closed, >30in masonry exposed or N/A

**Overhead Hazards:** No overhead hazards  
**Safety Zones:** Potential safety zone(s) in area  
**Additional Obstacles:** None  
**Triage Category:**  
**Hazmat:**

**Assessment Comments:** not accessible

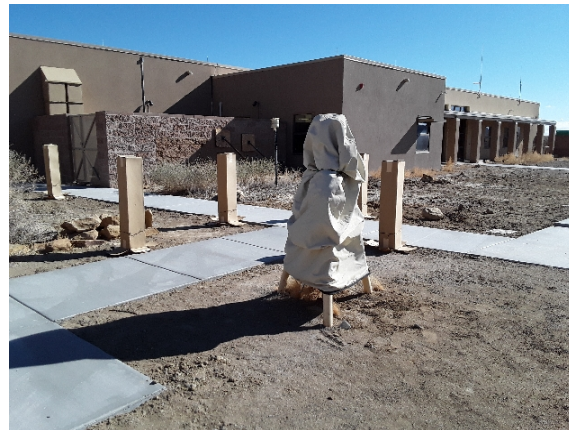
2021\_CHCU\_not found \_Telescope\_Front.jpg

**Primary Access:** Road  
**Ingress/Egress:** One roads in/out  
**Access Width:** 1.5 lanes (>18ft)  
**Access Condition:** Non-surfaced- gravel,dirt,grade<5%

**Bridge Condition:** None/nonflammable,load limit will not limit response  
**Access & Turnarounds:** Access is <300 ft from facility w/o turnaround  
**Facility Number/Sign:** None or not clearly visible

**Roof Material:** Fire resistant- tar,rubberized  
**Siding Material:** Rock, concrete, metal  
**Foundation:** Closed, < 6in masonry exposed  
**Fences/Decks:** None or noncombustible

**Firewood:** None  
**Propane Tanks:** None  
**Water Supply:** Limited or dependent on electricity  
**Overhead Hazards:** No overhead hazards  
**Safety Zones:** No safety zone(s) in area

**Additional Obstacles:** Hazmat, UXO,etc. , PLEASE COMMENT  
**Triage Category:**  
**Hazmat:**  
**Assessment Comments:**

**Score: 47**  
**Rating: Moderate**

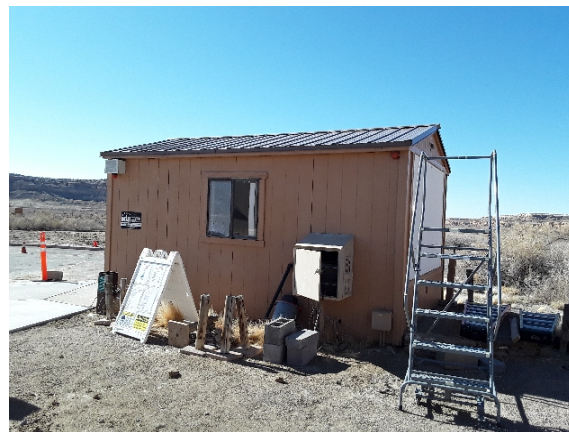
2021\_CHCU\_not found \_Ampitheatre\_Front.jpg

**Primary Access:** Road  
**Ingress/Egress:** One roads in/out  
**Access Width:** 1.5 lanes (>18ft)  
**Access Condition:** Non-surfaced- gravel,dirt,grade<5%

**Bridge Condition:** None/nonflammable,load limit will not limit response  
**Access & Turnarounds:** Access is <300 ft from facility w/o turnaround  
**Facility Number/Sign:** None or not clearly visible

**Roof Material:** Fire resistant- tar,rubberized  
**Siding Material:** Rock, concrete, metal  
**Foundation:** Closed, < 6in masonry exposed  
**Fences/Decks:** None or noncombustible

**Firewood:** None  
**Propane Tanks:** None  
**Water Supply:** Limited or dependent on electricity  
**Overhead Hazards:** No overhead hazards  
**Safety Zones:** No safety zone(s) in area

**Additional Obstacles:** Hazmat, UXO,etc. , PLEASE COMMENT  
**Triage Category:**  
**Hazmat:**  
**Assessment Comments:**

**Score: 54**  
**Rating: Moderate**

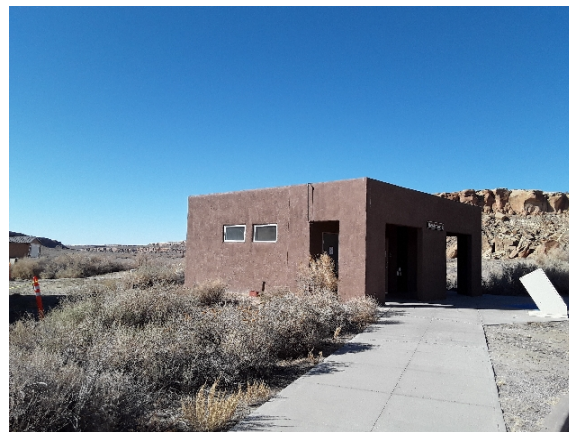
2021\_CHCU\_71930\_VC Restroom\_Front.jpg

**Primary Access:** Road  
**Ingress/Egress:** One roads in/out  
**Access Width:** 1.5 lanes (>18ft)  
**Access Condition:** Non-surfaced- gravel,dirt,grade<5%

**Bridge Condition:** None/nonflammable,load limit will not limit response  
**Access & Turnarounds:** Access is <300 ft from facility w/o turnaround  
**Facility Number/Sign:** Marked and clearly visible

**Roof Material:** Fire resistant- tar,rubberized  
**Siding Material:** Rock, concrete, metal  
**Foundation:** Closed, >30in masonry exposed or N/A  
**Fences/Decks:** None or noncombustible

**Firewood:** None  
**Propane Tanks:** None  
**Water Supply:** Limited or dependent on electricity  
**Overhead Hazards:** No overhead hazards  
**Safety Zones:** No safety zone(s) in area

**Additional Obstacles:** Hazmat, UXO,etc. , PLEASE COMMENT  
**Triage Category:**  
**Hazmat:**  
**Assessment Comments:**

**Score: 52**  
**Rating: Moderate**

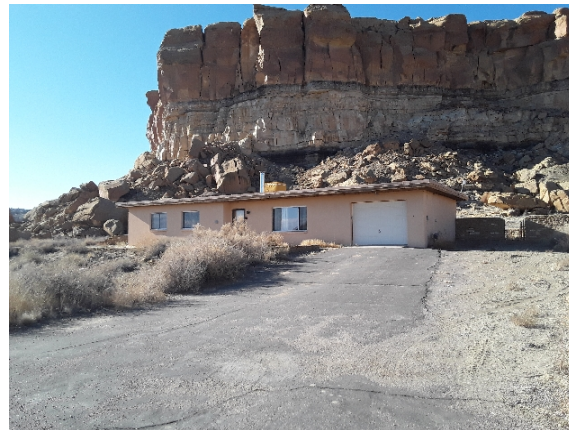
2021\_CHCU\_71912\_Residence 10\_Front.jpg

**Primary Access:** Road  
**Ingress/Egress:** One roads in/out  
**Access Width:** 1.5 lanes (>18ft)  
**Access Condition:** Non-surfaced- gravel,dirt,grade<5%

**Bridge Condition:** None/nonflammable,load limit will not limit response  
**Access & Turnarounds:** Access is <300 ft from facility w/o turnaround  
**Facility Number/Sign:** Marked and clearly visible

**Roof Material:** Fire resistant- tar,rubberized  
**Siding Material:** Rock, concrete, metal  
**Foundation:** Closed, >30in masonry exposed or N/A  
**Fences/Decks:** None or noncombustible

**Firewood:** None  
**Propane Tanks:** None  
**Water Supply:** Limited or dependent on electricity  
**Overhead Hazards:** No overhead hazards  
**Safety Zones:** No safety zone(s) in area

**Additional Obstacles:** Hazmat, UXO,etc. , PLEASE COMMENT  
**Triage Category:**  
**Hazmat:**  
**Assessment Comments:**

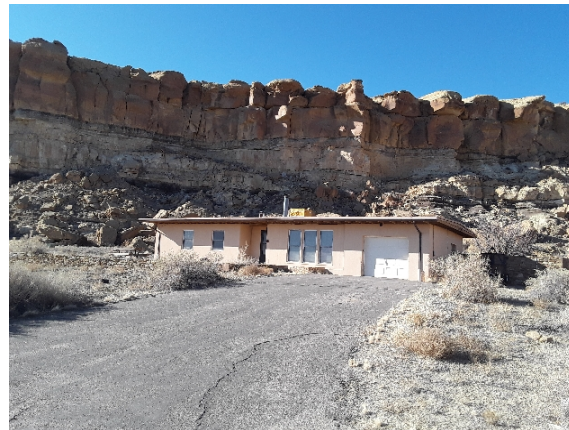
2021\_CHCU\_71911\_Residence 6\_Front.jpg

**Primary Access:** Road  
**Ingress/Egress:** One roads in/out  
**Access Width:** 1.5 lanes (>18ft)  
**Access Condition:** Non-surfaced- gravel,dirt,grade<5%

**Bridge Condition:** None/nonflammable,load limit will not limit response  
**Access & Turnarounds:** Access is <300 ft from facility w/o turnaround  
**Facility Number/Sign:** Marked and clearly visible

**Roof Material:** Fire resistant- tar,rubberized  
**Siding Material:** Rock, concrete, metal  
**Foundation:** Closed, >30in masonry exposed or N/A  
**Fences/Decks:** None or noncombustible

**Firewood:** 5ft to 30ft from facility  
**Propane Tanks:** None  
**Water Supply:** Limited or dependent on electricity  
**Overhead Hazards:** No overhead hazards

**Safety Zones:** No safety zone(s) in area  
**Additional Obstacles:** Hazmat, UXO,etc. , PLEASE COMMENT  
**Triage Category:**  
**Hazmat:**  
**Assessment Comments:**

**Score: 50**  
**Rating: Moderate**

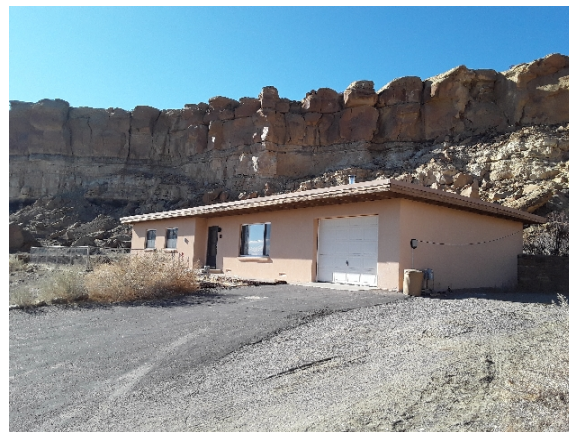
2021\_CHCU\_72090\_Residence 11\_Front.jpg

**Primary Access:** Road  
**Ingress/Egress:** One roads in/out  
**Access Width:** 1.5 lanes (>18ft)  
**Access Condition:** Non-surfaced- gravel,dirt,grade<5%

**Bridge Condition:** None/nonflammable,load limit will not limit response  
**Access & Turnarounds:** Access is <300 ft from facility w/o turnaround  
**Facility Number/Sign:** Marked and clearly visible

**Roof Material:** Fire resistant- tar,rubberized  
**Siding Material:** Rock, concrete, metal  
**Foundation:** Closed, >30in masonry exposed or N/A  
**Fences/Decks:** None or noncombustible

**Firewood:** None  
**Propane Tanks:** None  
**Water Supply:** Limited or dependent on electricity  
**Overhead Hazards:** No overhead hazards  
**Safety Zones:** No safety zone(s) in area

**Additional Obstacles:** Hazmat, UXO,etc. , PLEASE COMMENT  
**Triage Category:**  
**Hazmat:**  
**Assessment Comments:**

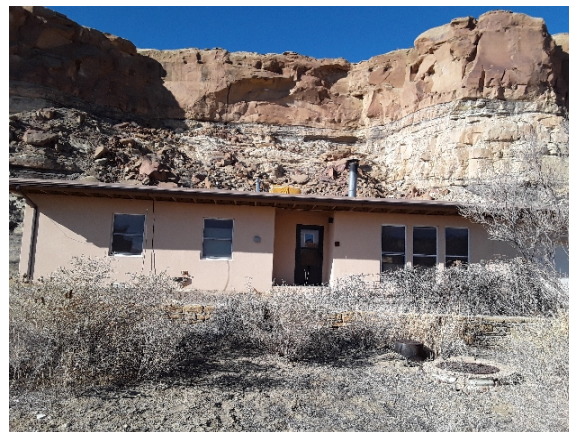
2021\_CHCU\_71909\_Residence 7\_Front.jpg

**Primary Access:** Road  
**Ingress/Egress:** One roads in/out  
**Access Width:** 1.5 lanes (>18ft)  
**Access Condition:** Non-surfaced- gravel,dirt,grade<5%

**Bridge Condition:** None/nonflammable,load limit will not limit response  
**Access & Turnarounds:** Access is <300 ft from facility w/o turnaround  
**Facility Number/Sign:** Marked and clearly visible

**Roof Material:** Fire resistant- tar,rubberized  
**Siding Material:** Rock, concrete, metal  
**Foundation:** Closed, < 6in masonry exposed  
**Fences/Decks:** Combustible but separated from facility

**Firewood:** None  
**Propane Tanks:** None  
**Water Supply:** Limited or dependent on electricity  
**Overhead Hazards:** No overhead hazards  
**Safety Zones:** No safety zone(s) in area

**Additional Obstacles:** Hazmat, UXO,etc. , PLEASE COMMENT  
**Triage Category:**  
**Hazmat:**  
**Assessment Comments:**

**Score: 52**  
**Rating: Moderate**

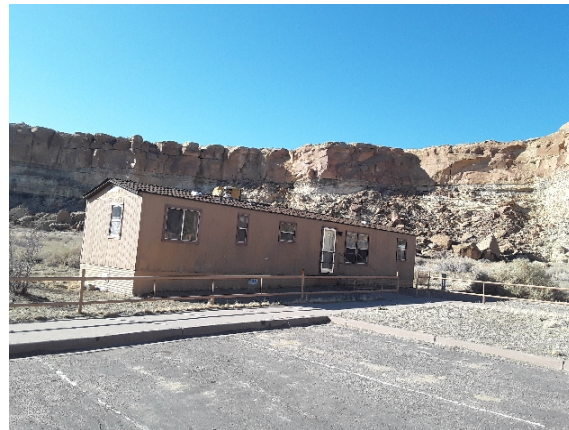
2021\_CHCU\_71918\_Apartment B\_Front.jpg

**Primary Access:** Road  
**Ingress/Egress:** One roads in/out  
**Access Width:** 1.5 lanes (>18ft)  
**Access Condition:** Non-surfaced- gravel,dirt,grade<5%

**Bridge Condition:** None/nonflammable,load limit will not limit response  
**Access & Turnarounds:** Access is <300 ft from facility w/o turnaround  
**Facility Number/Sign:** Marked and clearly visible

**Roof Material:** Fire resistant- tar,rubberized  
**Siding Material:** Rock, concrete, metal  
**Foundation:** Closed, >30in masonry exposed or N/A  
**Fences/Decks:** None or noncombustible

**Firewood:** None  
**Propane Tanks:** None  
**Water Supply:** Limited or dependent on electricity  
**Overhead Hazards:** No overhead hazards  
**Safety Zones:** No safety zone(s) in area

**Additional Obstacles:** Hazmat, UXO,etc. , PLEASE COMMENT  
**Triage Category:**  
**Hazmat:**  
**Assessment Comments:**

**Score: 48**  
**Rating: Moderate**  
**Asset Priority Index (API): 30**

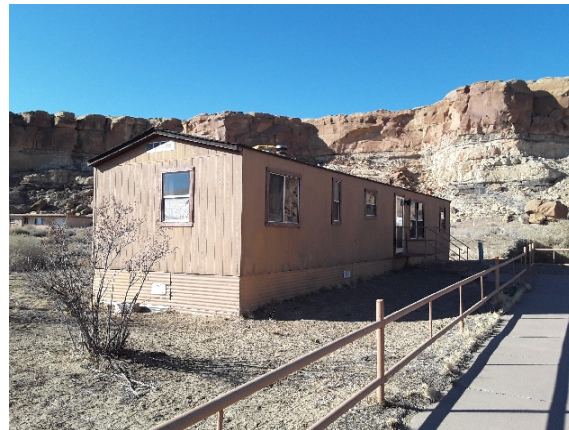
2021\_CHCU\_71913\_Trailer 2\_Front.jpg

**Primary Access:** Road  
**Ingress/Egress:** One roads in/out  
**Access Width:** 1.5 lanes (>18ft)  
**Access Condition:** Non-surfaced- gravel,dirt,grade<5%

**Bridge Condition:** None/nonflammable,load limit will not limit response  
**Access & Turnarounds:** Access is <300 ft from facility w/o turnaround  
**Facility Number/Sign:** Marked and clearly visible

**Roof Material:** Fire resistant- tar,rubberized  
**Siding Material:** Wood or open sided  
**Foundation:** Closed, < 6in masonry exposed  
**Fences/Decks:** None or noncombustible

**Firewood:** None  
**Propane Tanks:** None  
**Water Supply:** Limited or dependent on electricity  
**Overhead Hazards:** No overhead hazards  
**Safety Zones:** No safety zone(s) in area

**Additional Obstacles:** Hazmat, UXO,etc. , PLEASE COMMENT  
**Triage Category:**  
**Hazmat:**  
**Assessment Comments:**

**Score: 54**  
**Rating: Moderate**

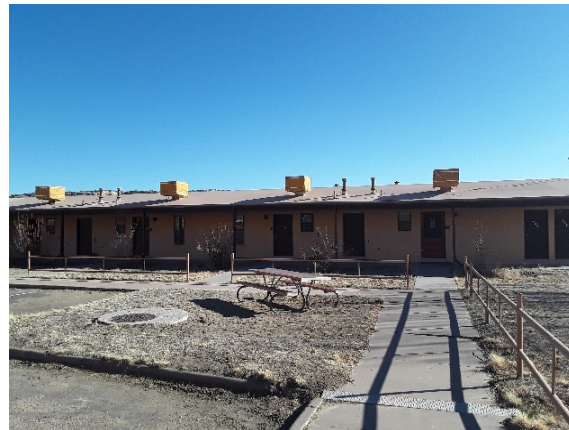
2021\_CHCU\_71915\_Apartment A\_Front.jpg

**Primary Access:** Road  
**Ingress/Egress:** One roads in/out  
**Access Width:** 1.5 lanes (>18ft)  
**Access Condition:** Non-surfaced- gravel,dirt,grade<5%

**Bridge Condition:** None/nonflammable,load limit will not limit response  
**Access & Turnarounds:** Access is <300 ft from facility w/o turnaround  
**Facility Number/Sign:** Marked and clearly visible

**Roof Material:** Fire resistant- tar,rubberized  
**Siding Material:** Rock, concrete, metal  
**Foundation:** Closed, >30in masonry exposed or N/A  
**Fences/Decks:** None or noncombustible

**Firewood:** None  
**Propane Tanks:** None  
**Water Supply:** Limited or dependent on electricity  
**Overhead Hazards:** No overhead hazards  
**Safety Zones:** No safety zone(s) in area

**Additional Obstacles:** Hazmat, UXO,etc. , PLEASE COMMENT  
**Triage Category:**  
**Hazmat:**  
**Assessment Comments:**

**Score: 48**  
**Rating: Moderate**  
**Asset Priority Index (API): 30**

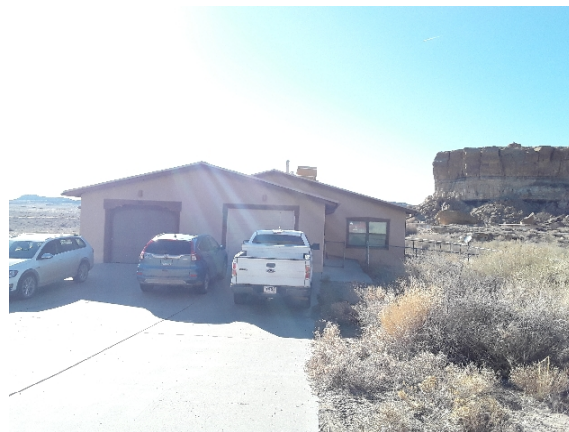
2021\_CHCU\_71921\_Duplex 12\_Front.jpg

**Primary Access:** Road  
**Ingress/Egress:** One roads in/out  
**Access Width:** 1.5 lanes (>18ft)  
**Access Condition:** Non-surfaced- gravel,dirt,grade<5%

**Bridge Condition:** None/nonflammable,load limit will not limit response  
**Access & Turnarounds:** Access is <300 ft from facility w/o turnaround  
**Facility Number/Sign:** Marked and clearly visible

**Roof Material:** Noncombustible or not applicable  
**Siding Material:** Rock, concrete, metal  
**Foundation:** Closed, >30in masonry exposed or N/A

**Fences/Decks:** None or noncombustible  
**Firewood:** None  
**Propane Tanks:** None  
**Water Supply:** Limited or dependent on electricity  
**Overhead Hazards:** No overhead hazards

**Safety Zones:** No safety zone(s) in area  
**Additional Obstacles:** Hazmat, UXO,etc. , PLEASE COMMENT  
**Triage Category:**  
**Hazmat:**  
**Assessment Comments:**

**Score: 55**  
**Rating: Moderate**  
**Asset Priority Index (API): 30**

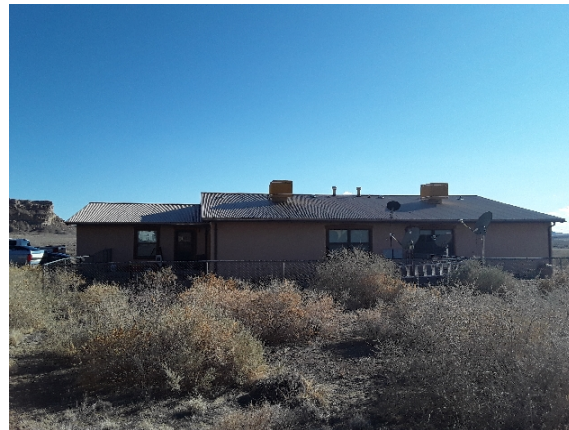
2021\_CHCU\_71925\_Duplex 14\_Front.jpg

**Primary Access:** Road  
**Ingress/Egress:** One roads in/out  
**Access Width:** 1.5 lanes (>18ft)  
**Access Condition:** Non-surfaced- gravel,dirt,grade<5%

**Bridge Condition:** None/nonflammable,load limit will not limit response  
**Access & Turnarounds:** Access is <300 ft from facility w/o turnaround  
**Facility Number/Sign:** Marked and clearly visible

**Roof Material:** Noncombustible or not applicable  
**Siding Material:** Rock, concrete, metal  
**Foundation:** Closed, >30in masonry exposed or N/A

**Fences/Decks:** None or noncombustible  
**Firewood:** None  
**Propane Tanks:** None  
**Water Supply:** Limited or dependent on electricity  
**Overhead Hazards:** No overhead hazards

**Safety Zones:** No safety zone(s) in area  
**Additional Obstacles:** Hazmat, UXO,etc. , PLEASE COMMENT  
**Triage Category:**  
**Hazmat:**  
**Assessment Comments:**

**Score: 55**  
**Rating: Moderate**

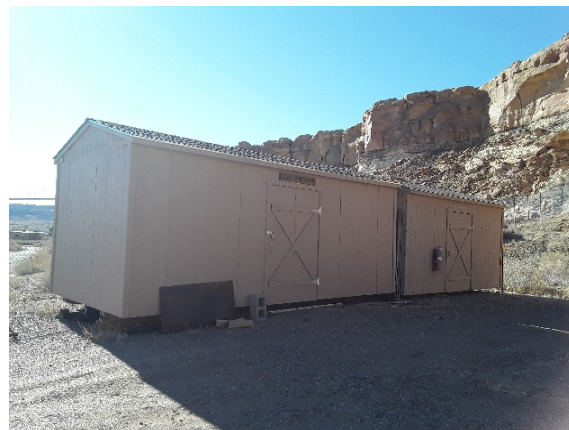
2021\_CHCU\_111413\_Ranger Fire Cashe\_Front.jpg

**Primary Access:** Road  
**Ingress/Egress:** One roads in/out  
**Access Width:** 1.5 lanes (>18ft)  
**Access Condition:** Non-surfaced- gravel,dirt,grade<5%

**Bridge Condition:** None/nonflammable,load limit will not limit response  
**Access & Turnarounds:** Access is <300 ft from facility w/o turnaround  
**Facility Number/Sign:** None or not clearly visible

**Firewood:** None  
**Propane Tanks:** None  
**Water Supply:** Limited or dependent on electricity  
**Overhead Hazards:** No overhead hazards  
**Safety Zones:** No safety zone(s) in area

**Additional Obstacles:** Hazmat, UXO,etc. , PLEASE COMMENT  
**Triage Category:**  
**Hazmat:**  
**Assessment Comments:**

**Score: 59**  
**Rating: Moderate**  
**Asset Priority Index (API):**  
**7**

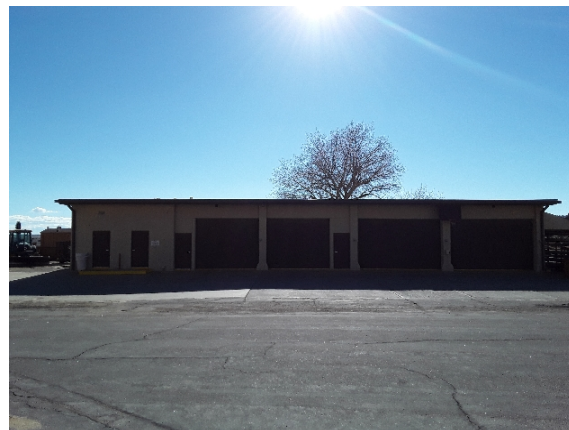
2021\_CHCU\_71949\_Maintenance Shop\_Front.jpg

**Safety Zones:** No safety zone(s) in area  
**Additional Obstacles:** Hazmat, UXO,etc. , PLEASE COMMENT  
**Triage Category:**  
**Hazmat:** fuel station nearby

**Score: 38**  
**Rating: Low**
