# NPS Wildfire Risk Assessments Assessment Locations

# Bandelier National Monument - Entrance Area - Entrance Road

# NPS Wildand Fire Risk Assessment - Facility Wildfire Risk Assessment Summary

## Unit - Location: BAND - Entrance Area/Road

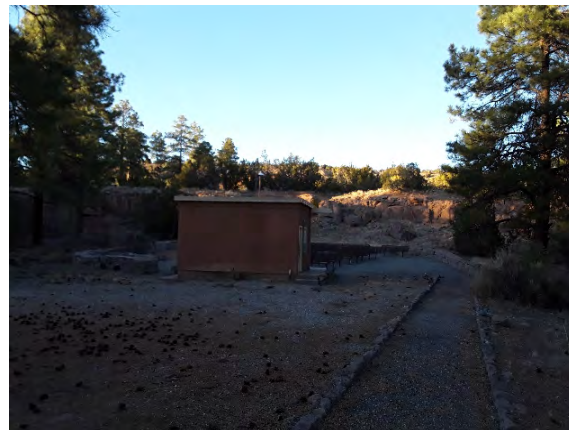
2020\_BAND\_91182\_B 58 Amphitheater AV Building / Speaker house\_Front

Score: 53  
Rating: Moderate

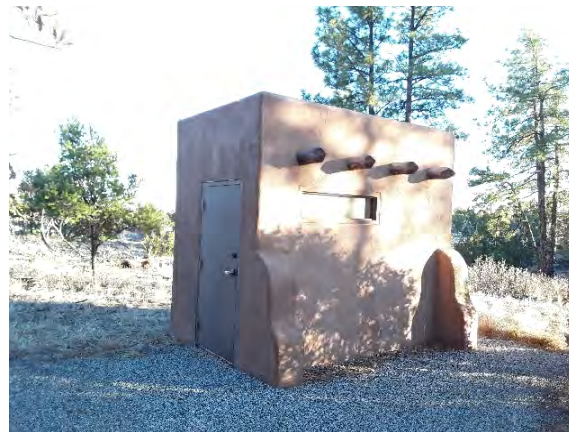
2020\_BAND\_searched not found\_ENTRANCE STATION RESTROOM\_Front

Assessment Comments: no treatment needed stand alone

Score: 42  
Rating: Low

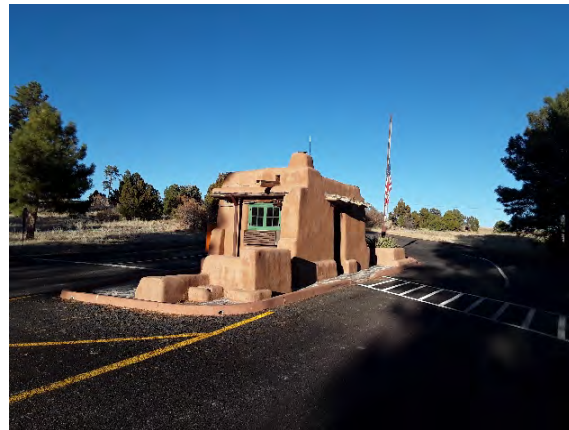
Photo 1.jpg

Assessment Comments: no treatment needed stand alone

Score: 34  
Rating: Low

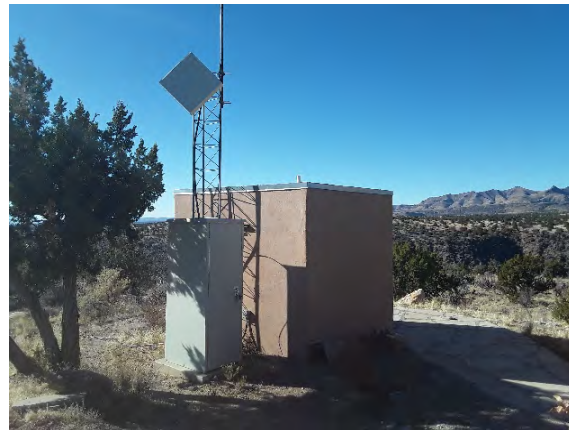
2020\_BAND\_31646\_HB-30FIRETOWER\_Front

**Score: 52** **Asset Priority Index (API): 76**  
**Rating: Moderate**

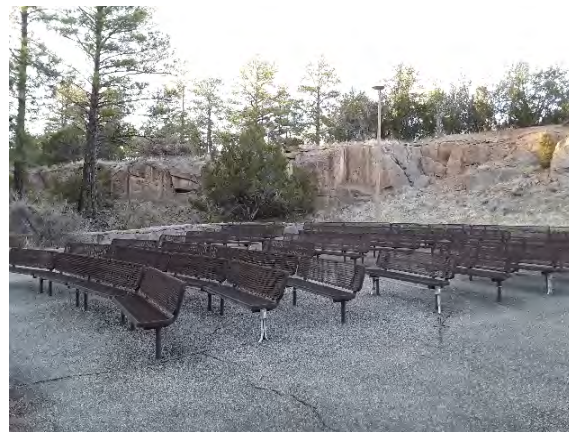
2020\_BAND\_31622\_AMPHITHEATER\_Front

**Score: 58**  
**Rating: Moderate**  
**Asset Priority Index (API):**  
N/A

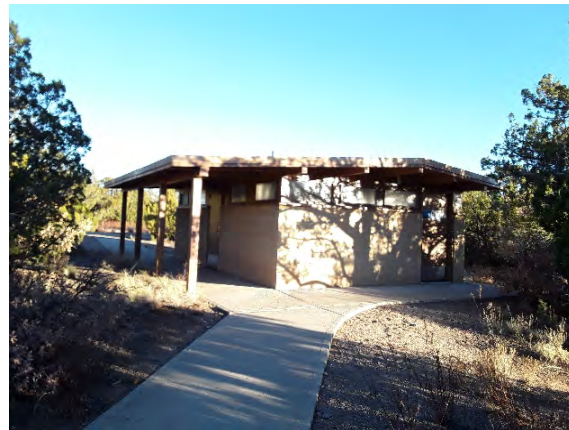
2020\_BAND\_5324\_B-66 Comfort Station\_Front

**Score: 68**  
**Rating: High**

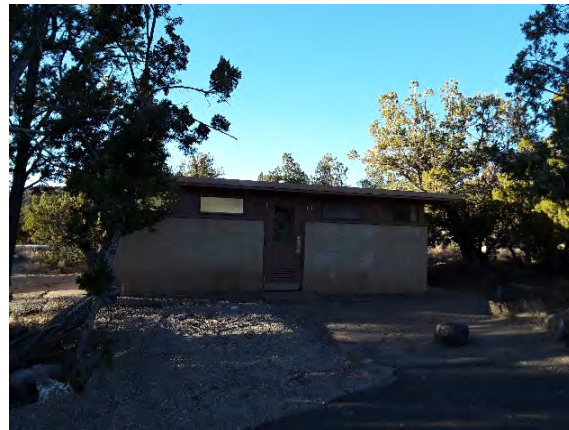
2020\_BAND\_5323\_B-65 Comfort Station\_Front

**Score: 68**  
**Rating: High**

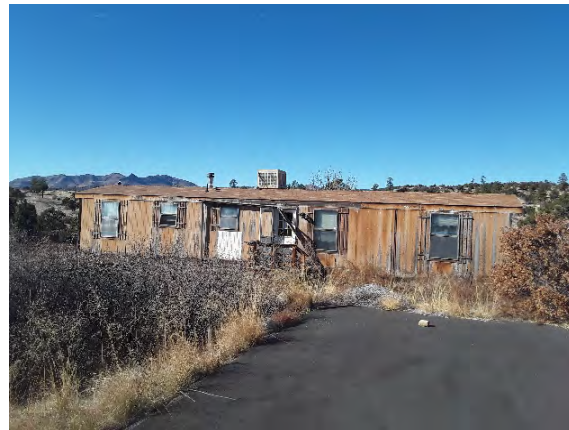
2020\_BAND\_103786\_FUMOOFFICEMH129\_Front

**Triage Category:**  
**Hazmat:** FUELS  
**Assessment Comments:**

**Score: 68**  
**Rating: High**

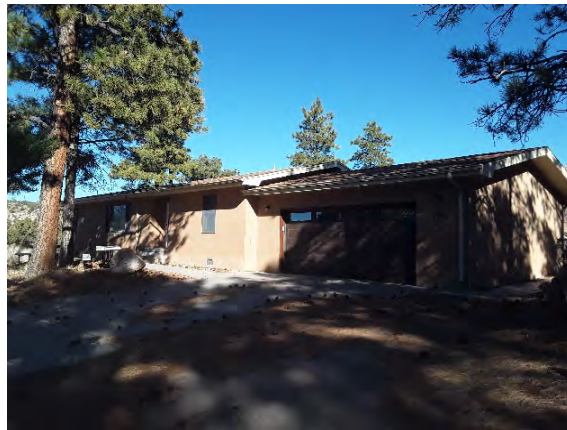
2020\_BAND\_31585\_Quarters 56\_Front

**Siding Material:** Rock, concrete, metal  
**Foundation:** Closed, < 6in masonry exposed  
**Fences/Decks:** None or noncombustible  
**Firewood:** 5ft to 30ft from facility

**Score: 59**  
**Rating: Moderate**  
**Asset Priority Index (API): 40**

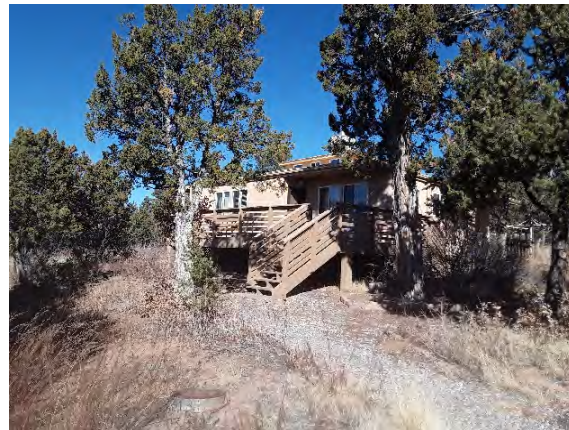
2020\_BAND\_31586\_Quarters 102\_Front

Score: 35  
Rating: Low

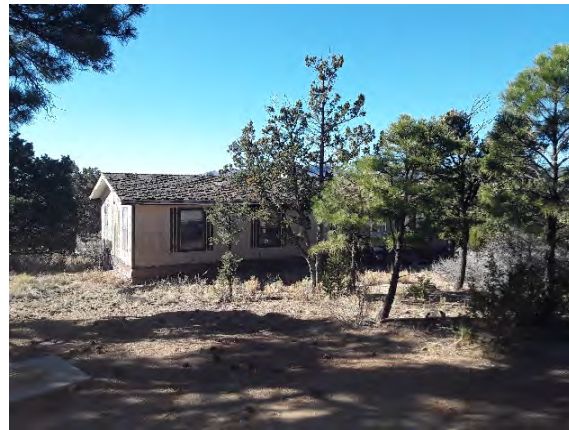
2020\_BAND\_97526\_FEMOOFFICEMH128\_Front

**Score: 61**  
**Rating: Moderate**  
**Asset Priority Index (API):**  
**0**

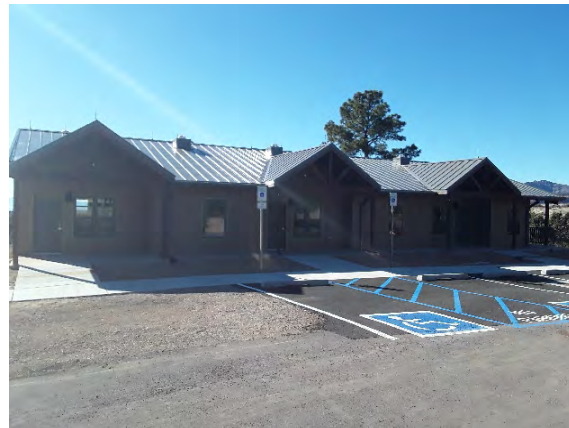
2020\_BAND\_97527\_Quarters MH-127 , 00000127\_Front

**Siding Material:** Wood or open sided  
**Foundation:** Closed, < 6in masonry exposed  
**Fences/Decks:** None or noncombustible  
**Firewood:** 5ft to 30ft from facility

**Score: 53**  
**Rating: Moderate**  
**Asset Priority Index (API):**  
**0**

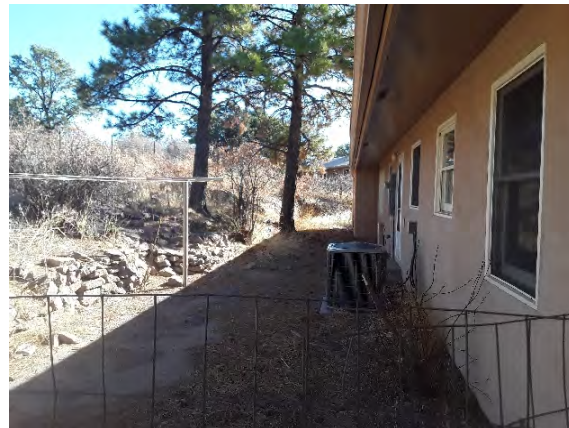
2020\_BAND\_31583\_Quarters 54\_Front

**Siding Material:** Rock, concrete, metal  
**Foundation:** Closed, < 6in masonry exposed  
**Fences/Decks:** None or noncombustible  
**Firewood:** 5ft to 30ft from facility

**Score: 60**  
**Rating: Moderate**  
**Asset Priority Index (API): 40**

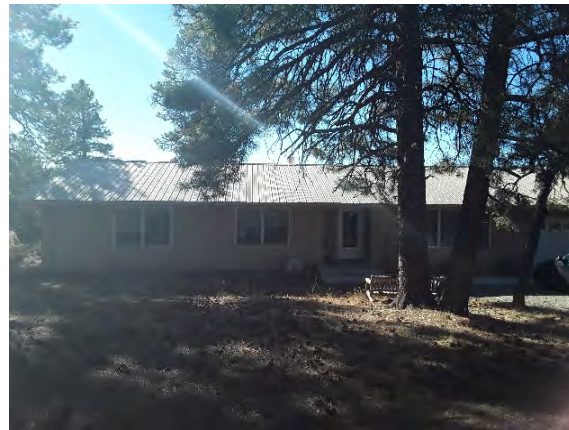
2020\_BAND\_31584\_Quarters 55\_Front

**Siding Material:** Rock, concrete, metal  
**Foundation:** Closed, < 6in masonry exposed  
**Fences/Decks:** None or noncombustible  
**Firewood:** Adjacent to/under deck of facility

**Score: 47**  
**Rating: Moderate**  
**Asset Priority Index (API): 40**

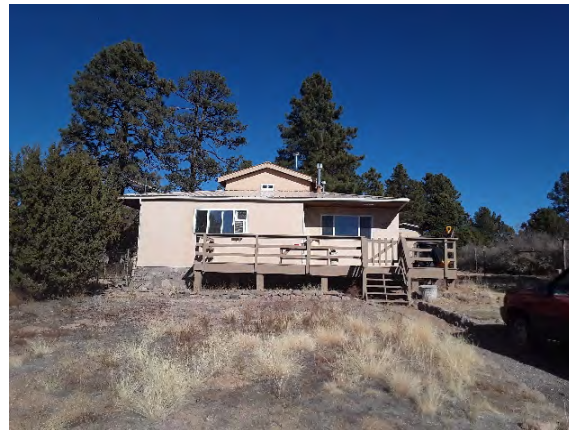
2020\_BAND\_31587\_Quarters 103\_Front

**Score: 47**  
**Rating: Moderate**  
**Asset Priority Index (API): 23**

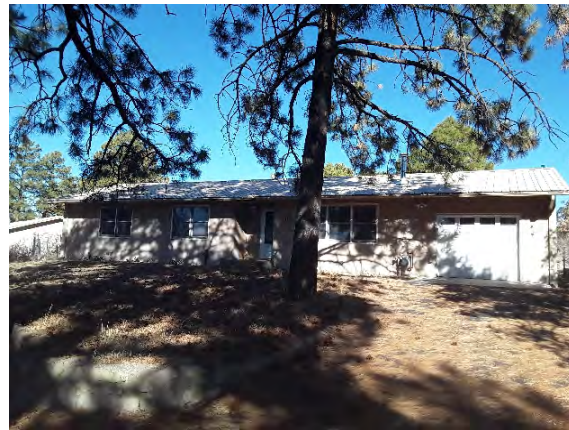
2020\_BAND\_31582\_Quarters 53\_Front

**Siding Material:** Rock, concrete, metal  
**Foundation:** Closed, < 6in masonry exposed  
**Fences/Decks:** None or noncombustible  
**Firewood:** 5ft to 30ft from facility

**Score: 46**  
**Rating: Moderate**  
**Asset Priority Index (API): 40**

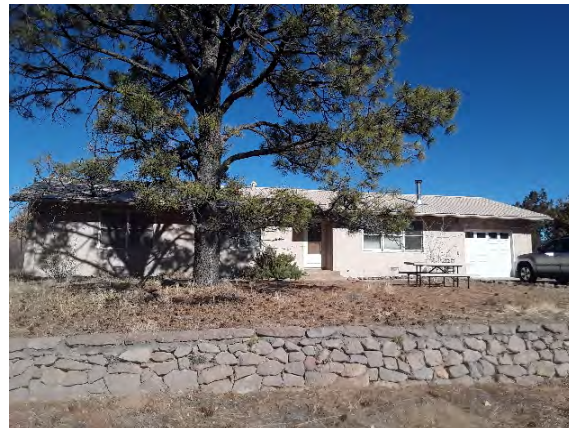
2020\_BAND\_31581\_Quarters 52\_Front

**Score: 55**  
**Rating: Moderate**  
**Asset Priority Index (API): 40**

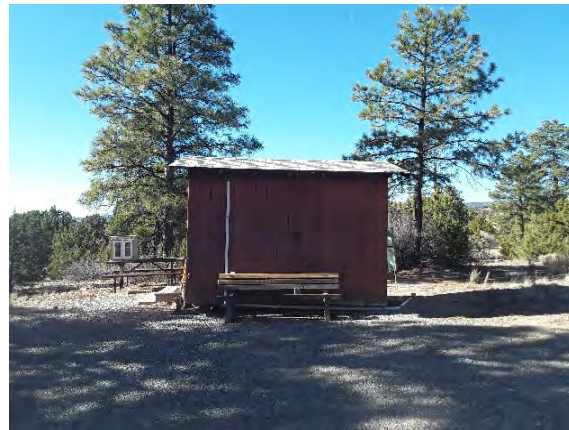
2020\_BAND\_\_LAUNDRY QUARTERS 103\_Front

Score: 39  
Rating: Low

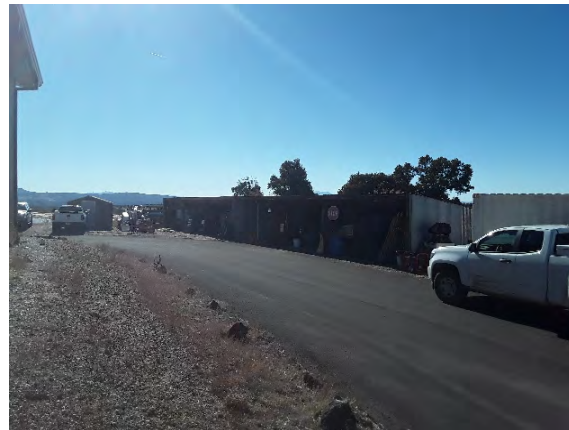
2020\_BAND\_108464\_EQUIPMENTSTORAGEBUILDING\_Front

**Additional Obstacles:** Hazmat, UXO,etc. , PLEASE COMMENT  
**Triage Category:**  
**Hazmat:** FUEL PUMPS  
**Assessment Comments:**

**Score: 50**  
**Rating: Moderate**  
**Asset Priority Index (API): 30**

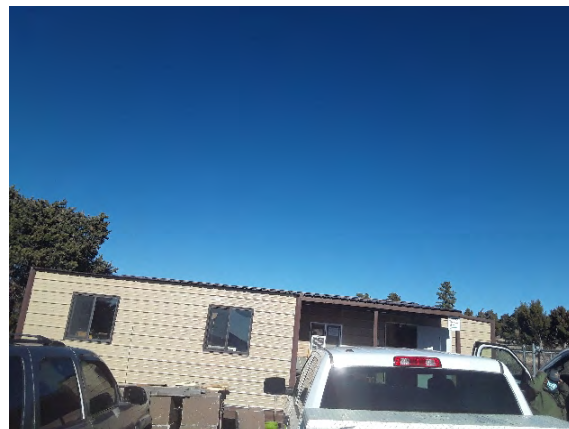
2020\_BAND\_\_MAINT OFFICE\_Front

Hazmat: FUEL ADJACENT

Score: 44  
Rating: Low

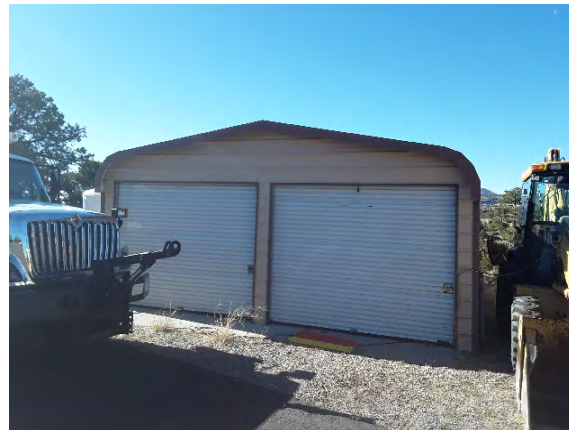
2020\_BAND\_\_MAINT SHED\_Front

Hazmat: PROPANE

Score: 44  
Rating: Low

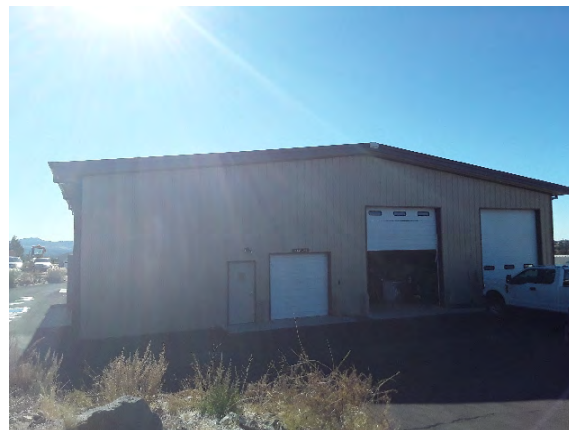
2020\_BAND\_116885\_B133EQUIPMENTBUILDING\_Front

**Additional Obstacles:** Hazmat, UXO,etc. , PLEASE COMMENT  
**Triage Category:**  
**Hazmat:** FUEL PUMP  
**Assessment Comments:**

**Score: 43**  
**Rating: Low**

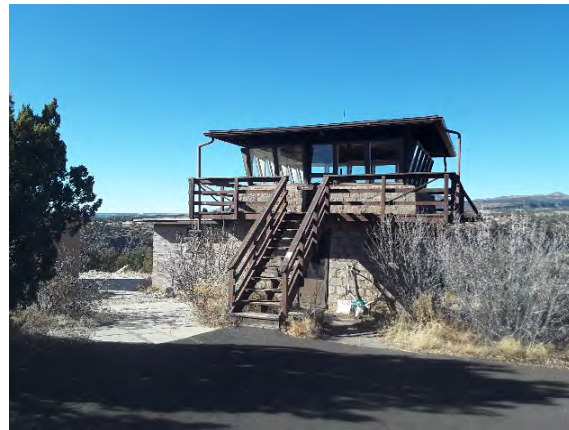
2020\_BAND\_46920\_B-100RADIOTOWERBUILDING\_Front

**Score: 52**  
**Rating: Moderate**  
**Asset Priority Index (API): 0**
