Fort Davis Historic Site  
FODA - Fort Davis National Historic Site

NPS Wildfire Risk Assessments  
NPS Fire GIS  
May 2024  
Data Source: ESRI Basedata, NPS  
NPS Wildfire Risk Assessment Project

# NPS Wildand Fire Risk Assessment - Facility Assessment

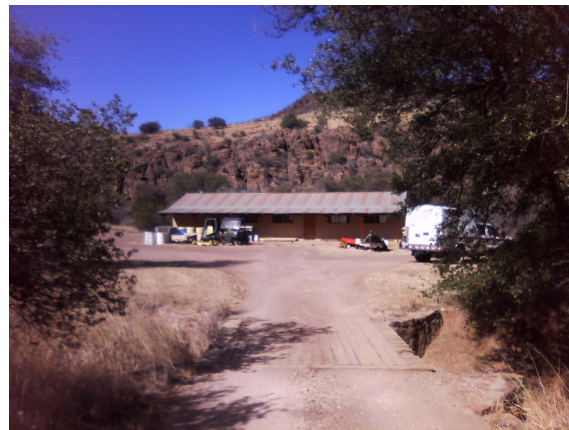
FODA\_55323\_B-104 Church Camp Bunkhouse.jpg

Hazmat: Debris pile within 60 ft radius of structure.

Score: 78  
Rating: High

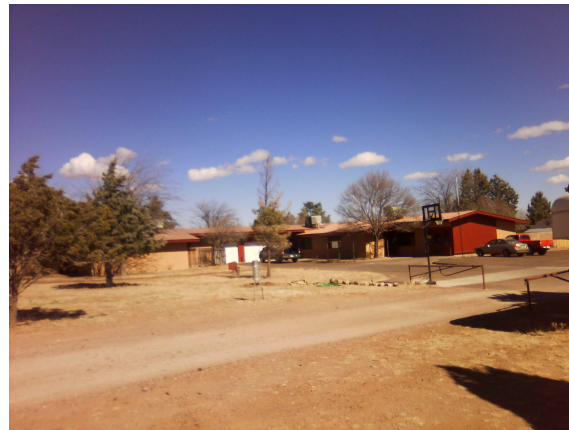
FODA\_55218\_Housing Office Triplex MA.jpg

**Score: 21**  
**Rating: Low**

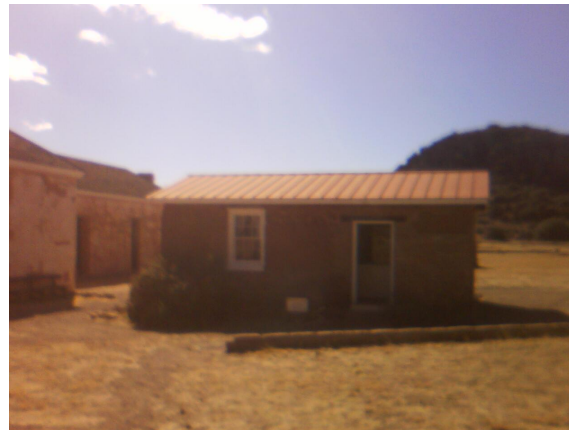
FODA\_54201\_HB-277 Kitchen For HB-12, IA.jpg

**Assessment Comments:** This structure is a historical building surrounded by a well maintained lawn. Current maintenance practices are adequate.

**Score: 31**  
**Rating: Low**

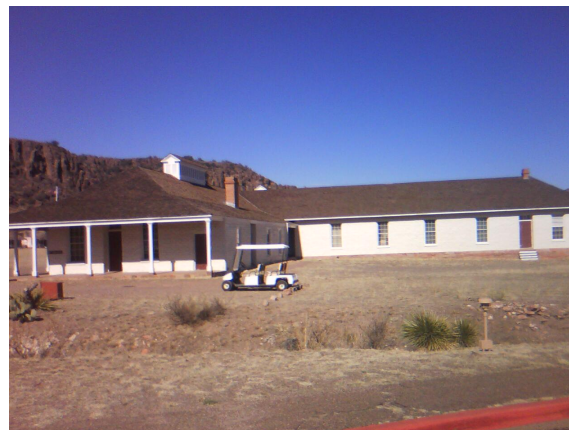
FODA\_54174\_HB 20 Enlisted Mens Barracks IA.jpg

**Assessment Comments:** This structure is a historical building surrounded by a well maintained lawn. Current maintenance practices are adequate. There are two fire hydrants adjacent to this structure.

Score: 42  
Rating: Low

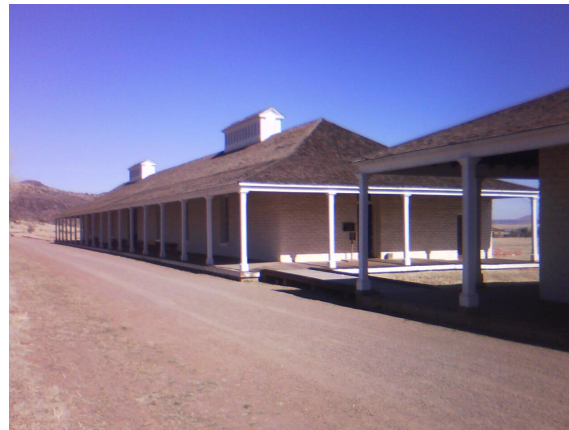
FODA\_54177\_HB-21 Enlisted Mens Barracks, IA.jpg

Assessment Comments: This structure is a historical building surrounded by a well maintained lawn. Current maintenance practices are adequate.

Score: 45  
Rating: Moderate

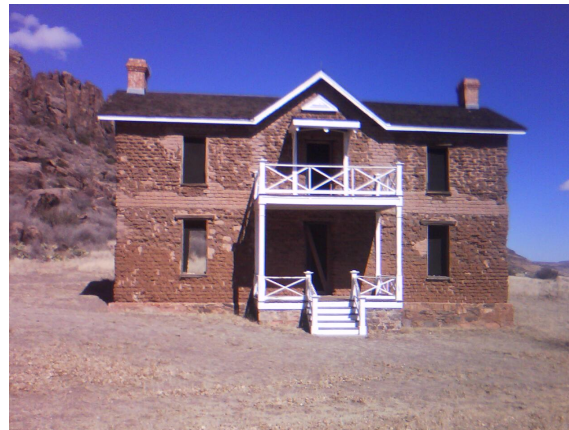
FODA\_54163\_HB-18 Officers NCOs Quarters, IA.jpg

**Assessment Comments:** This structure is a historical building surrounded by a well maintained lawn. Current maintenance practices are adequate.

**Score: 57**  
**Rating: Moderate**

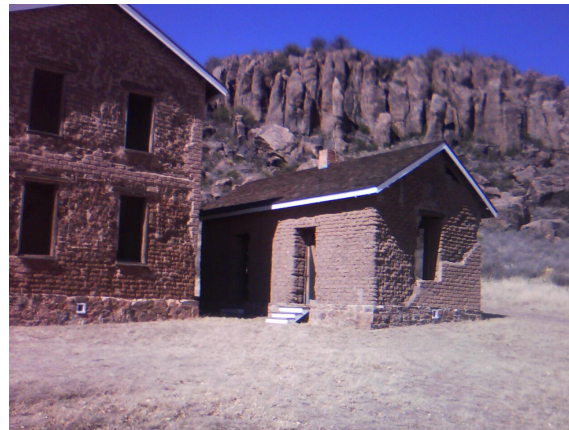
FODA\_54199\_HB-151 Kitchen For HB-18, IA.jpg

**Assessment Comments:** This structure is a historical building surrounded by a well maintained lawn. Current maintenance practices are adequate.

**Score: 71**  
**Rating: High**

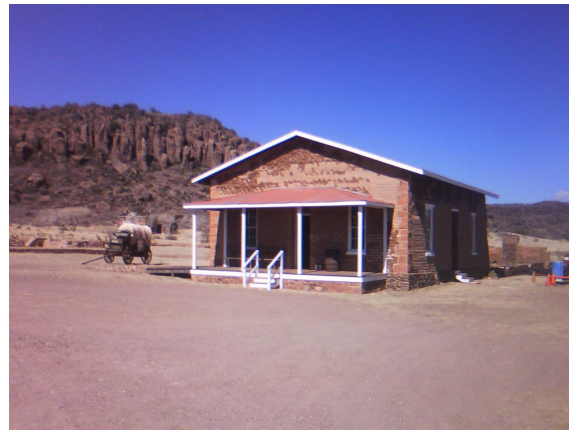
FODA\_54183\_HB-37 New Commissary Storehouse, IA.jpg

**Assessment Comments:** This structure is a historical building surrounded by a well maintained lawn. Current maintenance practices are adequate.

**Score: 45**  
**Rating: Moderate**

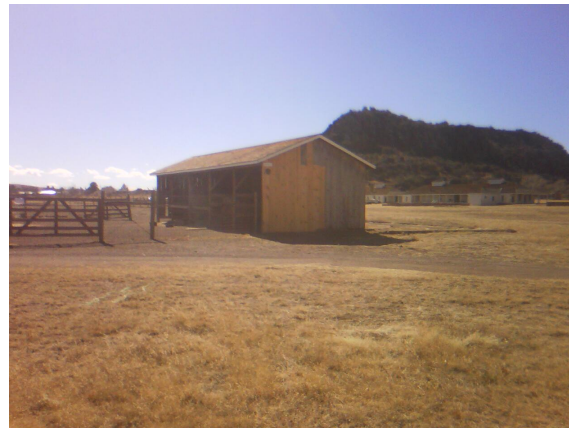
FODA\_54211\_Replica Stable Building (Located within HB-40 Footprint).jpg

**Assessment Comments:** This structure is a historical building surrounded by a well maintained lawn. Current maintenance practices are adequate.

**Score: 51**  
**Rating: Moderate**

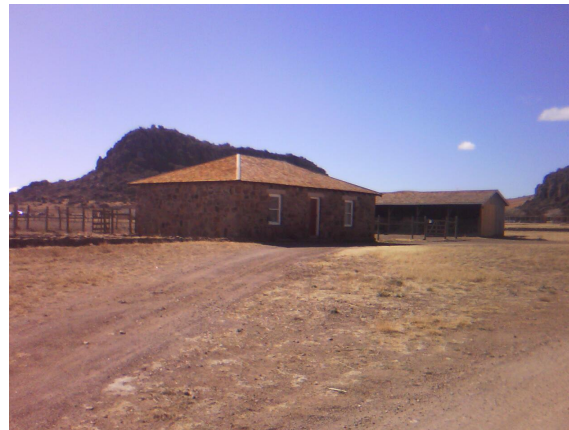
FODA\_54209\_Tack Building (1940's Building within HB-40).jpg

**Assessment Comments:** This structure is a historical building surrounded by a well maintained lawn. Current maintenance practices are adequate.

**Score: 44**  
**Rating: Low**

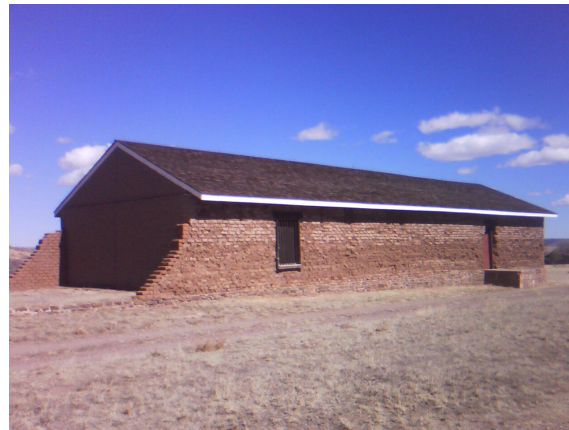
FODA\_54188\_HB-39 Forage House, IA.jpg

Assessment Comments: This structure is a historical building surrounded by a well maintained lawn. Current maintenance practices are adequate.

Score: 42  
Rating: Low
