# Clarno Unit

## JODA - John Day Fossil Beds National Monument

# NPS Wildand Fire Risk Assessment - Facility Assessment

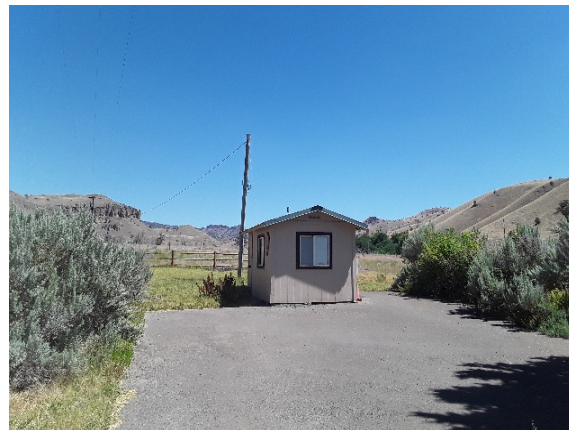
2022\_JODA\_28799\_CL BLDG Office\_Front.jpg

**Defensible Space:** <30 ft treated  
**Fuel Load (w/in 300 ft):** Light  
**Fuel Type (w/in 300ft):** Grass,shrub,hardwood litter  
**Topography (w/in 300ft):** Slope 5% to 20%

**Roof Material:** Noncombustible or not applicable  
**Siding Material:** Wood or open sided  
**Foundation:** Open or deck  
**Fences/Decks:** Combustible but separated from facility

**Score: 50**  
**Rating: Moderate**  
**Asset Priority Index (API): 92**

| Label # | Facility/Community Name | Assessment Scale | Site Visit Type | Firewise Zone | Treatment | Treatment Description | Person Hours | Date |
|---|---|---|---|---|---|---|---|---|
| 1 | CL BLDG Office | Facility In Community (Clarno) | Initial | 1 | Flammable ground cover such as leaf litter, woody debris or highly flammable vegetation should be removed | | 5.0 | 8/16/22 |
| | | Facility In Community (Clarno) | Initial | 1 | Mow dead/dying grass to less than 4 inches | | 1.0 | 8/16/22 |
| | | Facility In Community (Clarno) | Initial | 2 | Flammable ground cover should be removed or isolated | | 10.0 | 8/16/22 |
| | | Facility In Community (Clarno) | Initial | 3 | Remove heavy ground fuels such as logs and stumps | | 10.0 | 8/16/22 |

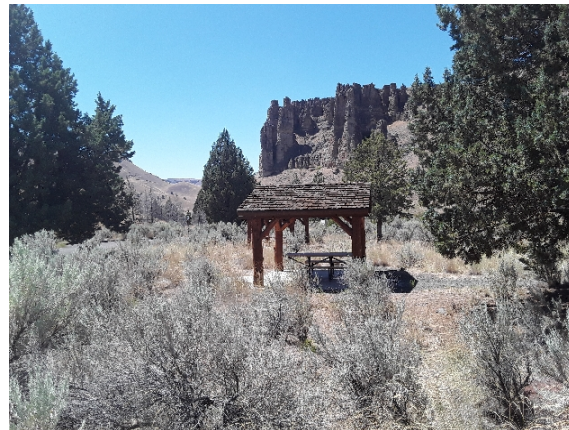
2022\_JODA\_237637\_CL BLDG Picnic Shelter 1\_Front.jpg

**Defensible Space:** <30 ft treated  
**Fuel Load (w/in 300 ft):** Light  
**Fuel Type (w/in 300ft):** Grass,shrub,hardwood litter  
**Topography (w/in 300ft):** Slope 5% to 20%

**Roof Material:** Combustible or no roof  
**Siding Material:** Wood or open sided  
**Foundation:** Closed, >30in masonry exposed or N/A  
**Fences/Decks:** None or noncombustible

**Score: 63**  
**Rating: High**

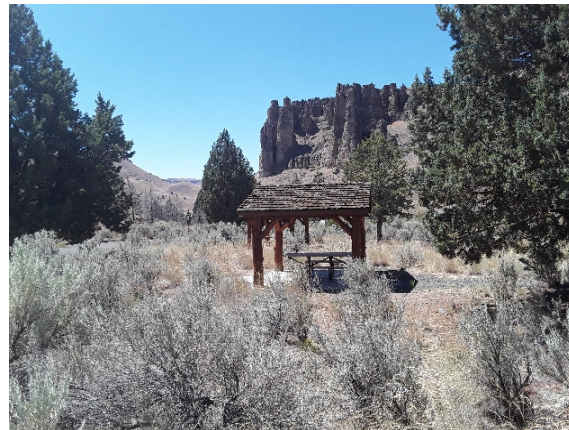
2022\_JODA\_237645\_CL BLDG Picnic Shelter 2\_Front.jpg

**Defensible Space:** <30 ft treated  
**Fuel Load (w/in 300 ft):** Light  
**Fuel Type (w/in 300ft):** Grass,shrub,hardwood litter  
**Topography (w/in 300ft):** Slope 5% to 20%

**Roof Material:** Combustible or no roof  
**Siding Material:** Wood or open sided  
**Foundation:** Closed, >30in masonry exposed or N/A  
**Fences/Decks:** None or noncombustible

**Score: 63**  
**Rating: High**

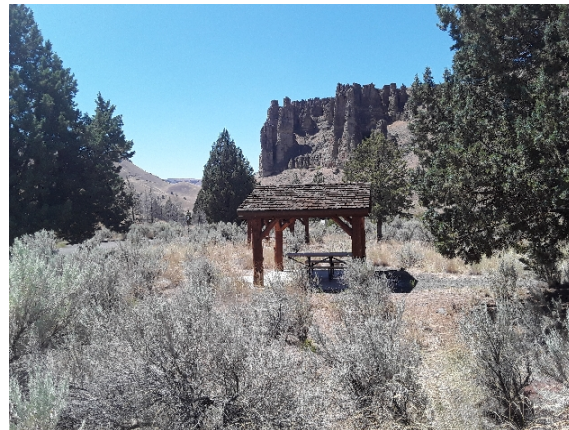
2022\_JODA\_237646\_CL BLDG Picnic Shelter 3\_Front.jpg

Roof Material: Combustible or no roof

Siding Material: Wood or open sided

Score: 63  
Rating: High

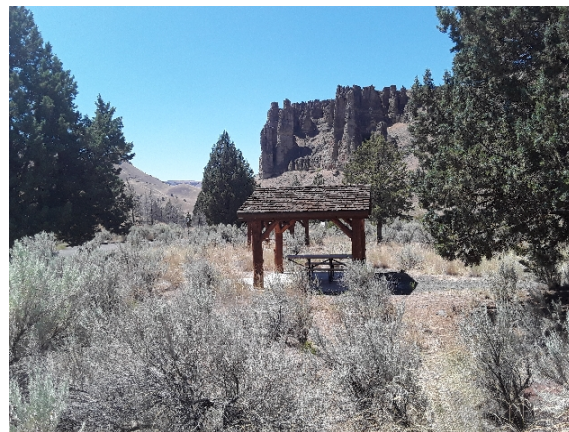
2022\_JODA\_237647\_CL BLDG Picnic Shelter 4\_Front.jpg

**Defensible Space:** <30 ft treated  
**Fuel Load (w/in 300 ft):** Light  
**Fuel Type (w/in 300ft):** Grass,shrub,hardwood litter  
**Topography (w/in 300ft):** Slope 5% to 20%

**Roof Material:** Combustible or no roof  
**Siding Material:** Wood or open sided  
**Foundation:** Closed, >30in masonry exposed or N/A  
**Fences/Decks:** None or noncombustible

**Score: 63**  
**Rating: High**

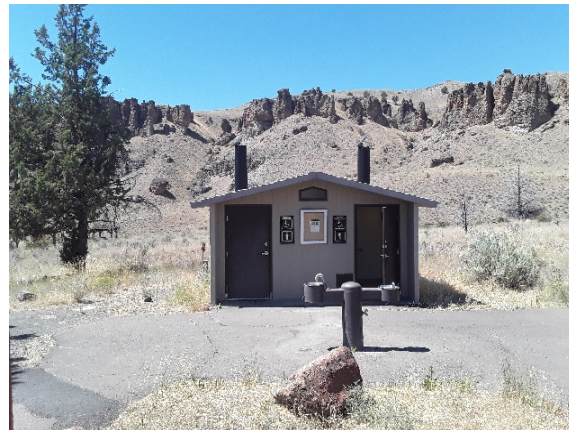
2022\_JODA\_88261\_CL BLDG Restrooms\_Front.jpg

**Roof Material:** Noncombustible or not applicable

**Siding Material:** Wood or open sided

**Foundation:** Closed, < 6in masonry exposed

**Score: 38**  
**Rating: Low**
