# NPS Wildfire Risk Assessments Assessment Locations

## CRLA -Crater Lake National Park - Overview

## CRLA - Headquarters - Overview

# NPS Wildland Fire Risk Assessment - Facility Assessment

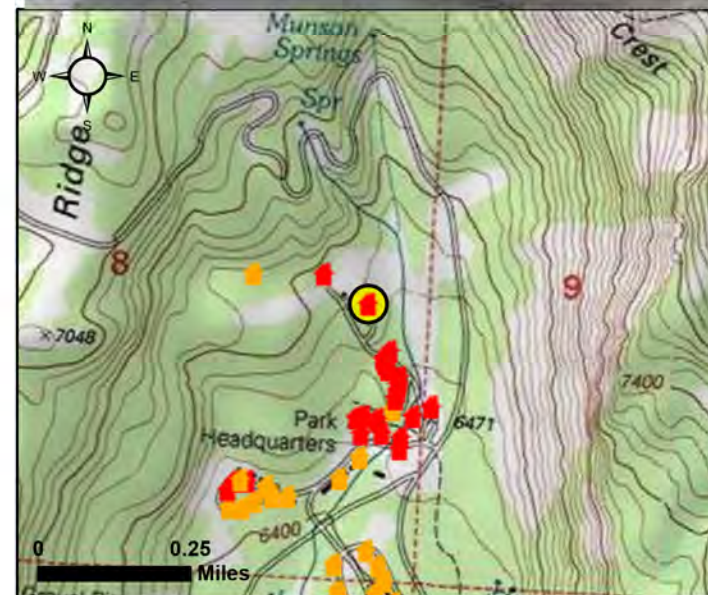
**Facility Name:** Qtrs. 20 Stone House

**Rating:** High

**Defensible Space:** Less than 30 ft treated

**Roof Material:** Combustible or no roof

**Water Supply:** Limited or dependent on electricity

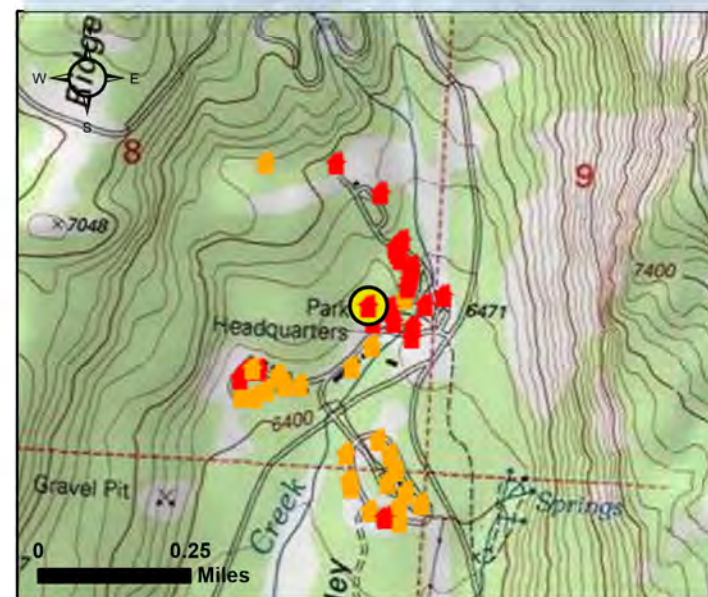
**Facility Name:** Open Storage Bldg.#10

**Rating:** High

**Defensible Space:** Less than 30 ft treated

**Siding Material:** Wood or open sided

**Foundation:** Open or deck

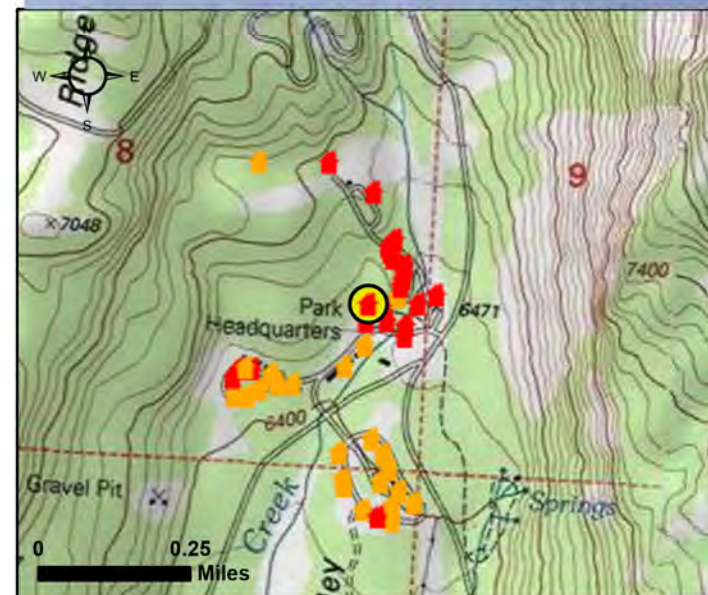
**Facility Name:** Open Storage Bldg.#7

**Rating:** High

**Foundation:** Open or deck
