# NPS Wildfire Risk Assessments Assessment Locations

REDW- Redwoods National and State Parks Overview

## REDW- Elk Camp Overview

# NPS Wildland Fire Risk Assessment - Facility Assessment

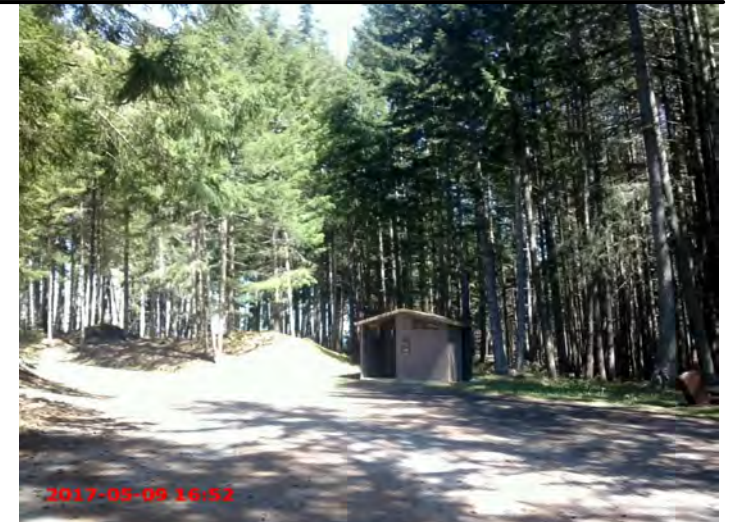
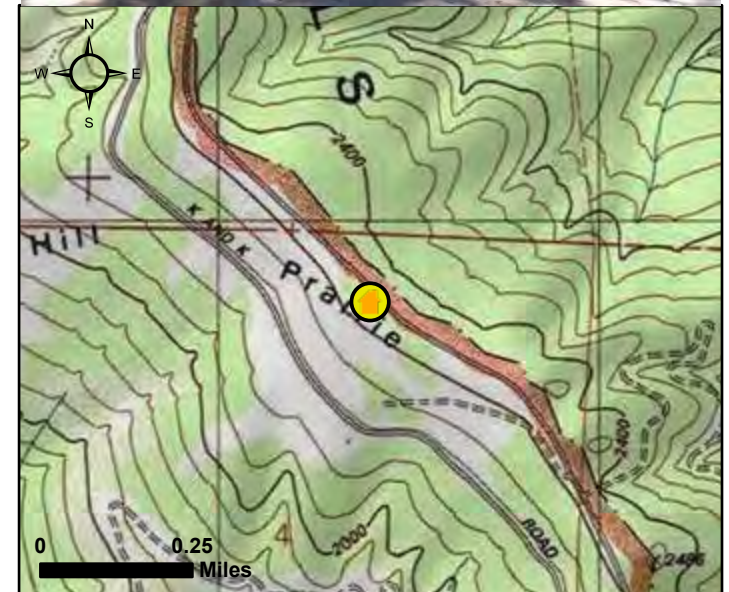
**Map Label:** 233

**Rating:** Moderate

**Fuel Type:** Shrub or timber

**Fuel Load:** Moderate

**Defensible Space:** Less than 30 ft treated

**Water Supply:** No reliable water source nearby

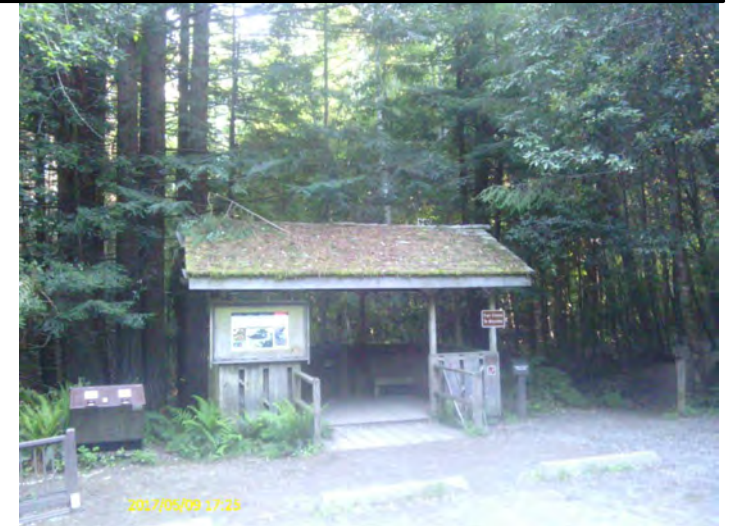
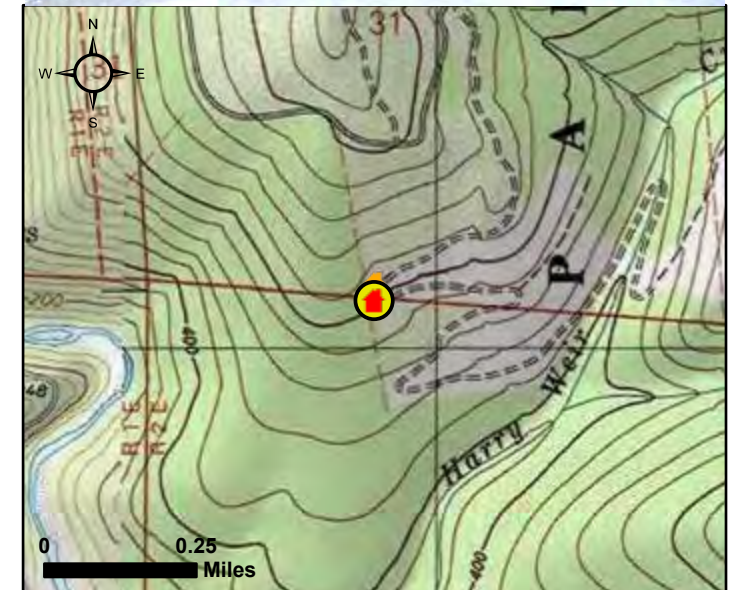
**Map Label:** 234

**Rating:** High

**Defensible Space:** Less than 30 ft treated

**Roof Material:** Combustible or no roof

**Siding Material:** Wood or open sided

**Foundation:** Open or deck

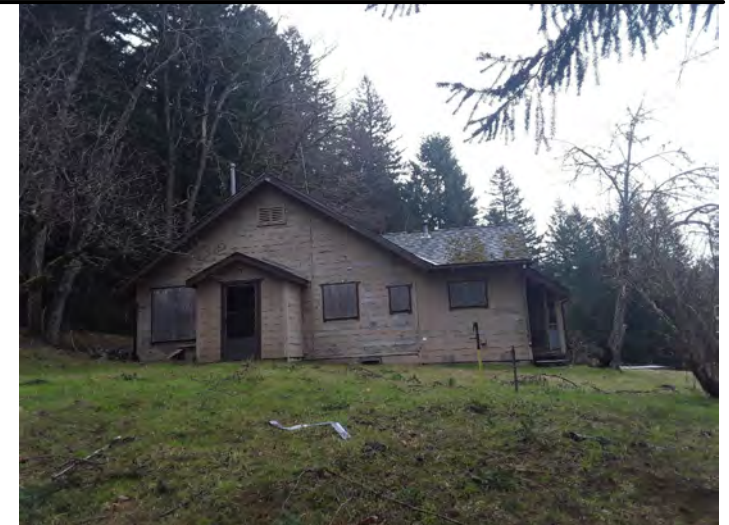
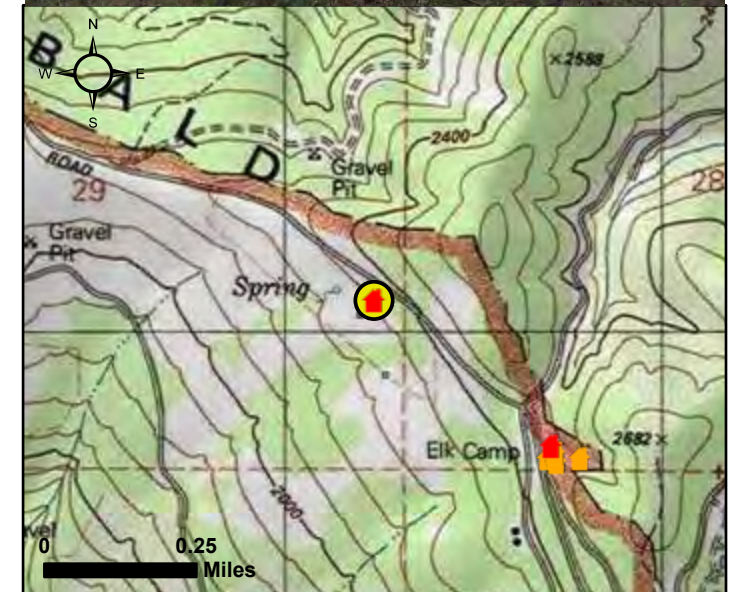
**Map Label:** 235

**Rating:** High

**Facility Number or Sign:** None or not clearly visible

**Defensible Space:** Less than 30 ft treated

**Siding Material:** Wood or open sided

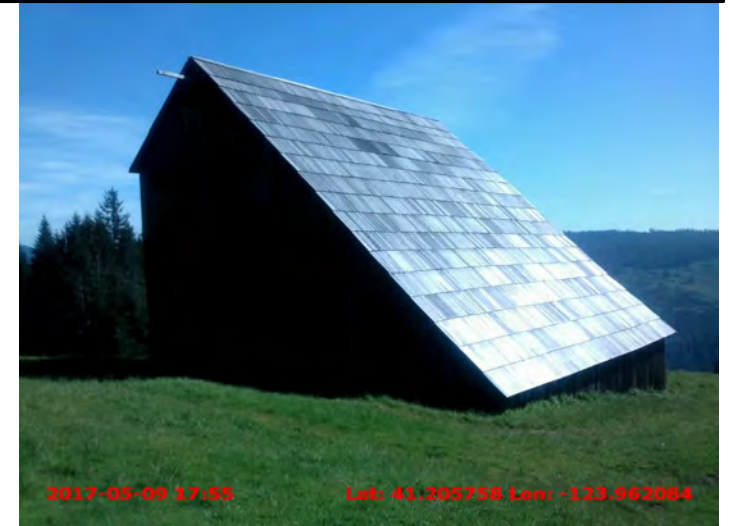
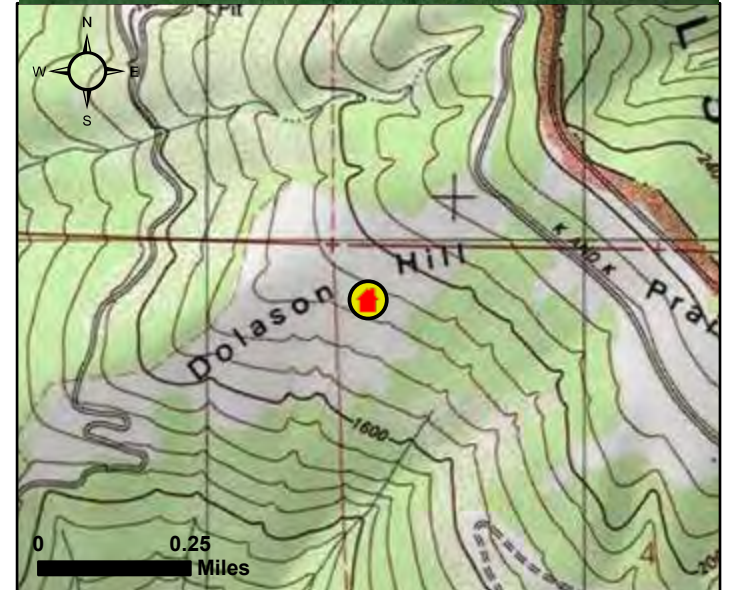
**Map Label:** 236

**Rating:** High

**Roof Material:** Combustible or no roof

**Siding Material:** Wood or open sided

**Foundation:** Open or deck

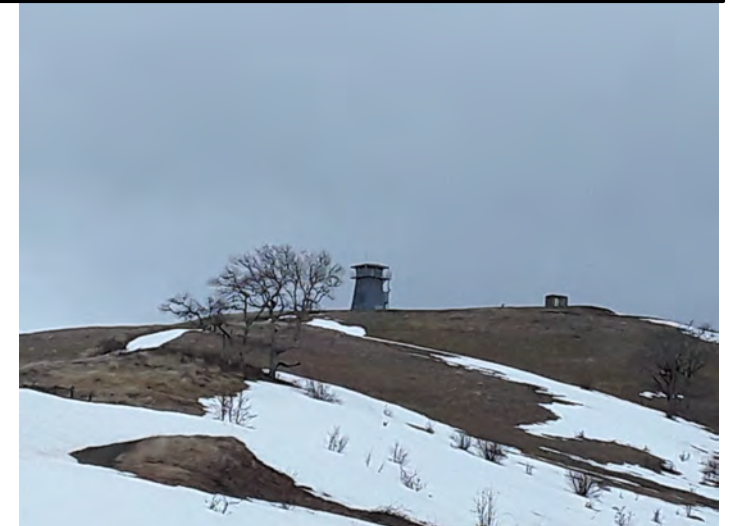
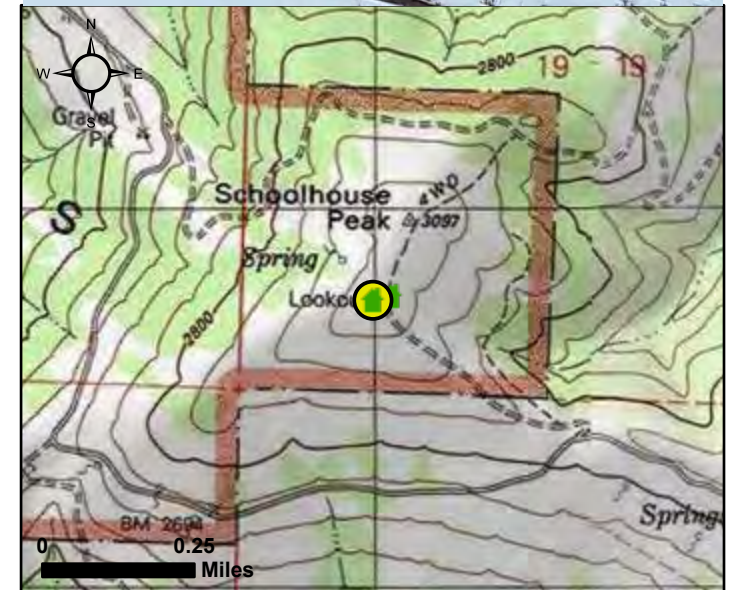
**Rating:** Low  
**ProtectionLevel:** Undesignated,  
**Resources of Concern:** Unknown  
**Occupied:** No  
**In Community:** No,  
**Revisit Interval:** 4 yrs  
**Map Label:** 237

**Firewood:** None  
**Water Supply:** Reliable water source nearby  
**Propane:** Present and little to no fuels clearance  
**Overhead Hazards:** No overhead hazards

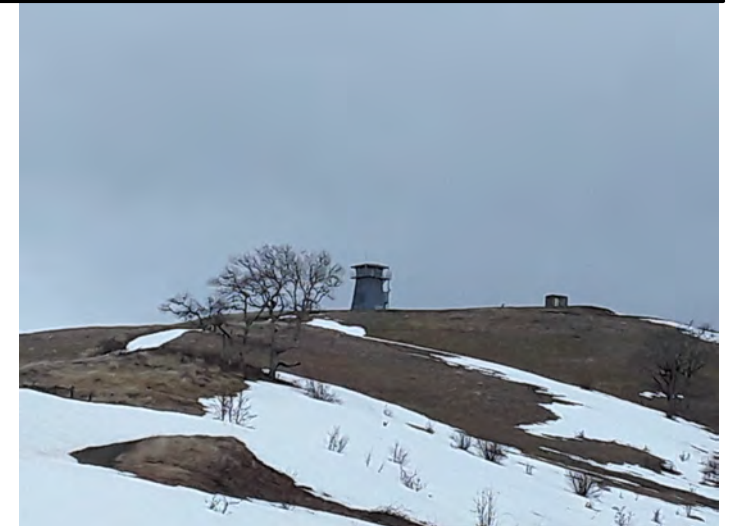
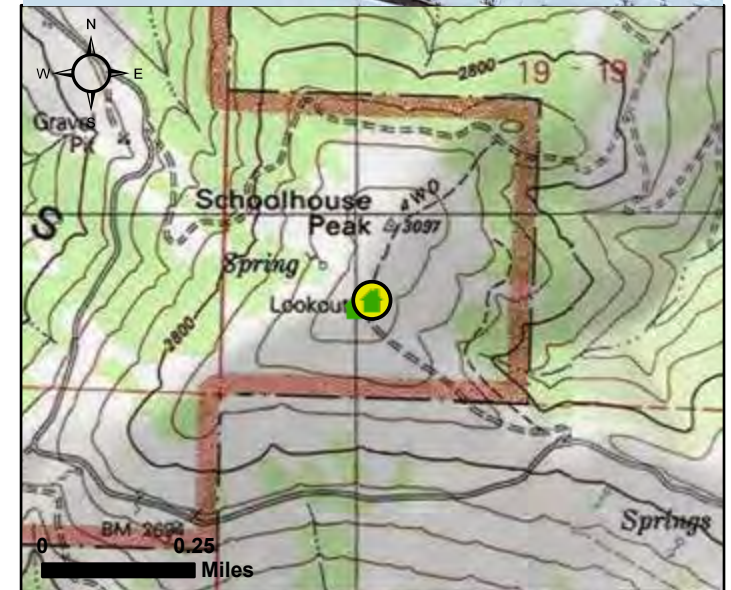
**Map Label:** 238

**Rating:** Low

**Propane:** Present and little to no fuels clearance

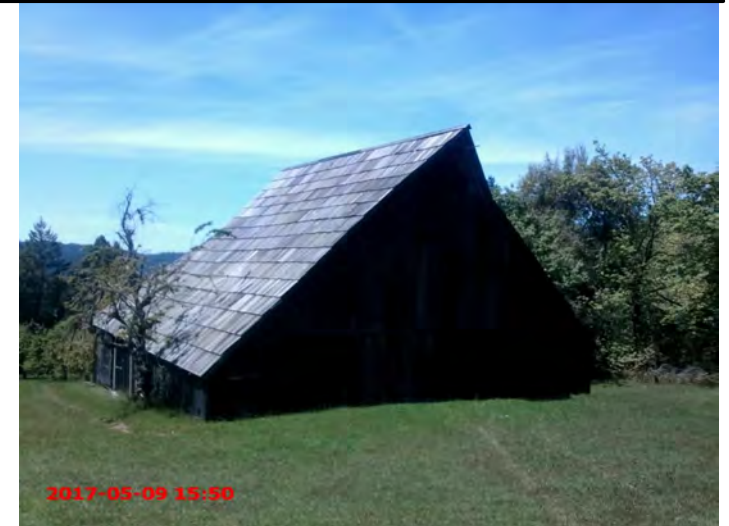
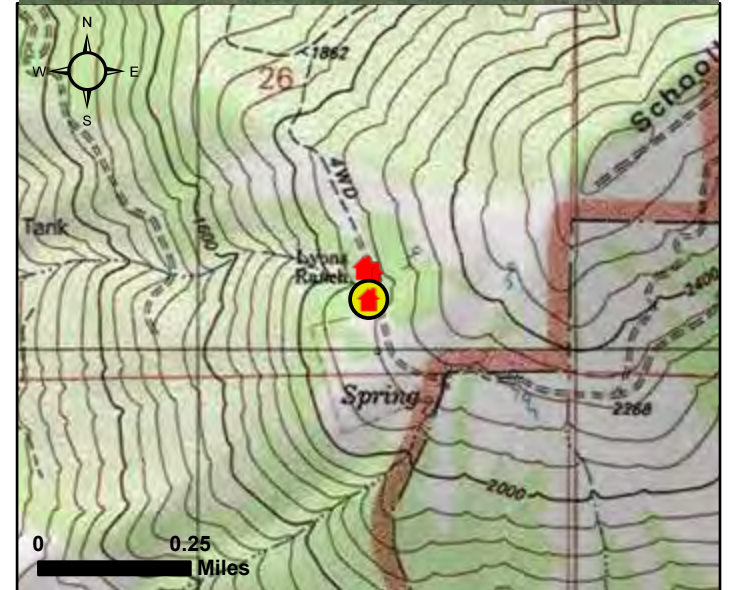
**Map Label:** 239

**Rating:** High

**Roof Material:** Combustible or no roof

**Siding Material:** Wood or open sided

**Foundation:** Open or deck

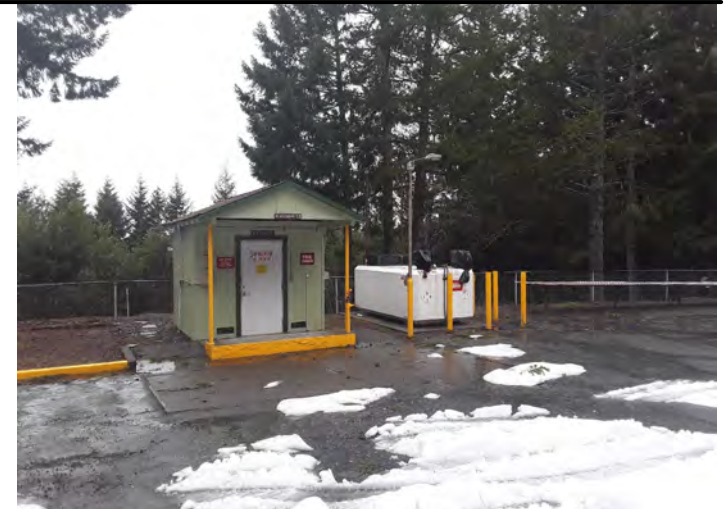
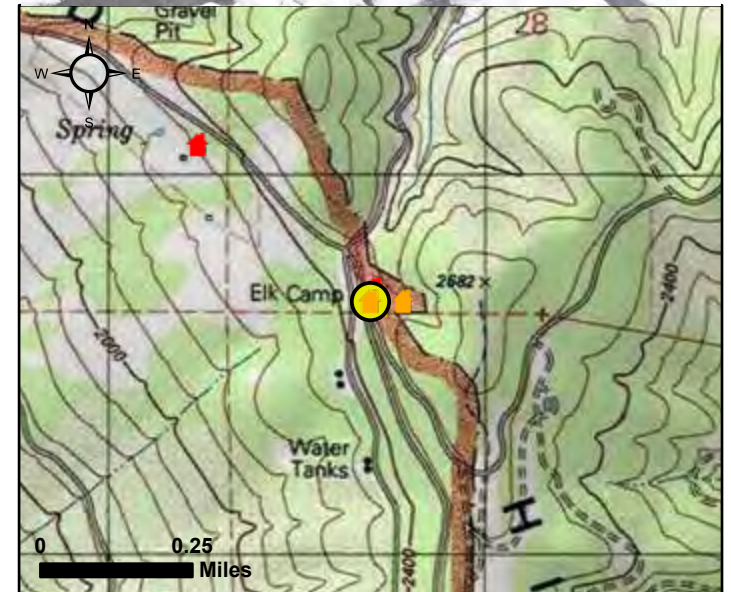
**Rating:** Moderate  
**ProtectionLevel:** Undesignated,  
**Resources of Concern:** Unknown  
**Occupied:** No  
**In Community:** No,  
**Revisit Interval:** 4 yrs  
**Map Label:** 240

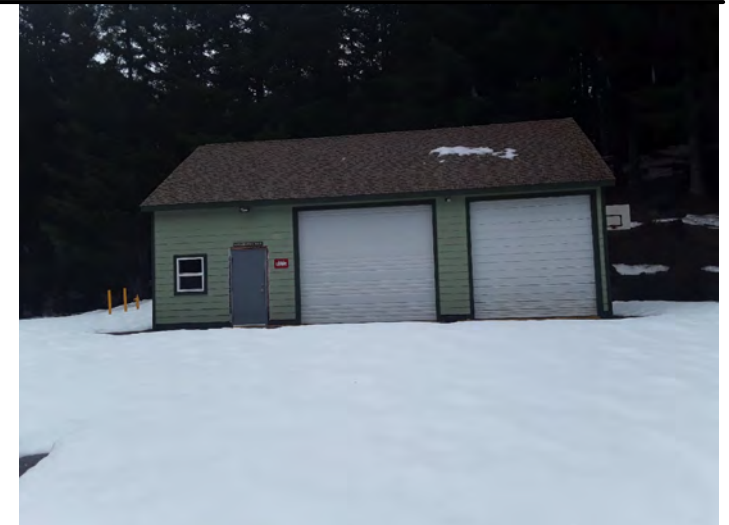
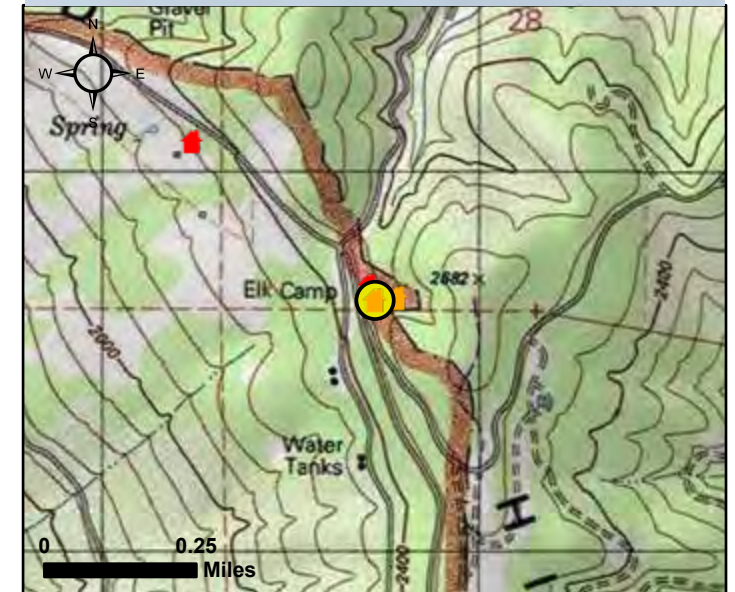
**Map Label:** 241

**Rating:** Moderate

**Siding Material:** Wood or open sided

**Water Supply:** Limited or dependent on electricity

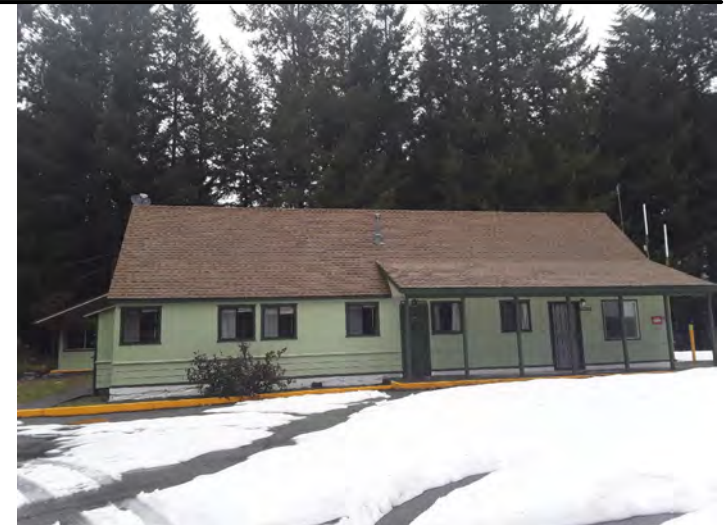
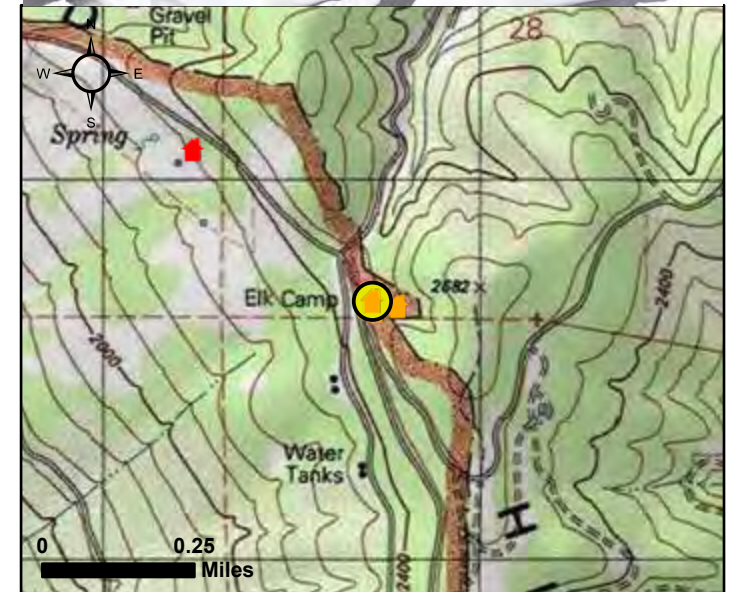
**Rating:** Moderate  
**ProtectionLevel:** Undesignated,  
**Resources of Concern:** Unknown  
**Occupied:** Yes  
**In Community:** No,  
**Revisit Interval:** 4 yrs  
**Map Label:** 242

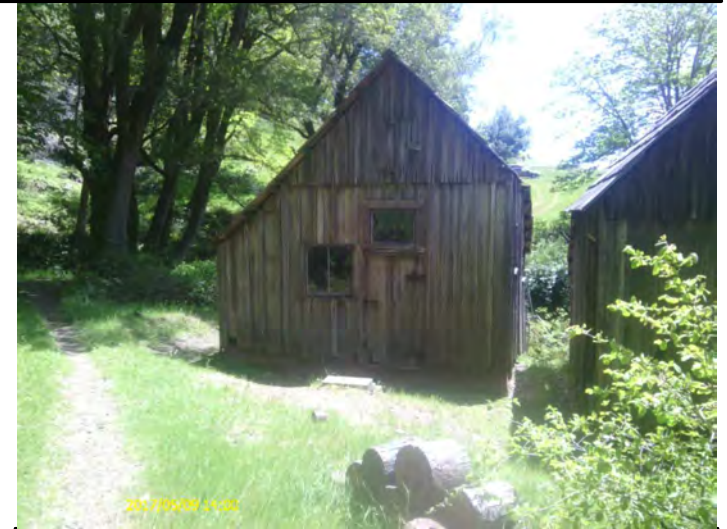
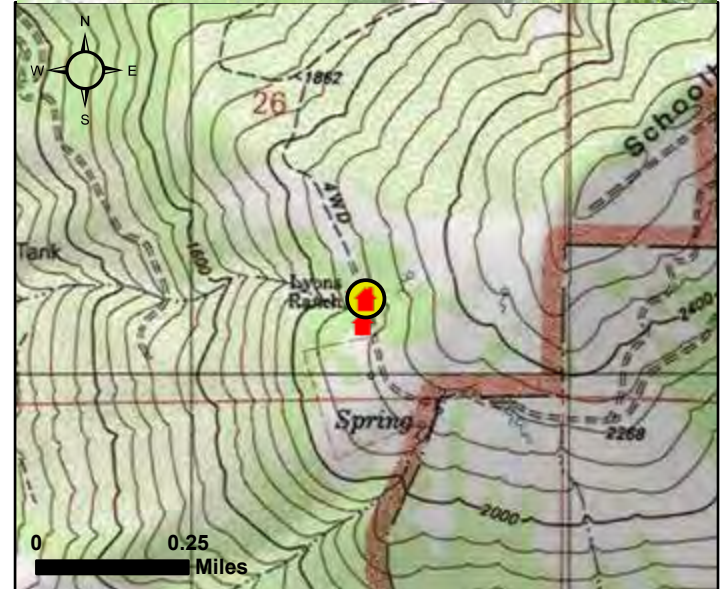
**Map Label:** 243

**Rating:** High

**Roof Material:** Combustible or no roof

**Siding Material:** Wood or open sided

**Foundation:** Open or deck

**Comments:** Lyon's Bunkhouse is an historic structure
