# NPS Wildfire Risk Assessments Assessment Locations

## GLAC - Glacier National Park - Overview

# NPS Wildland Fire Risk Assessment - Facility Assessment

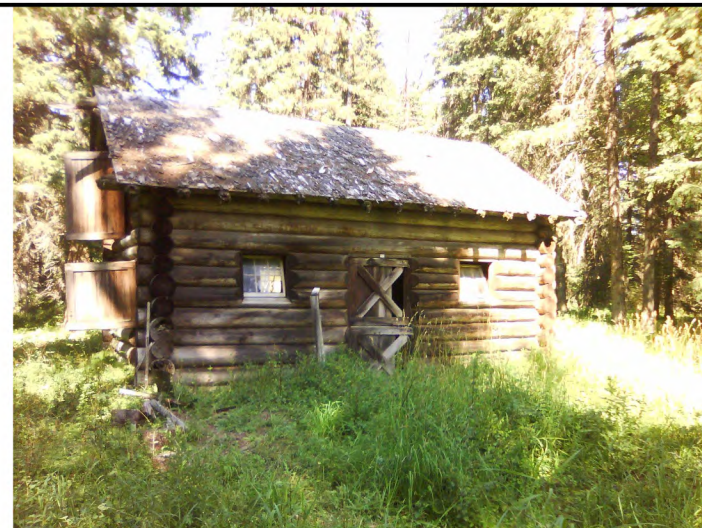
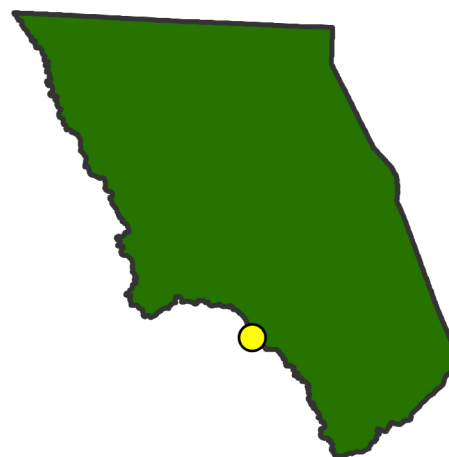
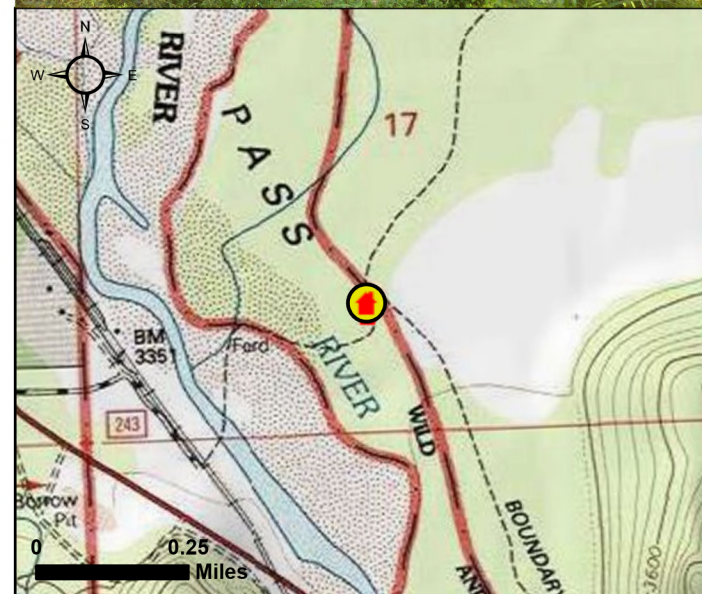
**Facility Name:** WLD Middle Fork Building 369 Nyack Barn

**Rating:** High

**Fuel Type:** Shrub or timber

**Fuel Load:** Heavy

**Roof Material:** Combustible or no roof

**Siding Material:** Log construction

**Comments:** Structure is deteriorating and is no longer being used.

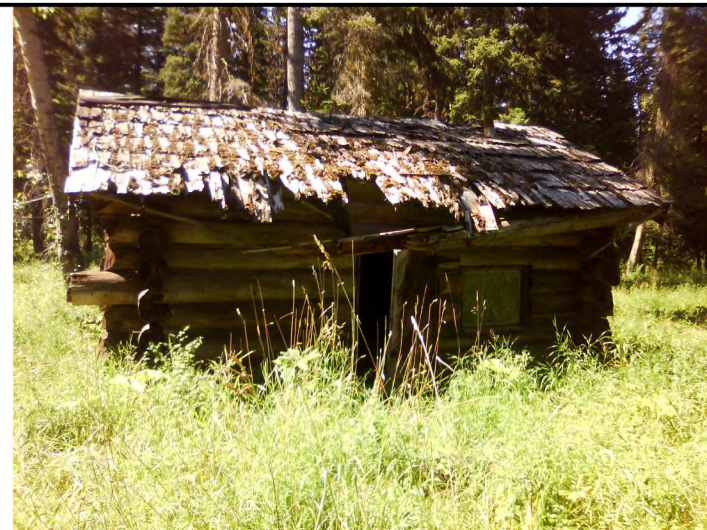
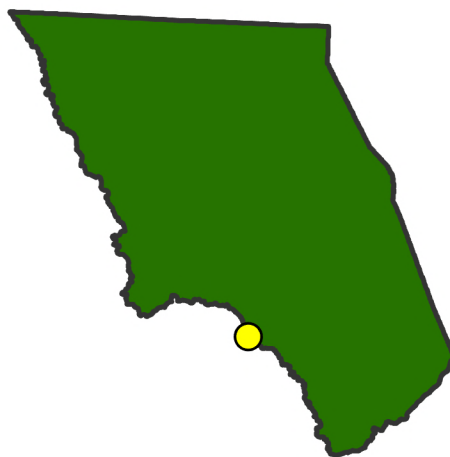
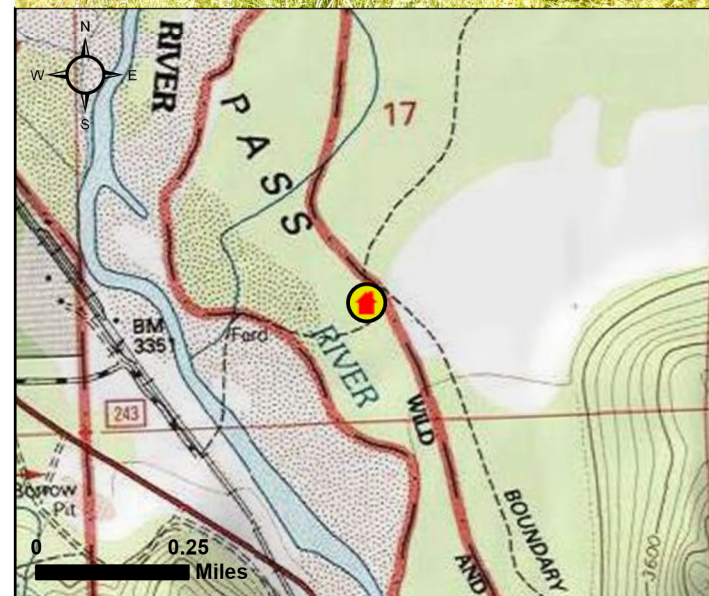
**Facility Name:** WLD Middle Fork Building 375 Nyack Fire Cache  
**Unit - Location:** GLAC - Hwy 2-North  
**FMSS ID:** 80407, **Local ID:**  
**Structure Type, Use:** Building, No known use  
**Owner:** National Park Service  
**Field Crew, Visit Date:** Fire Effects Crew, August 27, 2014  
**Coordinates (DDM):** 48° 26.40183912' N 113° 47.79249102' W

**Rating:** High  
**ProtectionLevel:** Not Designated,  
**Resources of Concern:** Unknown  
**Occupied:** No  
**In Community:** No,  
**Revisit Interval:** yrs  
**Map Label:** 762

**Primary Access:** Foot  
**Ingress Egress:** N/A, access by foot, boat, or air only  
**Access Width:** N/A, access by foot, boat, or air only  
**Access Condition:** N/A, access by foot, boat, or air only  
**Bridge Condition:** N/A, access by foot, boat, or air only  
**Access and Turnarounds:** N/A, access by foot, boat, or air only  
**Facility Number or Sign:** None or not clearly visible  
**Fuel Type:** Shrub or timber  
**Fuel Load:** Heavy  
**Defensible Space:** 30 ft treated  
**Topography:** Slope Less than 5%  
**Roof Material:** Combustible or no roof  
**Siding Material:** Log construction  
**Foundation:** Open or deck  
**Firewood:** None  
**Water Supply:** Reliable water source nearby  
**Propane:** None  
**Overhead Hazards:** No overhead hazards  
**Comments:** Structure is deteriorating and no longer used.

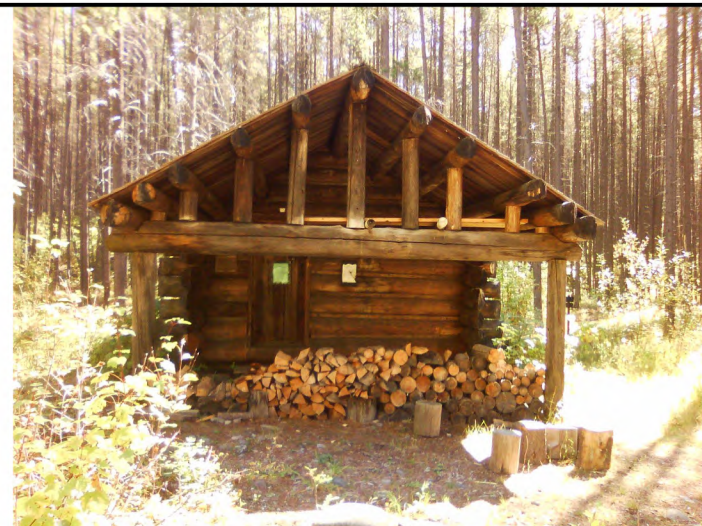
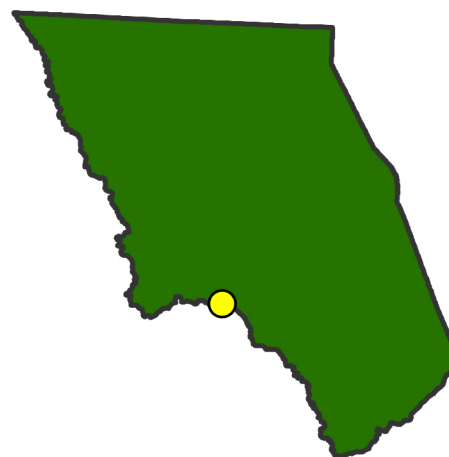
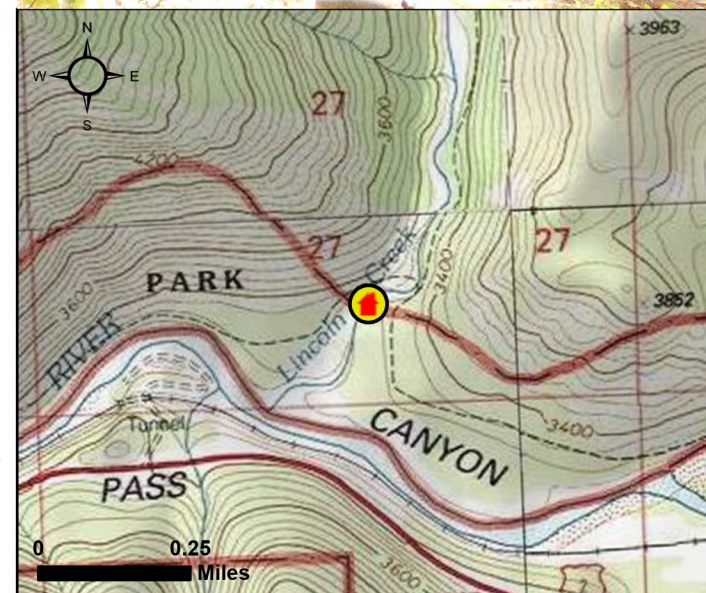
**Facility Name:** WLD Middle Fork Building 617 Lincoln Creek Patrol Cabin

**Rating:** High

**Fuel Load:** Moderate

**Roof Material:** Combustible or no roof

**Siding Material:** Log construction

**Foundation:** Open or deck

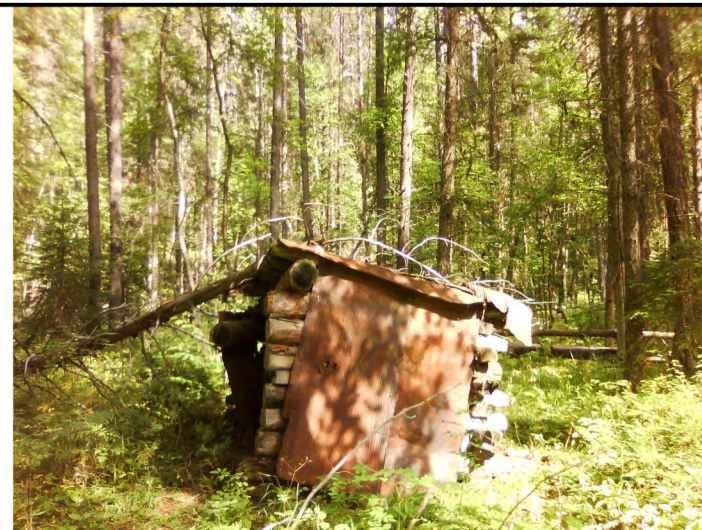
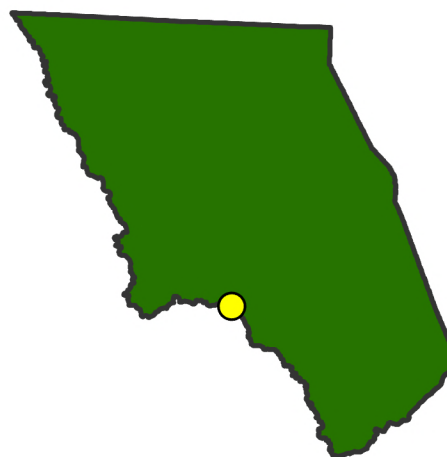
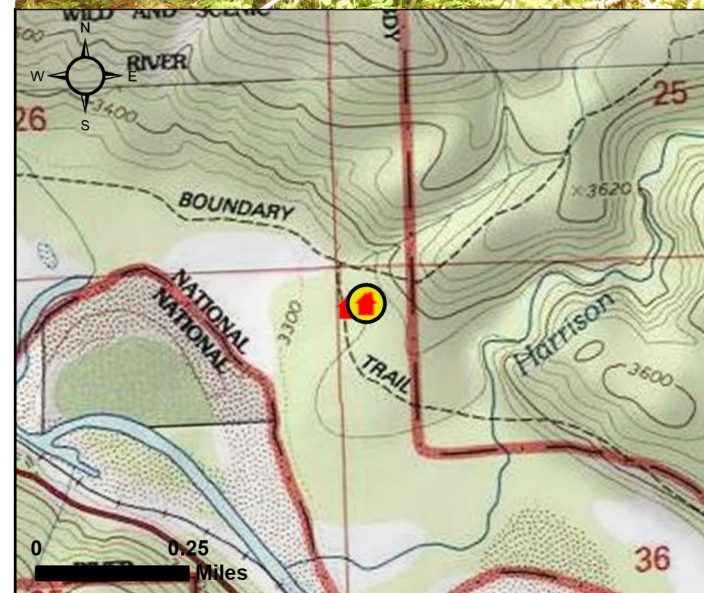
**Facility Name:** WLD Harrison Creek Dooty Homestead Pit Toilet  
**Unit - Location:** GLAC - Hwy 2-North  
**FMSS ID:** , **Local ID:**  
**Structure Type, Use:** Toilet, Administrative  
**Owner:** National Park Service  
**Field Crew, Visit Date:** K Kaszuba, September 2, 2014  
**Coordinates (DDM):** 48° 29.67188880' N 113° 50.92341096' W

**Rating:** High  
**ProtectionLevel:** Not Designated,  
**Resources of Concern:** Unknown  
**Occupied:** No  
**In Community:** No,  
**Revisit Interval:** yrs  
**Map Label:** 760

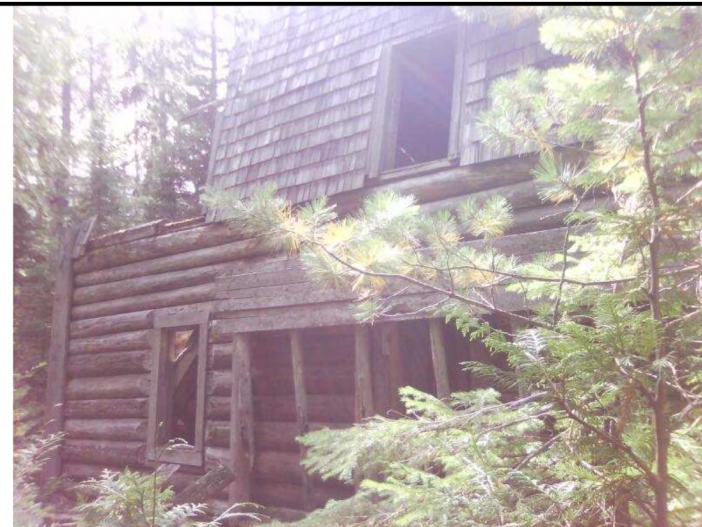
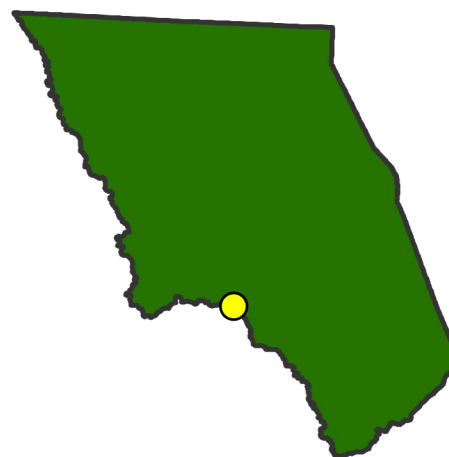
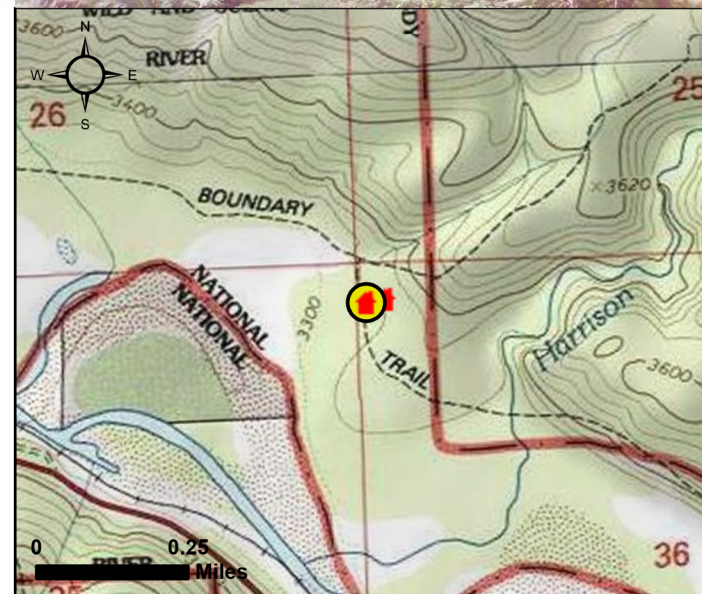
**Facility Name:** WLD Dudy Homestead Cabin

**Rating:** High

**Facility Number or Sign:** None or not clearly visible

**Fuel Load:** Heavy

**Defensible Space:** No defensible space

**Roof Material:** Combustible or no roof

**Siding Material:** Wood or open sided

**Firewood:** Adjacent to/under deck of facility

**Water Supply:** No reliable water source nearby
