# NPS Wildfire Risk Assessments Assessment Locations

## COLM - Colorado National Monument Overview

NPS Wildfire Risk Assessment Project

# NPS Wildand Fire Risk Assessment - Facility Assessment

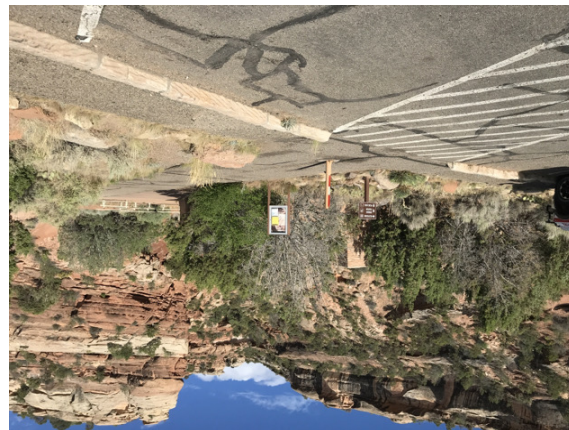
2021\_COLM\_79503\_Devils Kitchen Picnic Shelter\_Front.jpg

Rating: Low

**Defensible Space:** >100ft treated

**Fuel Load (w/in 300 ft):** Moderate

**Water Supply:** No reliable water source nearby

Score: 28  
Rating: Low

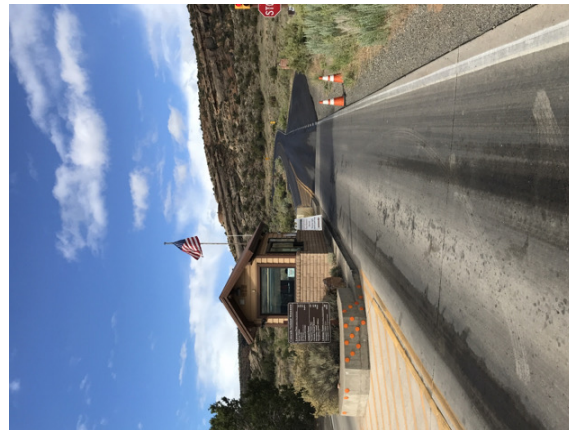
2021\_COLM\_79501\_East Entrance Kiosk\_Front.jpg

**Defensible Space:** 30 ft treated  
**Fuel Load (w/in 300 ft):** Light  
**Fuel Type (w/in 300ft):** Grass,shrub,hardwood litter  
**Topography (w/in 300ft):** Slope <5%

**Roof Material:** Noncombustible or not applicable  
**Siding Material:** Wood or open sided  
**Foundation:** Closed, >30in masonry exposed or N/A  
**Fences/Decks:** None or noncombustible

**Safety Zones:** Potential safety zone(s) in area  
**Additional Obstacles:** None  
**Triage Category:**  
**Hazmat:**  
**Assessment Comments:** Fire Hydrant near E shop. East direction. Buried gas line in area. South of building

**Score: 21**  
**Rating: Low**

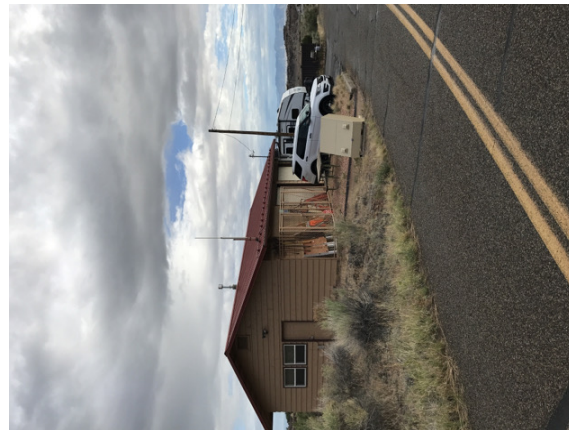
2021\_COLM\_79499\_East Office\_Front.jpg

**Defensible Space:** <30 ft treated

**Siding Material:** Wood or open sided

**Fences/Decks:** Combustible,adjacent,no veg/debris clearance

**Overhead Hazards:** Overhead hazards will limit aircraft

**Hazmat:** flammable cabinet

**Assessment Comments:** Used by LE for Parking. Seasonal RV Parking

**Score: 53**  
**Rating: Moderate**
