# NPS Wildfire Risk Assessments Assessment Locations

## BLCA - Black Canyon Of the Gunnison National Park

# Diversion Dam Area

# NPS Wildand Fire Risk Assessment - Facility Assessment

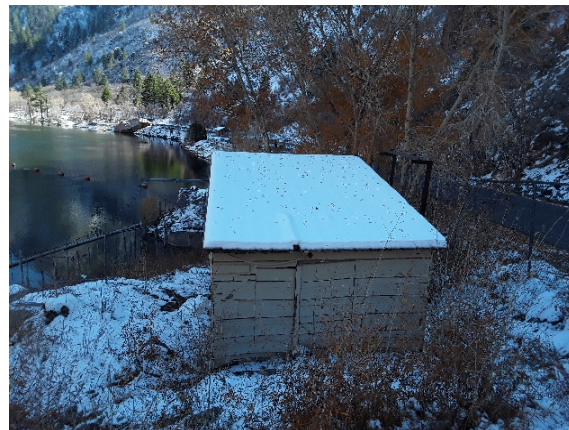
Z.jpg

Assessment Comments: Tactics included in adjacent structure.

Score: 65  
Rating: High

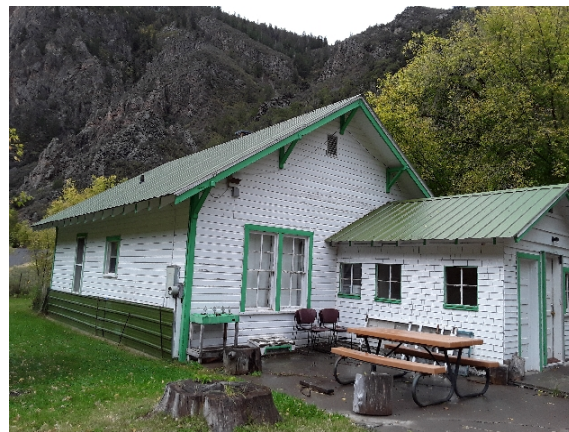
2022\_BLCA\_not found\_Caretakers Residence\_Front.jpg

**Score: 54**  
**Rating: Moderate**  
**Asset Priority Index (API):**  
N/A

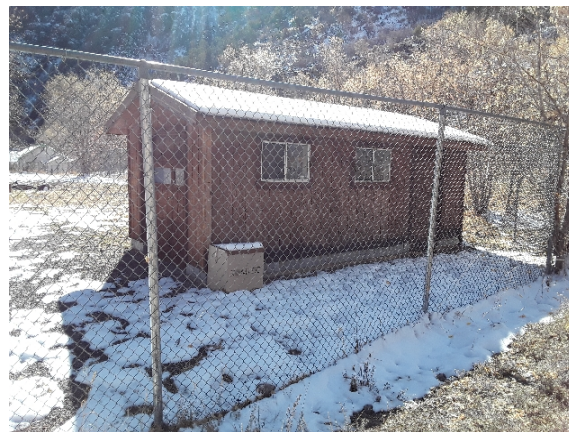
Z.jpg

**Assessment Comments:** Treatments and tactics included in adjacent structure.

**Score: 45**  
**Rating: Moderate**

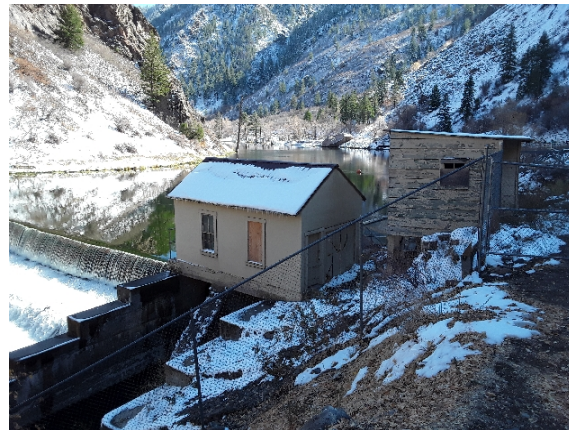
Z.jpg

Score: 82  
Rating: High

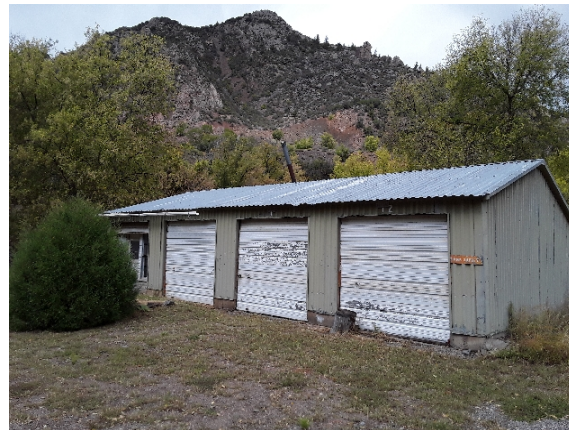
2022\_BLCA\_75184\_East Portal Garage / Storage Bldg\_Front.jpg

**Score: 61**  
**Rating: Moderate**

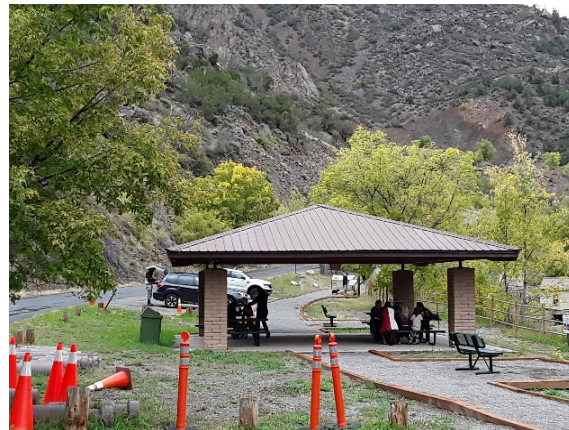
2022\_BLCA\_not found \_East Portal Picnic Shade Structure\_Front.jpg

**Score: 37**  
**Rating: Low**

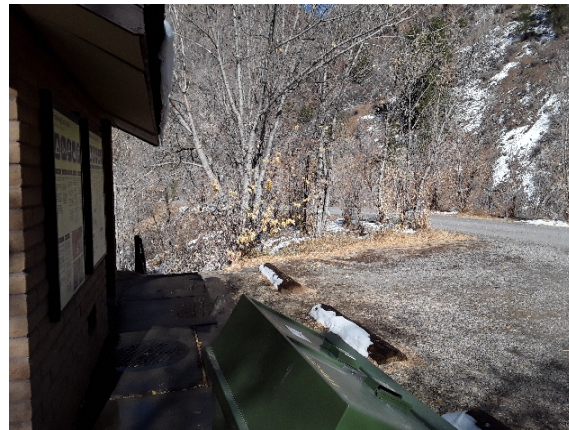
2020\_BLCA\_75187\_East Portal Campground Upper Comfort Station\_D\_.jpg

**Score: 58**  
**Rating: Moderate**

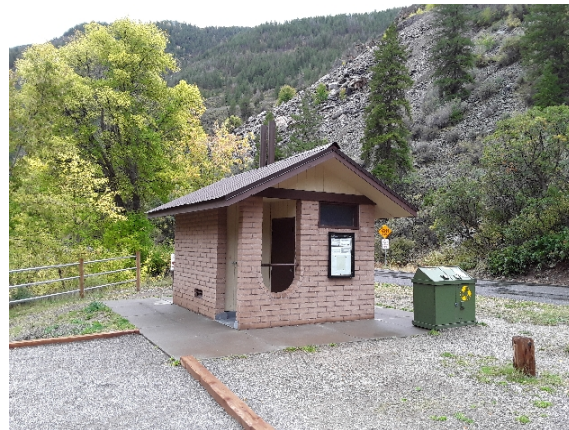
2022\_BLCA\_75198\_East Portal Picnic Area Comfort Station\_Front.jpg

**Score: 50**  
**Rating: Moderate**

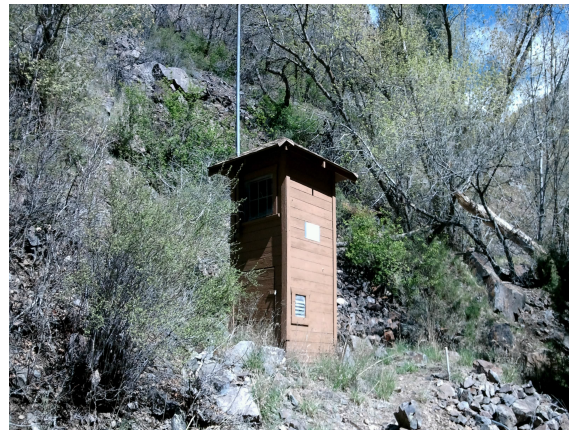
BLCA\_\_Crystal Dam Gauging Station\_Front.jpg

Score: 71  
Rating: High
