# NPS Wildfire Risk Assessments Assessment Locations

## Bent's Old Fort National Historic Site

# NPS Wildand Fire Risk Assessment - Facility Wildfire Risk Assessment Summary

## Unit - Location: BEOL - Bent's Old Fort

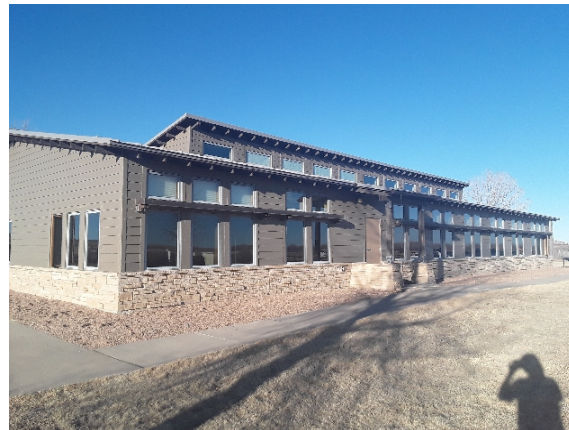
2021\_BEOL\_95818\_Administrative Building\_Front.jpg

Roof Material: Noncombustible or not applicable

Siding Material: Vinyl

Score: 18  
Rating: Low

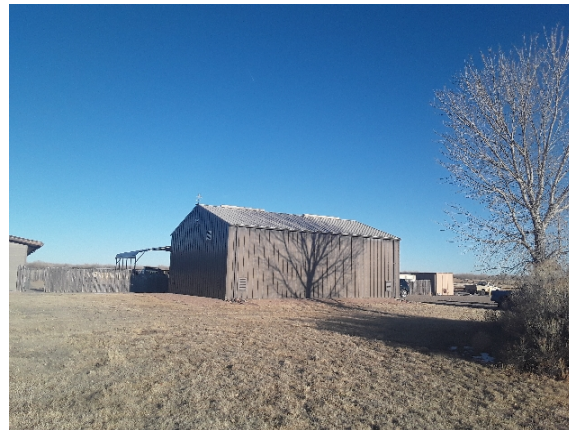
2021\_BEOL\_65830\_Lester Building\_Front.jpg

Siding Material: Rock, concrete, metal

Hazmat: fuel station

Score: 16  
Rating: Low

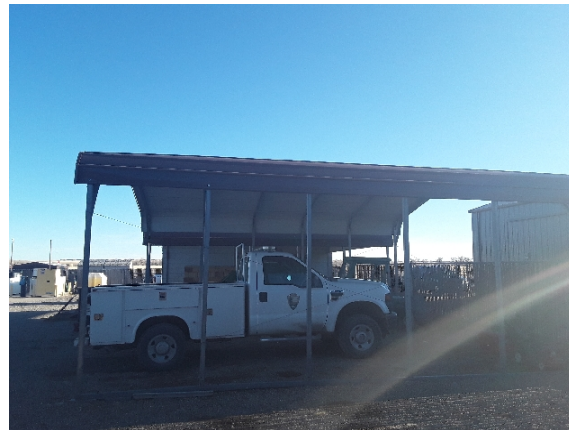
2021\_BEOL\_not found \_Shed\_Front.jpg

**Siding Material:** Vinyl

**Hazmat:** fuel station

**Score: 18**  
**Rating: Low**

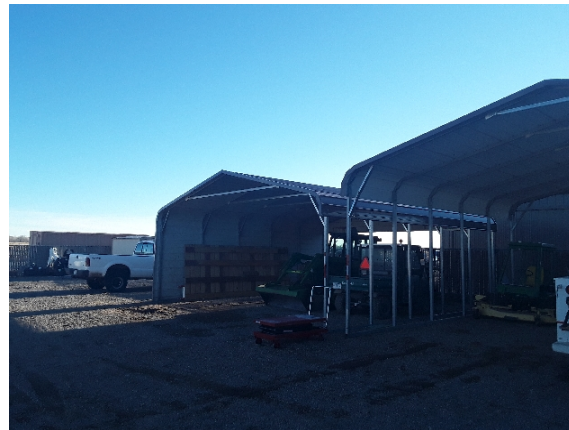
2011\_BEOL\_not found\_Shed\_Front.jpg

**Siding Material:** Rock, concrete, metal

**Hazmat:** fuel station

**Score: 16**  
**Rating: Low**

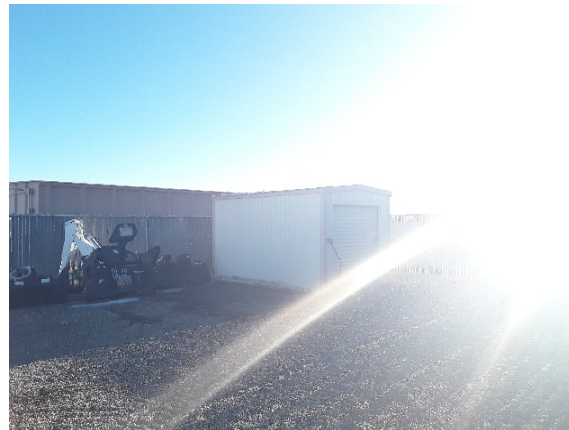
2021\_BEOL\_50453\_Bally Building\_Front.jpg

Siding Material: Vinyl

Hazmat: fuel station

Score: 18  
Rating: Low

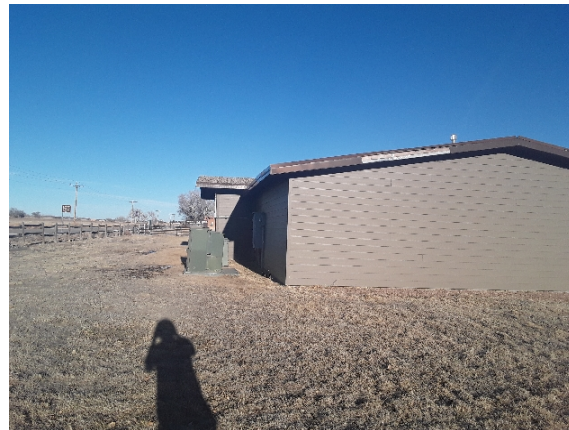
2021\_BEOL\_50321\_Maintenance Shop\_Front.jpg

**Defensible Space:** 100 ft treated  
**Fuel Load (w/in 300 ft):** Light  
**Fuel Type (w/in 300ft):** Shrub or timber  
**Topography (w/in 300ft):** Slope <5%

**Roof Material:** Fire resistant- tar,rubberized  
**Siding Material:** Rock, concrete, metal  
**Foundation:** Closed, >30in masonry exposed or N/A  
**Fences/Decks:** None or noncombustible

**Score: 21**  
**Rating: Low**

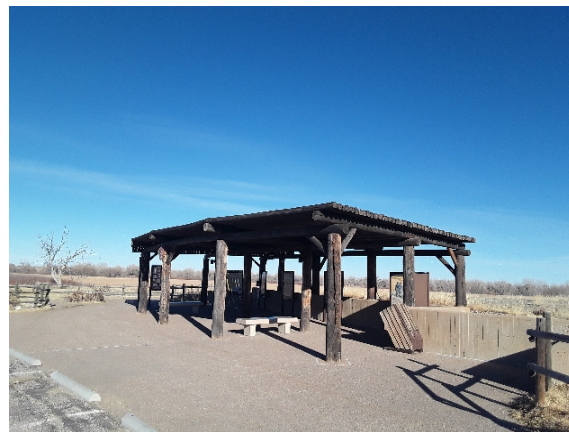
2021\_BEOL\_105449\_Visitor Contact Station\_Front.jpg

Defensible Space: <30 ft treated

Roof Material: Combination of fire resitant and combustible

Siding Material: Vinyl

Score: 52  
Rating: Moderate

| Label # | Facility/Community Name | Assessment Scale | Site Visit Type | Firewise Zone | Treatment | Treatment Description | Person Hours |
|---|---|---|---|---|---|---|---|
| 7 | Visitor Contact Station | Individual Facility | Initial | 1 | Mow dead/dying grass to less than 4 inches | | 2.0 |

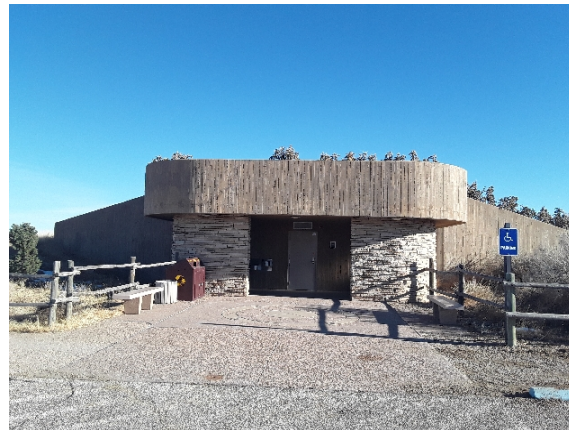
2021\_BEOL\_50541\_Comfort Station\_P.jpg

**Defensible Space:** <30 ft treated  
**Fuel Load (w/in 300 ft):** Light  
**Fuel Type (w/in 300ft):** Shrub or timber  
**Topography (w/in 300ft):** Slope <5%

**Roof Material:** Fire resistant- tar,rubberized  
**Siding Material:** Rock, concrete, metal  
**Foundation:** Closed, >30in masonry exposed or N/A  
**Fences/Decks:** None or noncombustible

**Score: 38**  
**Rating: Low**

| Label # | Facility/Community Name | Assessment Scale | Site Visit Type | Firewise Zone | Treatment | Treatment Description | Person Hours |
|---|---|---|---|---|---|---|---|
| 8 | Comfort Station | Individual Facility | Initial | 1 | Mow dead/dying grass to less than 4 inches | | 2.0 |

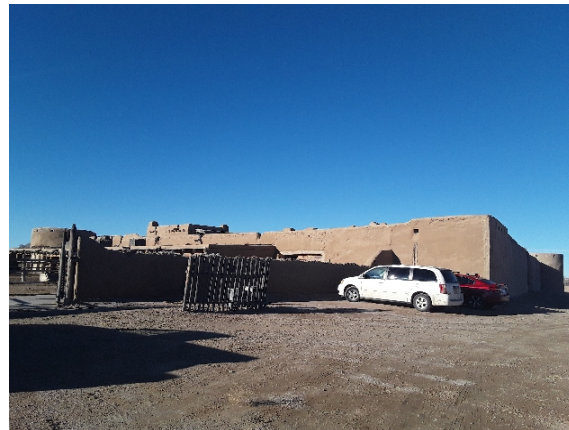
2021\_BEOL\_50483\_Fort exterior\_Front.jpg

Resources of Concern Present? Yes, contact unit staff before engaging.

Water Supply: Limited or dependent on electricity

Safety Zones: No safety zone(s) in area

Score: 26  
Rating: Low

| Label # | Facility/Community Name | Assessment Scale | Site Visit Type | Firewise Zone | Treatment | Treatment Description | Person Hours |
|---|---|---|---|---|---|---|---|
| 9 | Fort exterior | Individual Facility | Initial | 1 | Mow dead/dying grass to less than 4 inches | | 2.0 |
